HISTORIC STRUCTURES REPORT

BATES WELL RANCH

ORGAN PIPE CACTUS NATIONAL MONUMENT

A Service Learning Project of the
Preservation Studies Program
College of Architecture and Landscape Architecture
The University of Arizona

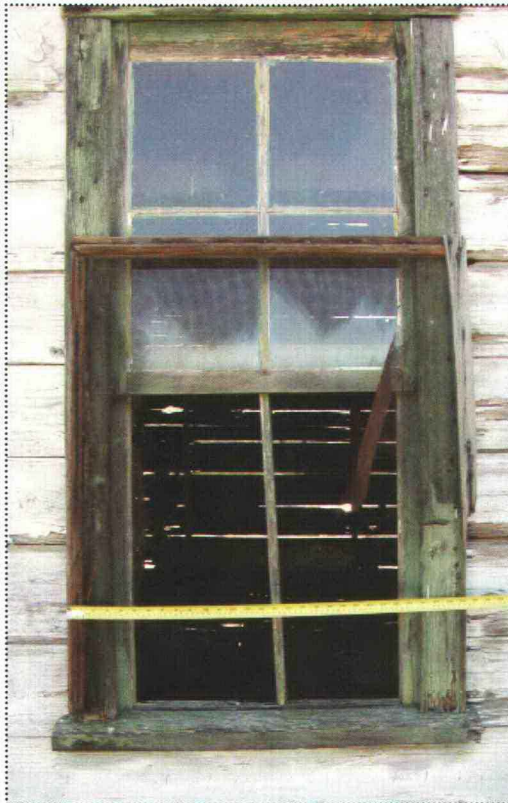
M. View of the window on north wall. Note the new frame nailed on top .

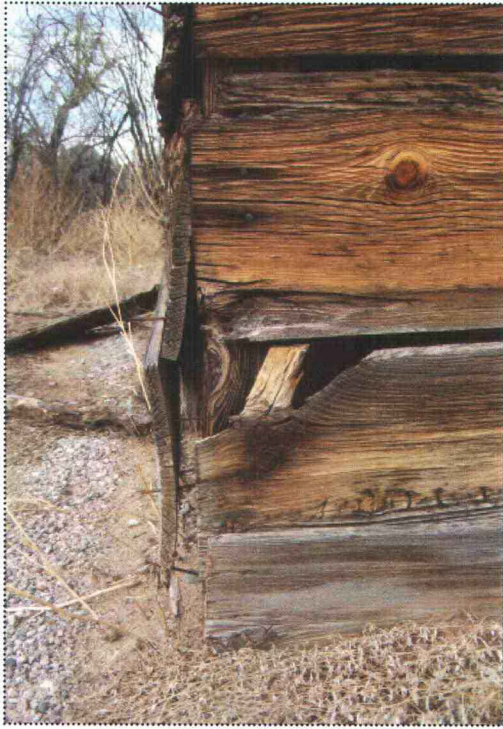
A,B,C. Water damage to wood paneling and fascia including warping and splintering & rotting due to microorganisms/ pests.

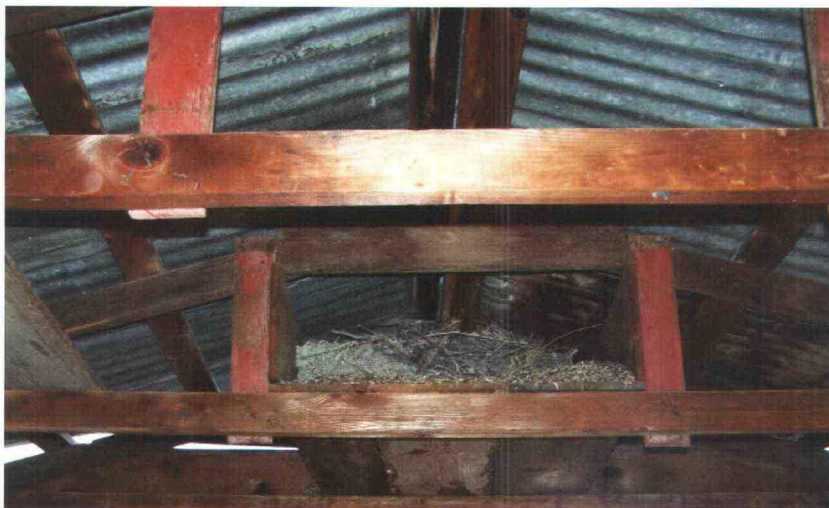
K. Pack rat midden in the roof platform inside the structure

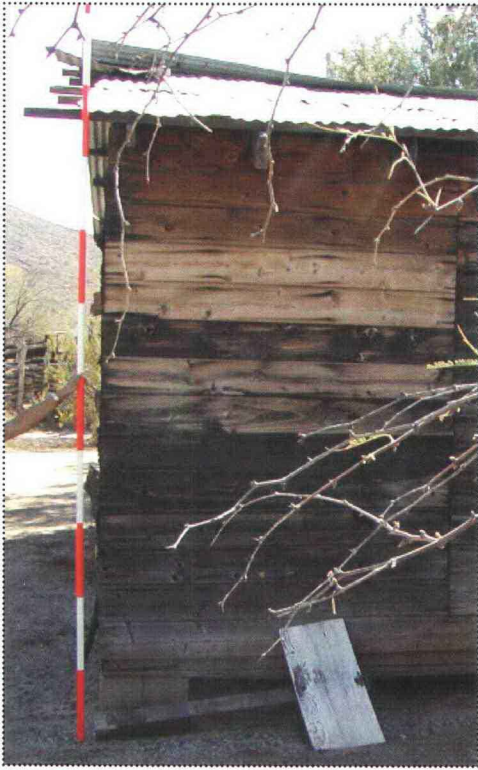
J. Detail view of north facade. Note the plank that is falling apart off near the base of the structure

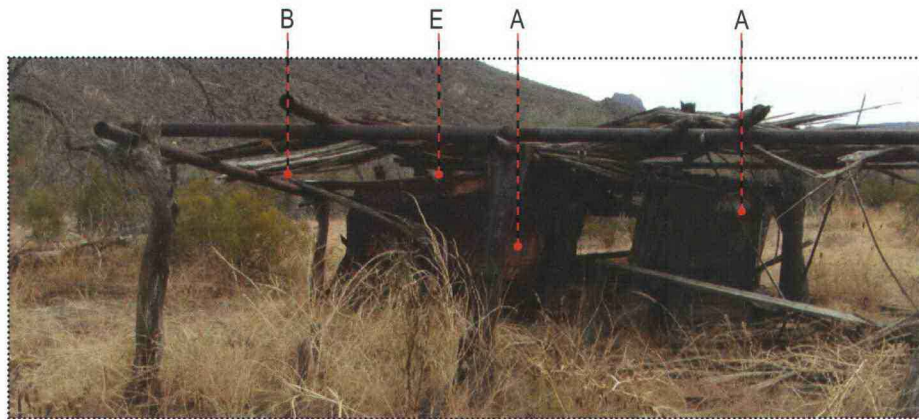
North elevation of Blacksmith Shop. (letters refer to notes in condition assessment table below)

Deficiencies	Recommended Treatments	Priority
A	Corrugated metal contains severe rust damage.	Replace roof with like material	Serious
B	Rotted/termite infested Wood	Application of biocides where damage is severe.	Critical
C	Missing Components	Replace lost components	Serious
D	Water Damage	Replace roof and repair or replace damaged material.	Serious
E	Broken Window Framing/glazing	Replace and repair as needed	Serious
F	Structural Failure	Repair structural damage	Critical

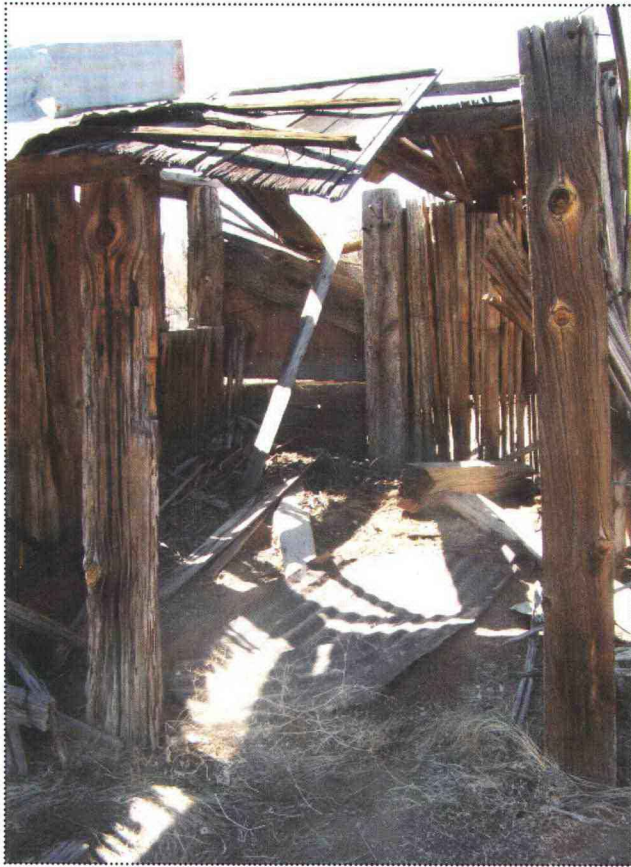
Interior of the Ocotillo Shed

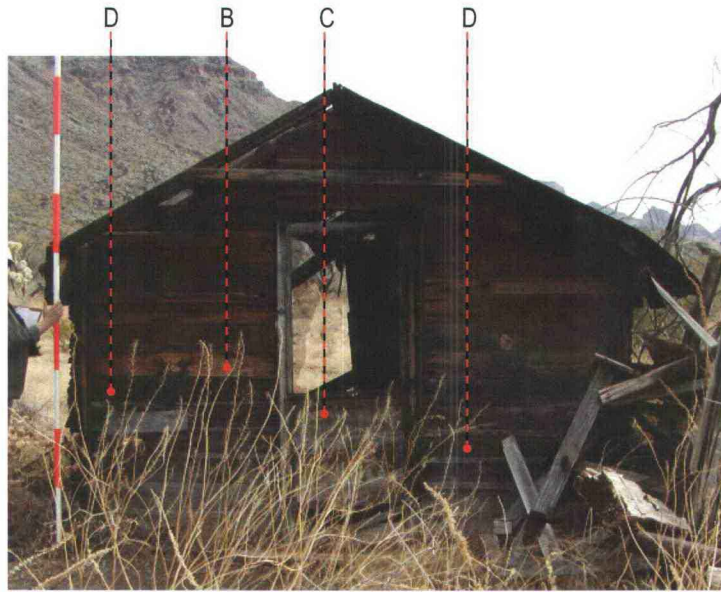
North elevation of the Small Residence (letters refer to notes in condition assessment table below)

Deficiencies	Recommended Treatments	Priority
A	Corrugated metal roof contains severe rust damage.	Replace roof with like material	Serious
B	Rotted/termite infested Wood	Application of biocides where severe damage.	Critical
C	Missing Components	Replace lost components with like material	Serious
D	Water Damage	Replace roof and repair or replace damaged material.	Serious
E	Broken Window Framing/glazing	Replace and repair as needed	Serious
F	Structural Failure	Repair structural damage	Critical

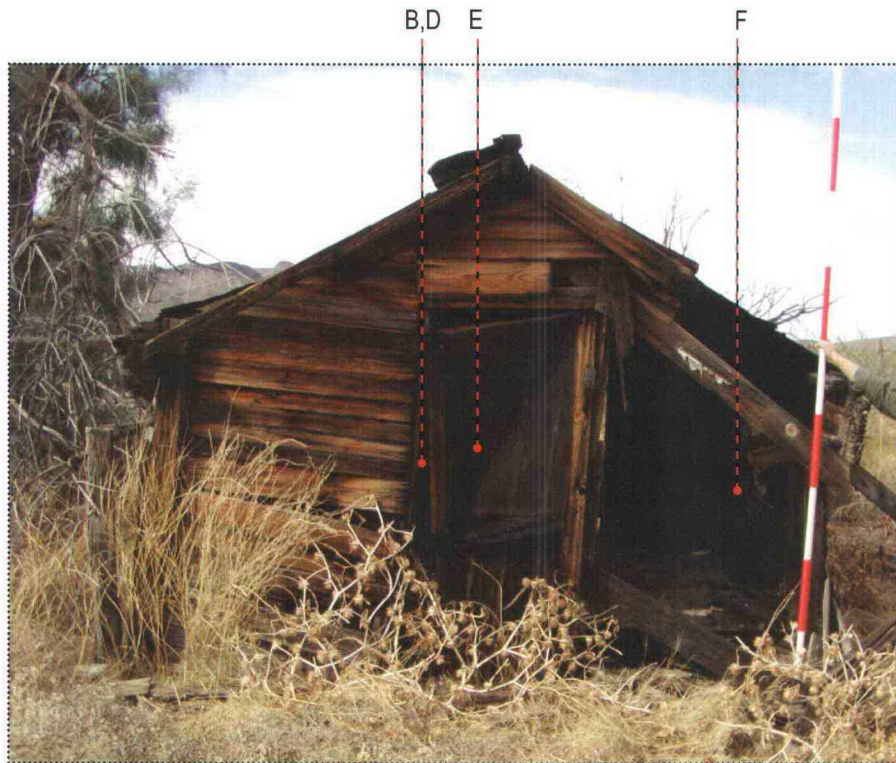
South elevation of the Small Residence (letters refer to notes in condition assessment table below)

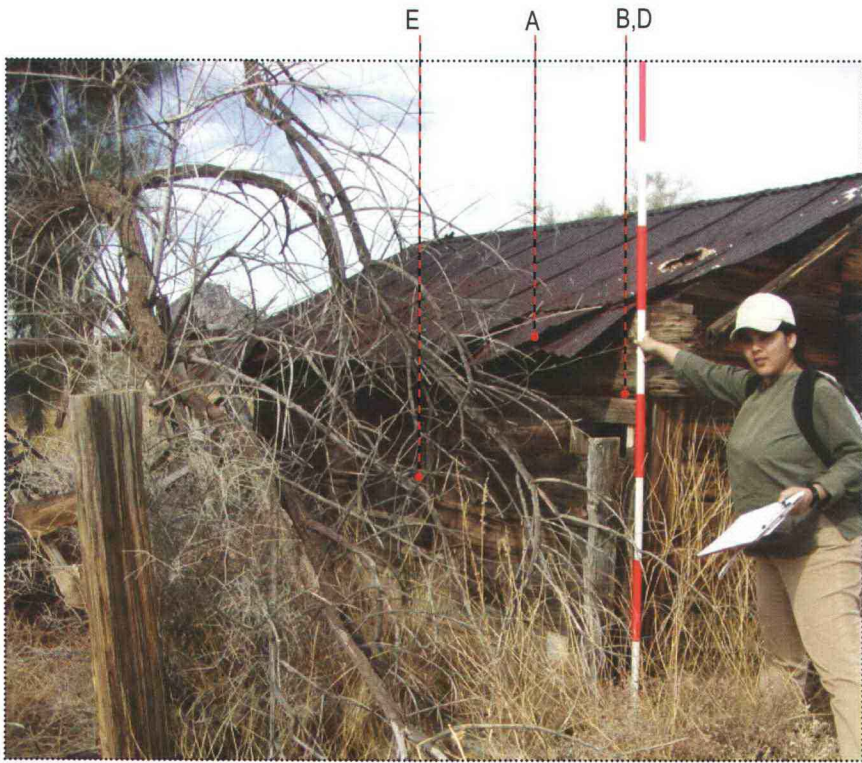
West elevation of the Small Residence (letters refer to notes in condition assessment table below)

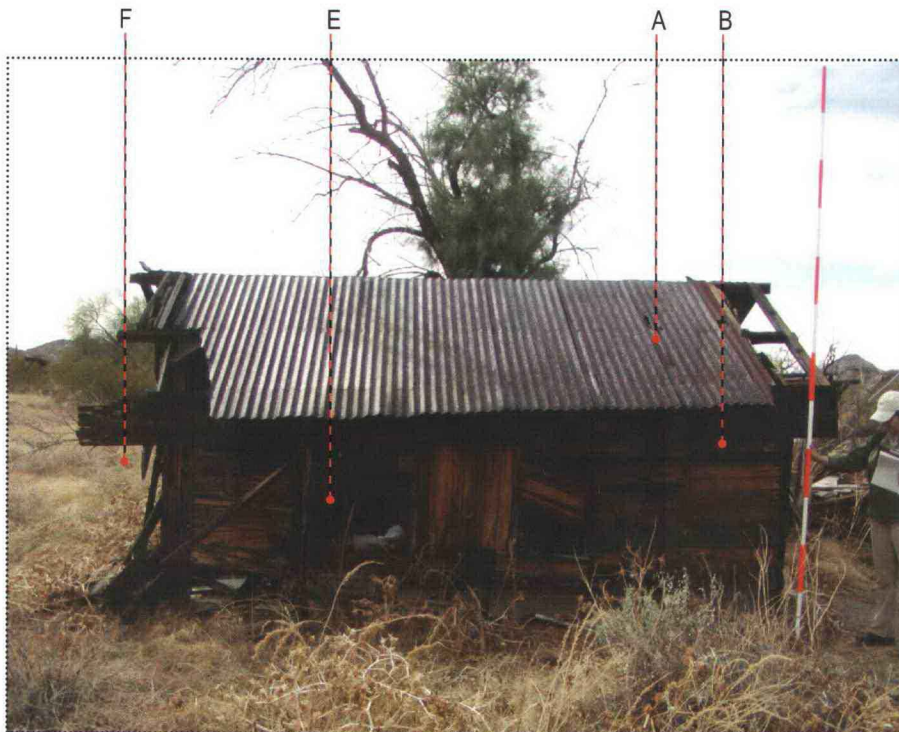
East elevation of the Small Residence (letters refer to notes in condition assessment table below)

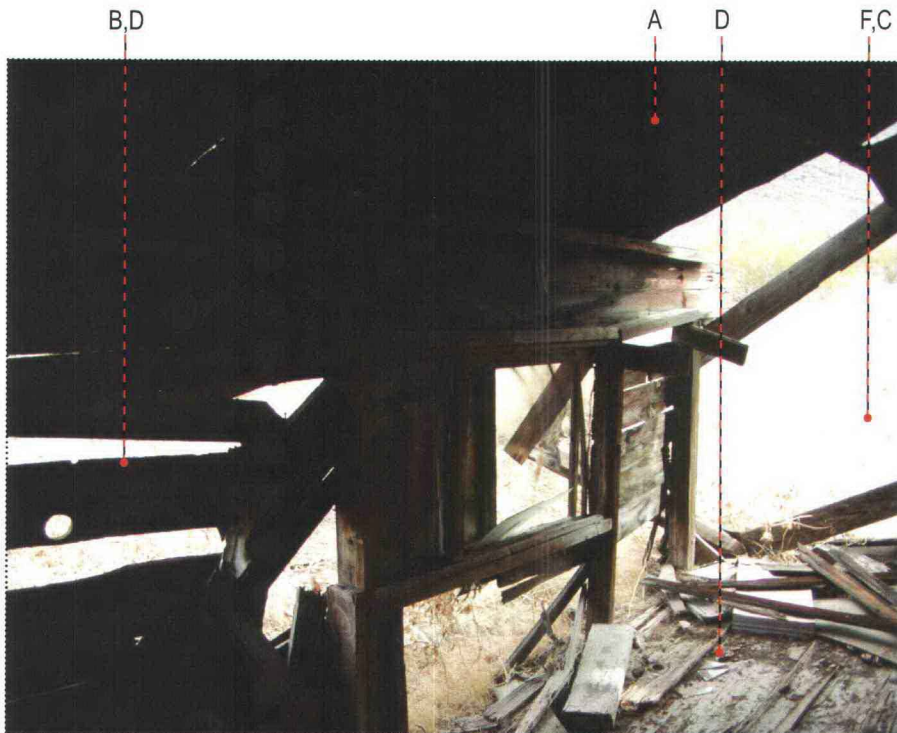
The building was in poor condition in 1986 when the National Register of Historic Places nomination was completed and has continued to deteriorate. The southeast corner of the building has failed and the building is leaning in this direction. It is only a matter of time before the balance of the building fails as well.

Interior southeast corner of the Small Residence (letters refer to notes in condition assessment table below)

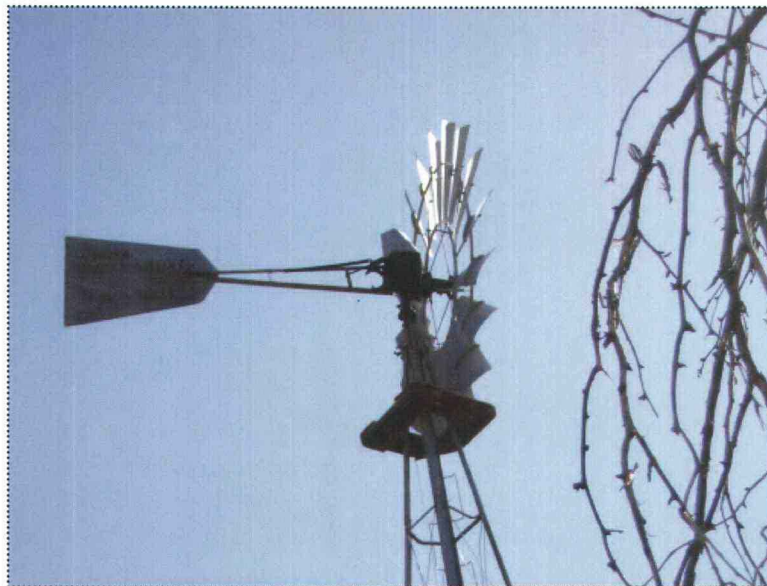
View of Windmill 2 - blades and vane from the north side.

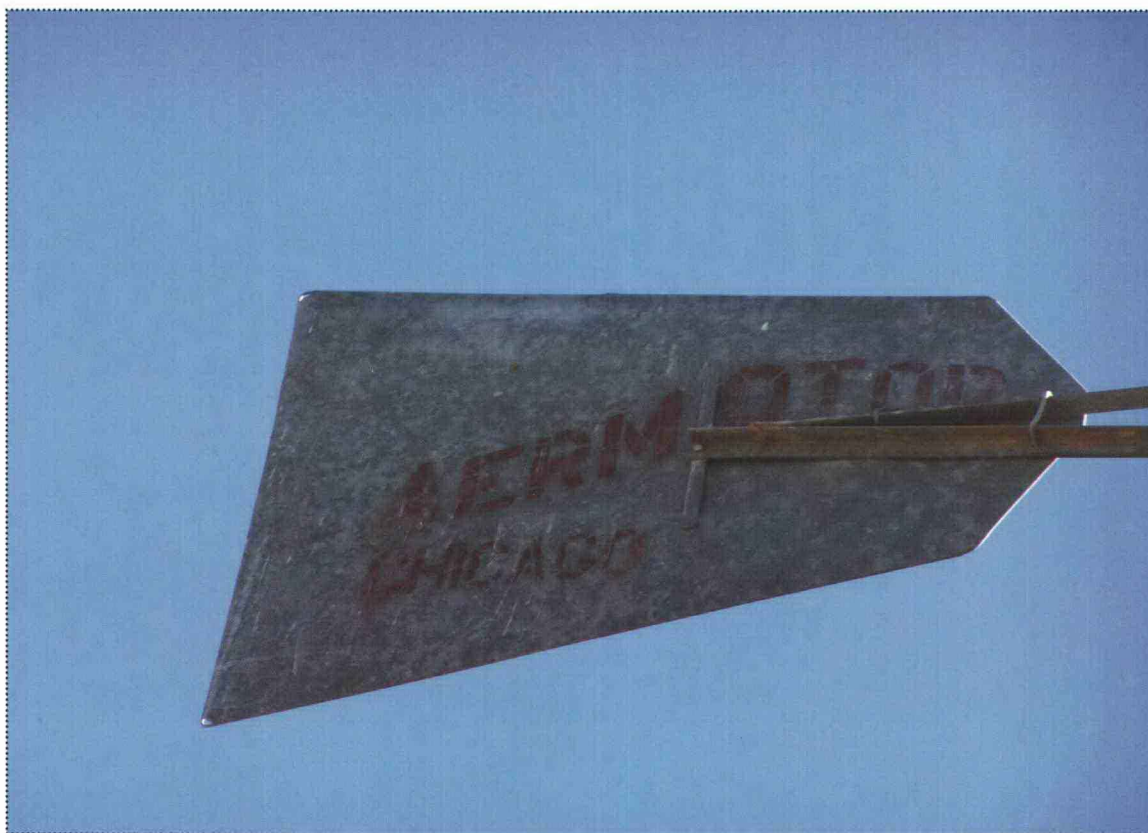
View of vane - windmill 3

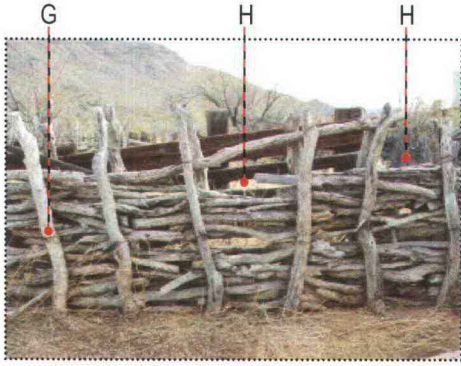
1 Horizontally stacked mesquite logs & regularly spaced vertical mesquite posts

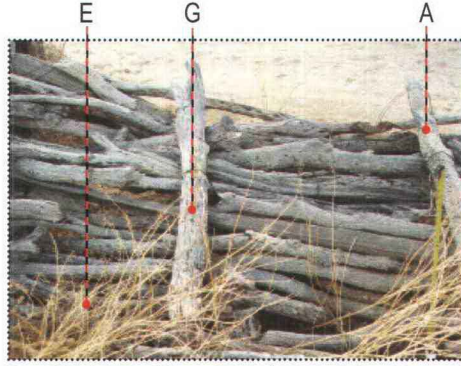
2 Horizontally stacked mesquite logs & regularly spaced vertical mesquite posts, collapsed

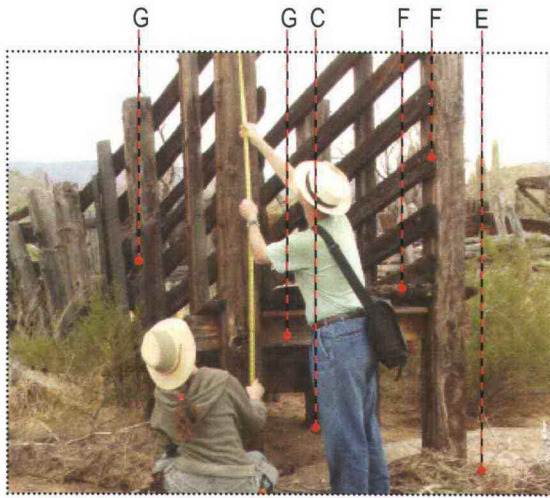
North elevation of the larger cattle chute (letters refer to notes in condition assessment table)

Deficiencies	Recommended Treatments	Priority
A	Complete structural collapse	Reconstruct collapsed portions using original material where possible; if original material is missing like elements should be used in the reconstruction	Critical
B	Partial structural collapse	Stabilize the structure where possible, any collapsed portions should be reassembled	Critical
C	Structural undermining attributed to water	Correction of the water source; replacement of earth where water has caused undercutting	Critical
D	Material displacement	Reinsertion of material where ever possible; if material is cracked or severely damaged replacement with a similar element is suggested	Serious
E	Vegetable overgrowth	Trim or remove vegetation within the corral	Serious
F	Cracking of wood from lack of moisture	Replace only when threatens the stability of the member	Low
G	Staining of wood due to water	Allow to occur naturally	Low

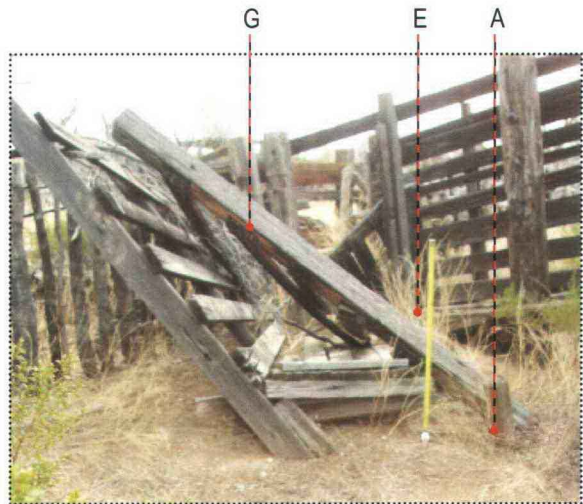
Northeast elevation of the smaller chute (letters refer to notes in condition assessment table)

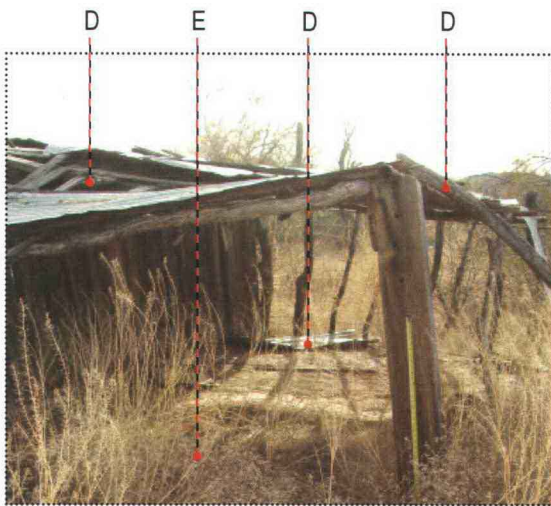
East elevation of the shade structure (letters refer to notes in condition assessment table)

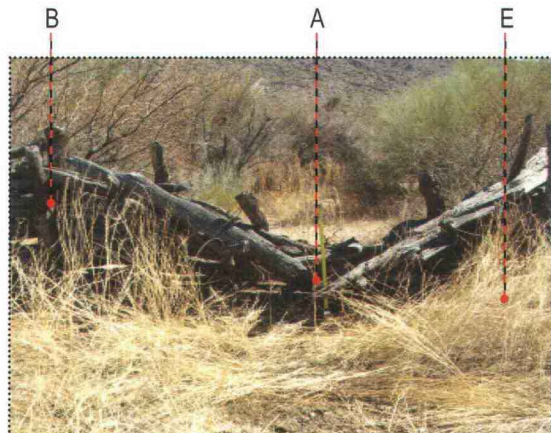
4 Collapsed portion of mesquite stacked fence

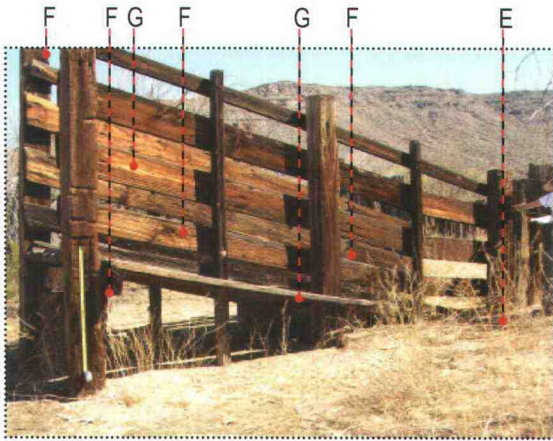
East elevation of the cattle chute (letters refer to notes in condition assessment table)

Deficiencies	Recommended Treatments	Priority
A	Complete structural collapse	Reconstruct collapsed portions using original material where possible; if original material is missing similar elements should be used in the reconstruction	Critical
B	Partial structural collapse	Stabilize the structure where possible, any collapsed portions should be reassembled	Critical
C	Pooling of stagnate water	Reinstate well water circulation by reactivating windmill/well and repairing metal pipeline from well to trough	Low
D	Material displacement	Reinsertion of material where ever possible; if material is cracked or severely damaged replacement with a similar element is suggested	Serious
E	Vegetable overgrowth	Trim or remove vegetation within the corral	Serious
F	Cracking of wood due to exposure	Replace only when threatens the stability of the member	Low
G	Staining of wood due to water	Allow to occur naturally	Low

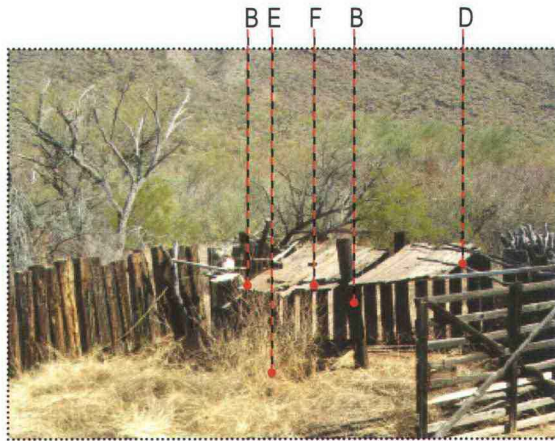
Southeast elevation of the shade structure (letters refer to notes in condition assessment table)

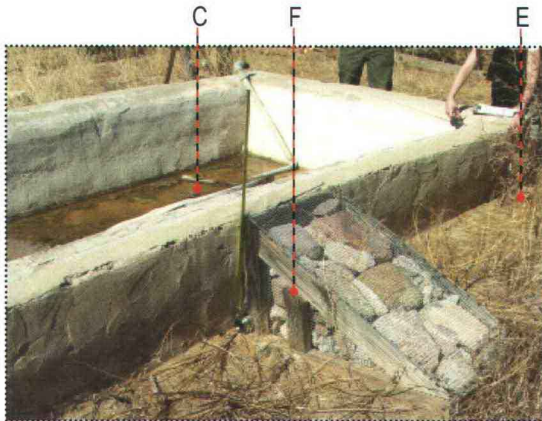
Southwest view of the concrete trough and ramp-like configurations (letters refer to notes in condition assessment table)

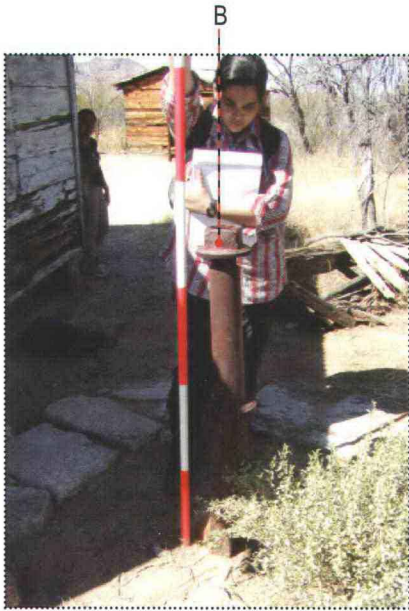
Center axle of Arrastra (letters refer to notes in condition assessment table below)

Deficiencies	Recommended Treatments	Priority
A	Missing Granite Stones	Replace with same	Medium
B	Missing arm and grinding wheel	Replace if period becomes part of significance.	low

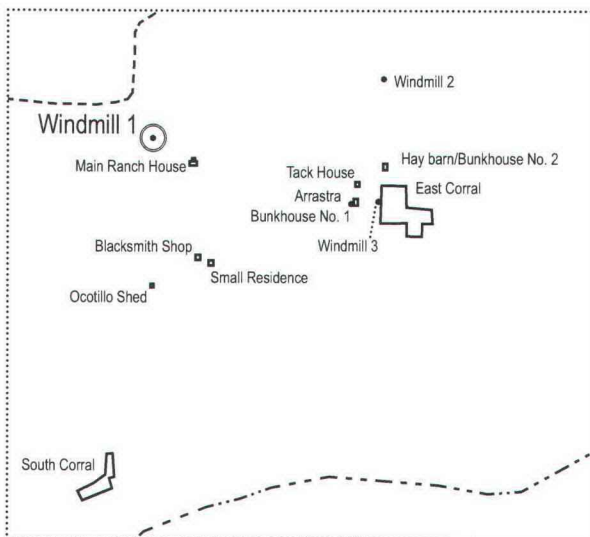
Windmill 1 is the most recent of all windmills on site, and is nearest to the Main Ranch House. Its frame is in good shape, with none of the members missing or badly deteriorated. There is not a significant amount of rust damage. The motor and rudder on the windmill are intact, but the blades have fallen to the ground, and lie near the base of the windmill. Some of these may be missing, and certainly many are damaged. The rod that connects the windmill to the well in order to pump the water is broken, and hence the pumping mechanism is

dysfunctional. The pipes that brought water from the well to the Southern Corral are disconnected and broken and pieces lie around the base of the structure. The concrete pad is in good shape

The recommended treatment for Windmill 1 is *Preservation* as defined by the Secretary of the Interior's Standards for the Treatment of Historic Properties. For more specific treatment recommendations, see the *Ultimate Treatments* section.

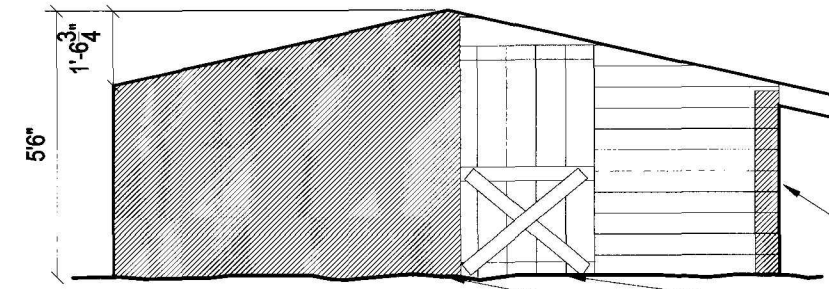
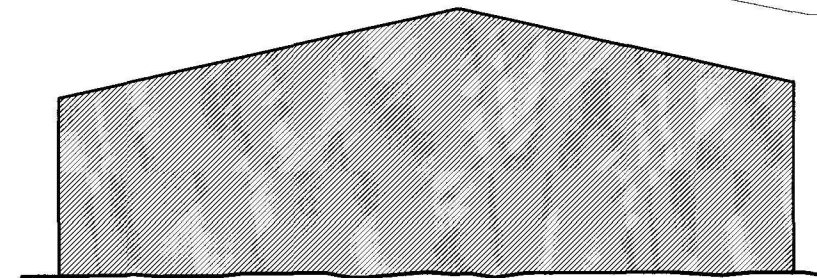
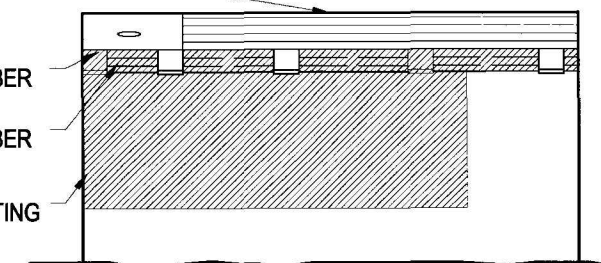
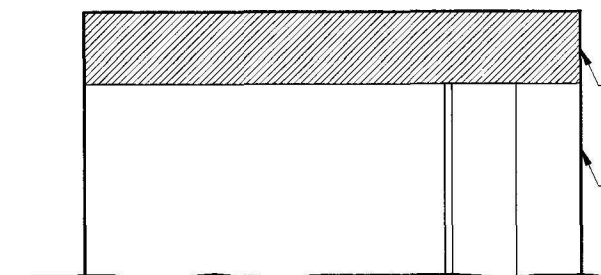
7

FAILURE OF CORNER POST CAUSING BUILDING TO LIST TO THE RIGHT (WEST)

CEDAR SHAKE ROOF IN ADVANCE STATE OF FAILURE

MISSING 1 X 6 LUMBER

CORRUGATED STEEL DELAMINATING

COMPLETE FAILURE OF ROOF - SEE EAST ELEVATION FOR DETAILS OF CONSTRUCTION

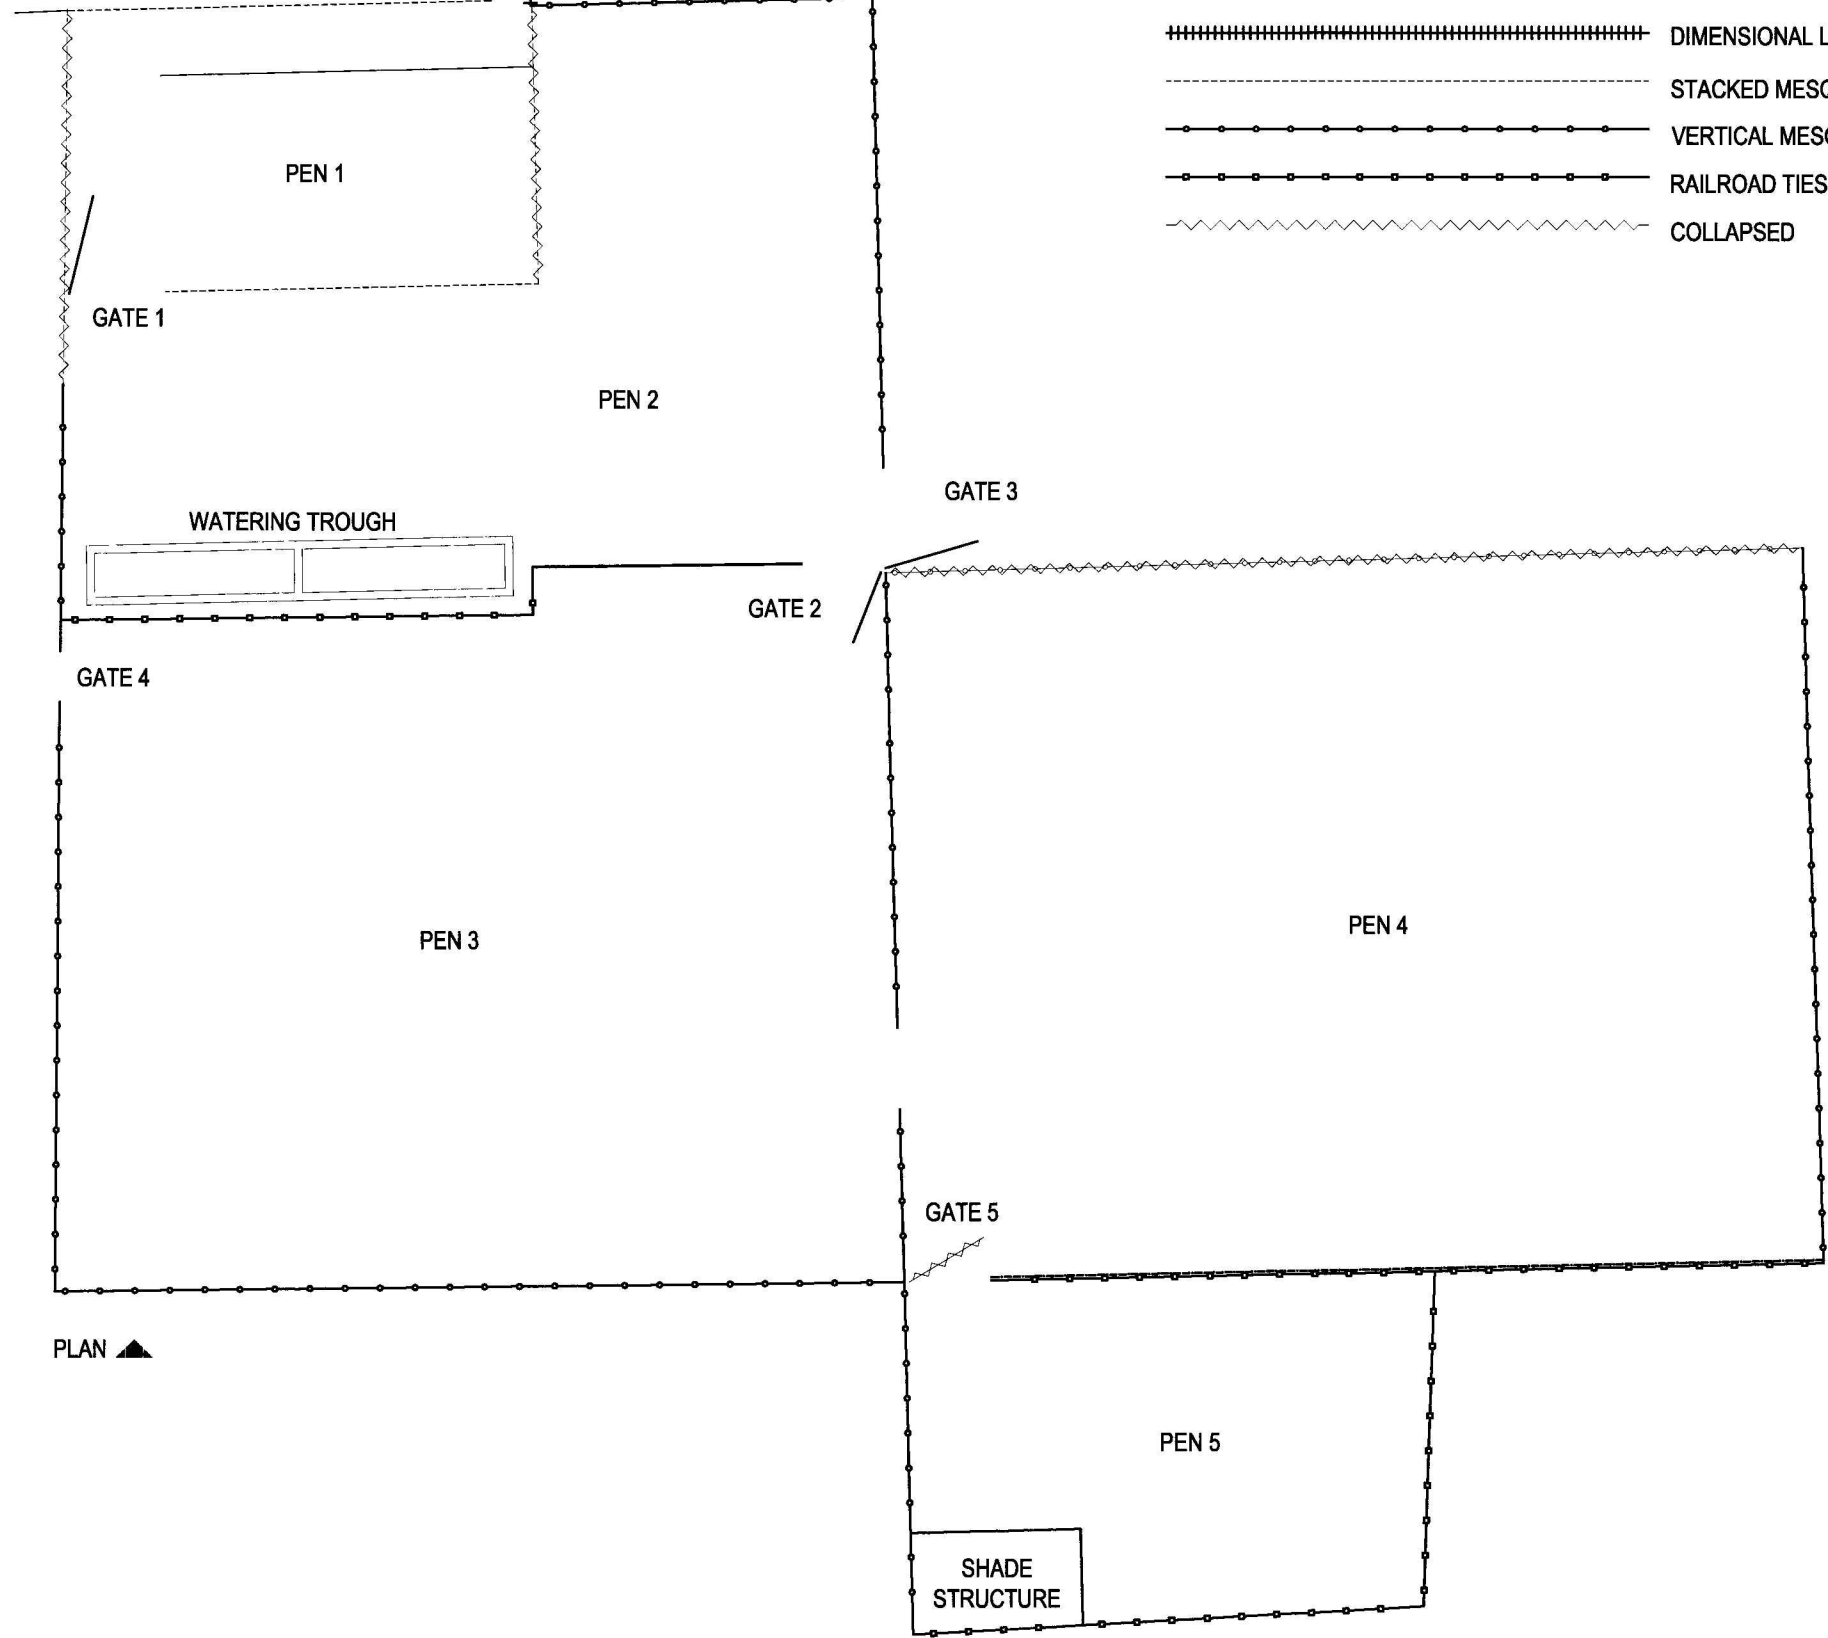
EAST CORRAL

- DIMENSIONAL LUMBER
- STACKED MESQUITE LOGS
- VERTICAL MESQUITE POSTS
- RAILROAD TIES
- COLLAPSED

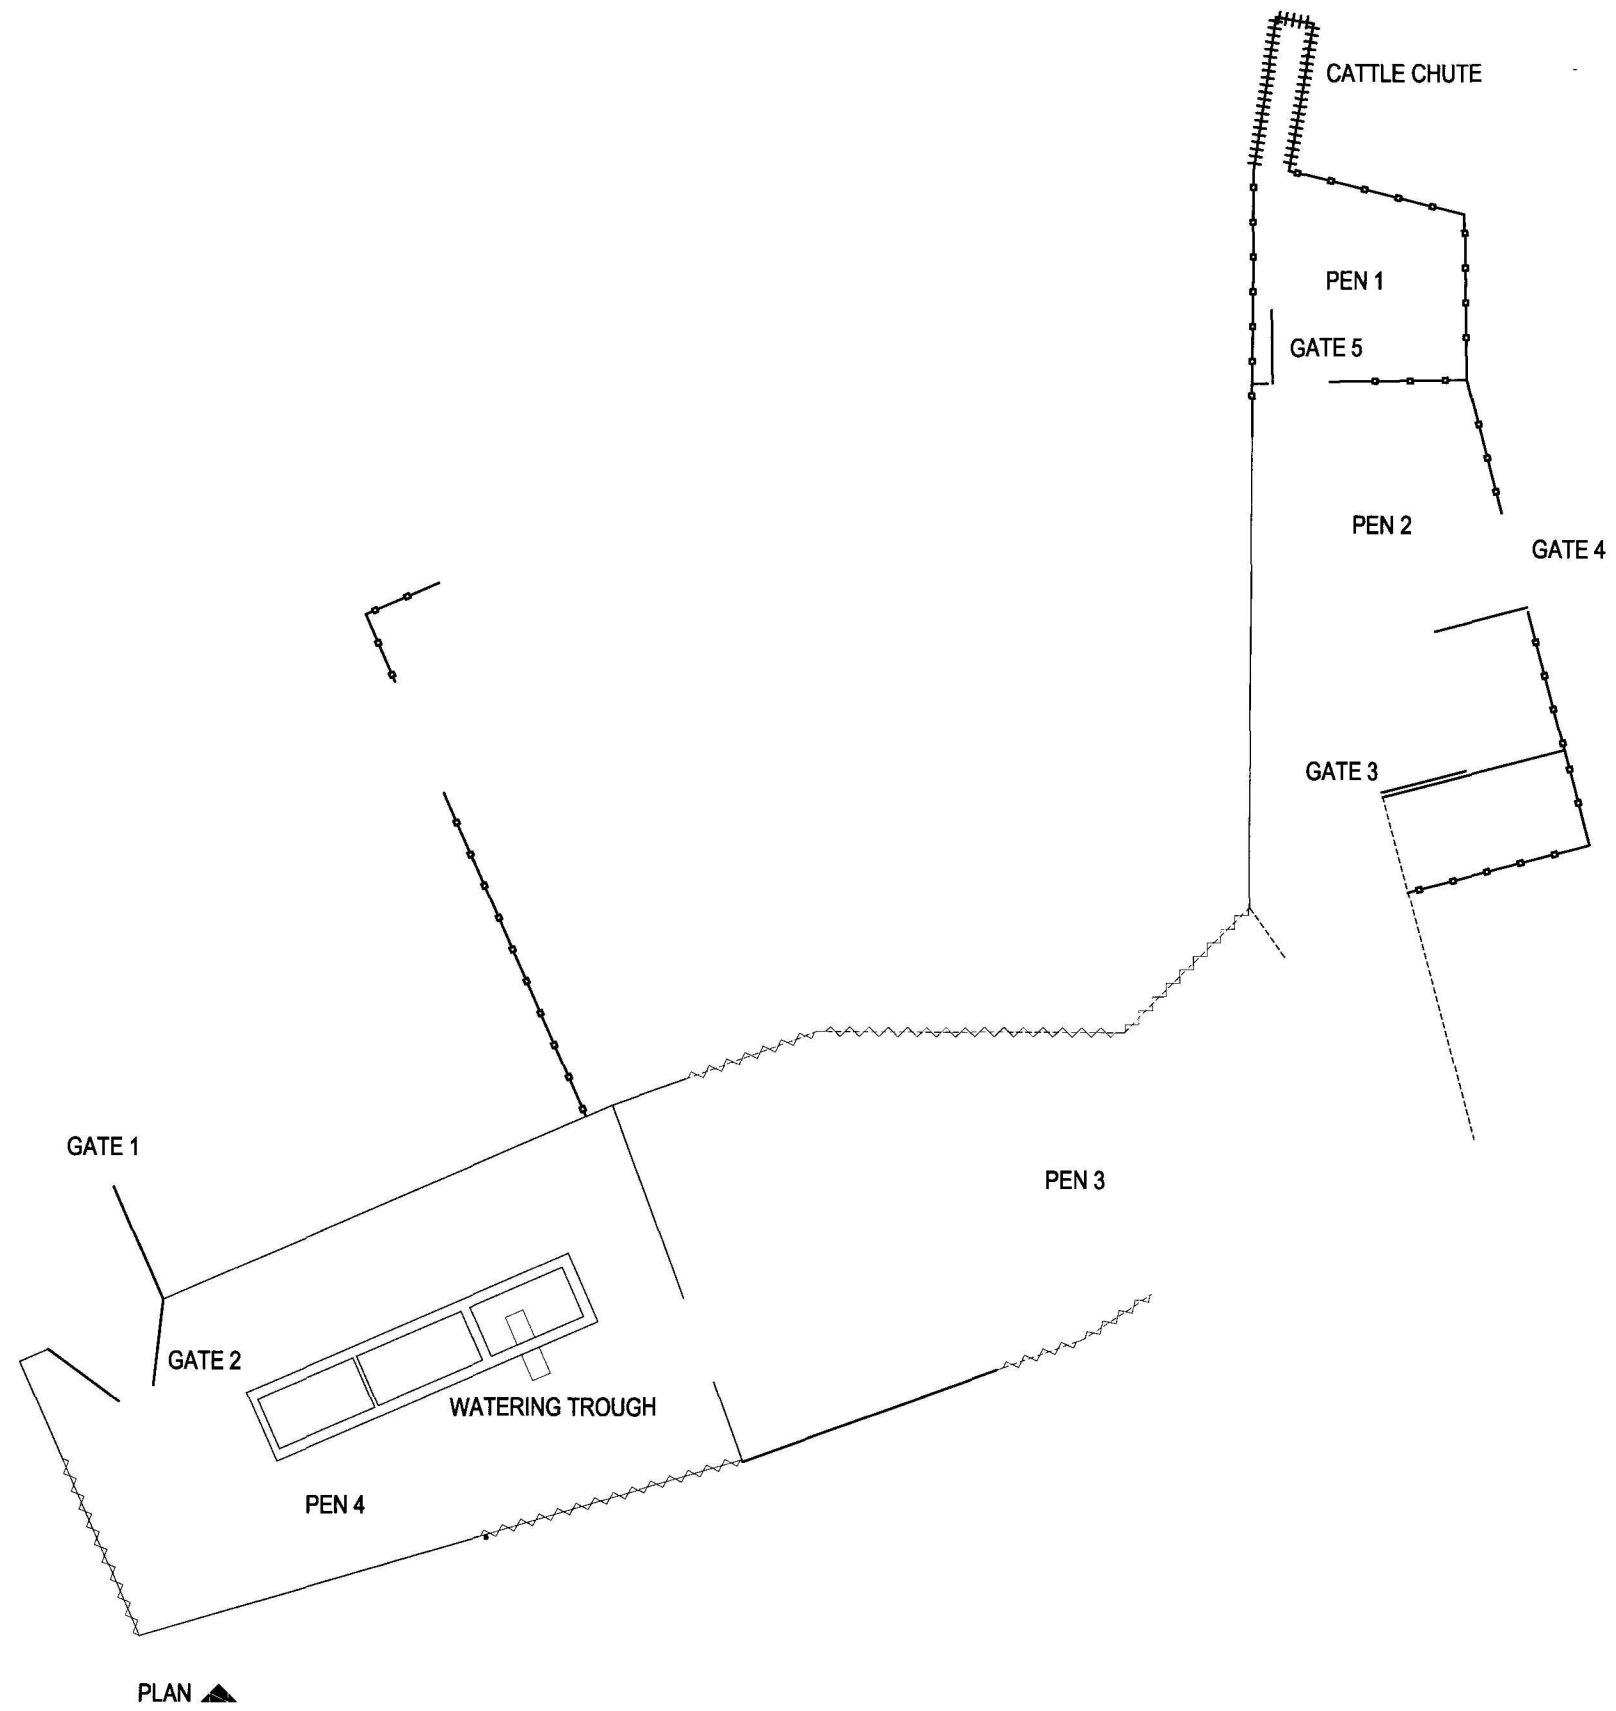
PLAN ▲

- ===== DIMENSIONAL LUMBER
- STACKED MESQUITE LOGS
- _____ HORIZONTAL RAILROAD TIES
- - - - - RAILROAD TIES
- ~~~~~ COLLAPSED
