HISTORIC STRCUTURE REPORT THEODORE ROOSEVELT BIRTHPLACE NATIONAL HISOTRIC SITE

CONTRACT No. 1443CX2000, PMIS 16068

NATIONAL PARK SERVICE DENVER SERVICE CENTER

JOHN MILNER ARCHITECTS, INC. 104 LAKEVIEW DRIVE CHADDS FORD, PA 19317

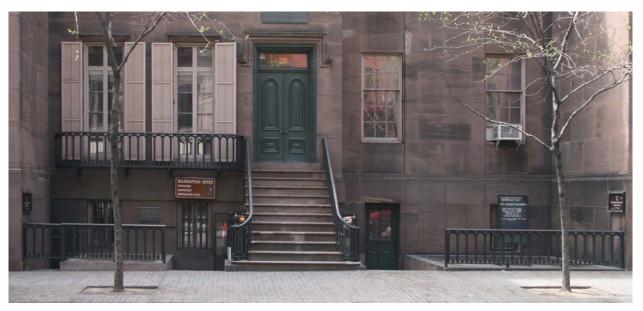
Exterior landscape of Theodore Roosevelt Birthplace, JMI, 2006.

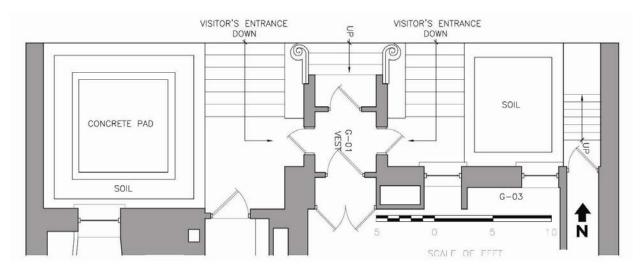
The paving on the sidewalk is comprised entirely of brick pavers and extends the entire width of the property from the street curb to the edge of the property. The pavers are in good condition overall, however there are a few broken units along the street curb. There are two trees located within the field of the brick pavers, measuring approximately 25 feet in height.

Exterior landscape plan of Theodore Roosevelt Birthplace north facade, JMI, 2006.

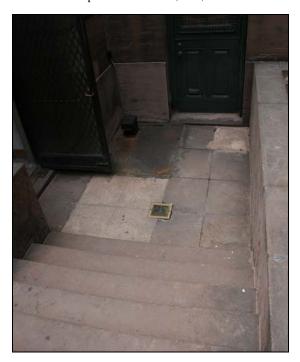
Brownstone and concrete tiles on west entrance. Inoperable coal shoot at top left JMI, 2006.

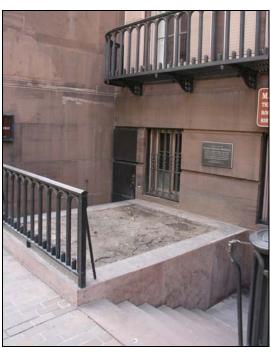
There are two soil beds, one in front of each building section. These beds have periodically been planted with vegetation, but are currently void of plantings. The western bed also contains a concrete slab which is in good condition; however the purpose of this slab is unclear. The slab and soil within the bed are sloped towards the building. The western and the eastern bed appear to have no means of proper drainage and may be contributing to interior moisture issues at the basement level.

Soil bed on east side of Theodore Roosevelt Birthplace north facade, JMI, 2006.

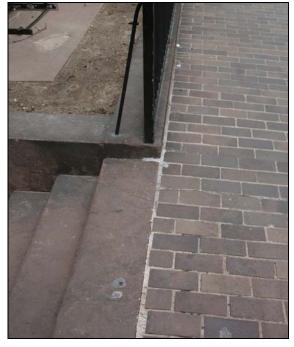
The paving within the building set-back is comprised of brownstone stair treads and pavers as well as composite cementitious materials. The brownstone steps have been significantly patched throughout and are currently in good condition. The slate pavers which flank the main stair have been damaged in the past and replaced with poured-in-place concrete.

Detail of brownstone steps and brick sidewalk pavers, JMI, 2006.

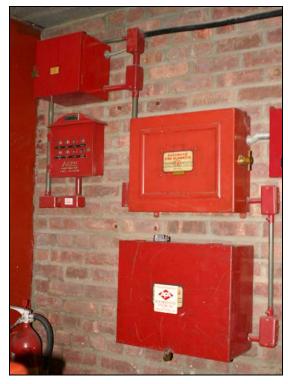
<u>UNITS IN PLACE:</u> Equipment for two different fire alarm systems is installed in the landing of the stairway: [Aero Automatic Fire Alarm] and [Automatic Fire Alarm Co]. One wall mounted wood hand rail exhibits some wear.

Detail of the fire alarm systems, JMI, 2006.

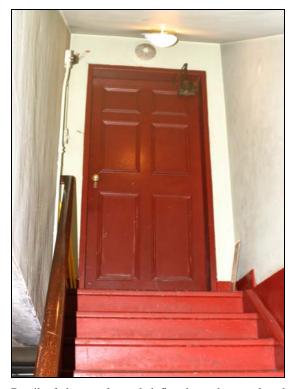
<u>WALLS:</u> The walls in this stairway are composed of concrete and are painted white. There is an 8" concrete baseboard which is painted red. Both the wall and the baseboard are in fair condition, and are characterized by isolated areas of flaking paint. A wood handrail is mounted on the east wall and shows signs of wear.

Detail of the metal paneled fire door, the metal and concrete staircase, and the wood hand rail, JMI, 2006.

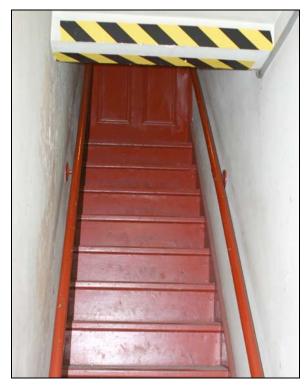
View of the metal paneled fire door, the metal and concrete staircase, and the metal hand rails, JMI, 2006.

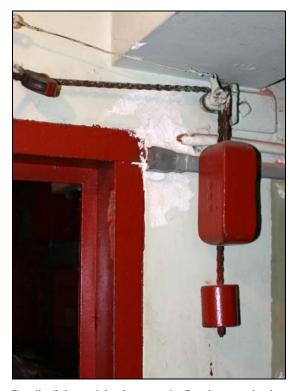
Detail of the weighted automatic fire door mechanics, JMI, 2006.

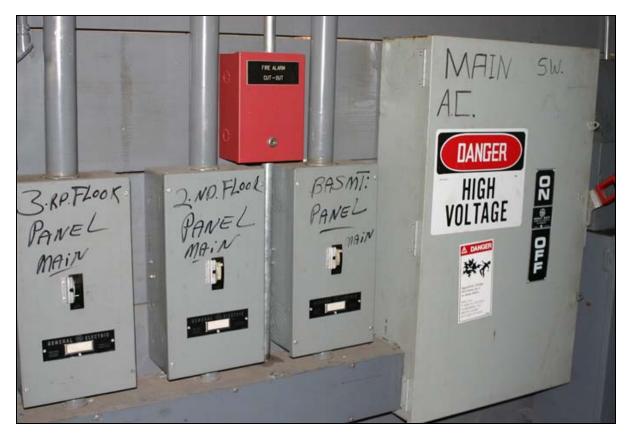
Main electrical AC breaker and sub breakers, JMI, 2006.

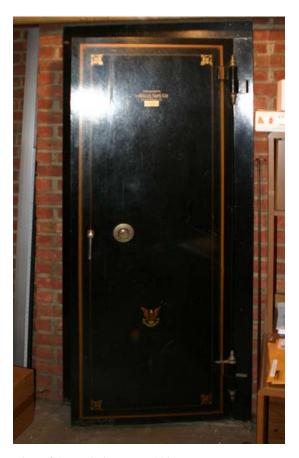
<u>UNITS IN PLACE</u>: The vault itself was manufactured by Halls Safe Co.; Cincinnati OH and appears to be functioning properly. Additional signage on the door indicates that the safe was at one time serviced by Greenwich Locksmith; 24 hour emergency service; 56 7th Avenue South; New York, NY 10014; 212 645-2858.

View of the vault door, JMI, 2006.

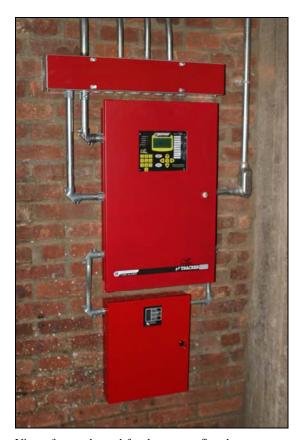
View of control panel for the current fire alarm system, JMI, 2006.

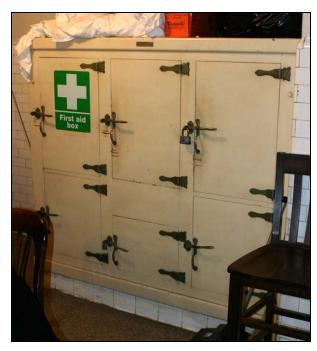
View of the icebox no longer in use, JMI, 2006.

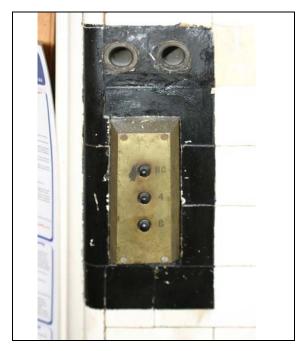
Detail of dumbwaiter hardware, JMI, 2006.

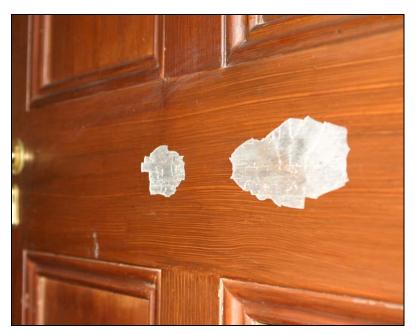
<u>DOORS:</u> The metal paneled door to G-09a is painted on both sides: the interior surface is painted white and the outside surface is painted in a decorative faux graining to imitate the appearance of the surrounding oak panels. The associated brass hardware appears to be in good condition and functioning properly; however, the paint is in poor condition and exhibits flaking and loss.

Detail of paint loss to faux graining on the metal door, JMI, 2006.

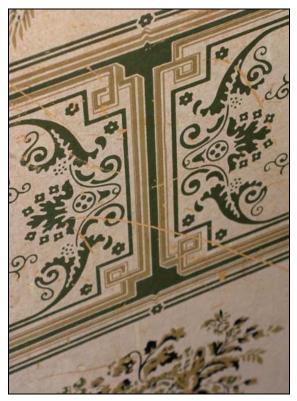
Detail of the wallpaper abrasion and markings, JMI, 2006.

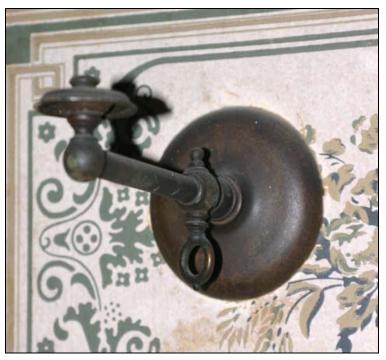
Detail of inoperable wall mounted fixture, JMI, 2006.

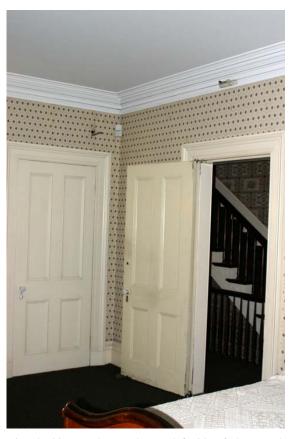
View looking southwest, door to left side of photograph is fixed-in-place, JMI, 2006.

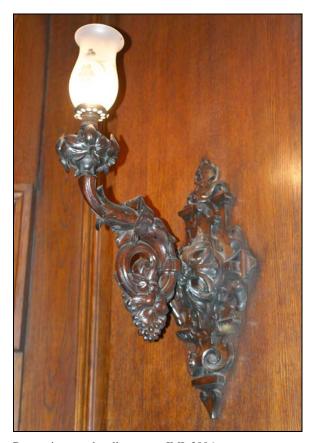
Decorative wood wall sconces, JMI, 2006.

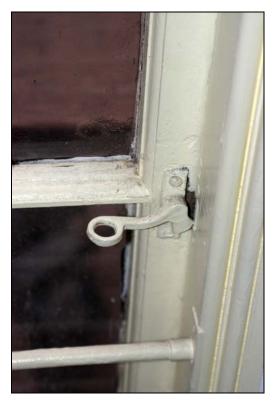
Detail of the window hardware, JMI, 2006.

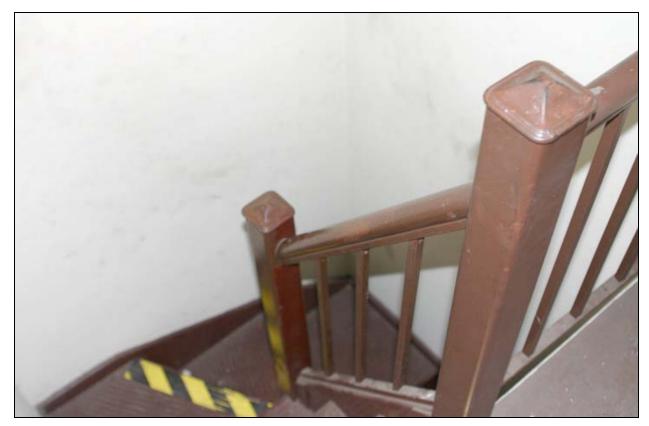
Metal stairway between rooms 403 and 409, JMI, 2006.

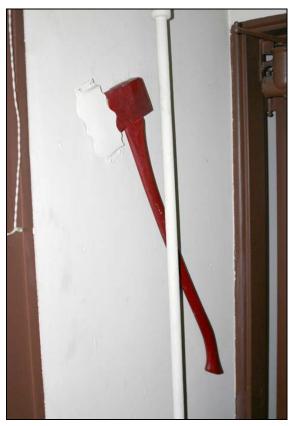
Detail of wall mounted axe, JMI, 2006.

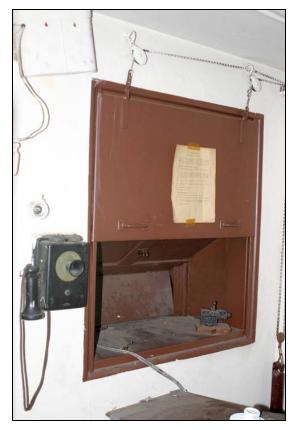
Detail of film projector space and phone to room 501, JMI, 2006.

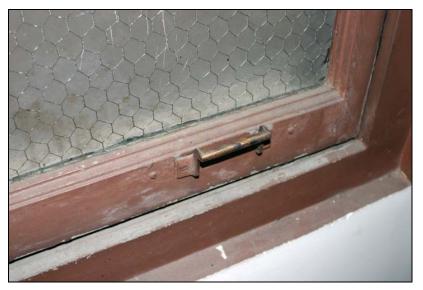
Detail of the painted wood sash window and wire glass, JMI, 2006.

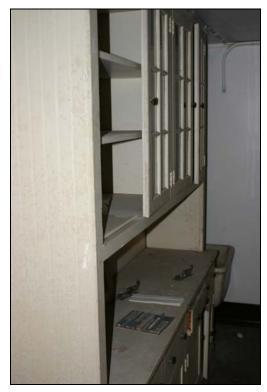
Detail of built-in cabinetry, JMI, 2006.

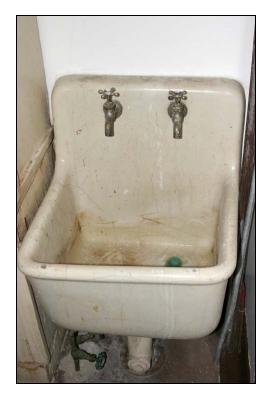
Detail of ceramic sink, JMI, 2006.

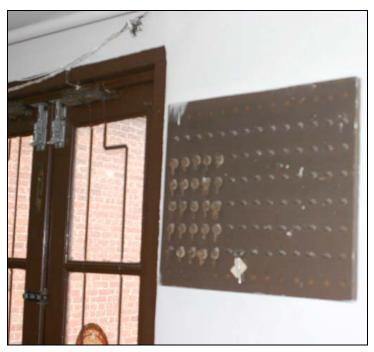
The double doors lead to the roof terrace, JMI, 2006.

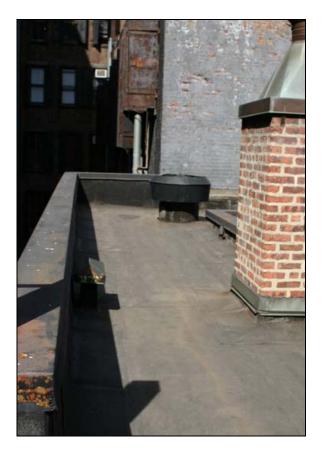
<u>ROOFING MEMBRANE:</u> The EPDM roof membrane appears to be in good condition however, evidence of trapped moisture is present on the interior finishes below and suggests that there should be further investigations into the efficacy of this material

View of copper flashing and EPDM roofing, JMI, 2007.

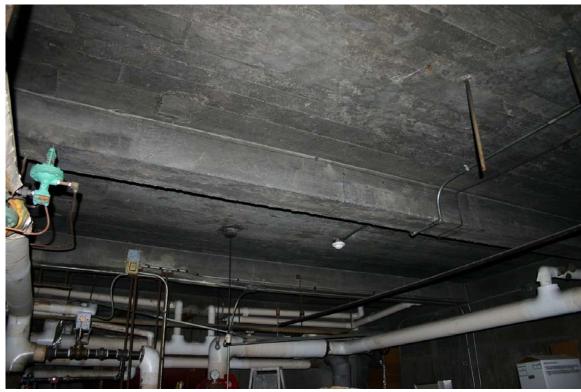
A visual survey of the underside of the Ground Floor slab revealed pipe hangers, trapeze hangers, and electrical conduit suspended from the underside of the slab and from the bottom flange of the structural steel beams. WJE also observed small diameter pipe penetrations, generally less than 6 inches in diameter with openings chipped through the floor slab, rather than core drilled (Photos 4-5). One exception was an opening formed in the concrete that is most likely an abandoned coal shoot or fireplace clean out shoot (Photo 6).

Photo 1. Overview of the underside of the Ground Floor as seen in the basement above Room B-10 Boiler Room

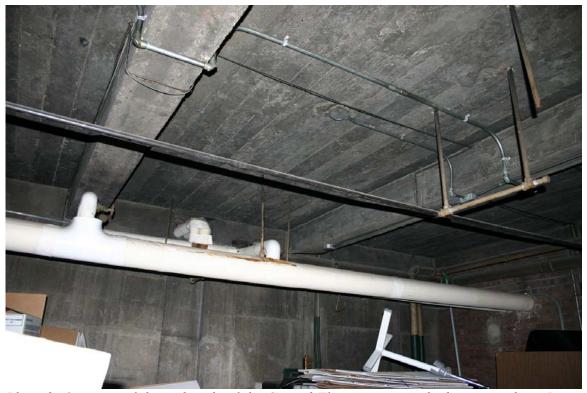
Photo 2. Overview of the underside of the Ground Floor as seen in the basement above Room B-10 Boiler Room

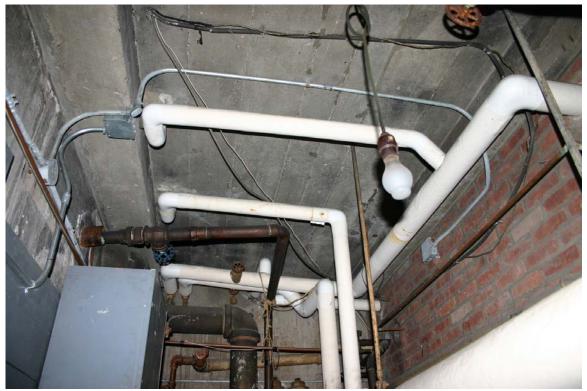
Photo 3. Overview of the underside of the Ground Floor as seen in the basement above Room B-02 Electrical Junction Box Room

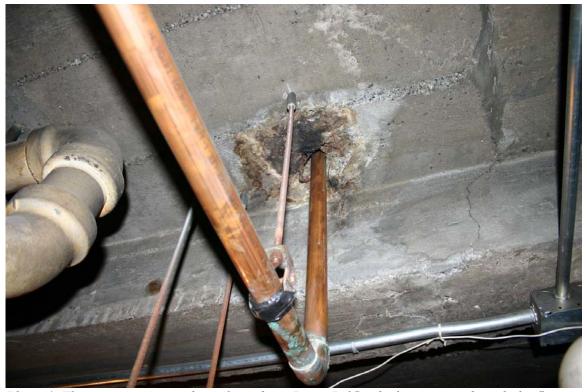
Photo 4. Floor penetration in the ceiling above Room B-05, which corresponds with the floor in Room G-07 Men's Room

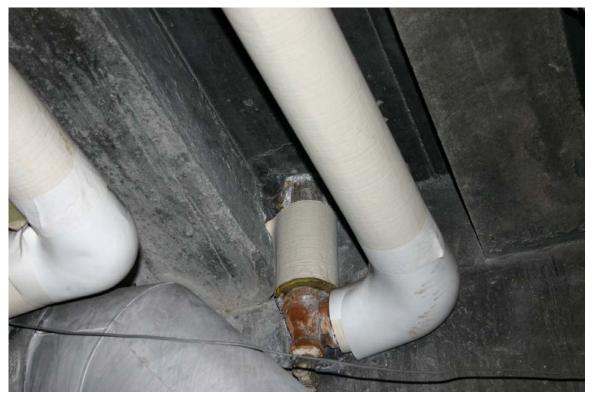
Photo 5. Floor penetration in the ceiling above Room B-10 Boiler Room

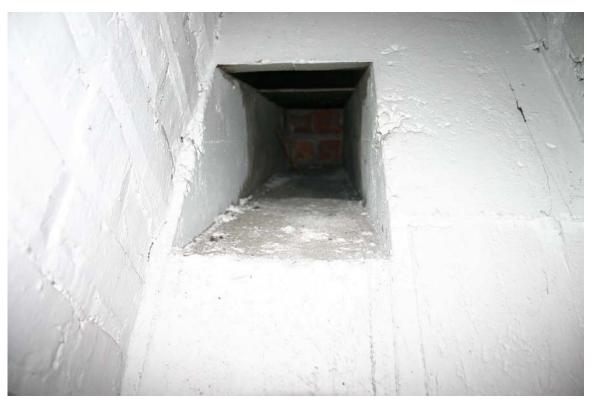
Photo 6. Formed opening in the concrete foundation wall at the ceiling with brick closure in the fireplace clean out shoot in Room B-01 Hallway

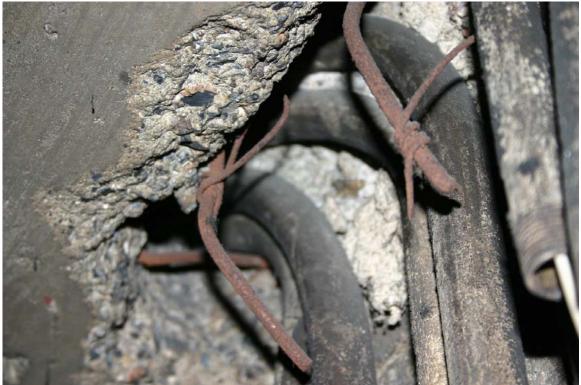
Reinforcement Survey: A reinforcement survey of the exposed wire mesh embedded within the cinder concrete slab revealed that for the primary wire reinforcement used in the ceiling above Stair FS-0 and oriented in the north-south direction, the wire measures 0.238 to 0.240 inch in diameter and spaced at 4-1/2 inches on center (Photo 7). Similar values were measured for the primary wire reinforcement in the ceiling above Room B-06 (Photo 8) and above Room 309.

Photo 7. Floor penetration in the ceiling above Stair FS-0 with exposed wire reinforcement in the slab with wire oriented in the north-south direction (wire measures 0.238 to 0.240 inch in diameter and spaced at 4-1/2 inches on center)

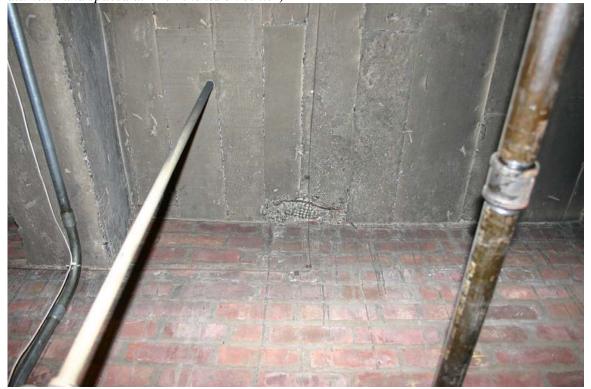
Photo 8. Floor penetration in the ceiling above Room B-06 with exposed wire reinforcement in the slab with wire oriented in the north-south direction

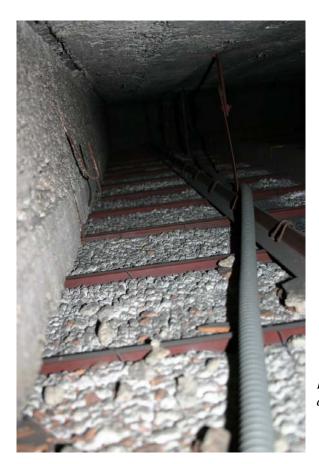
Photo 9. Space above the suspended ceiling above the archive vaults in Room 309

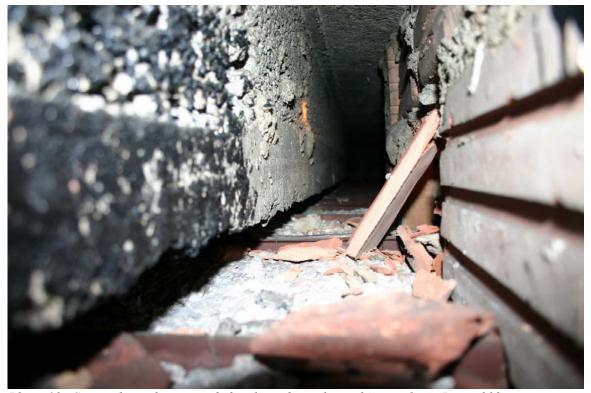
Photo 10. Space above the suspended ceiling above the archive vaults in Room 309

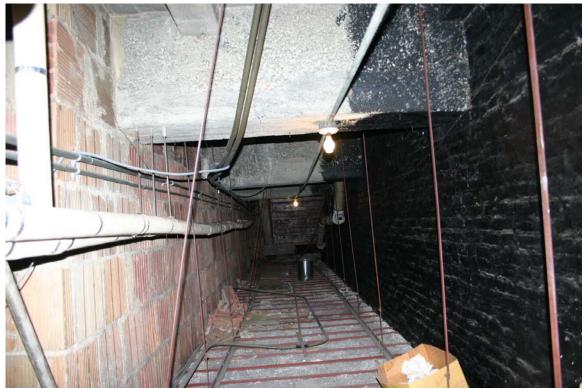
As-Built Structural Survey: An as-built structural survey was performed in the space above the archive vaults in Room 309 (Photos 21-24), the attic space above Room 409 Preparation Room (Photos 11-12), and the roof penthouses in Room 503 Vent Room (Photo 25). The survey revealed that the perimeter walls and also the center wall, which is situated directly above the concrete foundation wall in the basement, are constructed of load-bearing, multi-wythe brick masonry.

Photo 11. Suspended ceiling above Stair S-4 and the underside of the roof slab

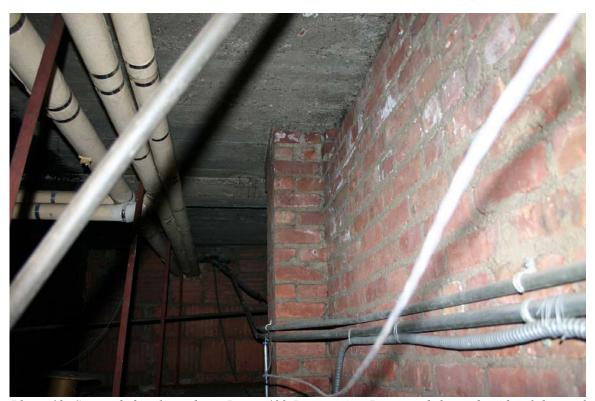
Photo 12. Suspended ceiling above Room 403 Preparation Room and the underside of the roof slab

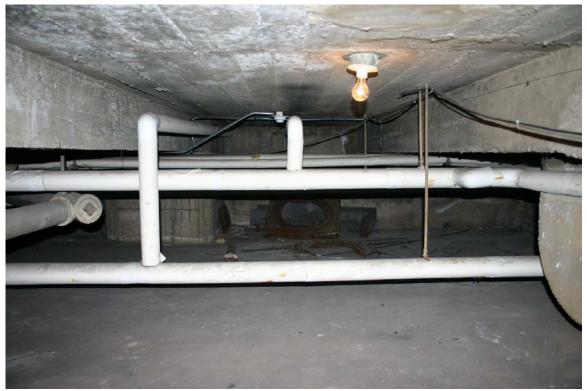
Photo 13. Overview of the East section of the under floor space

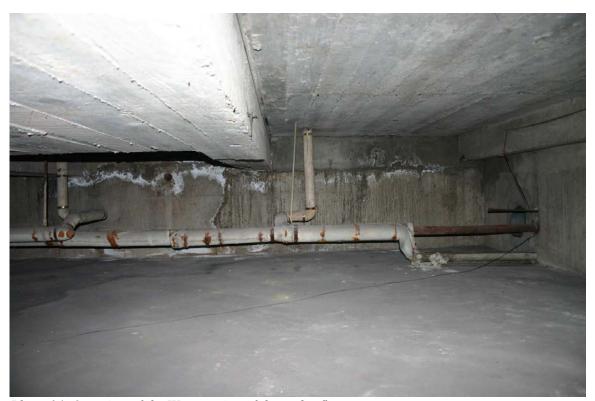
Photo 14. Overview of the West section of the under floor space

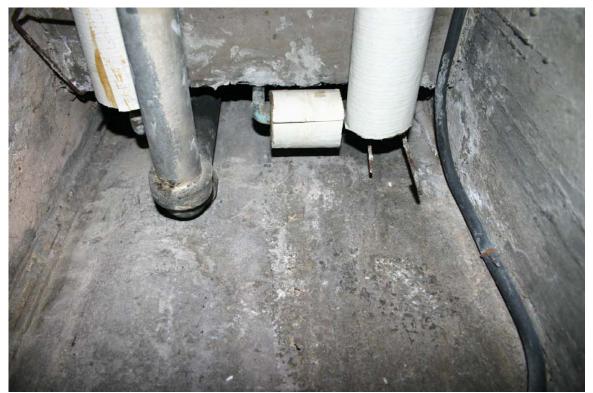
Photo 19. Close-up of the pipes in the pipe chase on the south wall of the under floor space

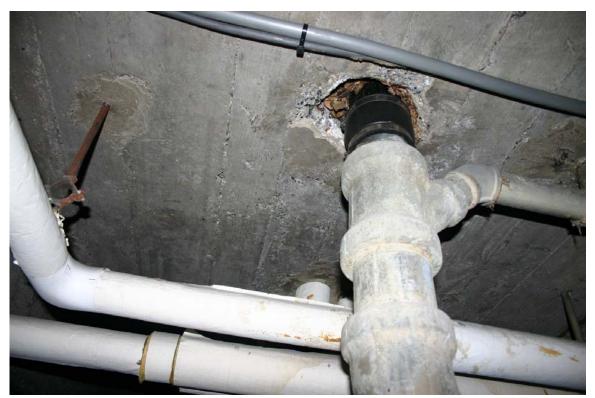
Photo 20. Typical floor penetration in the underside of the Ground Floor seen in the under floor space

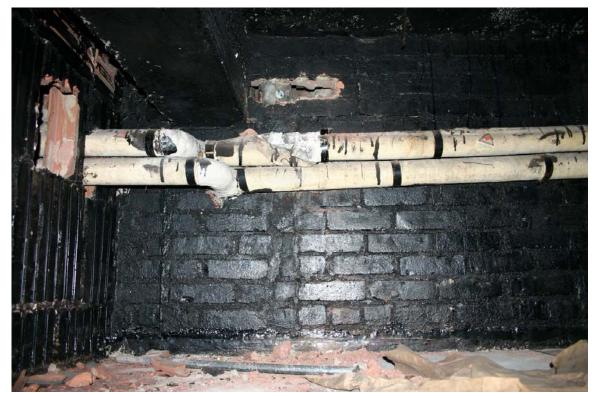
Photo 21. Space above the archive vaults in Room 309

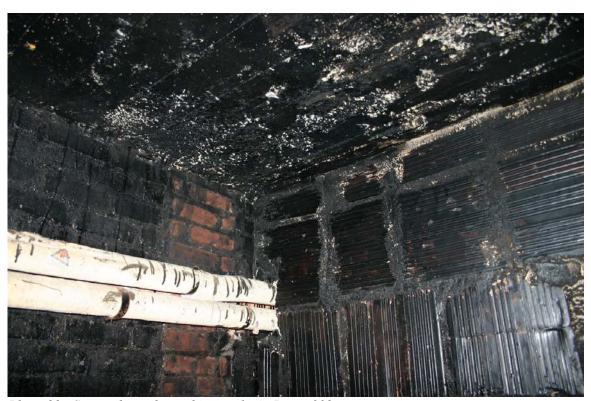
Photo 22. Space above the archive vaults in Room 309

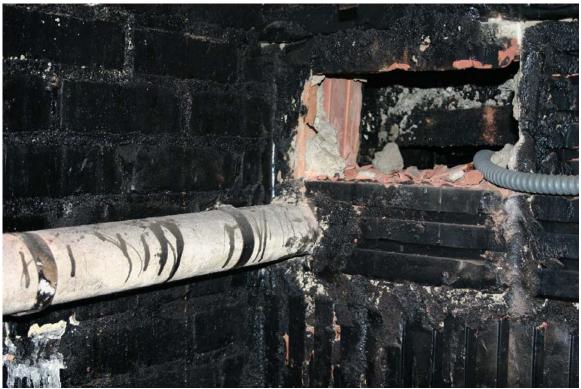
Photo 23. Space above the archive vaults in Room 309

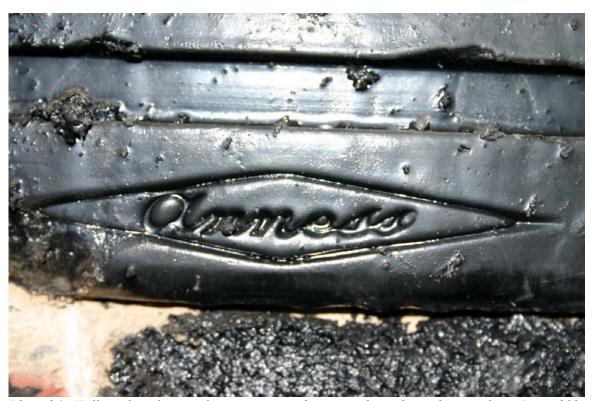
Photo 24. Hollow clay tile manufacturer seen in the space above the archive vaults in Room 309

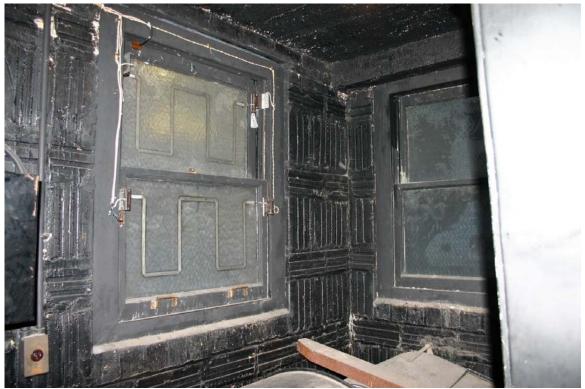
Photo 25. Hollow clay tile used in Room 503 Vent Room

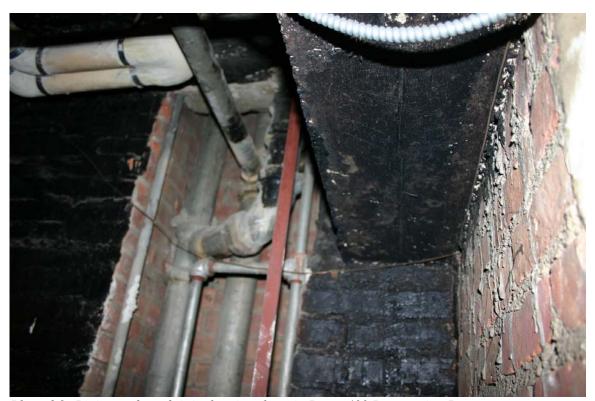
Photo 26. Piping and conduit in the pipe chase in Room 403 Preparation Room

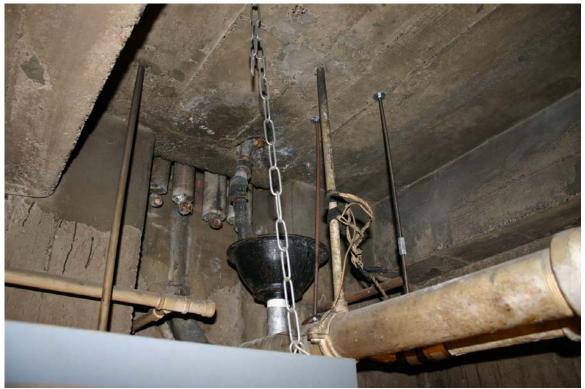
Photo 27. Abandoned piping and conduit in the pipe chase in Room B-05

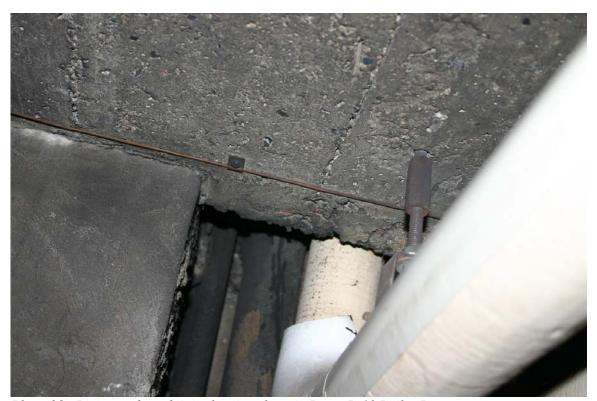
Photo 28. Piping and conduit in the pipe chase in Room B-10 Boiler Room

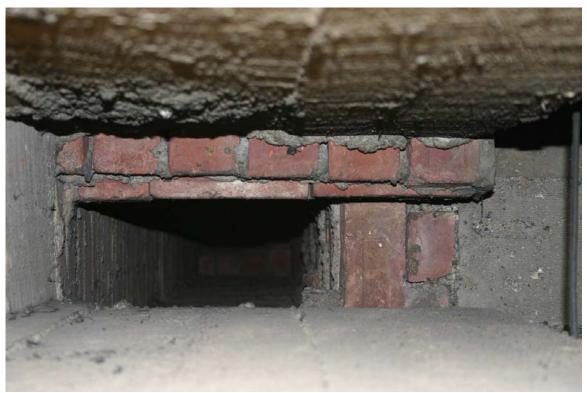
Photo 29. Empty pipe chase in the east foundation wall adjacent to Room B-03 Restroom

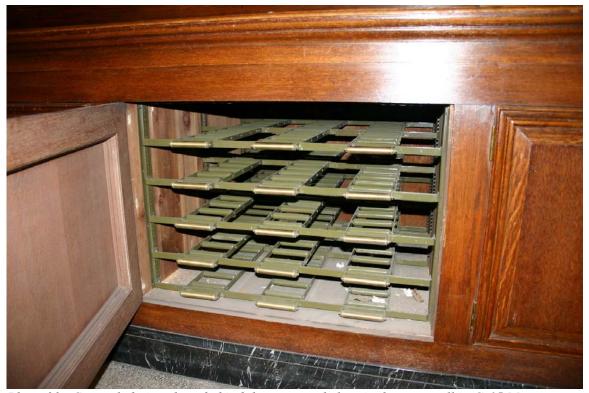
As-Built Structural Survey: An as-built structural survey that was performed in the basement, Room 309 Vault Room, and in the attic space above Room 403 Preparation Room. The survey also revealed pipe chases set inside the concrete foundation walls in the basement extend upwards in the brick masonry on the upper floors. At locations where the chases are visible, WJE observed that the spaces were filled with piping and conduit (Photos 26-29). However, one chase located at the north end of the east wall was empty of pipes and other conduit. On other intermittent floors the chases were not readily visible and were concealed (Photo 30).

Photo 30. Concealed pipe chase behind the storage shelves in the west wall in G-15 Museum

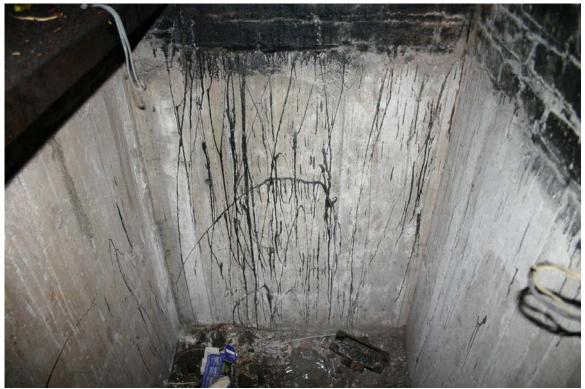
Photo 31. Concrete foundation wall in the dumb waiter pit

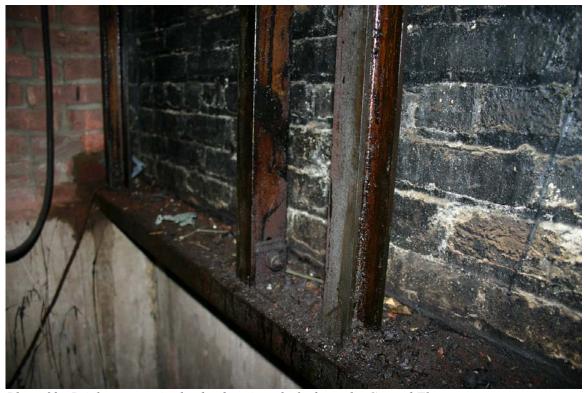
Photo 32. Brick masonry in the dumb waiter shaft above the Ground Floor

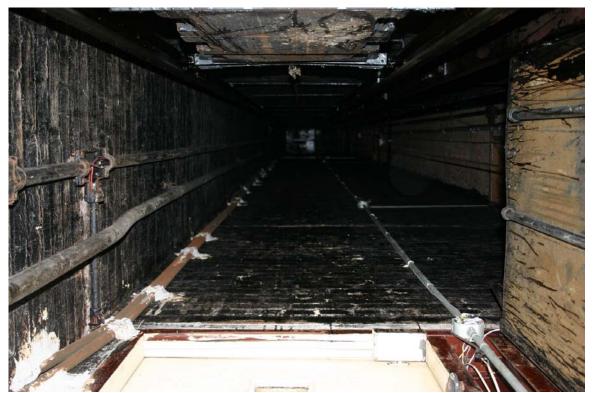
Photo 33. Brick masonry in the dumb waiter shaft above the Ground Floor

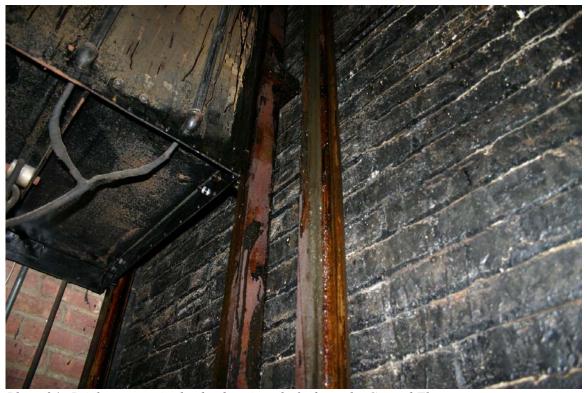
Photo 34. Brick masonry in the dumb waiter shaft above the Ground Floor

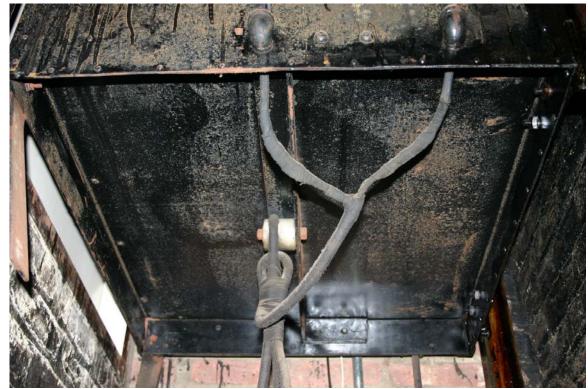
Photo 35. Underside of one of two dumb waiter cars

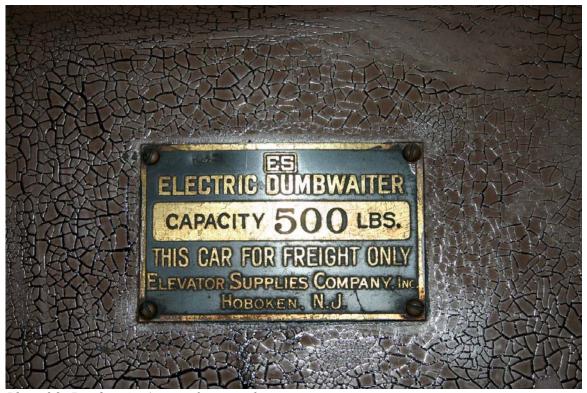
Photo 36. Dumb waiter's manufacturer plaque

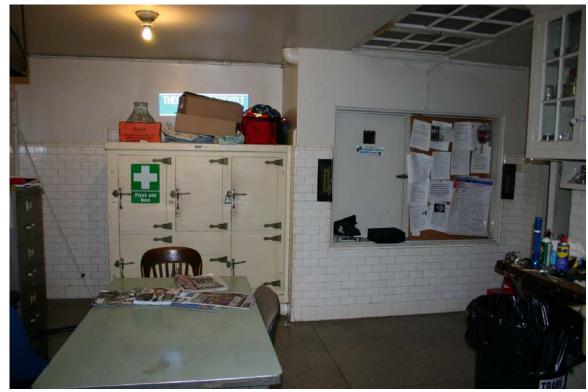
Photo 37. Dumb waiter access in Room G-09 Kitchen

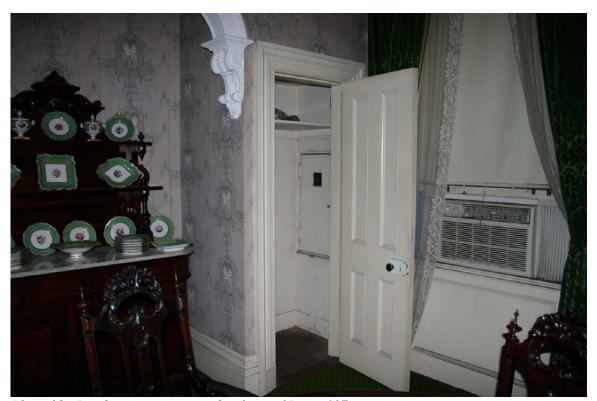
Photo 38. Dumb waiter access in the closet of Room 107

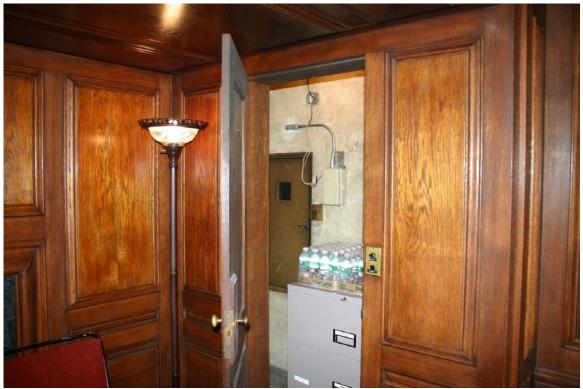
Photo 39. Dumb waiter access in the closest of Room 306 Office

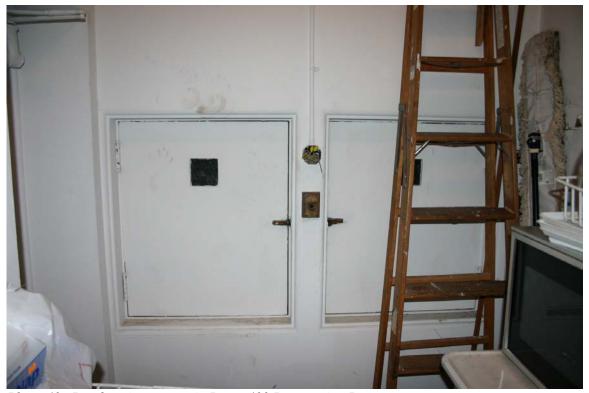
Photo 40. Dumb waiter access in Room 403 Preparation Room

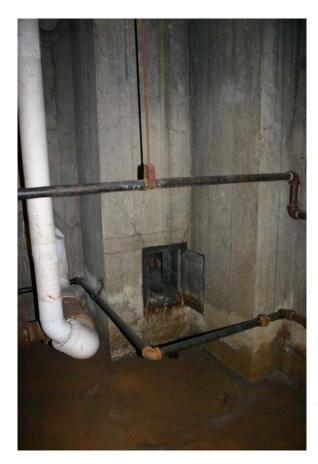
Photo 41. Abandoned fireplace chimney in Room B-10 Boiler Room

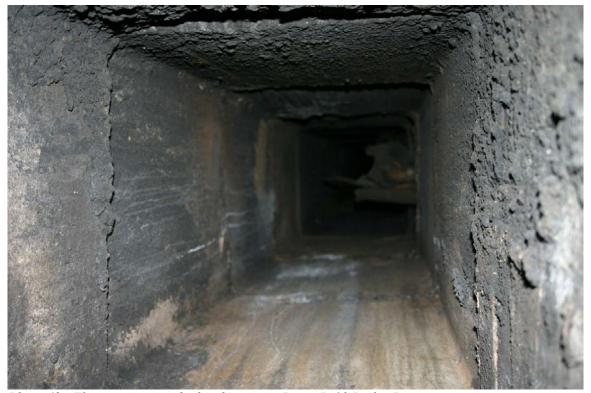
Photo 42. Flue opening inside the chimney in Room B-10 Boiler Room

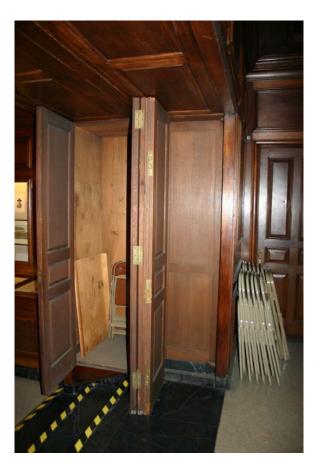
Photo 43. Fireplace chimney concealed behind the closet doors in the Tea Room

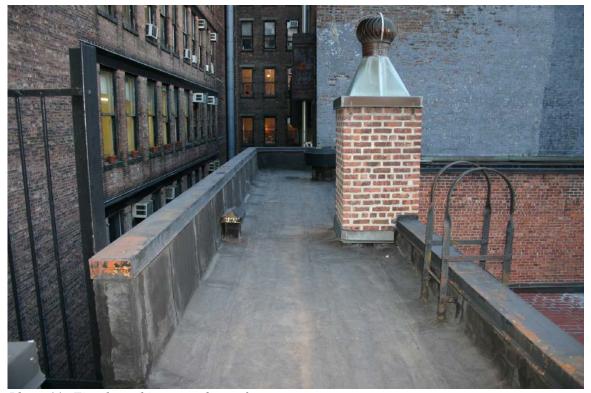
Photo 44. Fireplace chimney at the roof

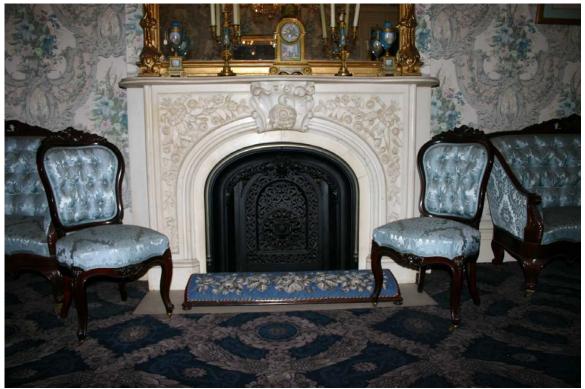
As-Built Structural Survey: An as-built structural survey of the fireplace chimneys was performed in the period rooms, archive room, and office. The survey revealed that the chimneys are constructed of brick masonry and the flues are lined with clay tile (Photos 45-58). The flue openings measure approximately 6-8 inches square. The flues in the archive room and the office were welded in the closed position (Photos 54 and 56).

Photo 45. Fireplace and chimney flue in Room 103 Front Parlor

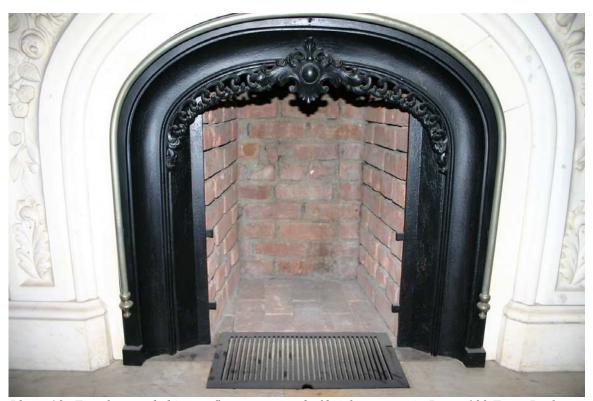
Photo 46. Fireplace and chimney flue constructed of brick masonry in Room 103 Front Parlor

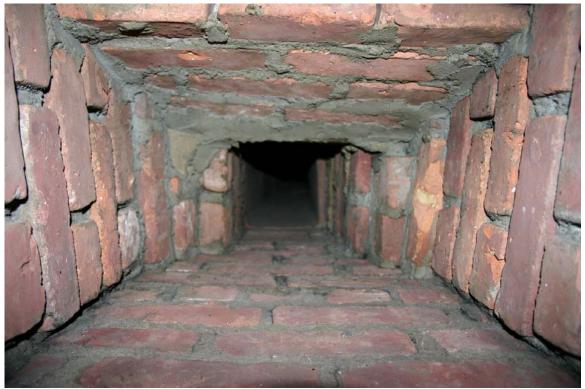
Photo 47. Chimney flue lined with clay masonry in Room 103 Front Parlor

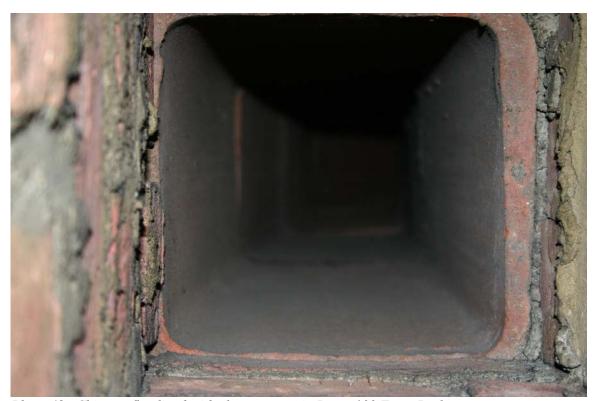
Photo 48. Chimney flue lined with clay masonry in Room 103 Front Parlor

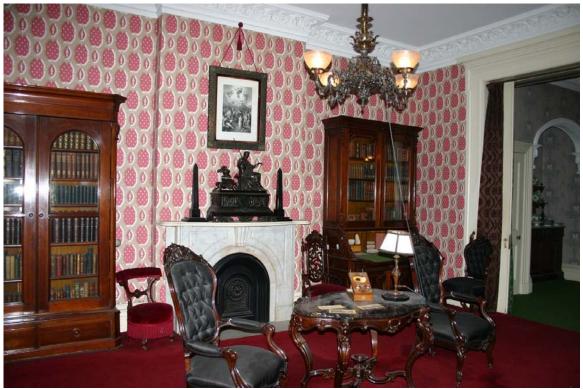
Photo 49. Fireplace and chimney flue constructed of brick masonry in Room 104 Family Parlor

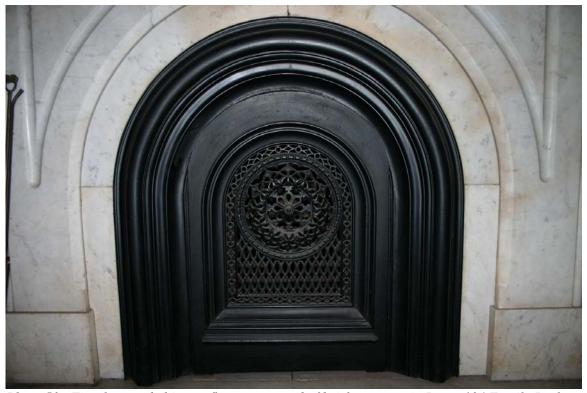
Photo 50. Fireplace and chimney flue constructed of brick masonry in Room 104 Family Parlor

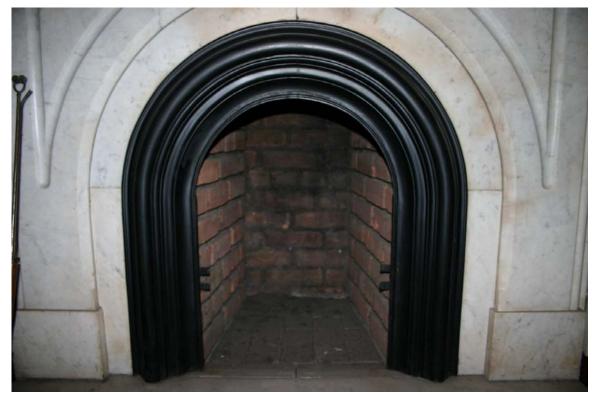
Photo 51. Chimney flue constructed of brick masonry and lined with clay tile in Room 104 Family Parlor

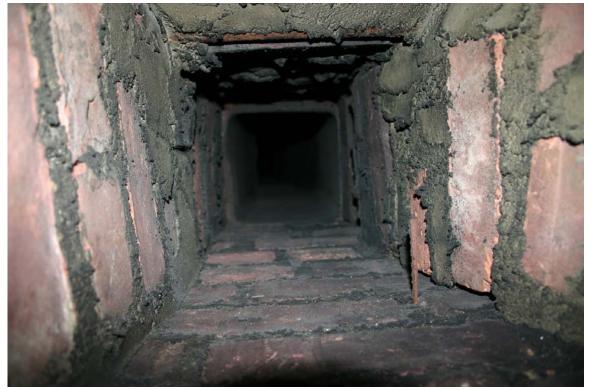
Photo 52. Chimney flue constructed of brick masonry and lined with clay tile in Room 104 Family Parlor

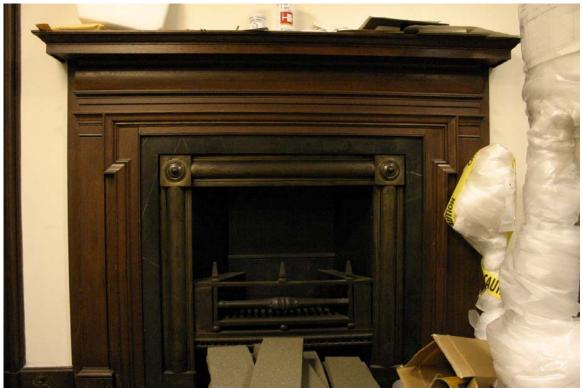
Photo 53. Fireplace and chimney flue in Room 310 Archive Storage

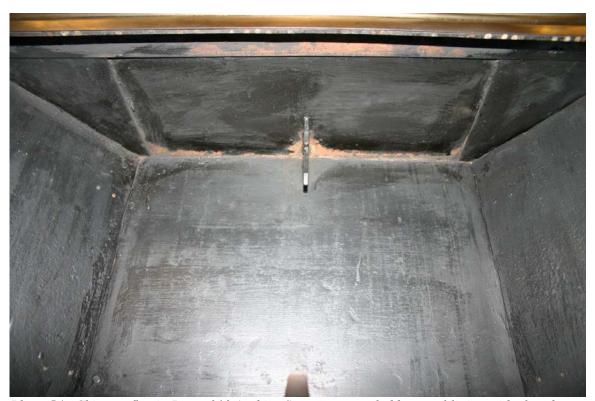
Photo 54. Chimney flue in Room 310 Archive Storage concealed by metal lining with closed vent

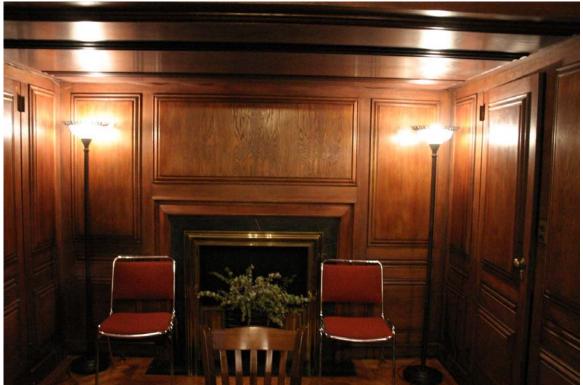
Photo 55. Fireplace and chimney flue in Room 306 Office

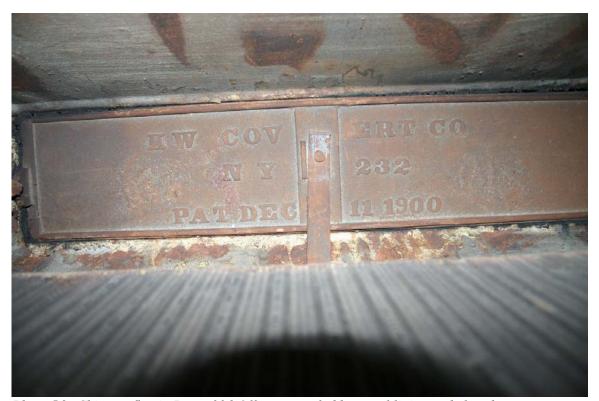
Photo 56. Chimney flue in Room 306 Office concealed by metal lining and closed vent

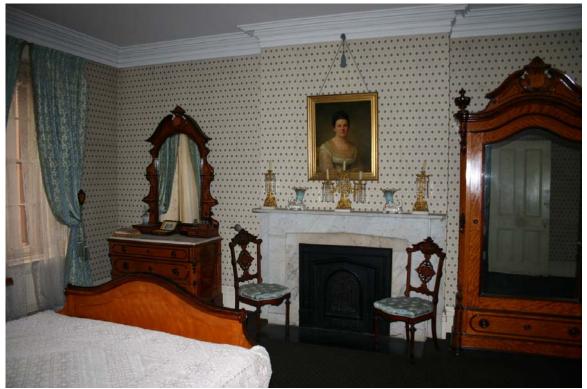
Photo 57. Fireplace and chimney flue in Room 203 Bedroom

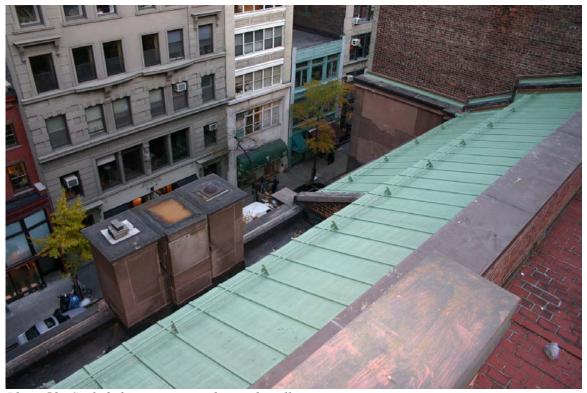
Photo 58. Sealed chimney tops at the north wall

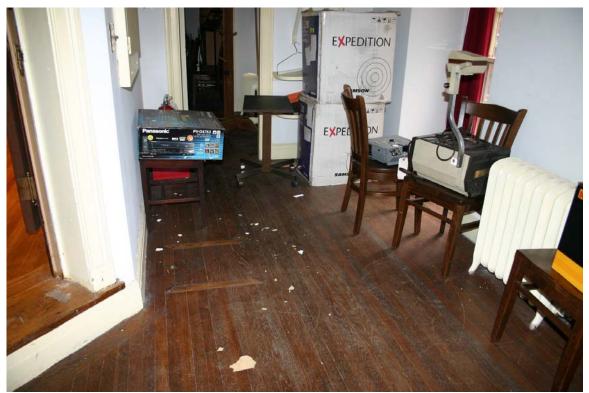
Photo 59. Under floor space beneath Room 403 Dressing Room

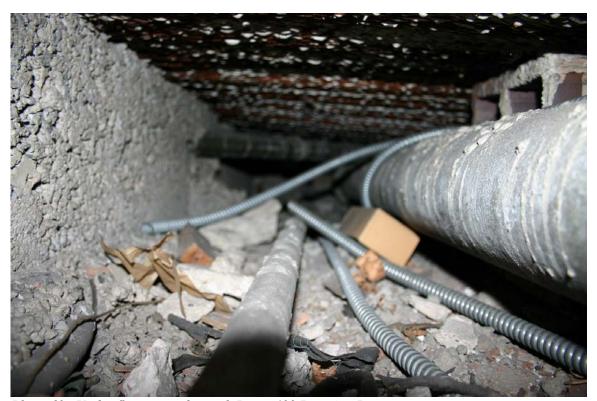
Photo 60. Under floor space beneath Room 403 Dressing Room

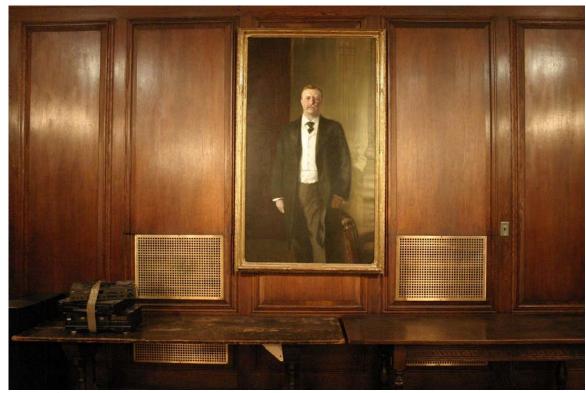
Photo 61. Hollow clay tile walls are hidden behind the wood paneling of the Room 405 Auditorium

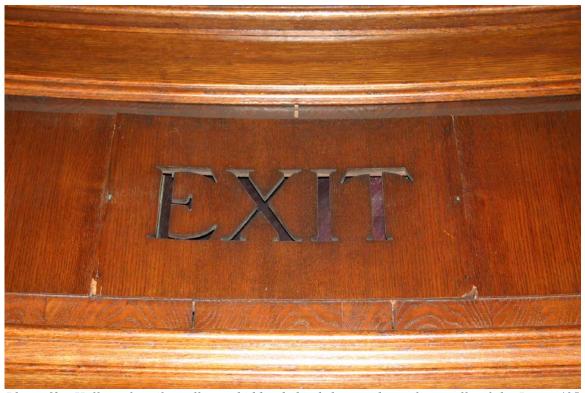
Photo 62. Hollow clay tile walls are hidden behind the wood paneling walls of the Room 405 Auditorium

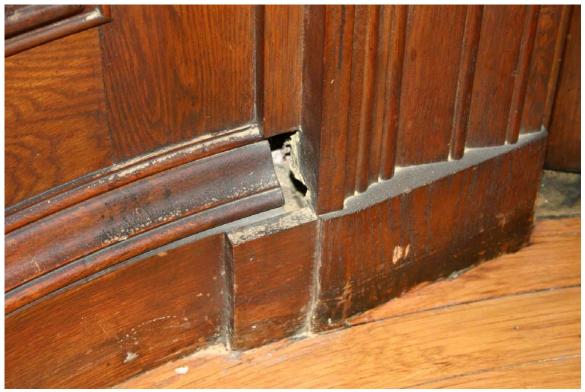
Photo 63. Hollow clay tile walls are hidden behind the wood paneling of the Room 405 Auditorium

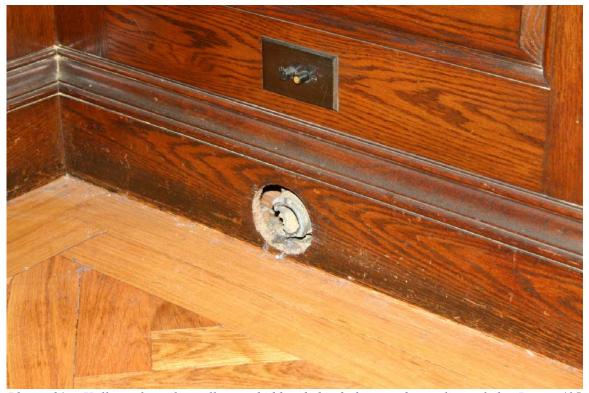
Photo 64. Hollow clay tile walls are hidden behind the wood paneling of the Room 405 Auditorium

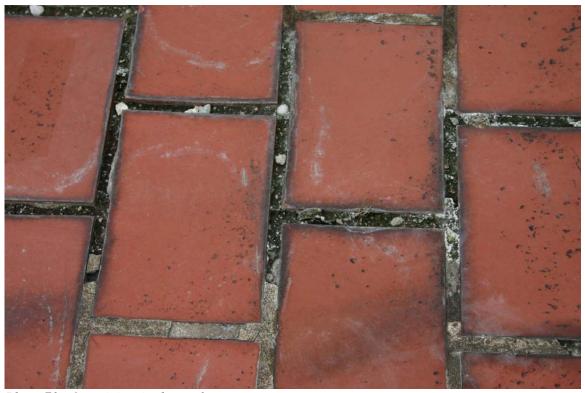
Photo 70. Open joints in the roof top terrace pavers

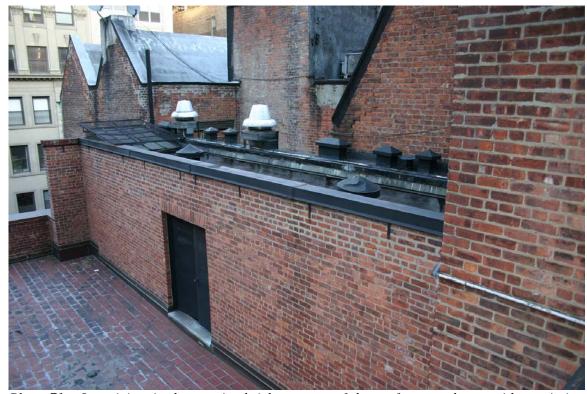
Photo 71. Open joints in the exterior brick masonry of the roof top penthouse with repointing near the top of the wall
