**STRUCTURAL ASSESSMENT REPORT
FOR
HISTORIC MONROE STATION STABILIZATION**

**BIG CYPRESS NATIONAL PRESERVE
50910 Tamiami Trail East
Ochopee, FL, 33943**

September 19, 2008

BICY Contract No. C5120085452

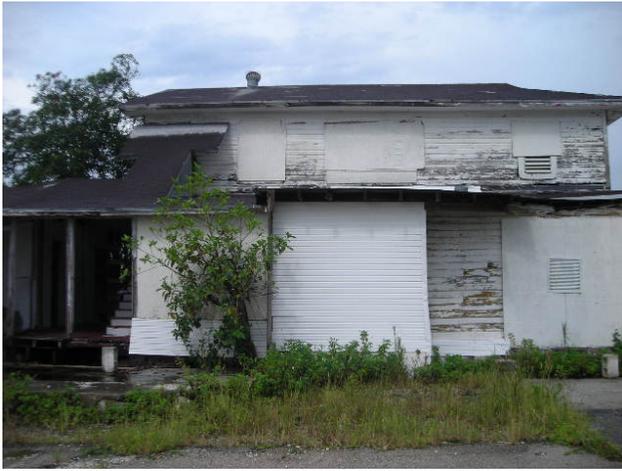
B1. Existing east side of structure. View of historic structure and non-historic additions.

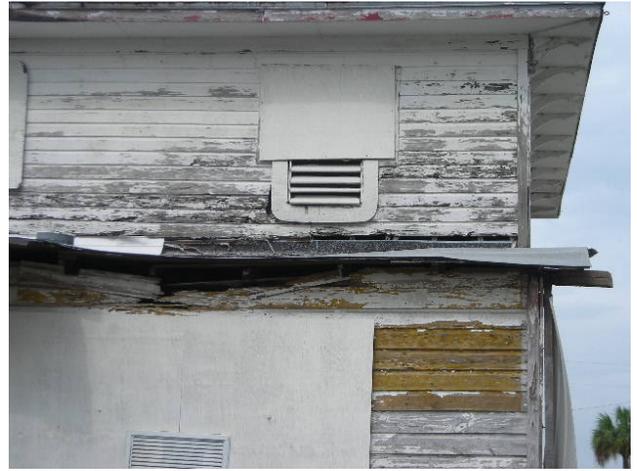
B2. Existing east side of structure. View of NE corner of historic structure (second floor) and non-historic addition (first floor).

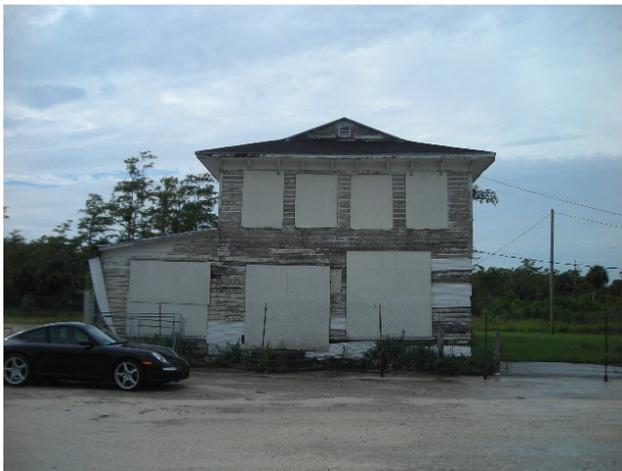
B3. Existing north side of structure. View of historic two story structure and non-historic one story addition.

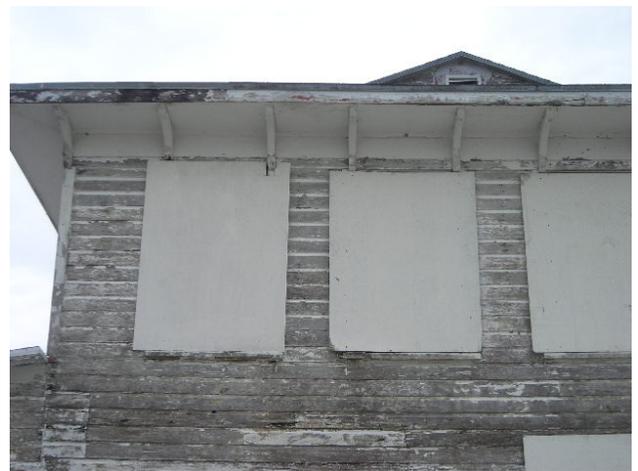
B4. Existing north side of historic structure. Partial view of second floor northeast corner.

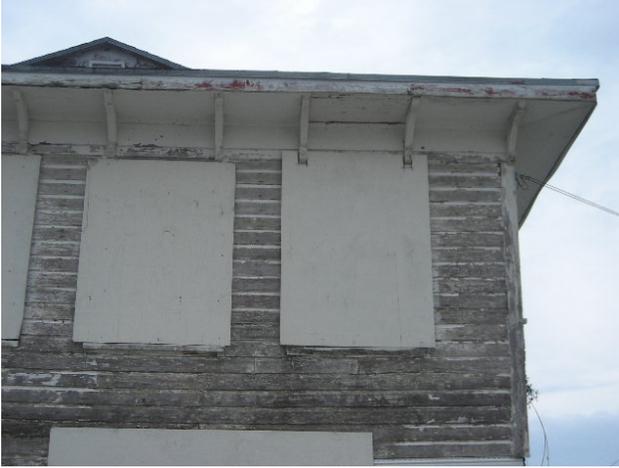
B5. Existing north side of historic structure. Partial view of second floor northwest corner of structure.

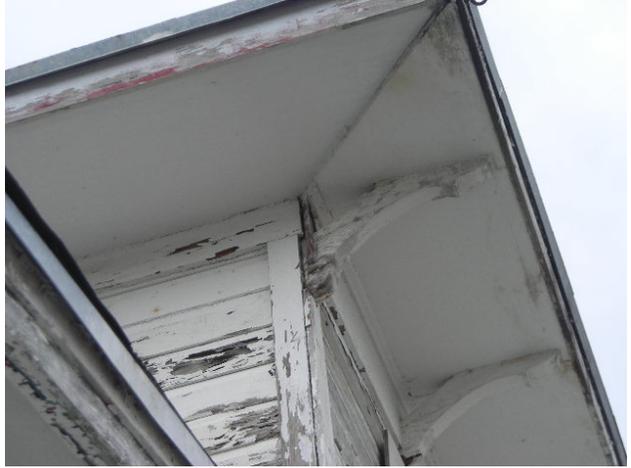
B6. Existing detail of historic second floor northeast corner.

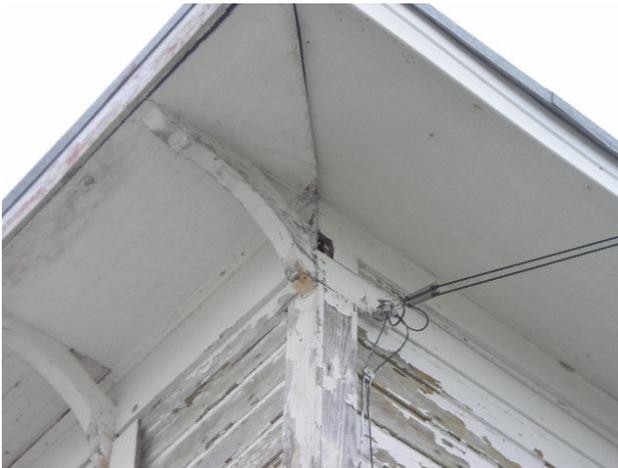
B7. Existing detail of second floor northwest corner.

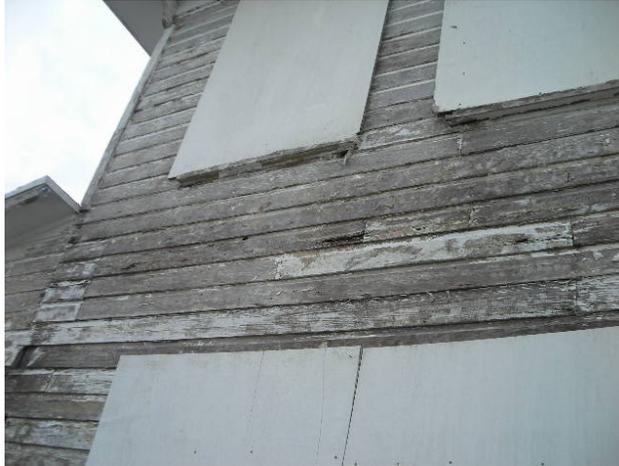
B9. Existing view of north wall detail.

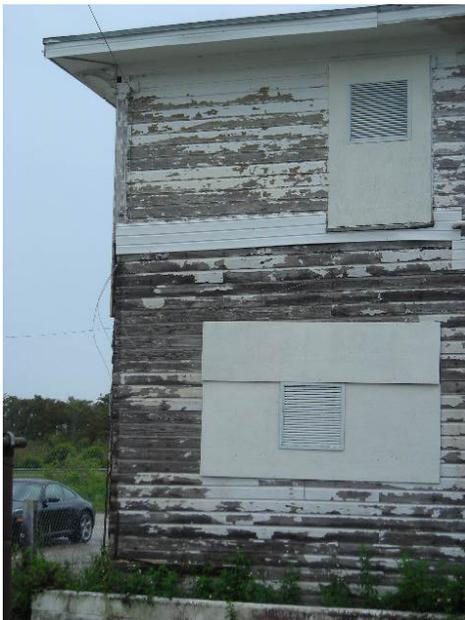
B10. Existing view of west side of historic structure.

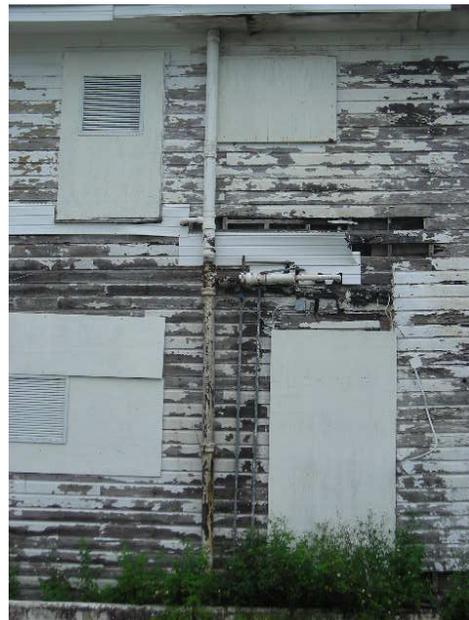
B11. Existing west side of structure. Partial view of historic structure and non-historic addition.

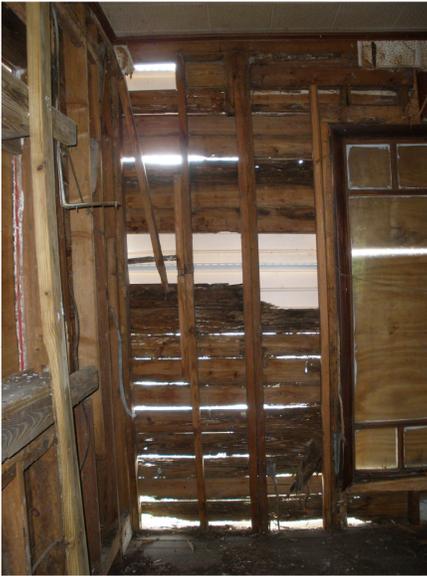
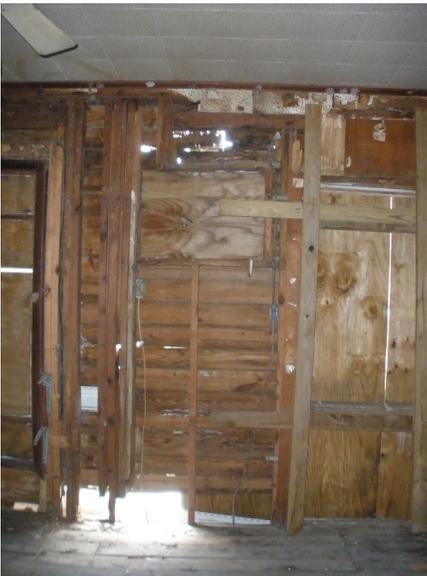
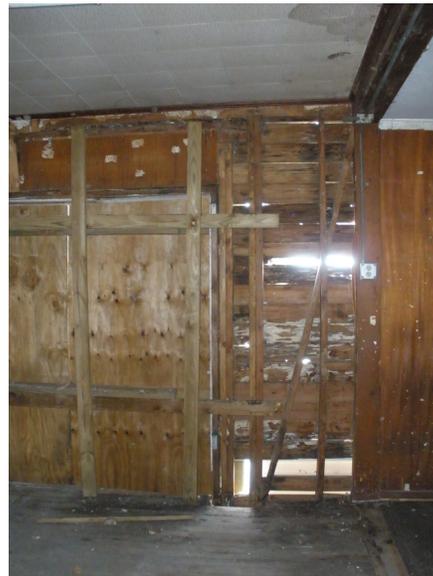
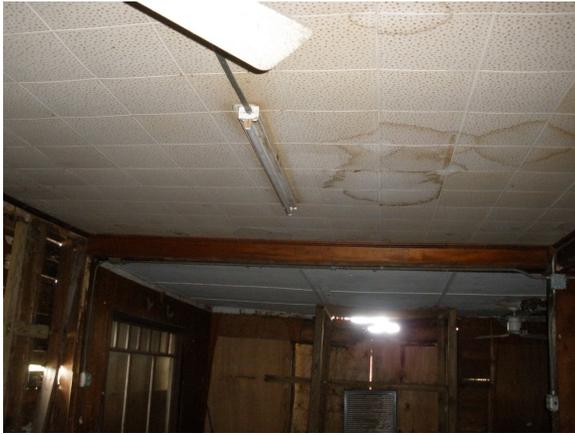
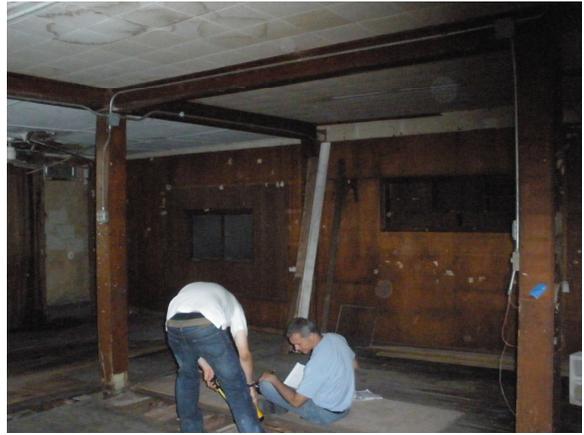
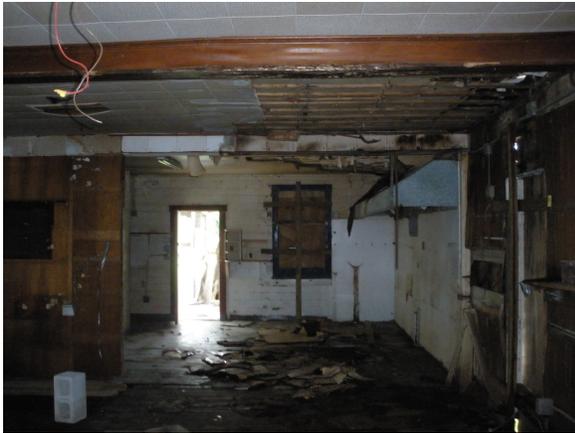
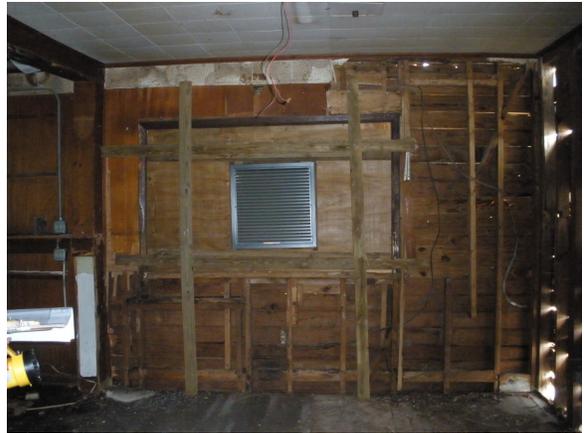
The finish flooring is comprised of the original wood boards that appear in poor condition. The flooring has areas of water damage and areas where there is no flooring existing; these areas are covered in plywood. The existing ceiling is comprised of 1' x 1' acoustical tile, and not original. There are no original wall finishes remaining. The historic east and south walls no longer exist, therefore no original siding exists. There are wood columns and beams where these walls stood. The north and west walls remain, the existing door and window openings on these walls have been altered and no longer reflect the historic photograph. There are no remaining historic windows and doors. All the existing siding on the north elevation has been severely damaged by weather and insects and is beyond repair. Approximately 75% of the existing siding on the west elevation appears to be beyond repair. See Photos # B12 - B19 on Appendix B.

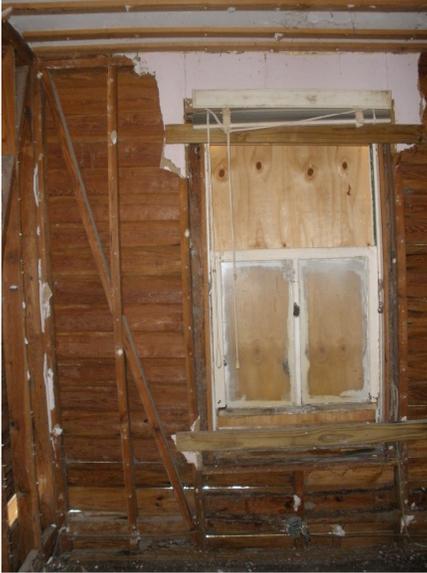
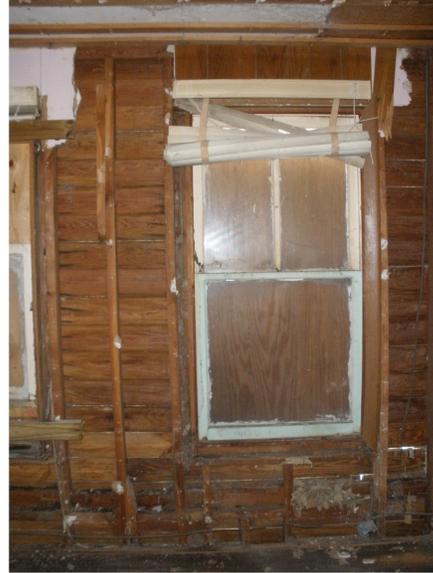
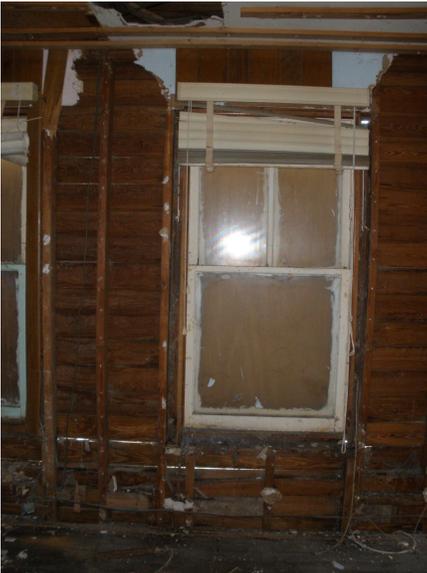
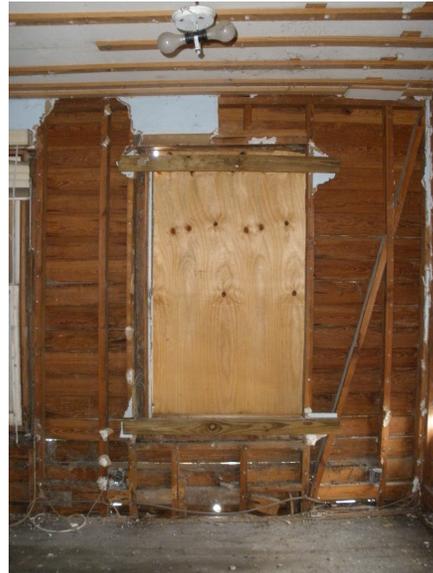
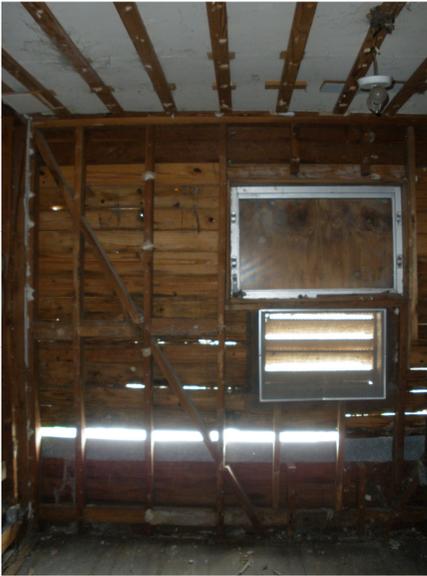
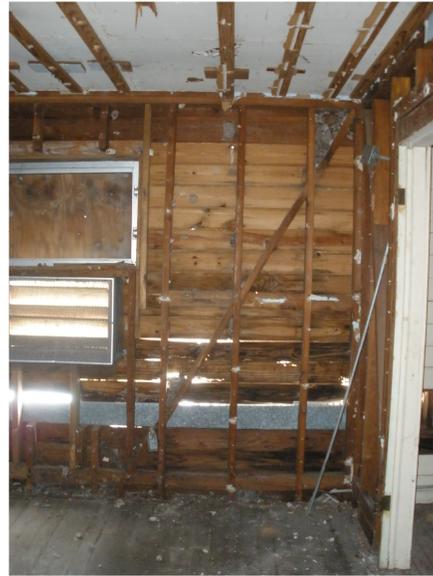
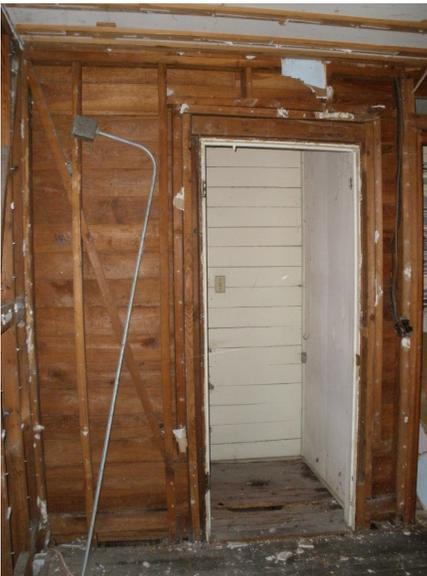
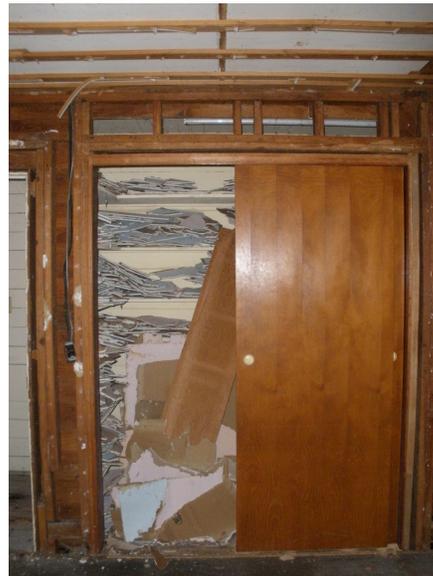
The historic finish flooring appears to be in better condition than on the first floor. It appears to be salvageable although there are areas where there are missing or broken floor planks. The existing ceiling is not original and comprised of gypsum drywall with wood furring strips running below the drywall. The original walls remain. The north and west walls retain the original window openings visible in the historic photograph. There are three existing windows on the north wall that may be original, the fourth opening is covered in plywood and not visible. The west wall has an existing window which appears to be original. The south wall has an area which appears to be

original framing for a window, but has been covered by tongue and groove siding, indicating that the remaining south side siding (on the interior of the non-historic addition) is not original. There are no original wall finishes remaining. On both the north and west elevations approximately 80% of the existing siding appears to be in good condition. On the east elevation approximately 20% of the existing siding appears to be in good condition. On the south elevation approximately 90% of the existing siding appears to be in good condition, although this siding is not original. An accessible area of the attic showed that the exterior historic building's soffit is made of 3.5 inch wood planks; these may be original to the structure. Closer examination is required. See Photos # B20 - B31 on Appendix B.

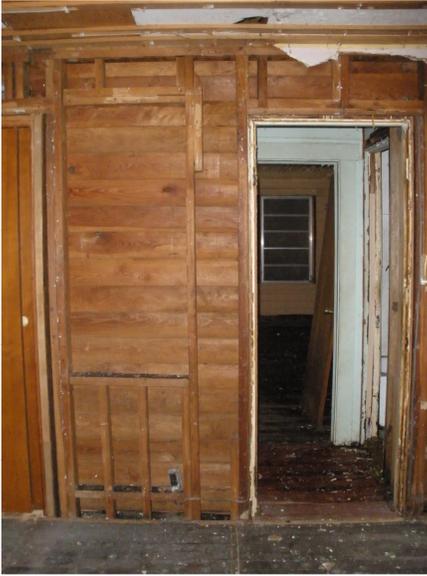
B28. Partial interior view looking south, second floor.

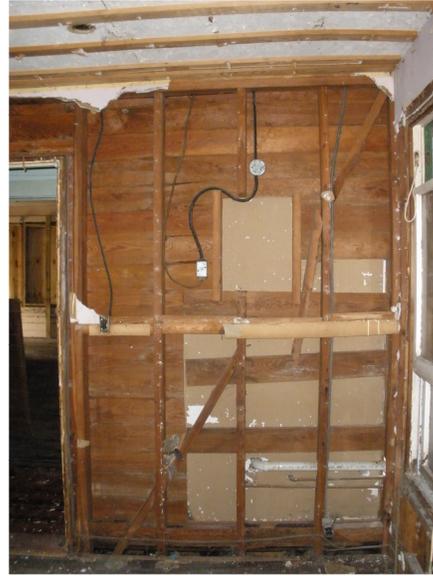
B29. Partial interior view looking south, near SW corner, second floor.

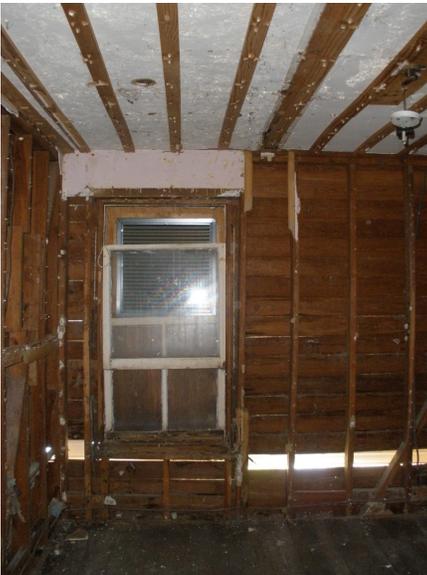
B30. Partial interior view looking west, near SW corner, second floor.

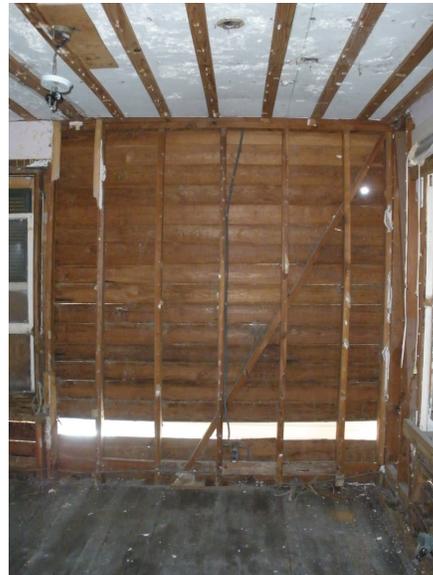
B31. Partial interior view looking west, near NW corner, second floor.
