PROPERTY NAME: Hoyt-Barnum House

District/Property Name Hoyt-Barnum House
Address (For individual nomination) 713 Bedford Street
(Proposed relocation to 1508 High Ridge Road)

HOYT BARNUM HOUSE RELOCATION

713 BEDFORD STREET,
STAMFORD, CONNECTICUT
TO
1508 HIGH RIDGE ROAD,
STAMFORD, CONNECTICUT

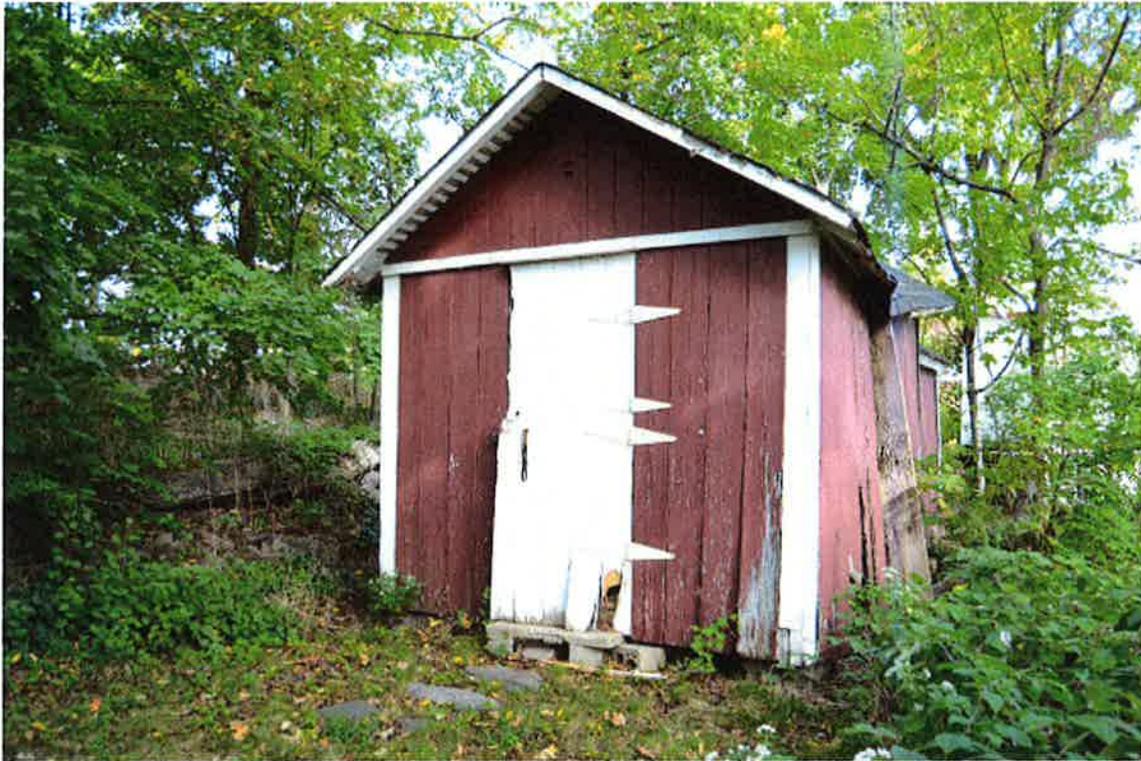
A one-story, one-bay, gable-roof shed, dated ca. 1920 based on visual analysis, is east of the main house and the rock ledge and faces southwest into the front yard. A shed-roof outbuilding, no longer extant, appears on a 1901 Sanborn map and in a ca. 1900 historic photograph, located southwest of the current shed. The existing shed has an asphalt-shingle clad front-gable roof with overhanging eaves and vertical board walls. The entrance is located centrally on the southwest elevation and is vertical board with metal strap hinges and is accessed by one concrete block step. The shed sits on rubblestone piers and is in dilapidated condition (Figure B-7, Photo 12).

Photo 12 . Shed in the side yard east of the house, looking northwest.

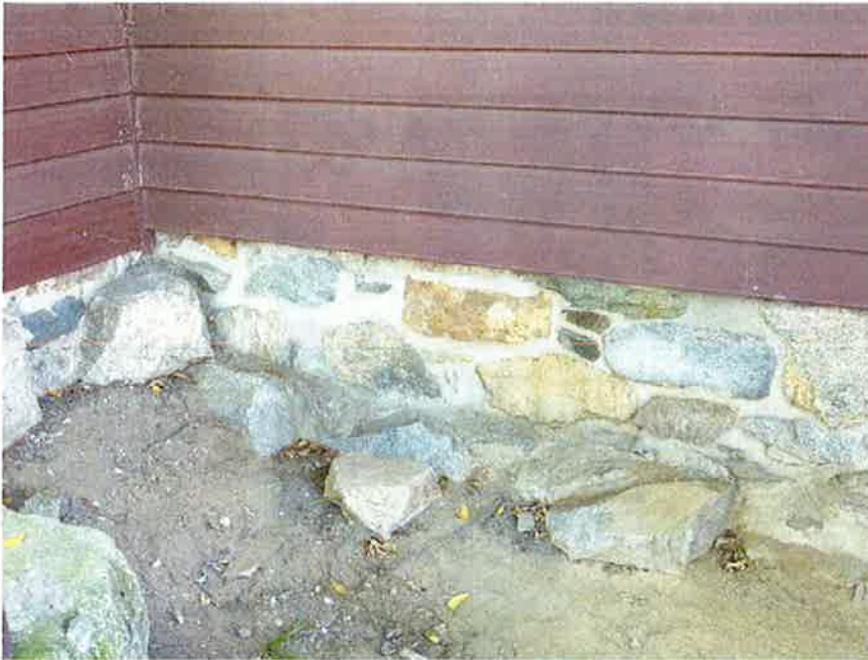
Photo 3 - Cement rich pointing mortar at Southeast corner of North elevation at removed porch

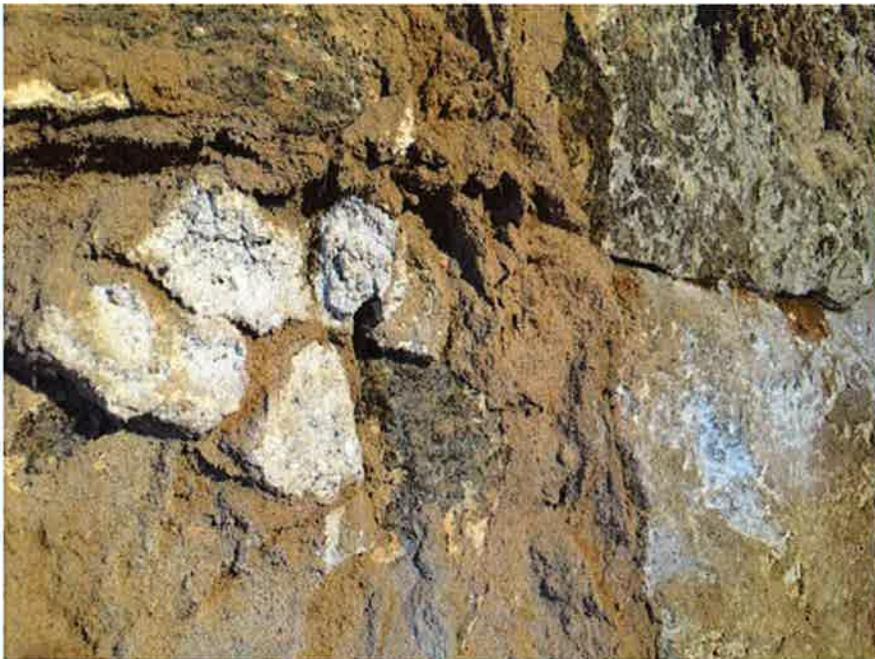
Photo 5 - Mortar displacement consistent with insect activity.

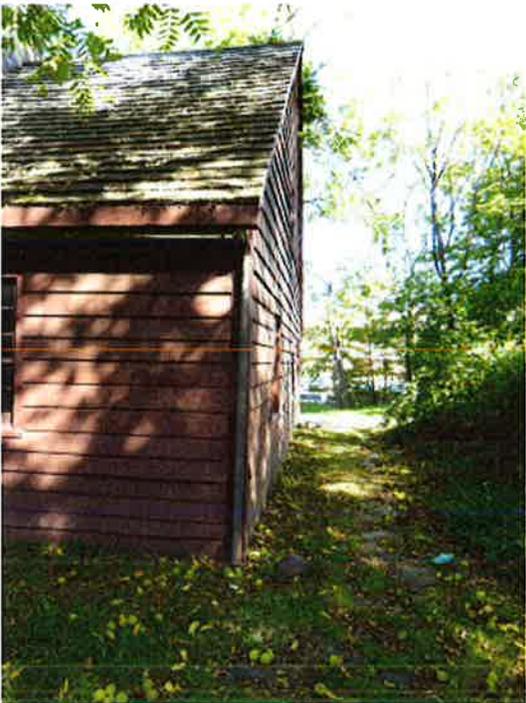
Photo 6 - South Elevation, east side, clapboard in contact with grade.

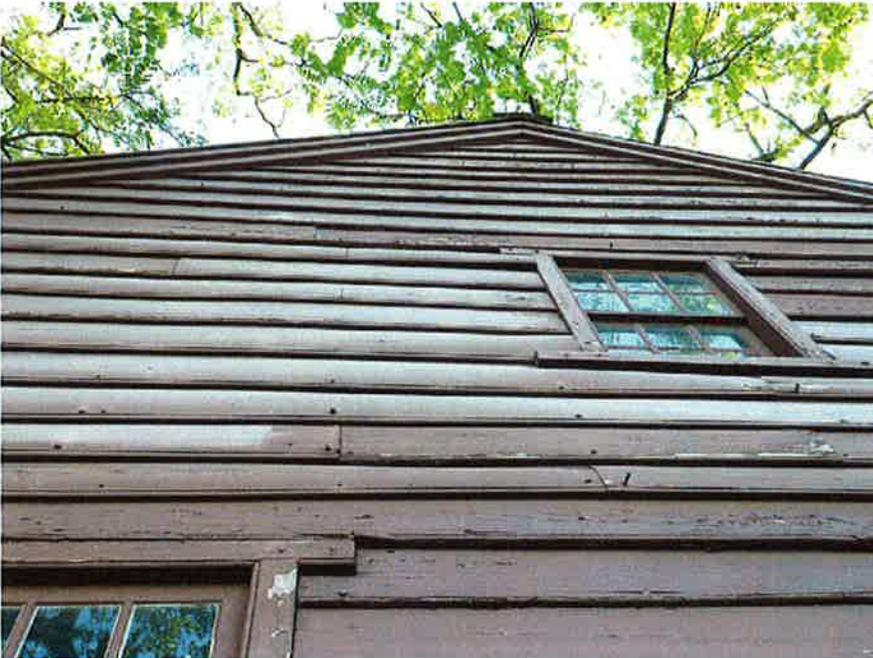
Photo 9 - West gable overview of cupped siding, jacked nails, overall warped surface.

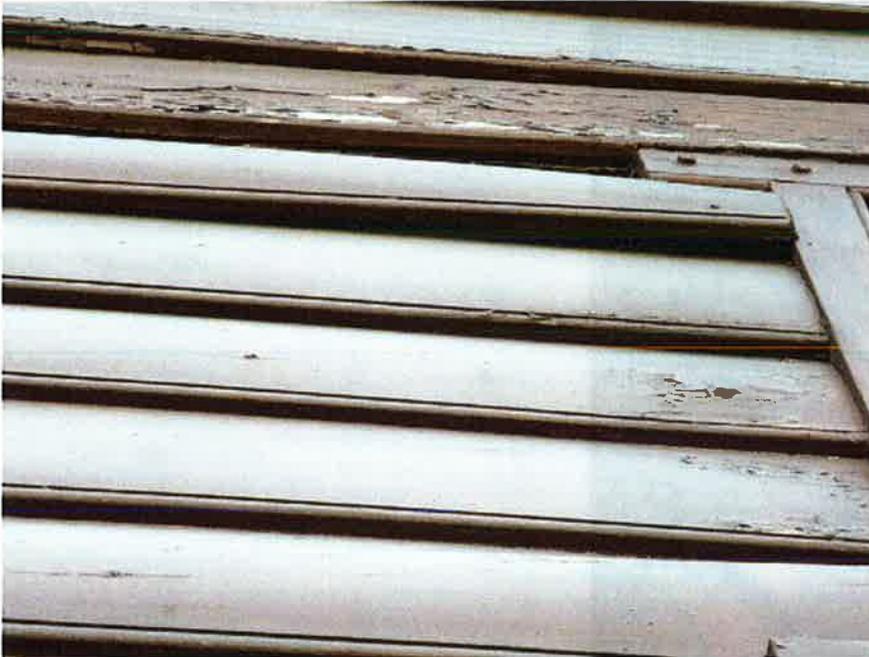
Photo 9a - Close view of siding meeting West attic window head and jamb.

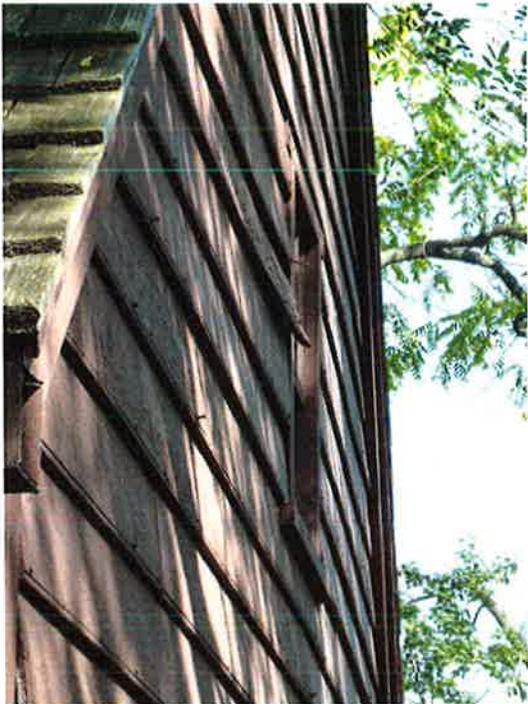
Photo 9b - Siding curling away from East attic window

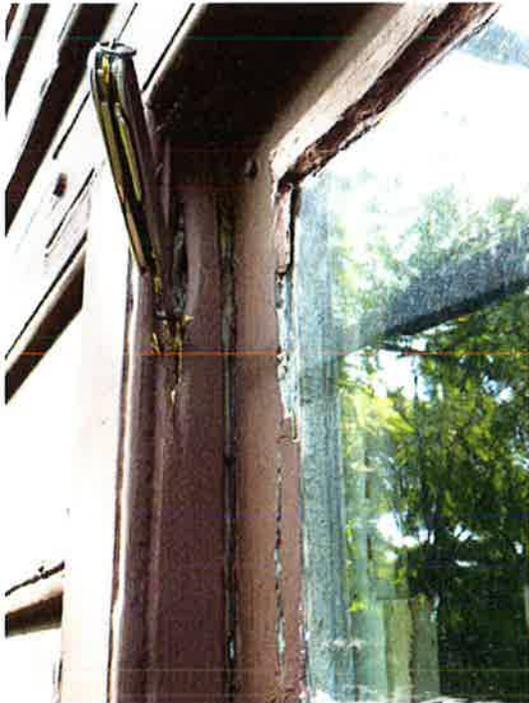
Photo 11 - Rotted jamb, East elevation, SE Room

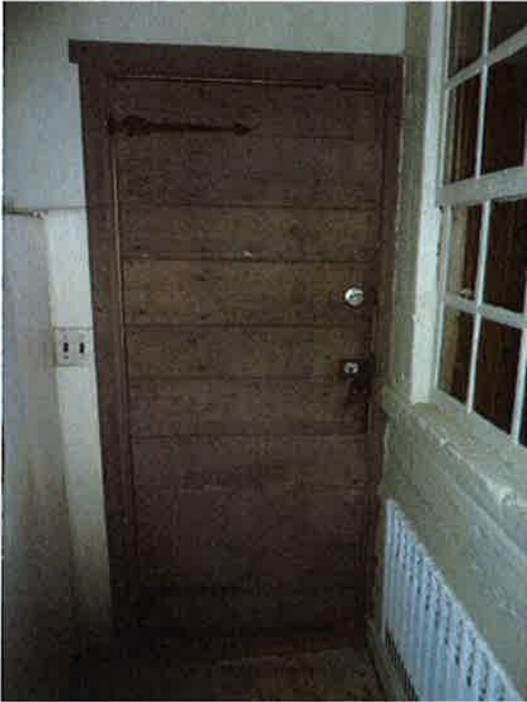
Photo 15 - Kitchen entrance, hinge

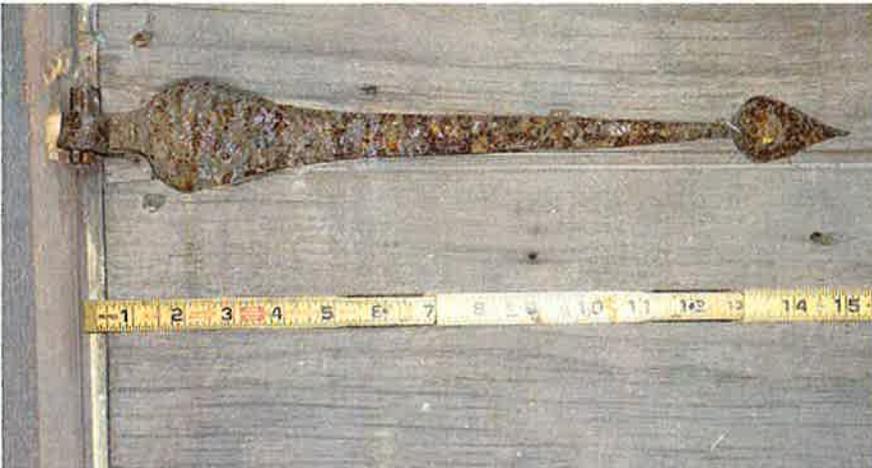
Photo 15a - Kitchen entrance interior

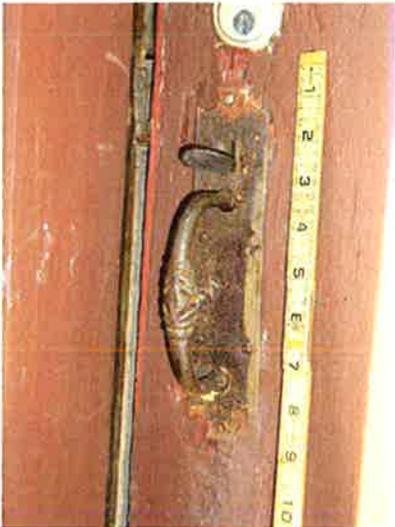
Photo 15b - Kitchen entrance hinge

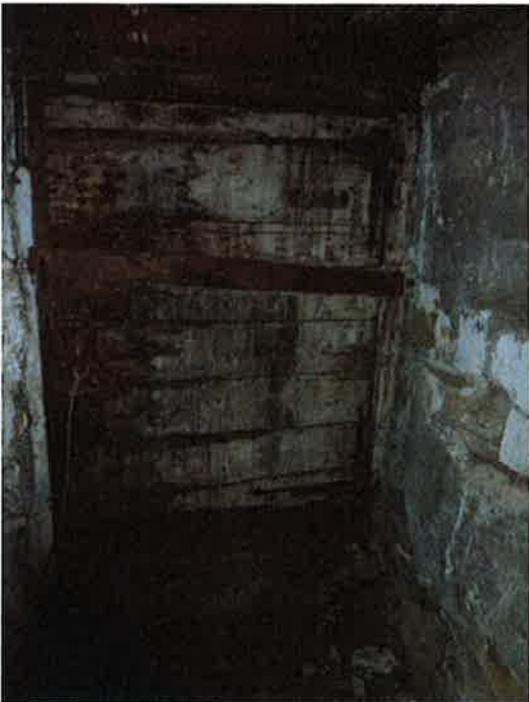
Photo 16 - Basement entry, exterior

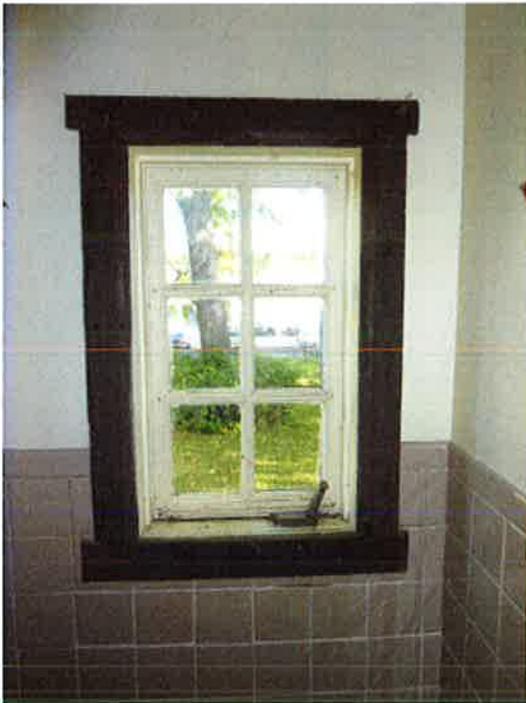
Photo 16a - Basement entry, interior

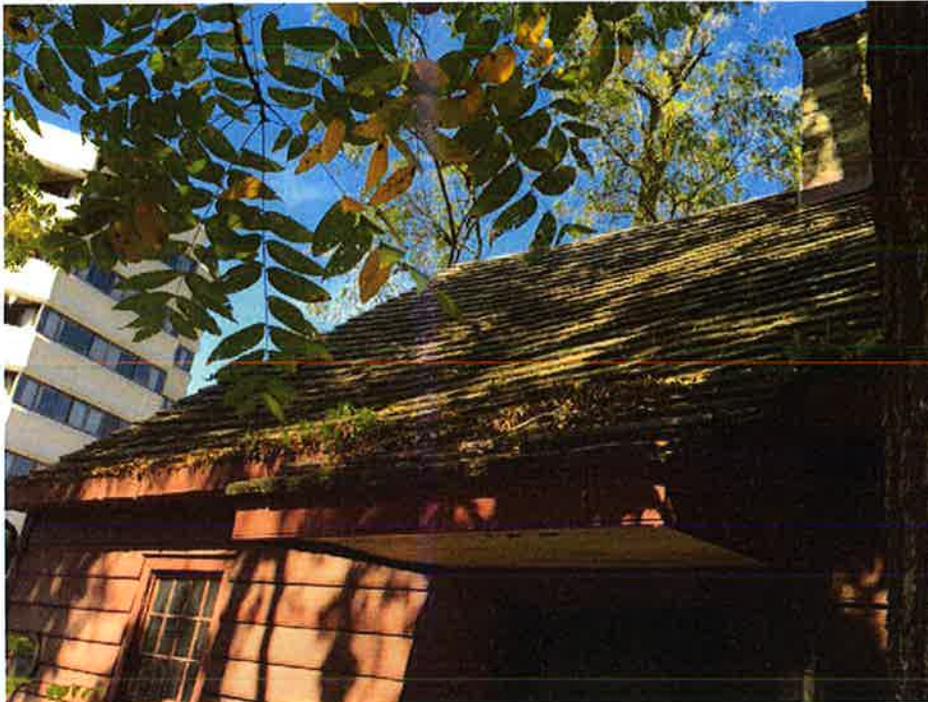
Three roof projections are found: (1) the typically minimal sloped soffit and fascia perpendicular to the slope projecting from the house approximately six inches; (Photo 24) (2) the extended shed added to shelter the front door, having a pronounced eave and board soffit; (3) the six foot overhang of the “porch,” whose eave-line relationship is consistent with the front of the house. The porch is open to the roof deck and framing. Visual inspection did not indicate leakage from ice dams, vermin infiltration, or insect habitation.

Gutters are used only on the south facing slope starting at- and pitching away from the shed over the entry. A copper half-round gutter connects to 3" copper elbows and leaders directly connected and discharging into presumed storm sewer lines at the east and west corner. There is no lower cleanout. The gutter is set into an open-top box-shaped construction finished to emulate a rough adze finish (Photo 29). The assembly is supported by square section spikes forged with a flat face retaining bar terminating in a scroll and fastened to the gutter face with a Phillips screw (Photo 30). The spike end is driven through the clapboard into the upper beam. The gutters were loaded to overhanging with debris at the time of this inspection.

Photo 23 - Type 4 Window looking down on meeting rails

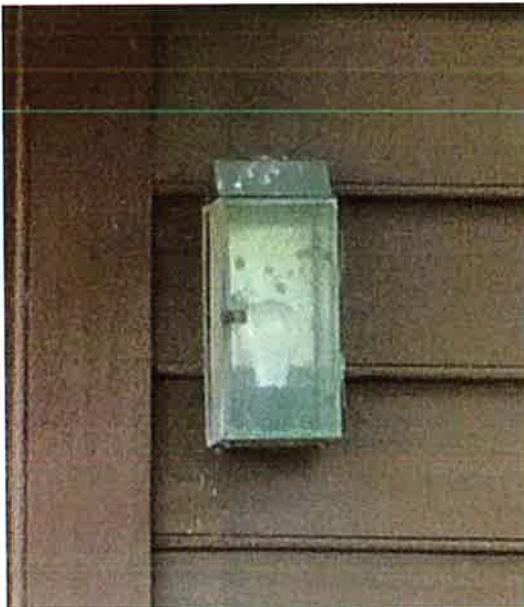
Two exterior light fixtures were noted, both electrified replicants of older lantern formats. The light adjacent to the main door (Photo 25) is a four inch by ten inch framed rectangular case made from folded brass with a folded metal top vent. All glass is intact; a lamp was installed but not tested. The kitchen entry light (Photo 26) is fabricated from sheet metal into a tapered case with a formed roof with finial, and punched and pierced ornament at the broad top face. All glass was intact, no lamp was installed. The patina of both fixtures suggests brass

Photo 24 - View of later entry shed and minimal overhang along balance of façade. Note debris accumulation in gutters.

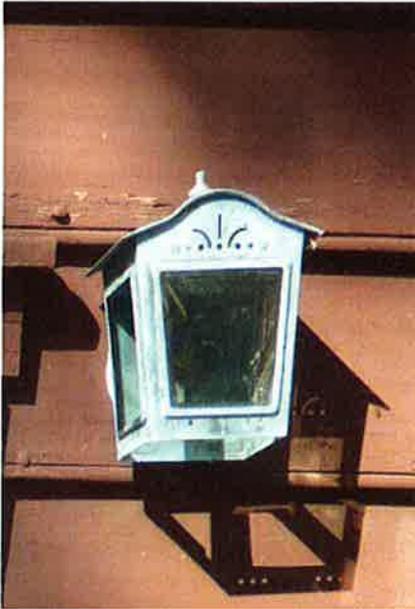
Photo 25 - Electrified lantern replica, hinge side of main door

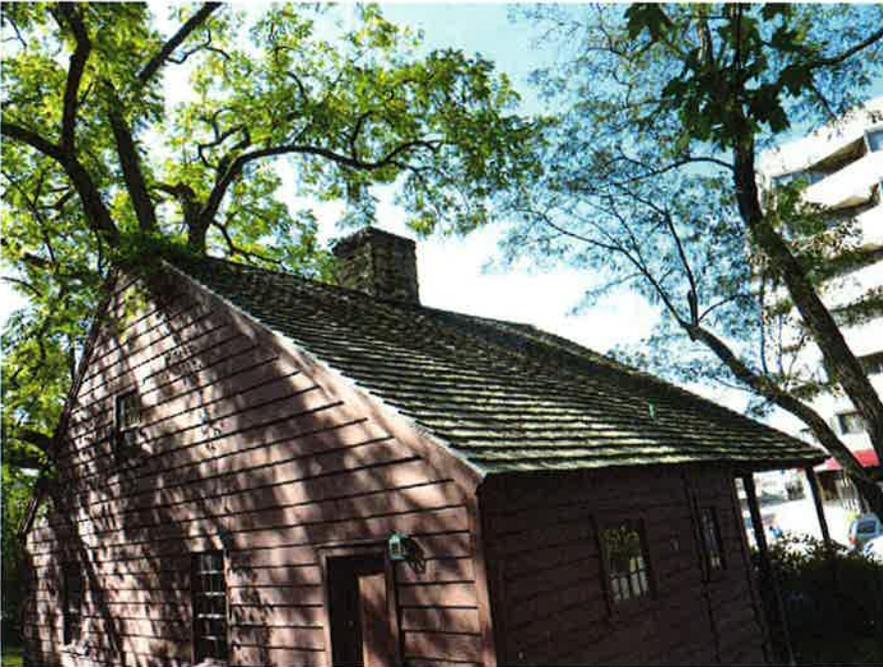
Viewed from the exterior, the roof is covered with eighteen inch hand split, squared and rebuted cedar shakes with a nominal eight inch exposure. Consistent with shake application practice, there are no metal edge or drip accessories. Laps and overhangs are well placed though incidental swell-rises were noted indicative of spacing that is too narrow or clogged with debris. The shingles are step-flashed to the chimney with what appears to be copper. One 3" copper DWV plumbing vent penetrates the roof through a manufactured metal and rubber flashing boot. (Photo 27)

Photo 26 - Electrified replica, hinge side kitchen door

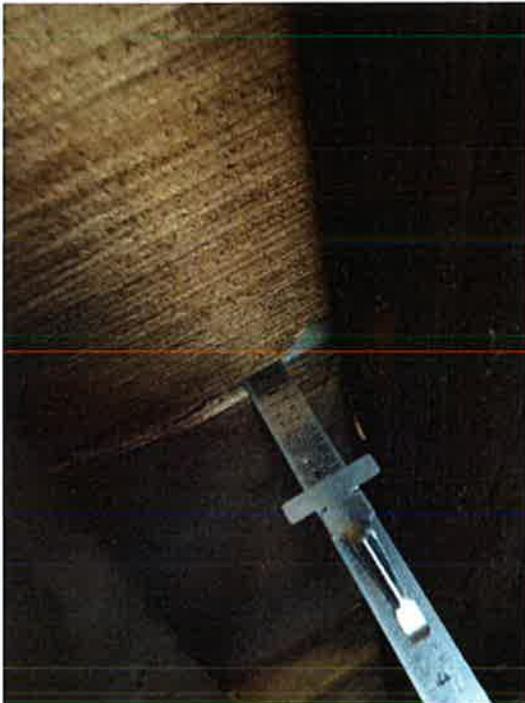
Viewed from the interior, older cedar shingles are visible through the gaps in the roof sheathing. Overlaying these shingles is an application of blue urethane foam board probed to be ¾" thick, likely one of a family of contemporary nail-base-roof-insulation panel products (Photo 28). To the credit of the installer, random fasteners were not evident penetrating the sheathing.

Photo 27 - General view of roof looking south east

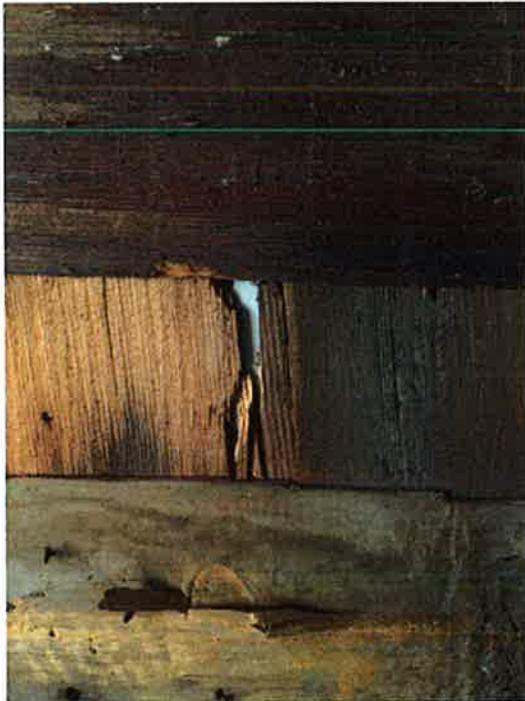
Photo 28 - Penetration into visible urethane foam=3/4"

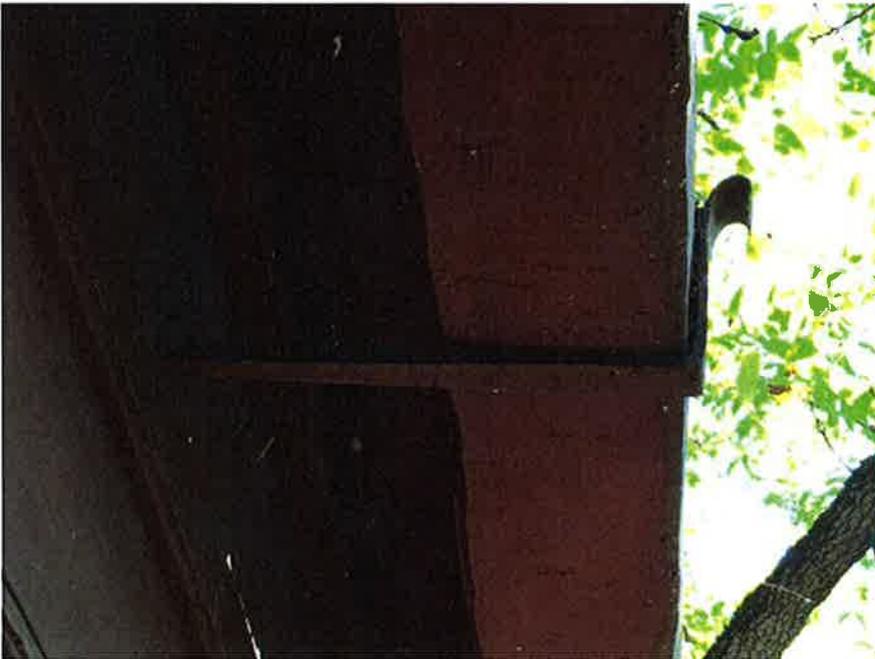
Photo 29 - End view of gutter assembly

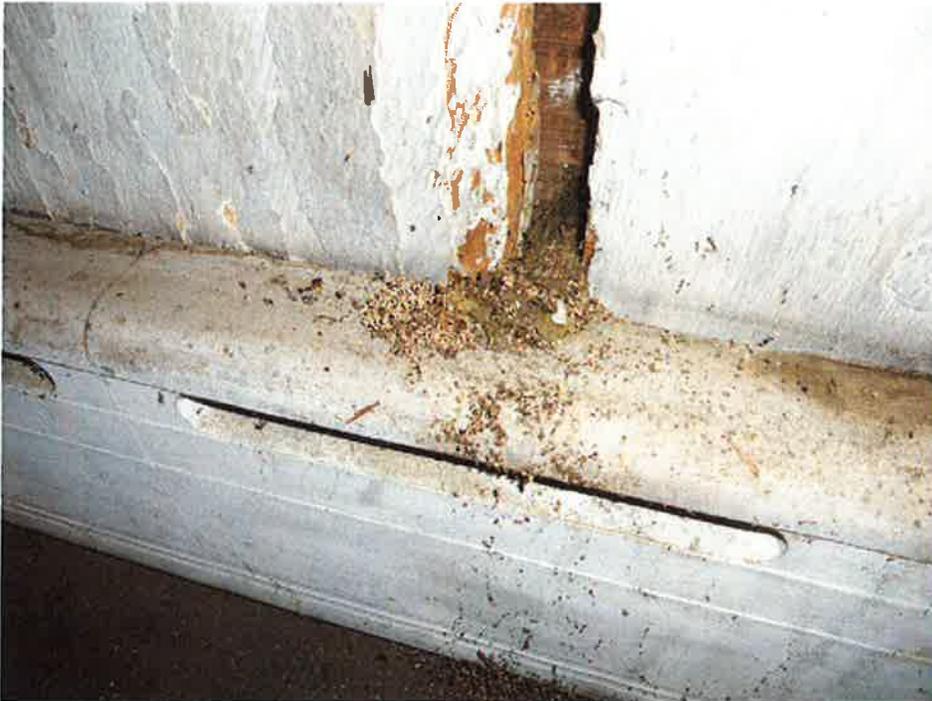
| SOUTH EAST ROOM (Parent's Room) | | | |
|---|---|---|---|
| <i>South Wall</i> | | Random width, square edge, closely spaced vertical boards finished to resemble a lime wash. Of notable concern was the presence of wood particles consistent with carpenter ants below the window, sill on the radiator. (Photo 33) | Verify |

Photo 32 - NW corner, basement ceiling exposed riven lath
