OLD HARBOR LIFE-SAVING STATION

Cape Cod
National Seashore

HISTORIC STRUCTURE REPORT

June 1988

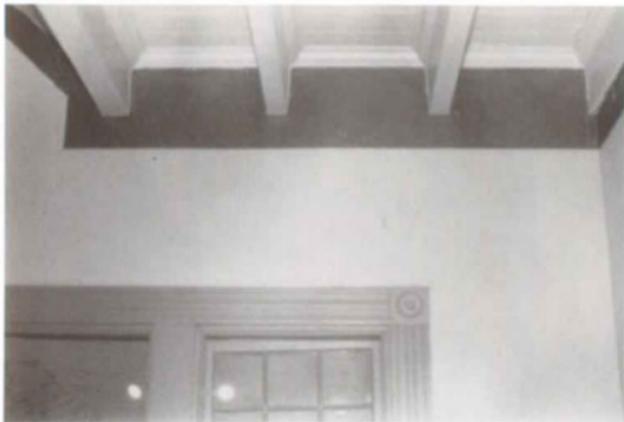
Illustration 47. First-Floor Stair Hall:
Cornice Paint on North Wall.

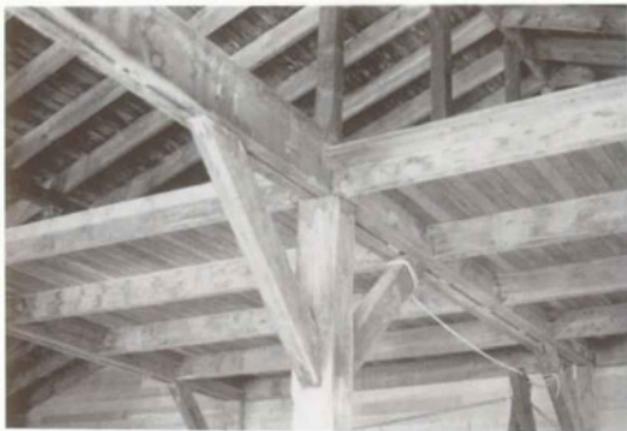
Illustration 48. Boat Room: Roof Truss
and Post.

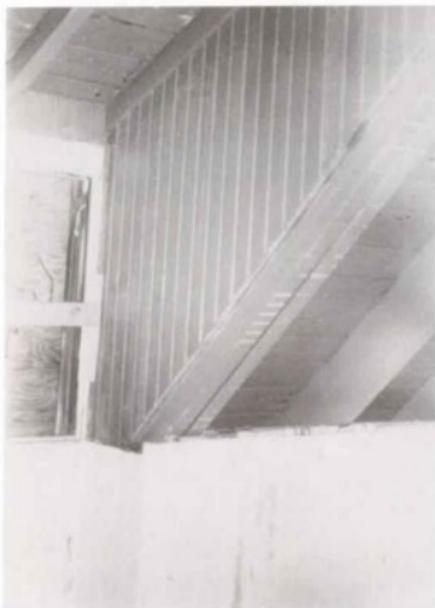
Illustration 49. Quarters: Side of
South Dormer.

In addition to the double-beaded matchboard used as wainscot in the Quarters, single-beaded matchboarding is used to sheathe the upper sections of the side walls of the south-dormer alcove (fig. 49). Such sheathing also exists in the north-dormer alcove, but only on the south ends of the side walls. It is missing from the north ends, which exposes the unpainted dormer framing members and exterior sheathing boards here. All of the single-beaded matchboard sheathing is painted gray-green; the paint is in generally poor condition.

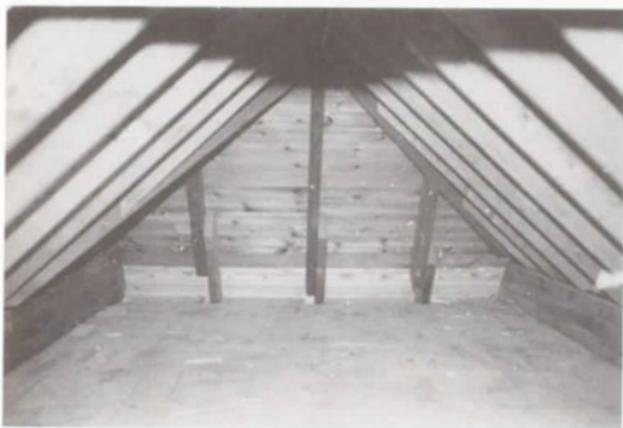
Illustration 52. Stowaway: Looking South.

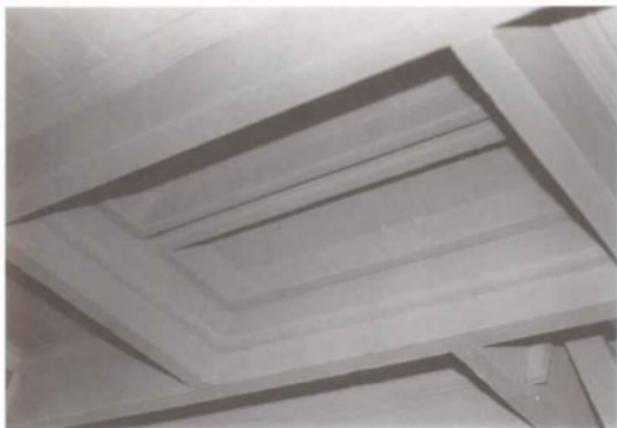
Illustration 53. Third-Floor Stair Hall:
Historic Hatchway in Ceiling.

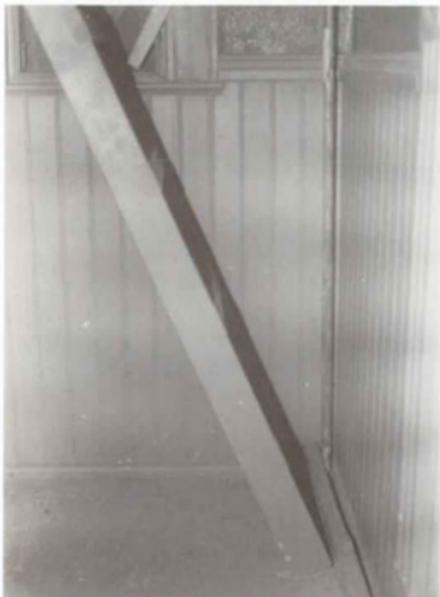
Illustration 54. Third-Floor Stair Hall:
Ladder Serving Posthistoric Opening in Ceiling.

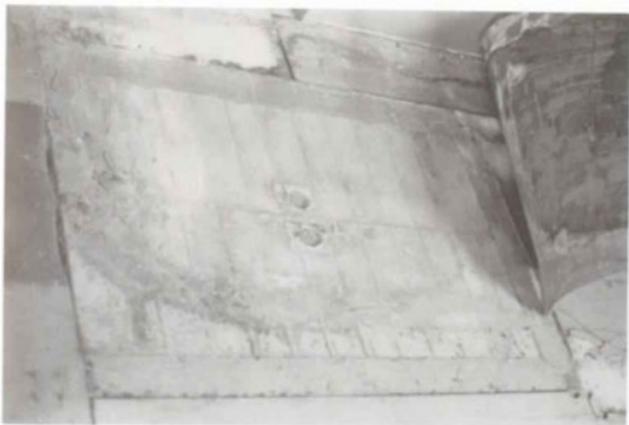
Illustration 55. Lookout: Doors of Historic Hatchway.

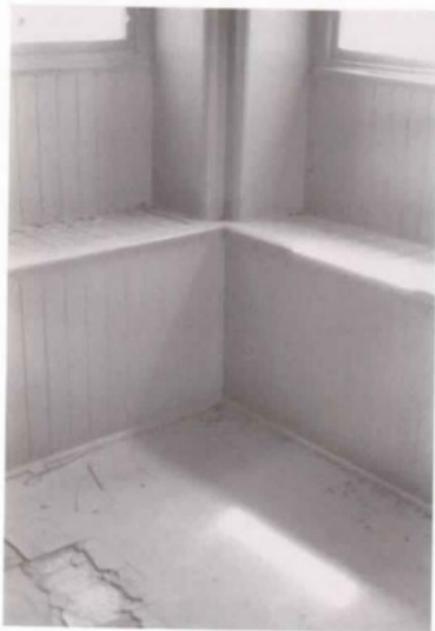
Illustration 57. Lookout: Lower
and Middle Wall Tiers.

Most of the original matchboarding and smooth lumber is intact. It is missing in two places, which have been patched with wide pine boards. These places are part of one bench seat, and the east half of the middle tier of the north wall.

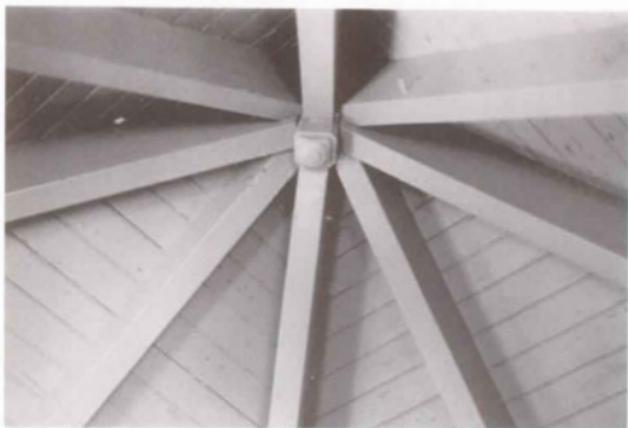
Illustration 59. Lookout: Apex of Roof Framing.
