Cane River Creole National Historical Park
Magnolia Plantation
Overseer's House
Historic Structure Report

Hartrampf, Inc.

The Office of Jack Pyburn, Architect, Inc.

2004
Historic Structure Report
Overseer's House
Magnolia Plantation
Cane River Creole National Historical Park
Natchez, LA
LCS#: 091558

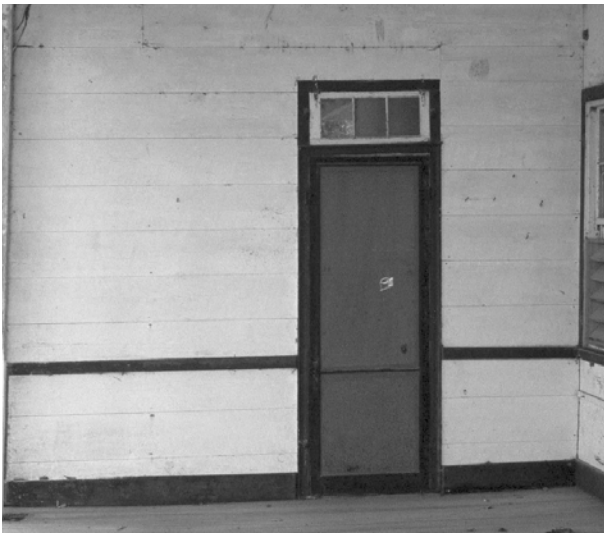
FIGURE 28. Southwest elevation.

Main Building. The exterior elevations of the main building in the Overseer’s House that are not protected by the gallery are finished with clapboard siding painted white. The clapboards measure ¾" thick with a 5¾" exposure. According to the *Design Analysis*, this siding was installed during the stabili-

zation measures that were completed in 1998 and matches the clapboard siding that historically finished the exterior walls. This information conflicts with the developmental history of the exterior presented in Barbara Yocum's Materials Analysis. A discussion of this discrepancy may be found in the Chronology of Development portion of this report.

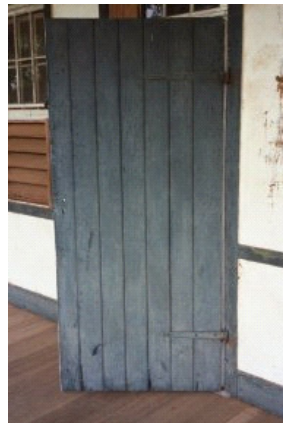
Door 5, Exterior

Door 5: There are two doors in this opening. The exterior board- and- batten door is comprised of seven boards connected to three beveled battens. The boards each measure 5" wide. The battens all measure 9³/₄" by 4/4" and have a 3/4" bevel. The strap hinges are wrought iron and measure 1'- 5" and 1'- 3" wide.
