FIRE ISLAND LIGHTHOUSE AND KEEPER'S DWELLING

**HISTORIC STRUCTURE REPORT
Architectural Data Section**

**Fire Island National Seashore
Patchogue, New York**

Carole L. Perrault

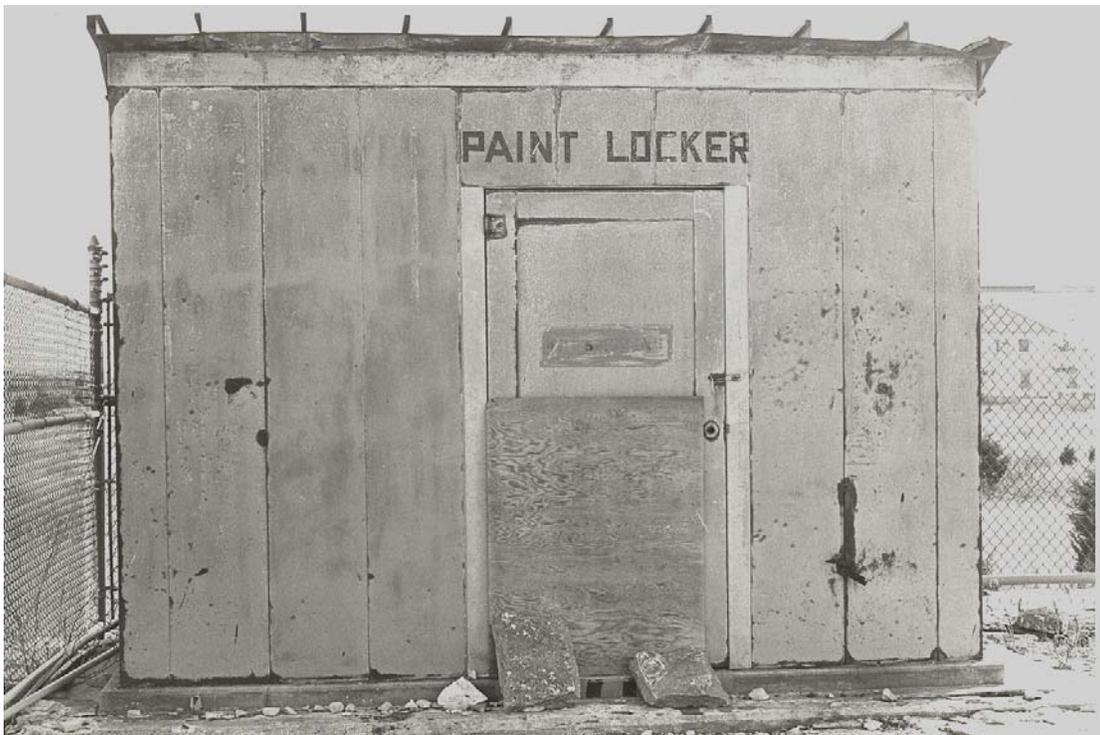
Figure 46. Terrace: paint locker, in northeast corner (1983).

The paint locker (fig. 46) dates to the early 1950's; it was in place by 1956 (figs. 39-40). The archeological report done on the site makes the following comment about the foundation upon which the paint locker sits:

Design A one-story metal structure, the paint locker measures 10 by 14 feet. The locker rests on a concrete slab foundation that apparently dates to the introduction of the extant structure. This slab was poured over an already existing foundation of concrete. The structure features only one doorway located off center on the west elevation. The words "PAINT LOCKER" have been stenciled above the doorway in black. The roof is a metal shed-type with raised seams.

Condition Requires repair and maintenance.

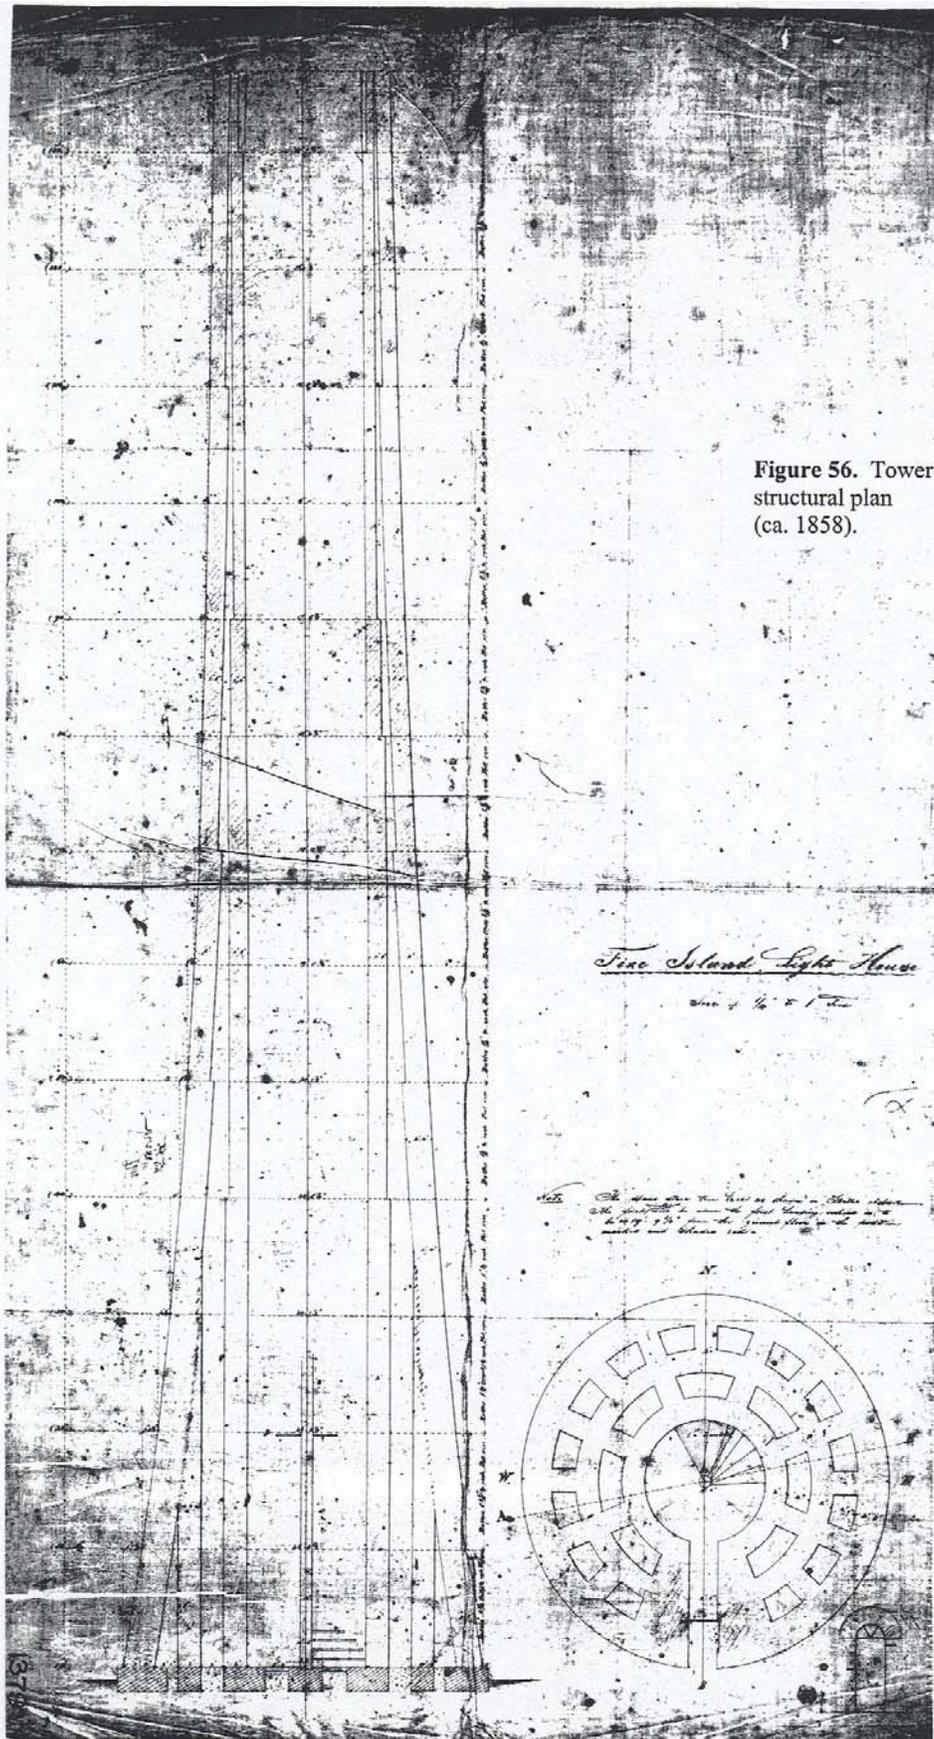
Figure 56. Tower:
structural plan
(ca. 1858).

Figure 54, and thus also 55, is incorrect in several respects, according to figure 56. Figure 56 is apparently slightly later than figure 54, because it omits the original concept of stone steps, and shows instead the cast-iron steps that were actually installed. It also omits the inner ring of brickwork seen in figure 54. This ring may have been designed to support the stone steps, and so would have been made unnecessary by the cast-iron steps.

Figure 56 depicts a sketch of the entry doorway with a three-light fanlight above. The hinges are designated as being on the east side, with the lock on the west. The placement of the door—recessed from the exterior wall plane—is defined as well. Descriptions of three doors are included in the 1861 specifications, but they do not appear to be similar to those introduced into the second Fire Island lighthouse.

A note on figure 56 states: "The first window will be above the first landing, which is to be at 19' 9-3/4" from the ground floor." Finally constructed were seven windows, as follows:

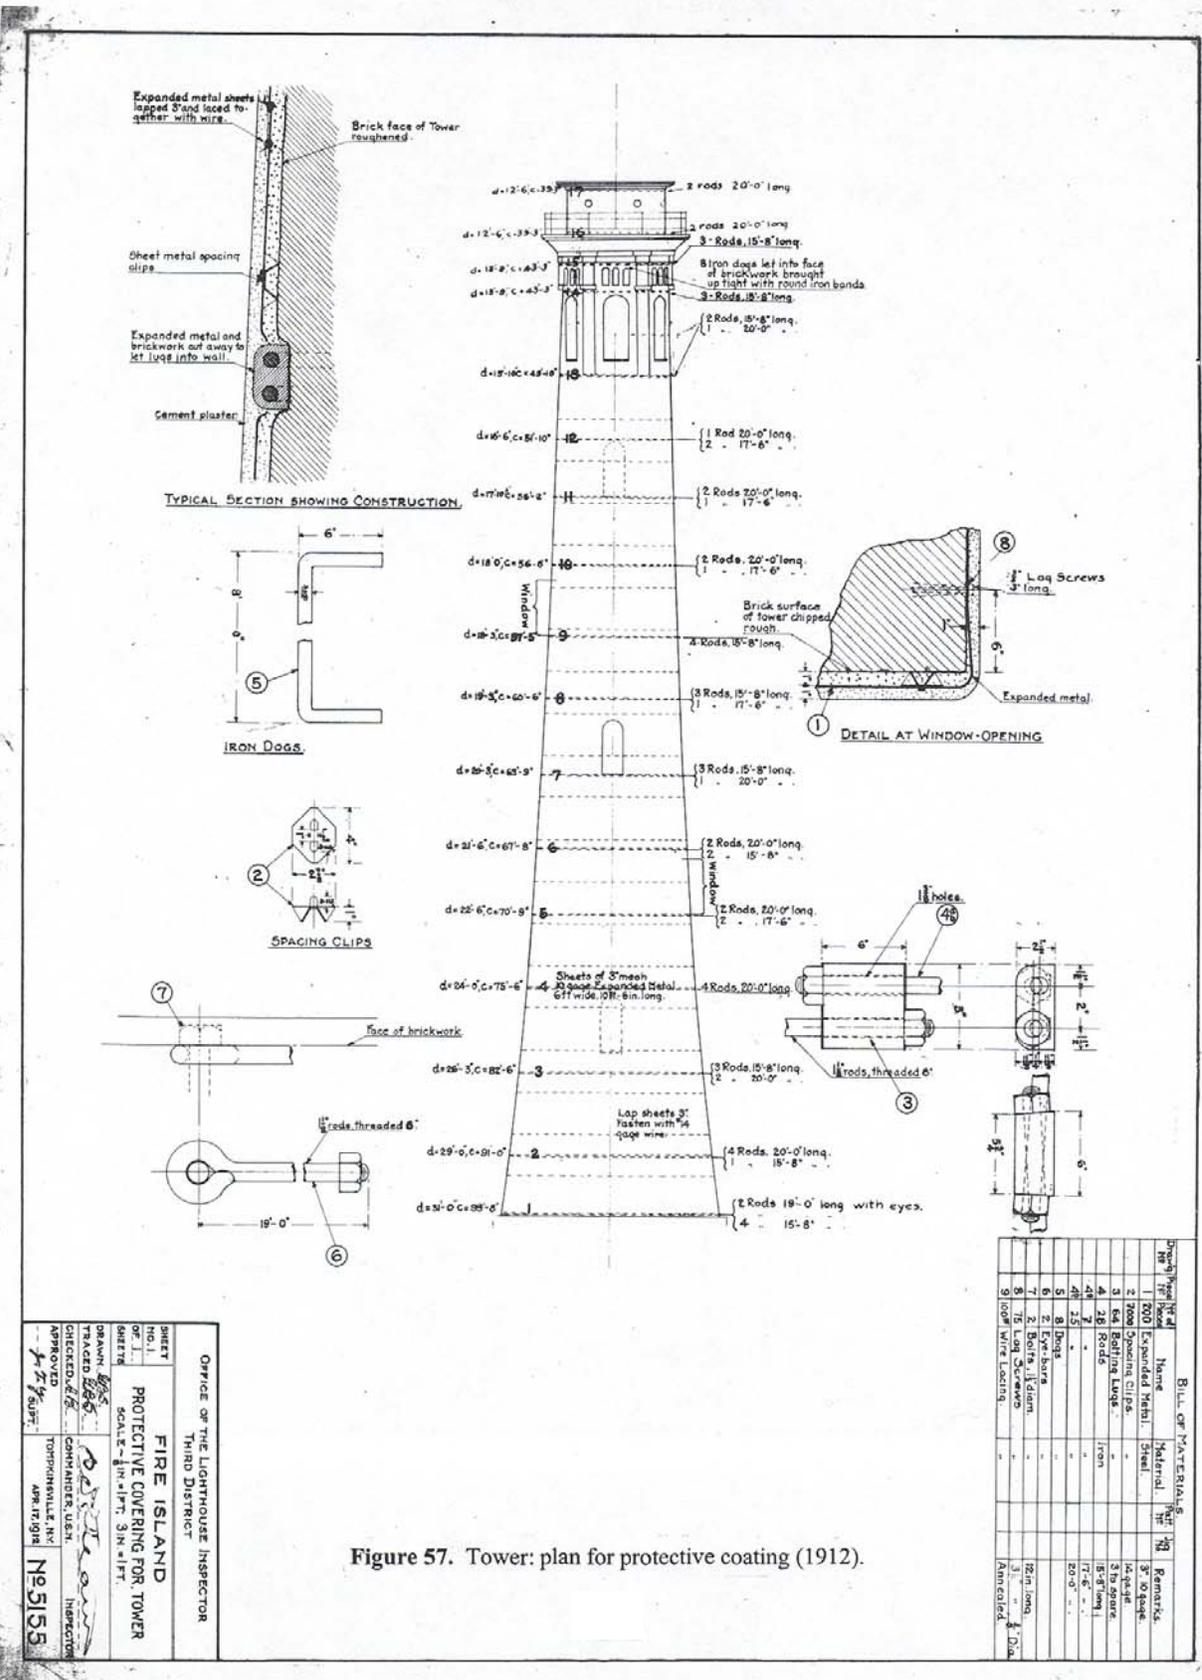
Figure 57. Tower: plan for protective coating (1912).

The doorway from the Watch Room to the lower balcony received a new door in 1911 (App. C-120). The tower received reinforcing bands in 1912, followed by the thick coating of reinforced concrete that obliterated so much of the original decorative detail (fig. 57 and Appendices C-122 to C-132).

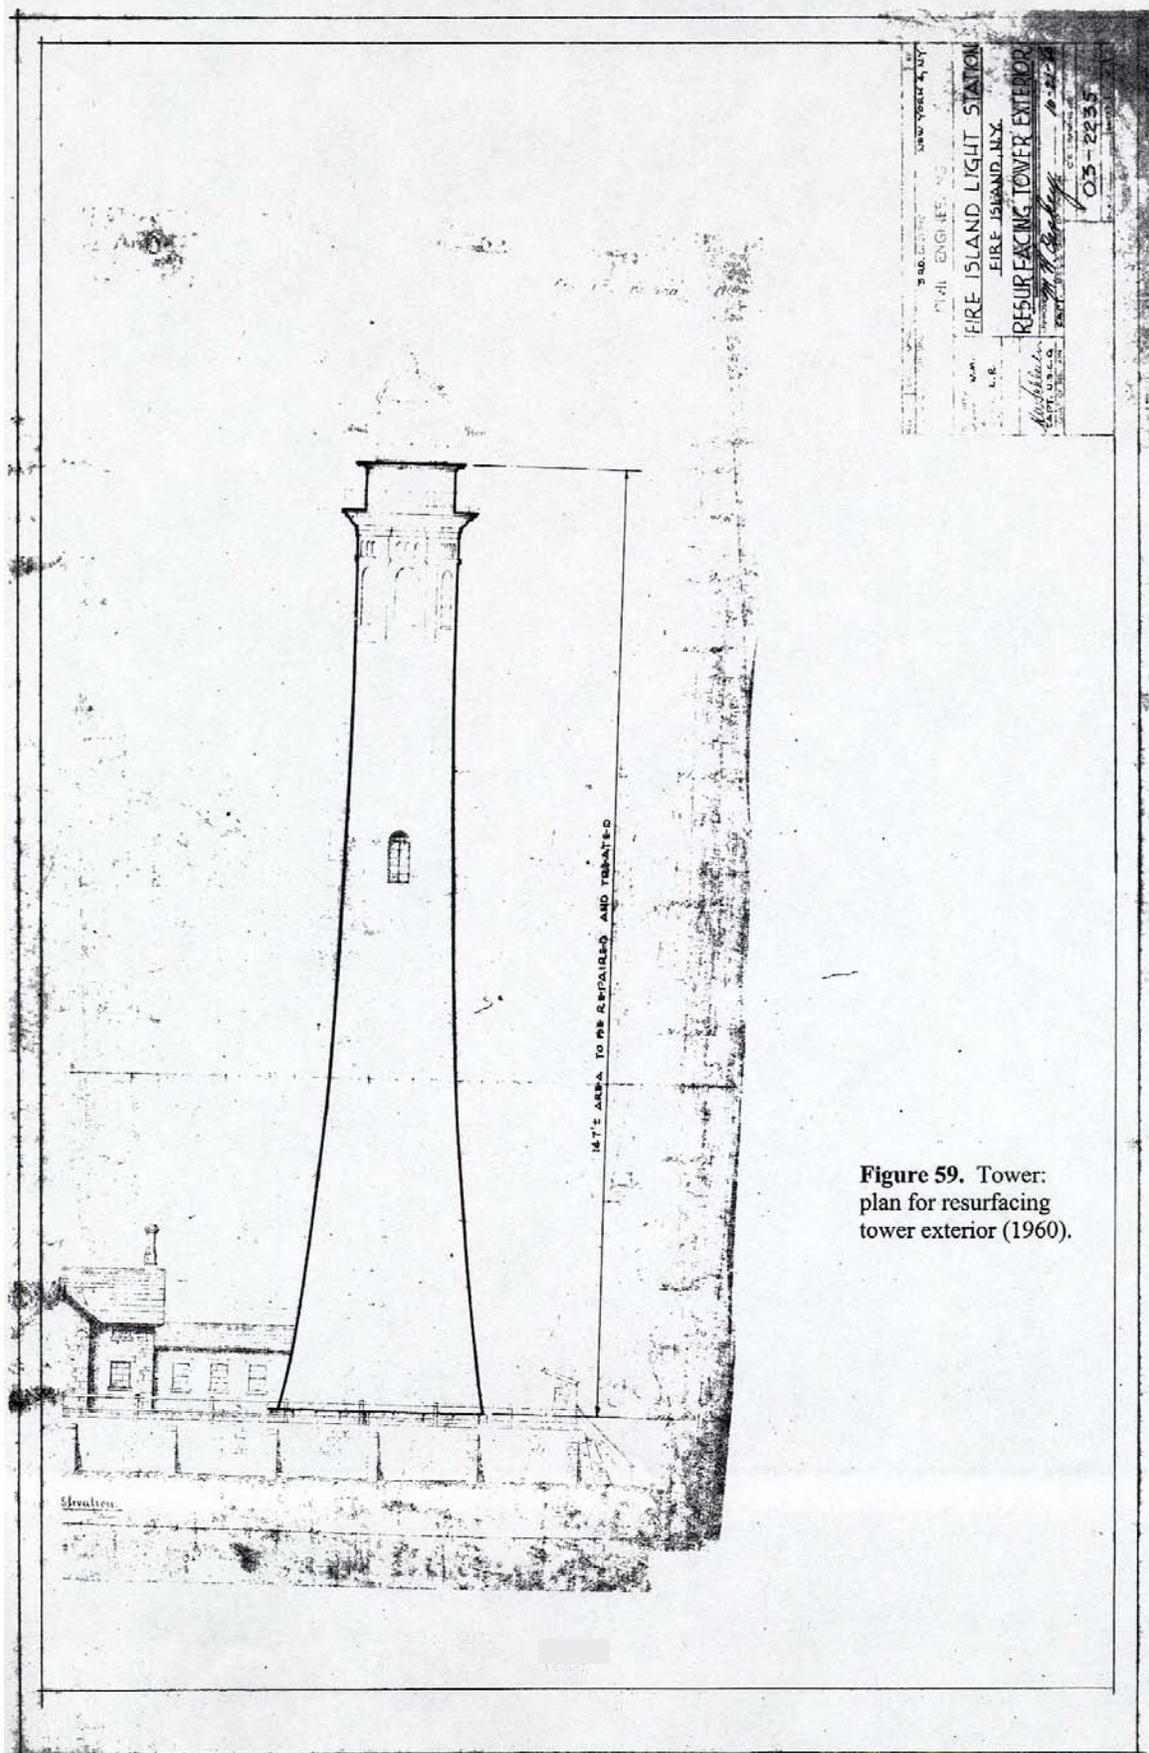
Figure 59. Tower:
plan for resurfacing
tower exterior (1960).

Few repairs or changes occurred during this period. Two sets of reflector antenna brackets were attached to the balconies in 1958 (fig. 58), and a third set was added sometime thereafter. The 1912 coating deteriorated to the point that in the 1960's, the Coast Guard considered resurfacing the tower (fig. 59). This did not happen. The door from the Watch Room to the lower balcony was replaced in 1962 (fig. 60).

By 1956, the brick shaft had lost large portions of its painted finish (figs. 40-41). Apparently the structure had not been painted since 1945. Figure 58 is a drawing dated October 21, 1960, entitled "Resurfacing Tower Exterior." It shows the area of the tower to be repaired and treated. The treatment seems to have consisted of a thin, paint-like application of "white mica-mastic." Paradoxically, the photograph thought to date from this work—Figure 42—shows the tower as being completely black at one point in this project.

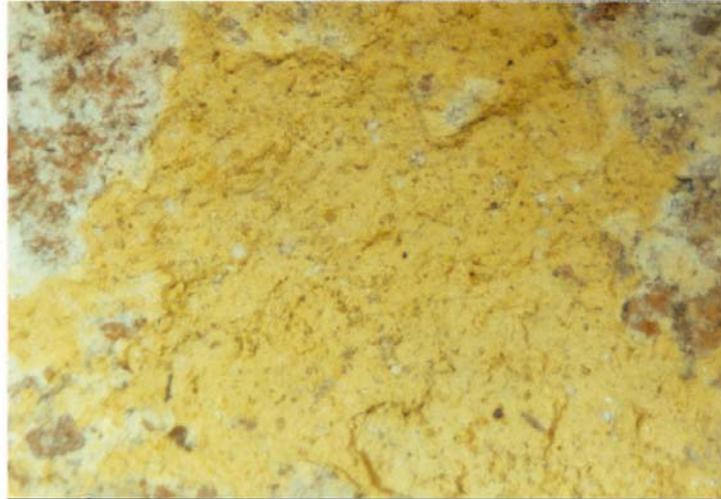
Figure 92. Tower exterior: paint sample #FIIS 13 P008, spalled brick (1983).

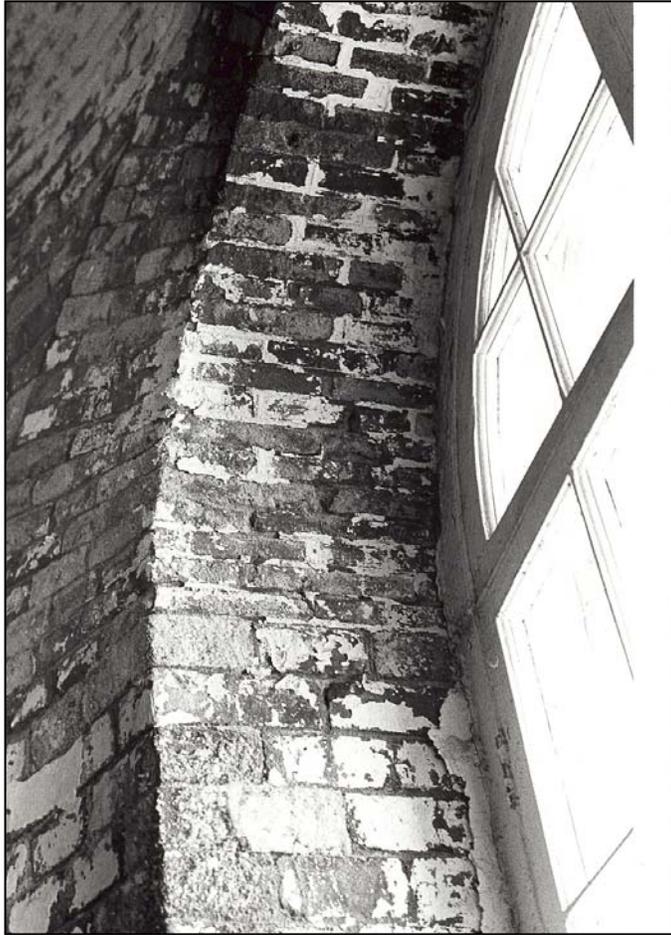
Figure 102. Tower interior: efflorescence of wall brickwork (1983).

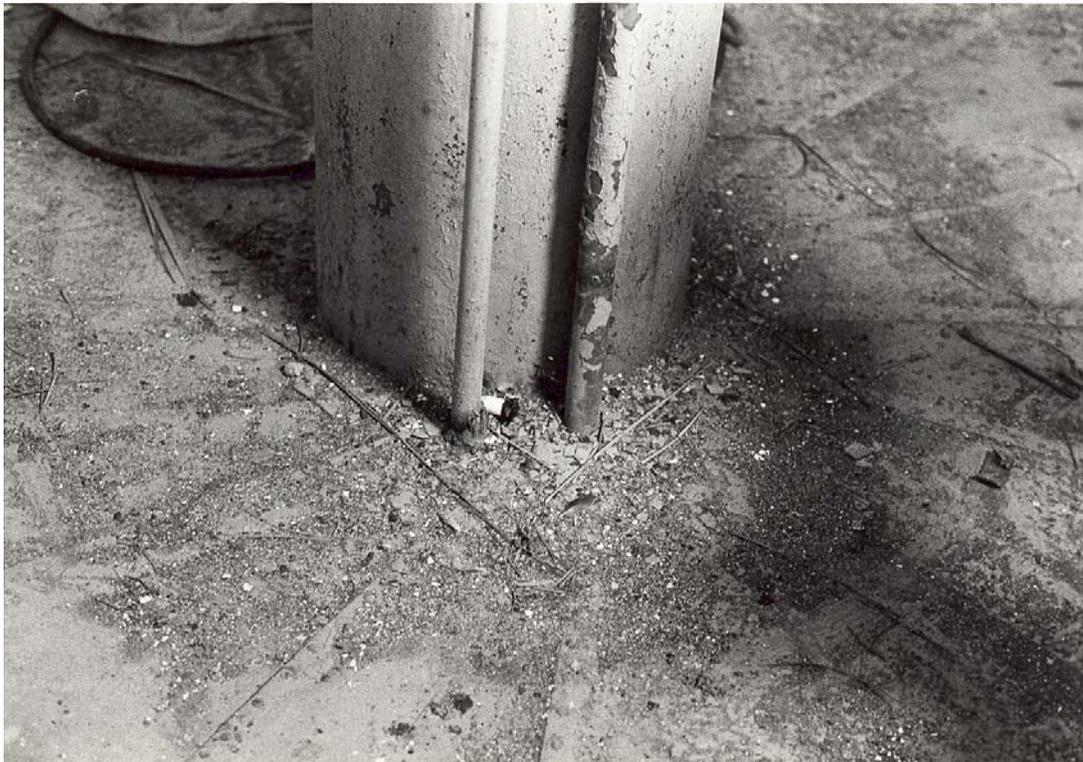
Condition The floor is covered with debris and needs painting; otherwise, it is in good condition. Because of high moisture content, the copper cladding should be removed in areas to check the condition of the wood flooring.

Figure 115. Tower interior: Service Room floor (1983).

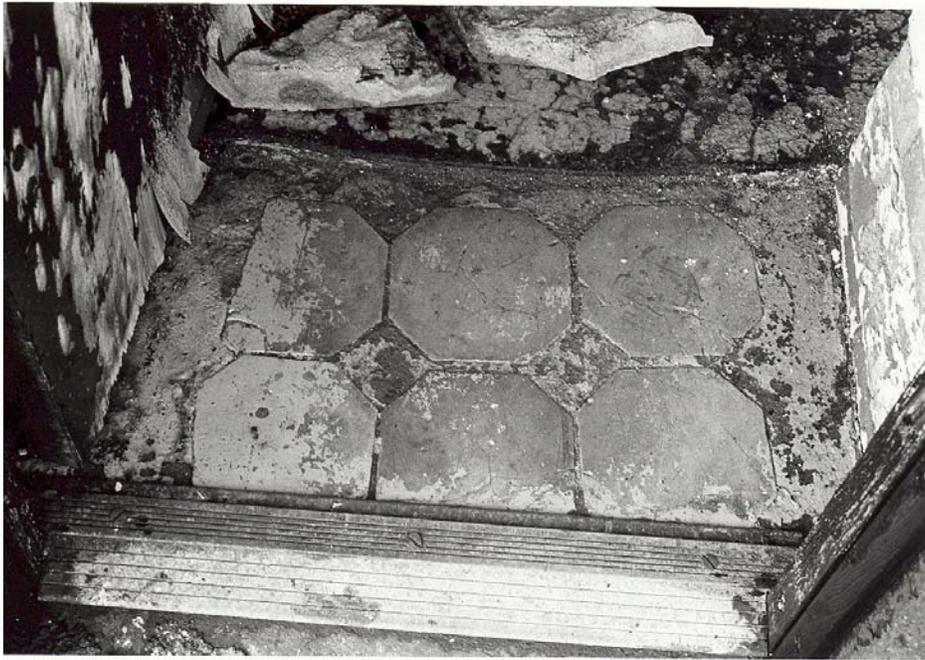
Condition The floor retains dampness; it is deteriorated, and some corrosion is evident. Several ceramic tiles at the threshold are cracked.

Figure 118. Tower interior: Watch Room floor, threshold of doorway to lower balcony (1982).

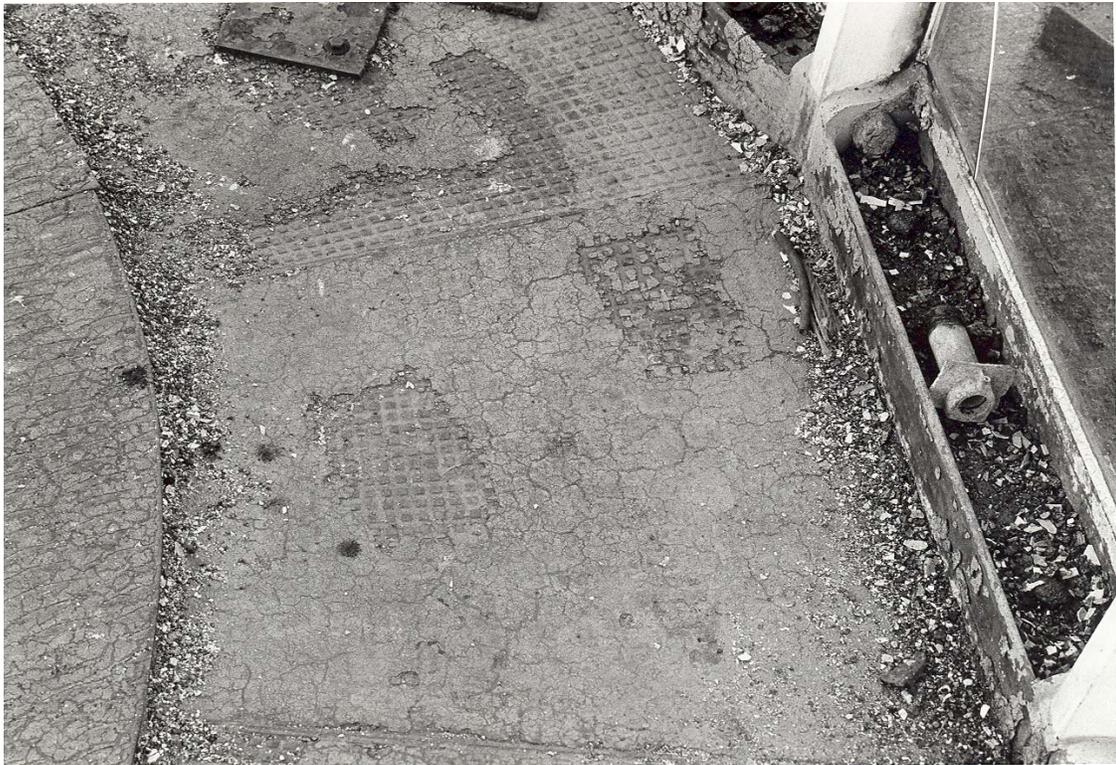
Condition The floor appears to be structurally sound and in good condition; however, it collects water and is full of dirt, debris, and paint chips.

Figure 121. Tower interior: peripheral flooring of lantern (1983).

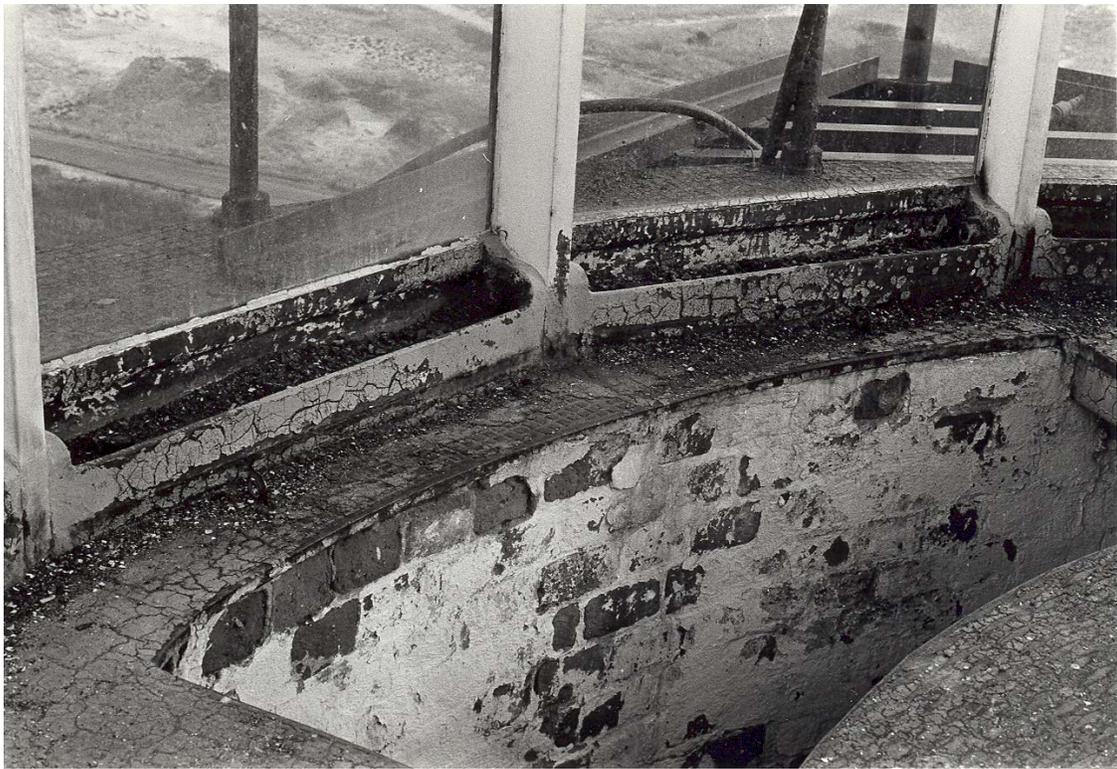
There are three openings in the lantern floor: one for a stovepipe, 5¼ inches diameter: one for the light-apparatus pedestal; and one for the stairway along the east-southeast wall. The stairway hole is formed by the omission of the inner part of two sections. These sections thus extend only from the outer edge of the stairway hole out to the upper balcony. One opening exists in the upper balcony deck for the ladder ascending from the lower balcony. At the southwest corner of the opening is a break in the plate, which has been repaired.

Figure 126. Tower interior: opening in lantern floor (1982).

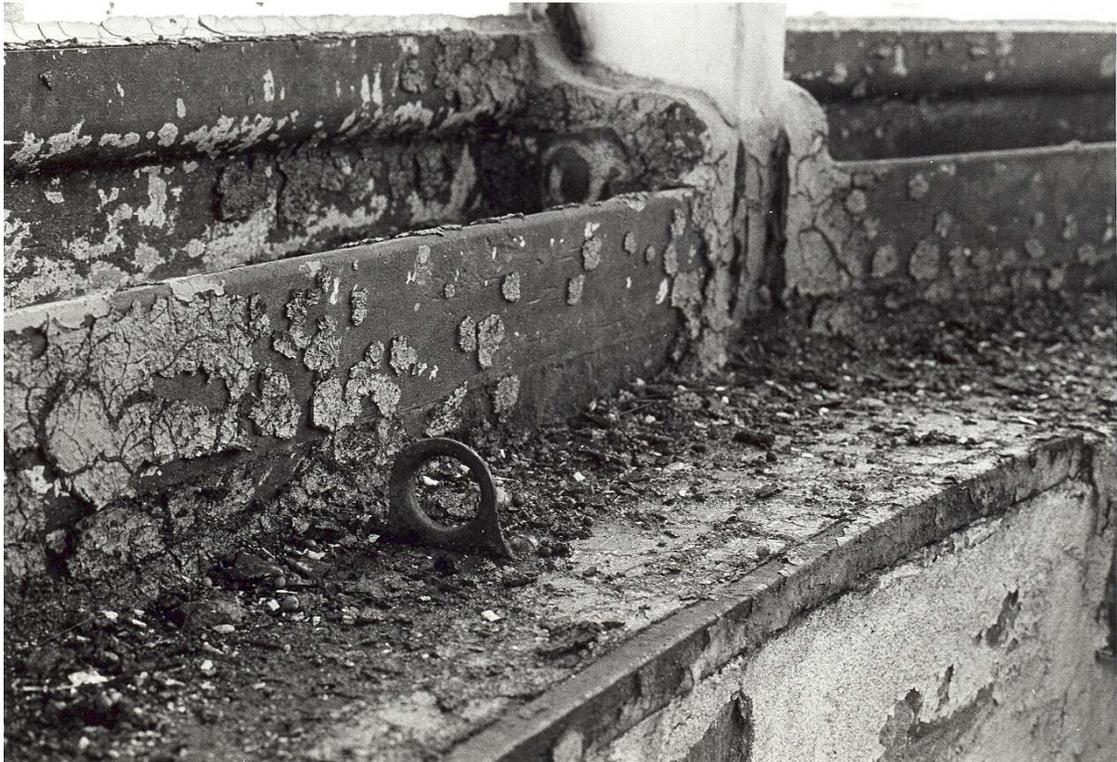
Concerning the trapdoor missing from the opening in the floor of the lantern, the Form No. 36—prepared in March 1880—described the trapdoor in this location as being of wood lined with copper. When this door was removed is not known.

Figure 127. Tower interior: opening in lantern floor, traces of former trapdoor (1982).

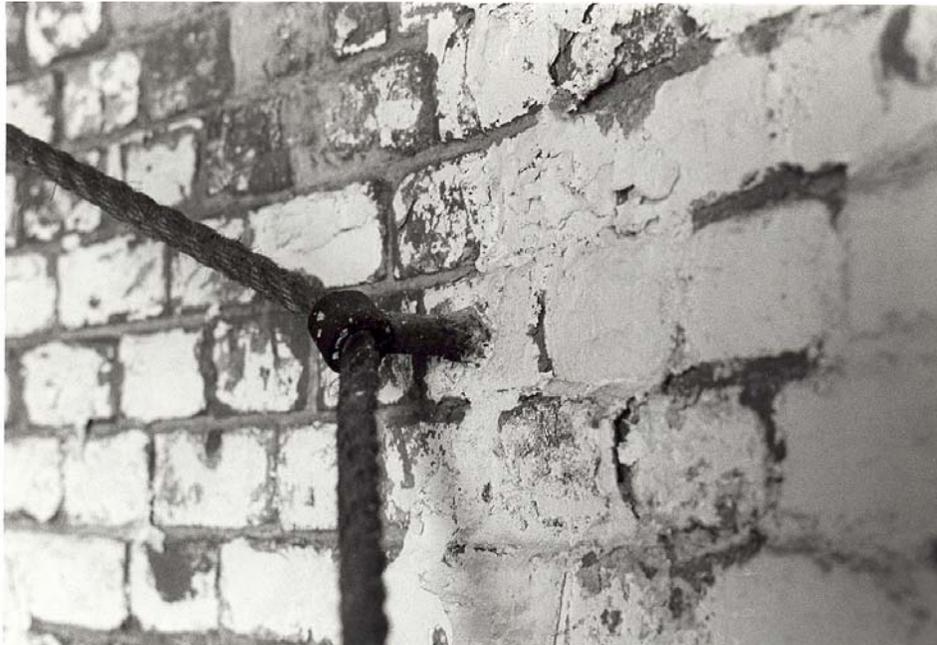
Figure 138. Tower interior: main stairway, safety-line anchor (1983).

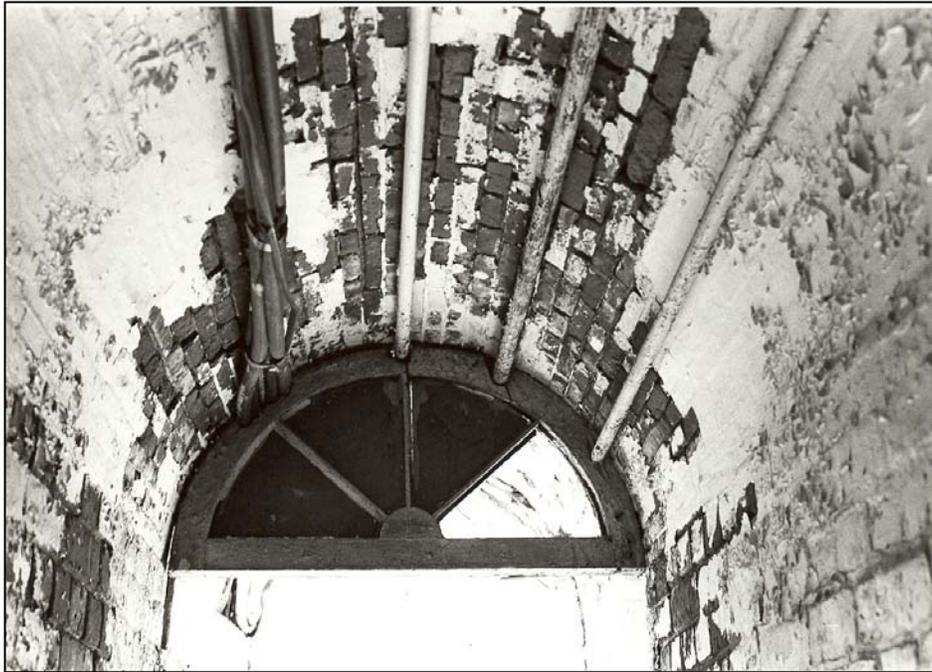
Conditions Conduits deactivated: paint film deteriorated.

Figure 151. Tower interior: conduits entering through entrance-doorway fanlight (1983).

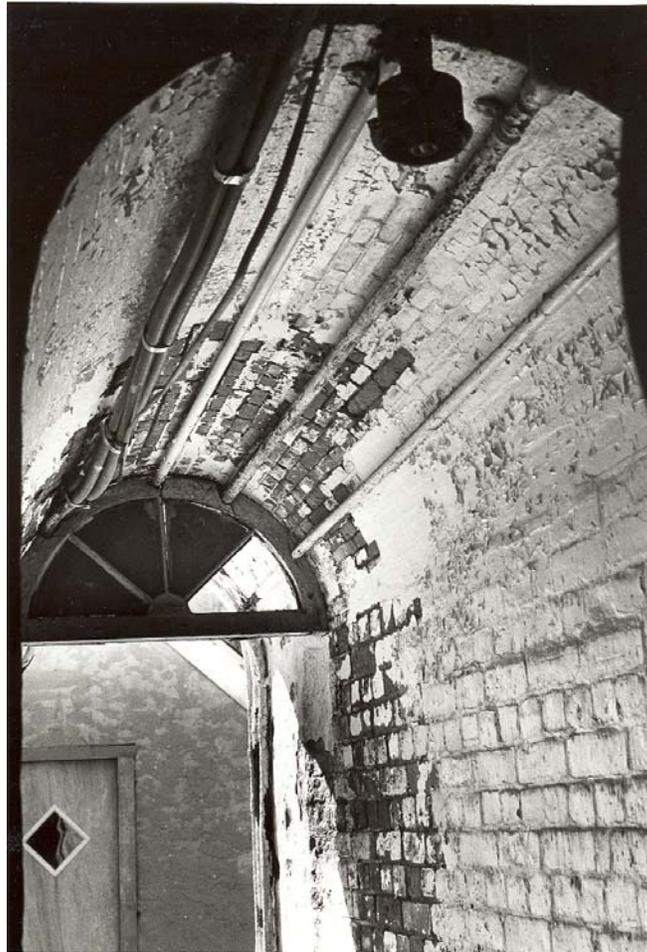
Figure 152. Tower interior: conduits at ceiling of entrance hallway (1983).

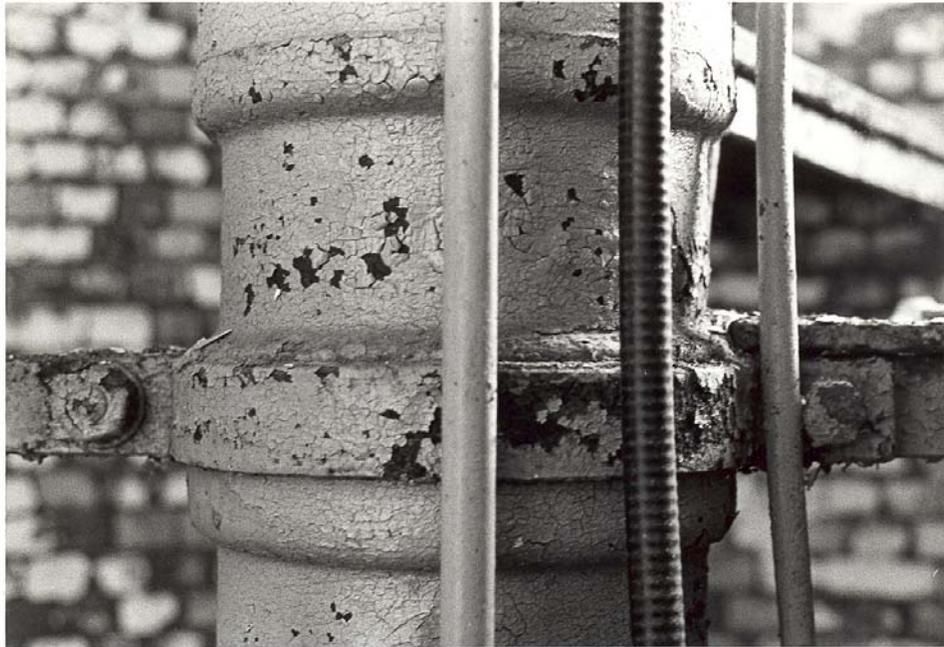
Figure 153. Tower interior: conduits along central column (1983).

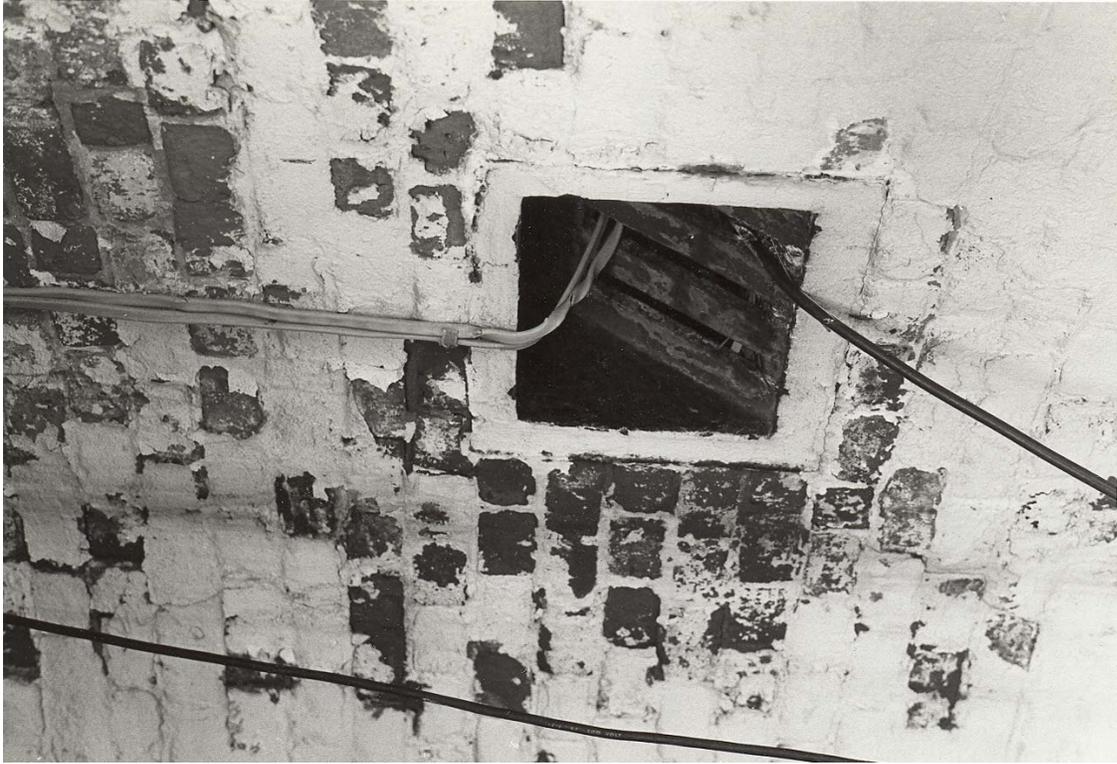
Figure 155. Tower interior: conduits in Watch Room (1983).

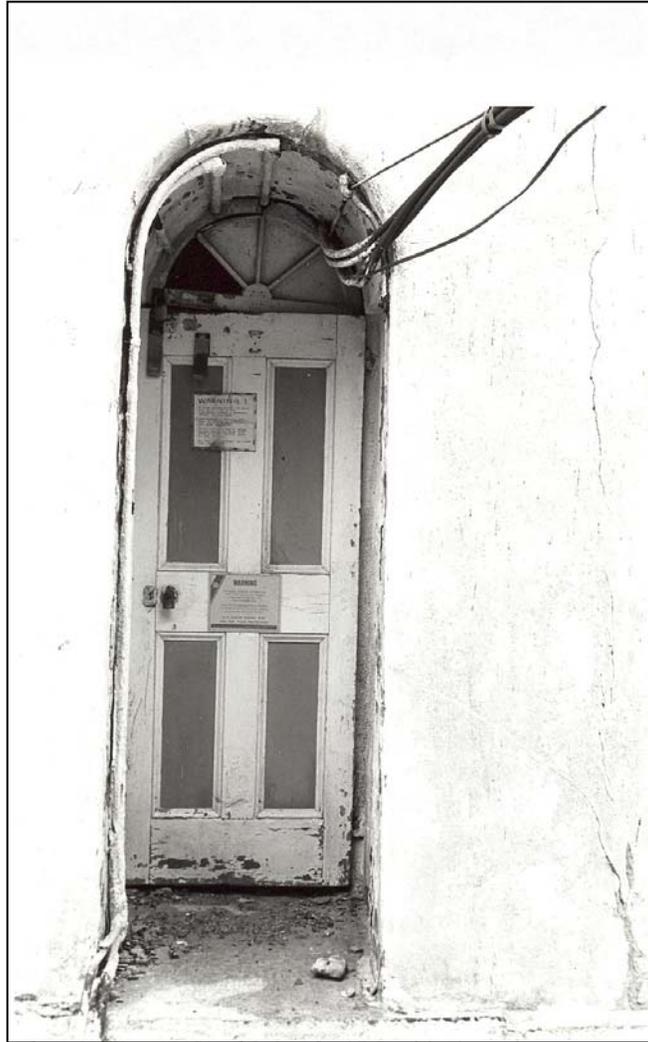
Condition Paint is peeling on the door and its hardware. The door and fanlight have been adversely affected by attempts to secure the door with modern hardware. The fanlight is badly deteriorated, and its west light is missing. The hardware is in poor repair; the metal rim lock is corroded.

Figure 157. Tower exterior: entrance doorway (1982).

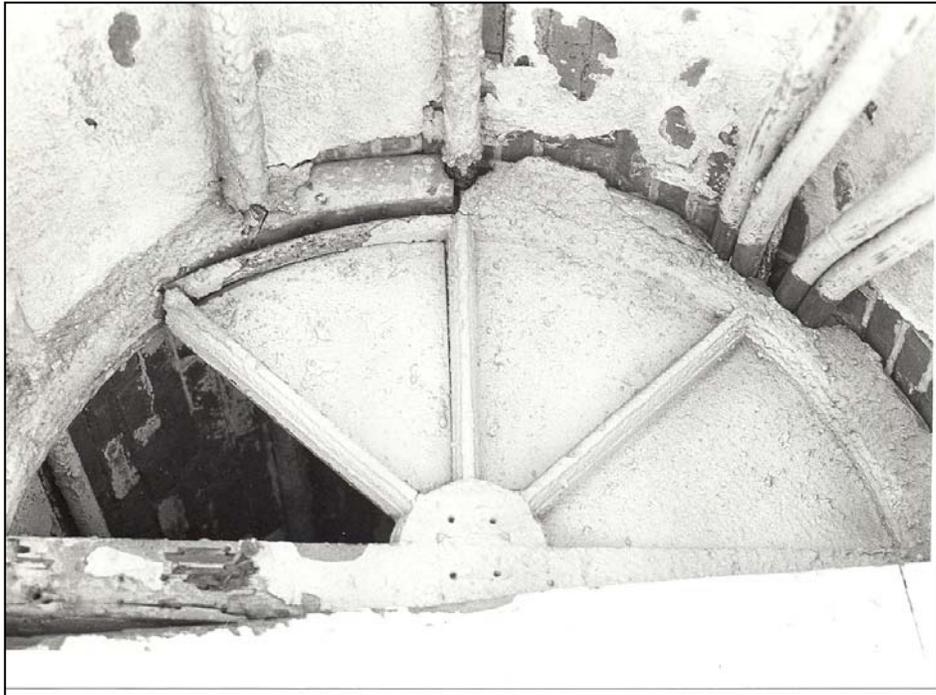
Figure 158. Tower exterior: entrance-doorway fanlight (1982).

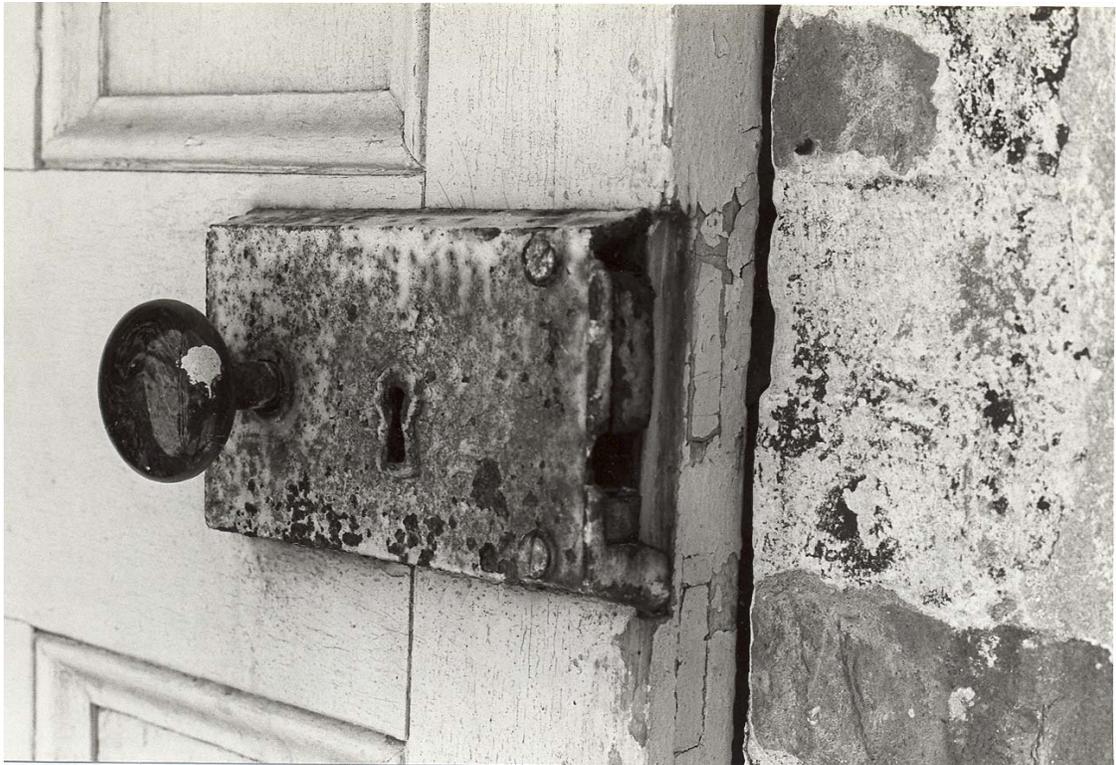
The metal rim lock is 5 inches wide by 7 ¾ inches long, and appears to be original to the door. The lock exhibits a mineral doorknob on its inside face, while the doorknob is missing on the outside. The outside face of the door features the keyhole escutcheon for the lock.

Figure 159. Tower interior: entrance door, lock (1983).

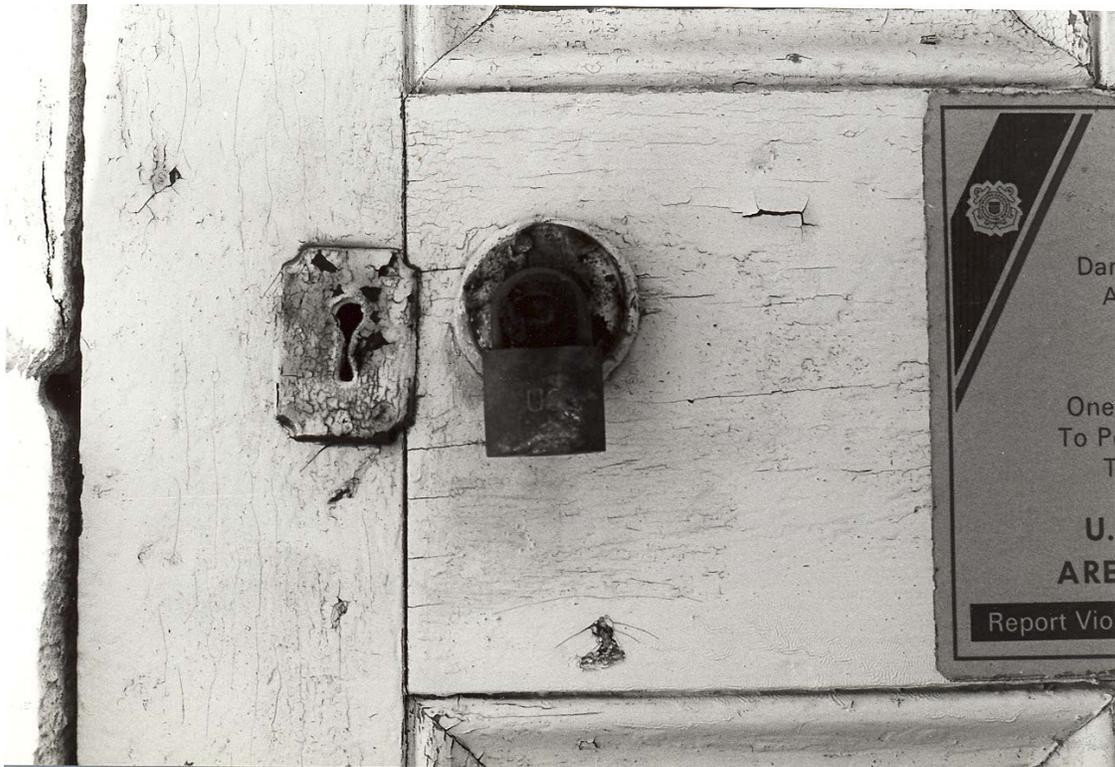
Figure 160. Tower interior: entrance door, key escutcheon and remnant of doorknob (1983).

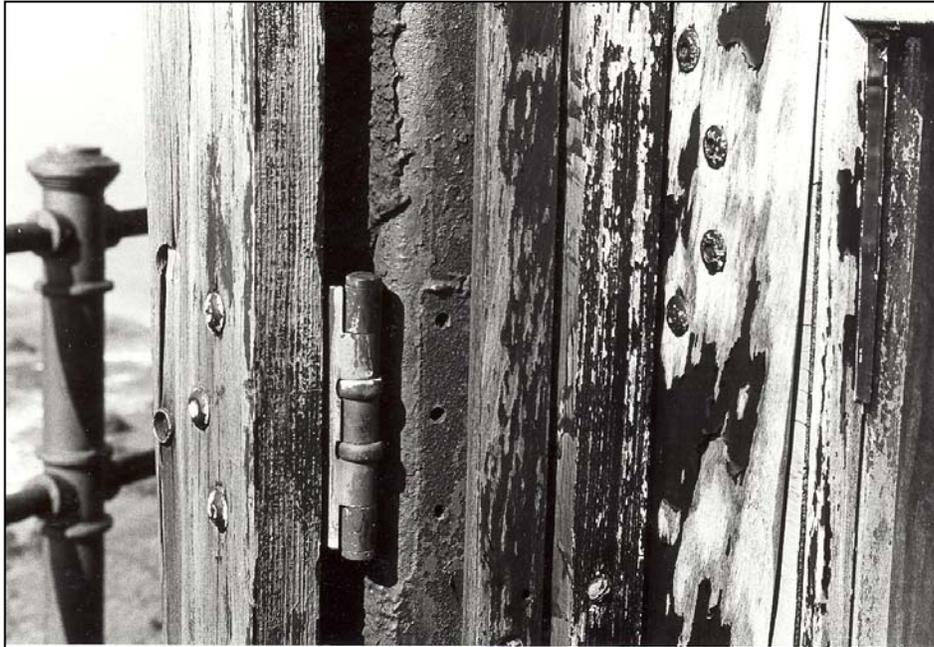
Figure 170. Tower exterior: lower balcony doorway to Watch Room, with iron frame and evidence of early hardware (1983).

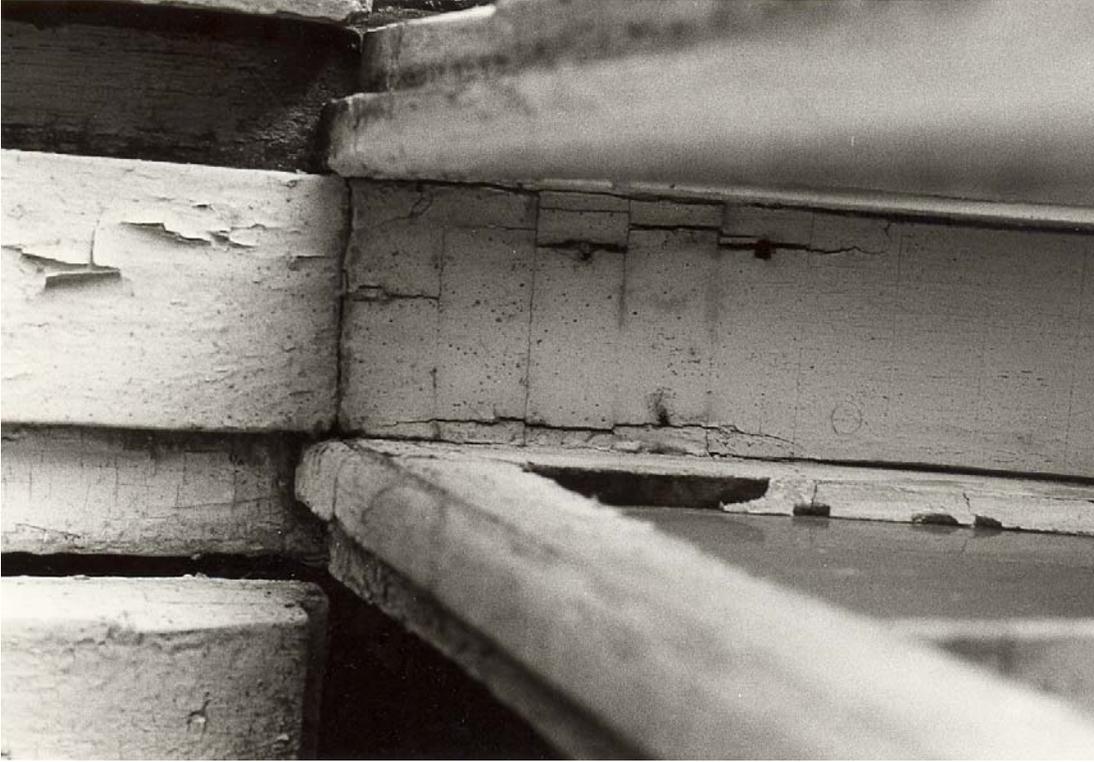
Figure 174. Tower interior: area of window frame between interior and exterior storm sashes (1983).

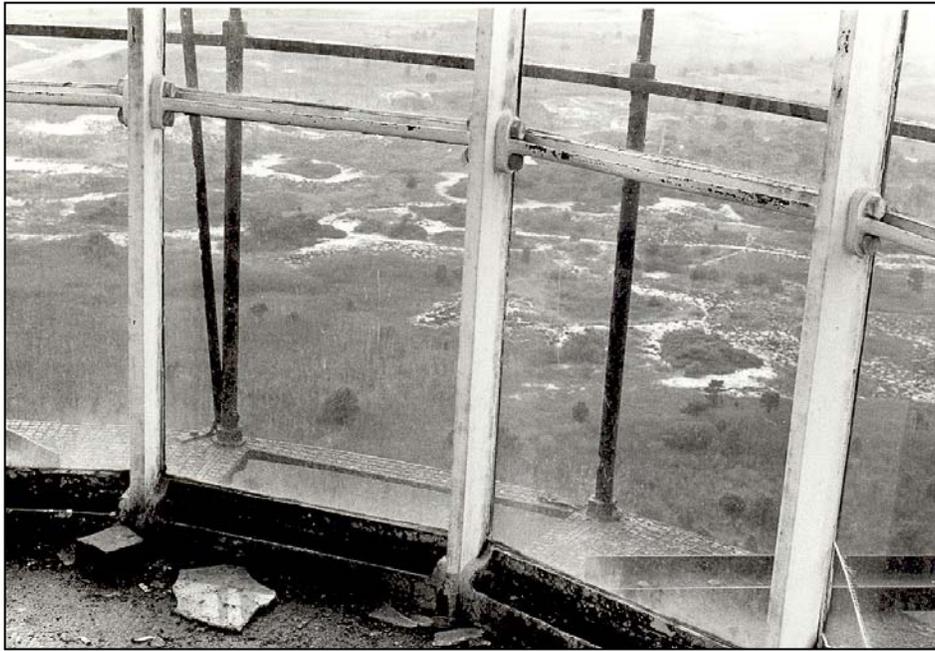
Structure Some of the sill-troughs are filled with water and debris. The cast-iron bolts securing the sills are badly deteriorated. Paint is chipped on the sashes and roof structure. The juncture of the roof structure with the cornice is corroded in several areas, possibly the result of galvanic action between the different metals.

Figure 186. Tower interior: lantern posts and sills (1982).

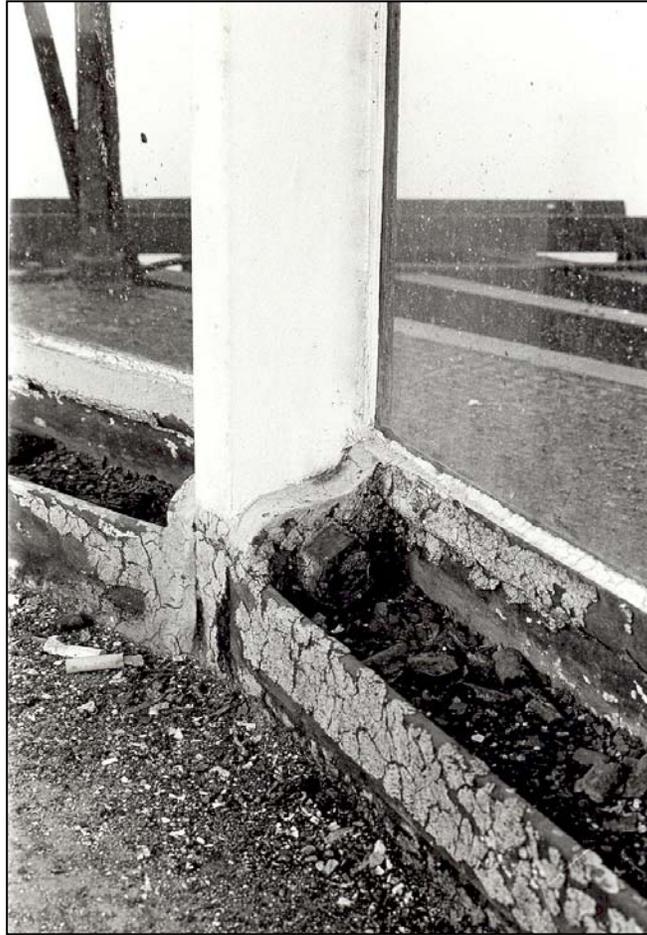
Figure 187. Tower interior: detail of lantern sill (1982).
