FIRE ISLAND LIGHTHOUSE AND KEEPER'S DWELLING

**HISTORIC STRUCTURE REPORT
Architectural Data Section**

**Fire Island National Seashore
Patchogue, New York**

Carole L. Perrault

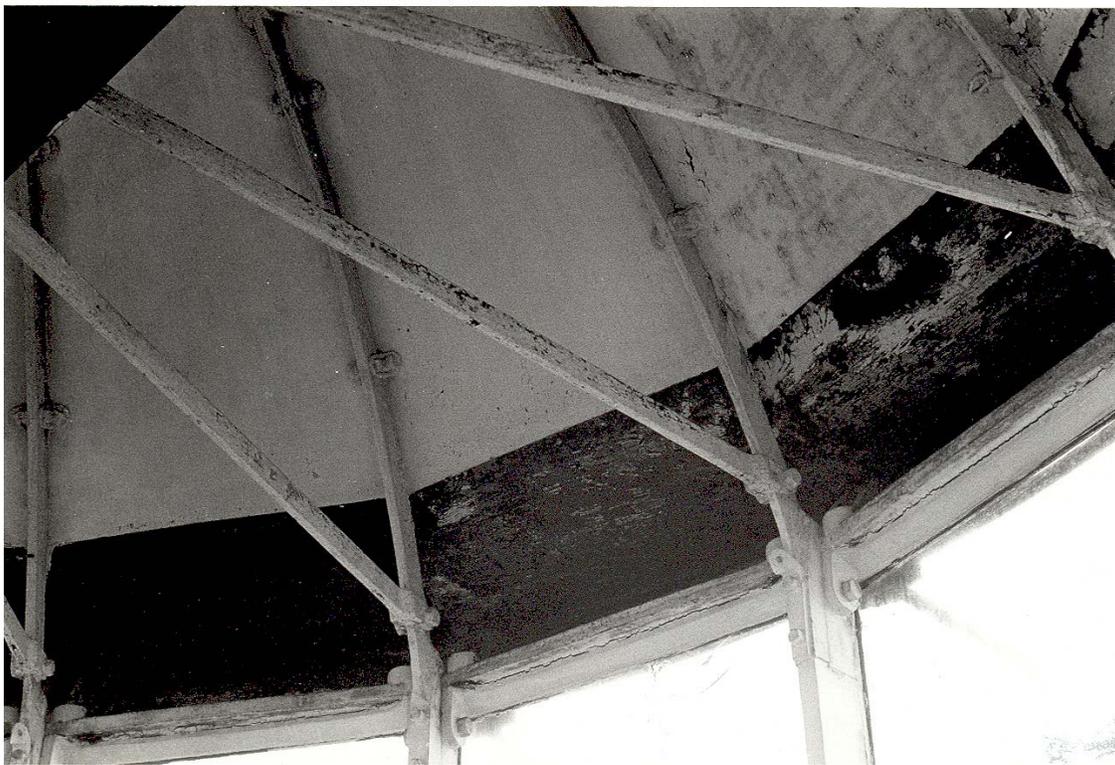
Figure 189. Tower interior: lantern roof, junction of spider frame and lower frame (1982).

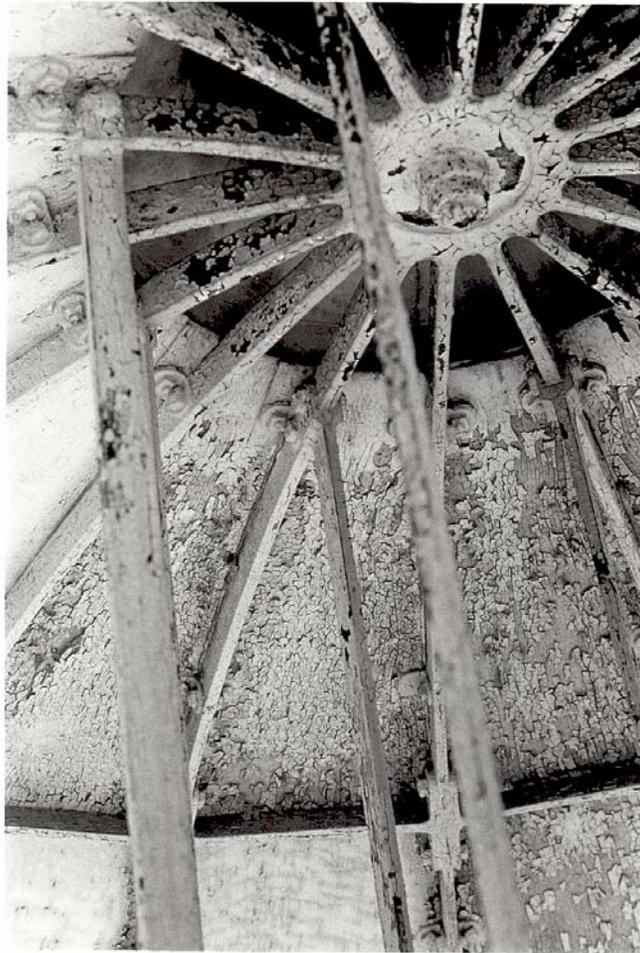
Figure 190. Tower interior: lantern roof, spider frame, and suspension rods (1982).

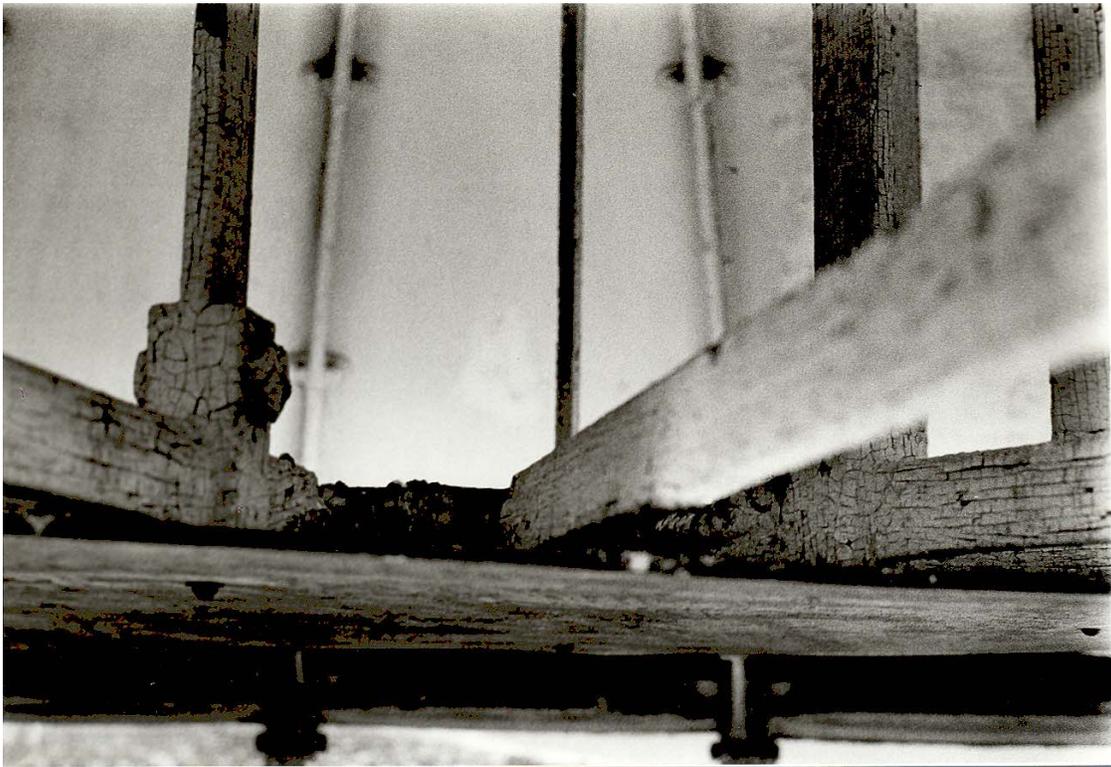
Figure 191. Tower interior: lantern roof, with lower frame, tie rods, and hub above plywood disk (1982).

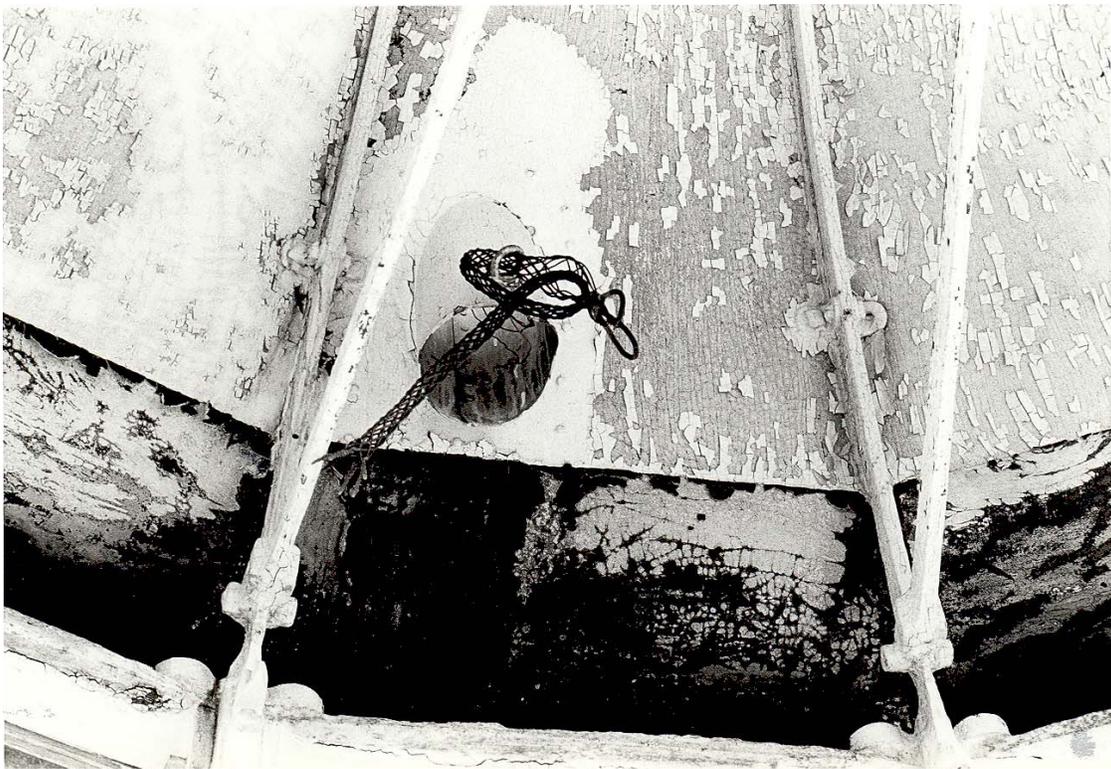
Figure 192. Tower interior: lantern cornice area and stovepipe hole (1982).

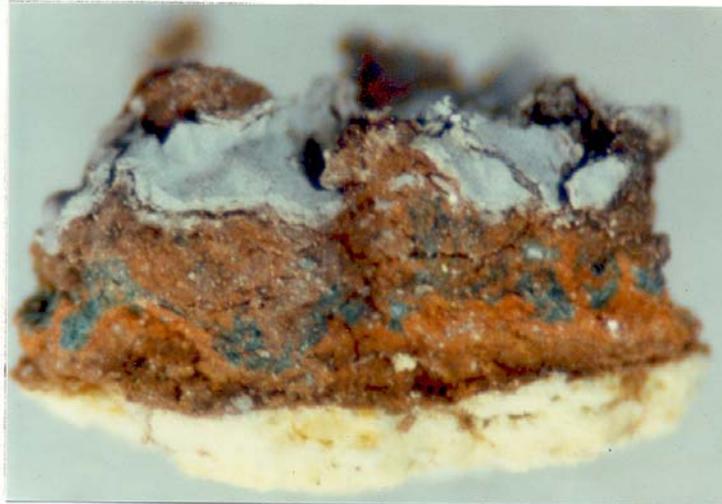
SAMPLE NO.: FIIS 13 P002
LOCATION: Lantern Interior Post, Sill

1. White
2. Dark yellow ochre
3. Rust brown
4. Red
5. Dark green
6. Rust brown
7. Red
8. Medium brown
9. Off white
10. Gray

Figure 195. Tower interior: paint sample #FIIS 13 P002, lantern sill (1983).

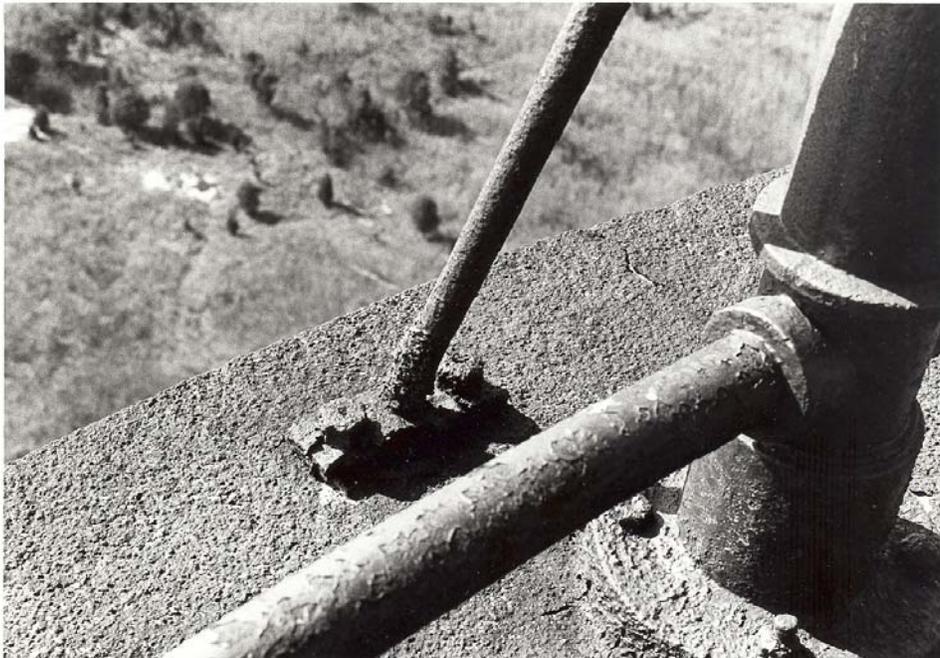
Condition The paint finish is deteriorated and peeling throughout. The posts and rails of the lower balcony show evidence of minor corrosion. The upper balcony posts and piping, as well as the diagonal braces, are badly eroded in areas. This condition may be due to abrasion caused by wind-blown sand.

Figure 196. Tower interior: diagonal brace bolted to deck of lower balcony (1983).

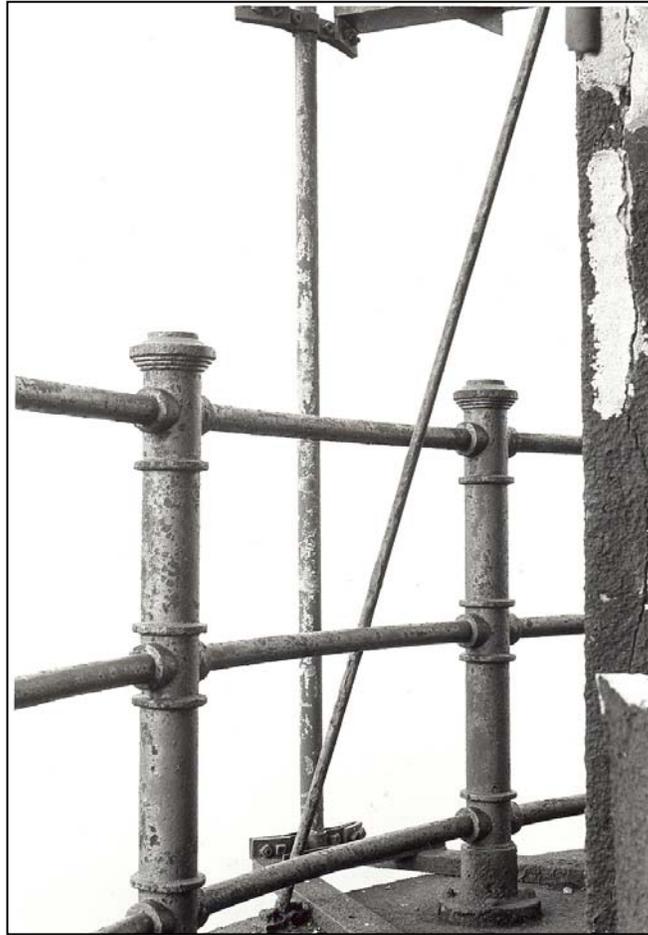
Figure 197. Tower interior: diagonal brace at lower balcony (1982).

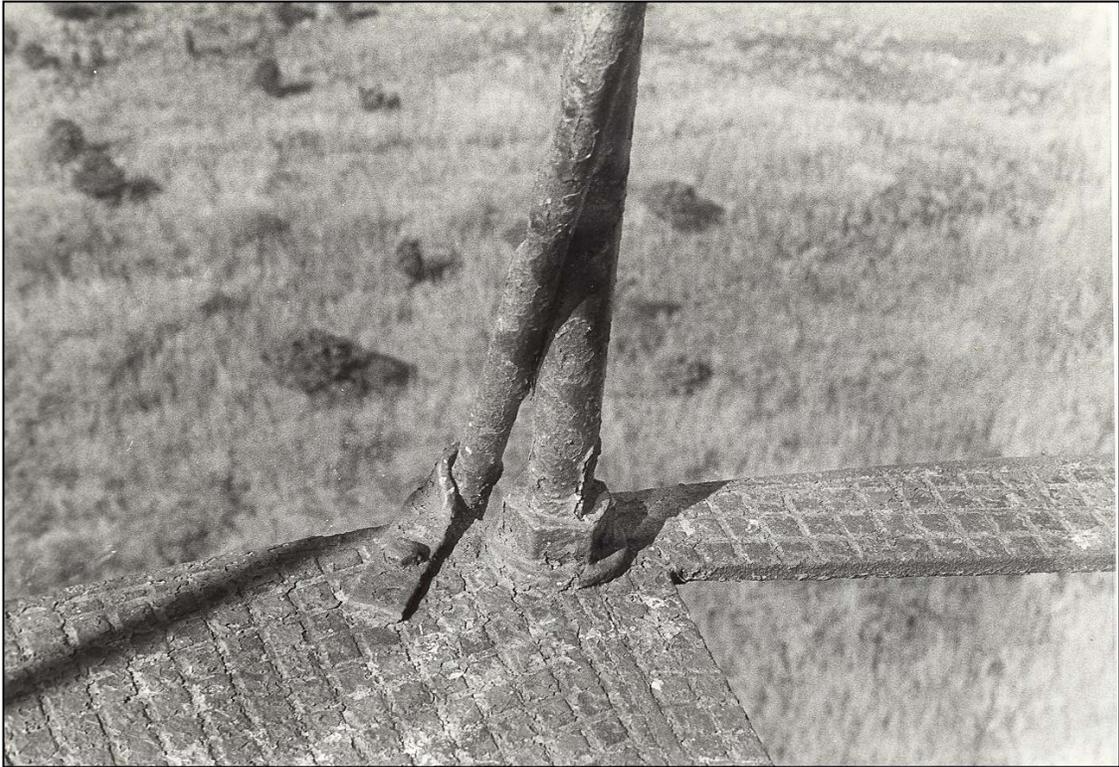
Figure 198. Tower exterior: diagonal brace tied to deck of upper balcony (1983).

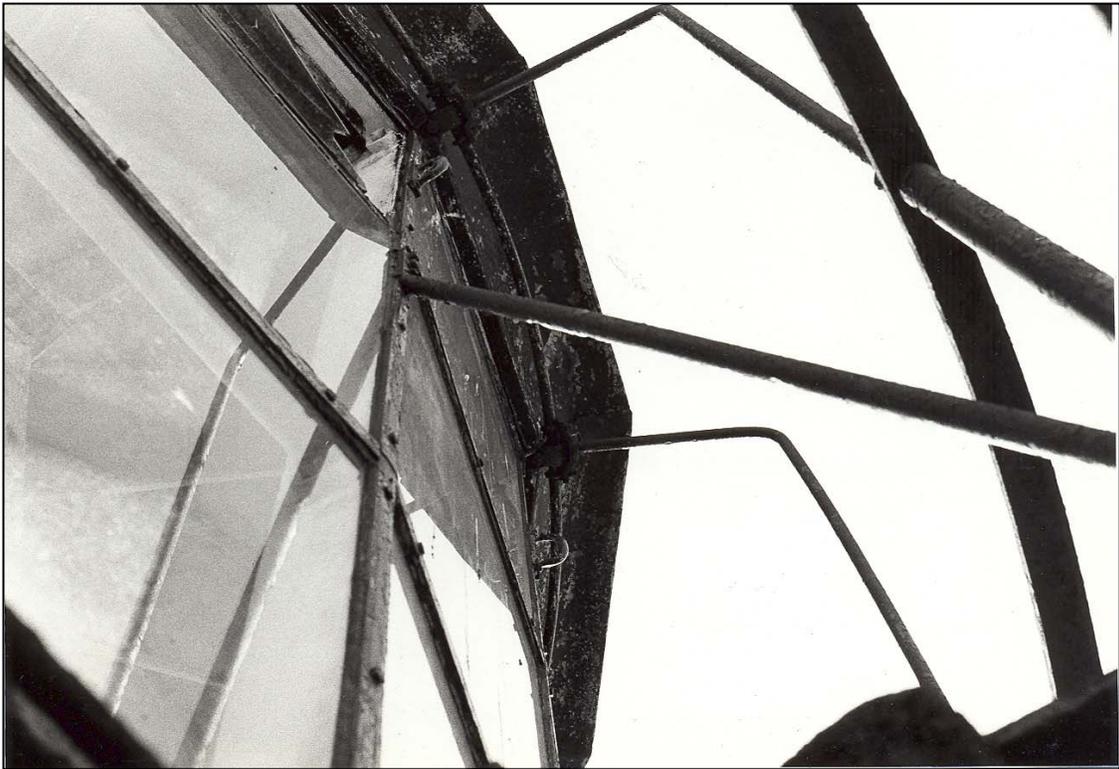
Figure 199. Tower exterior: diagonal brace bolted to side of lantern, and railing of upper balcony (1983).

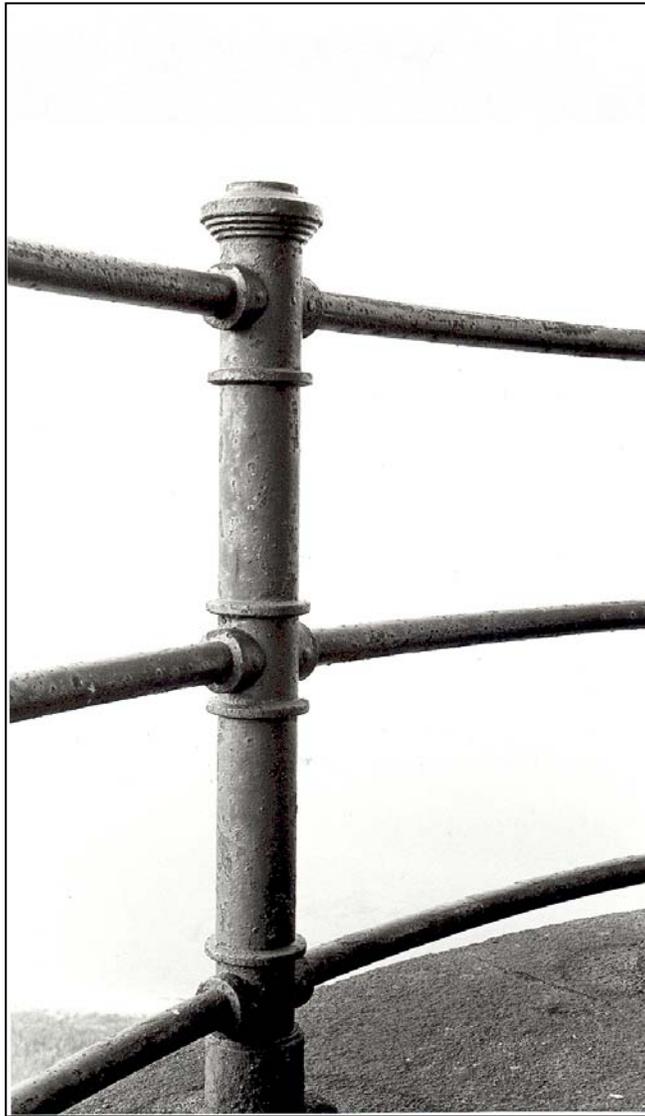
Figure 200. Tower exterior: railing of lower balcony (1982).

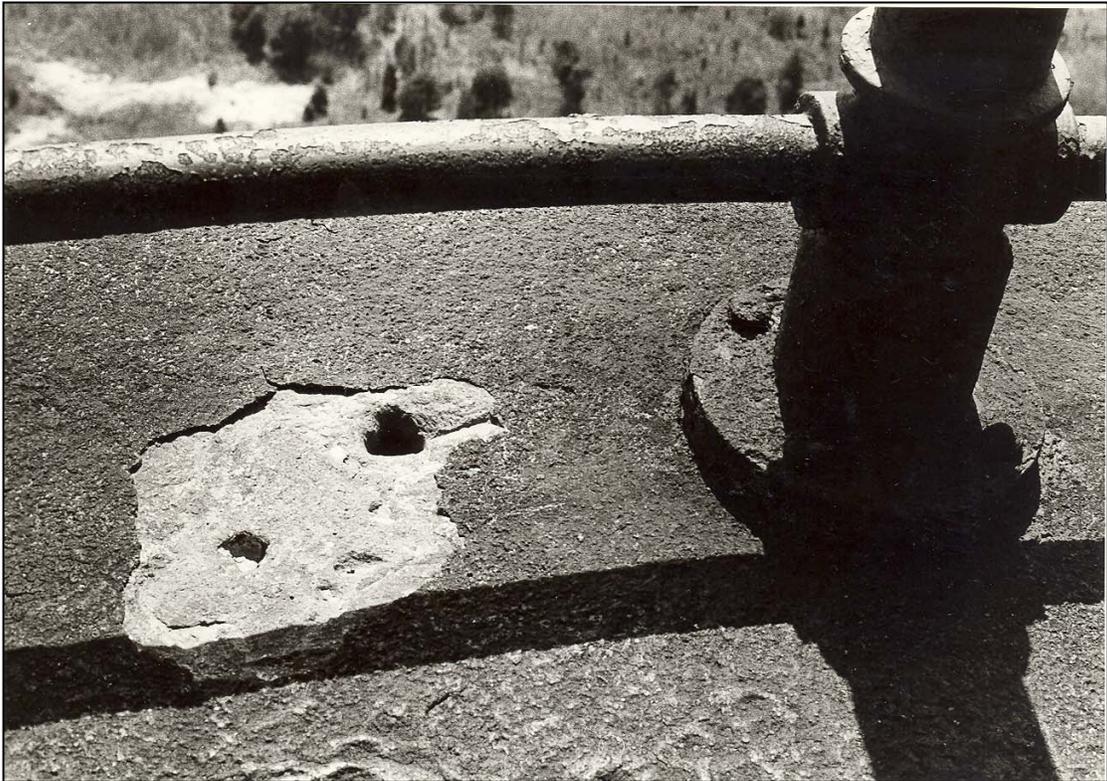
Figure 201. Tower exterior: evidence of earlier railing for lower balcony (1983).

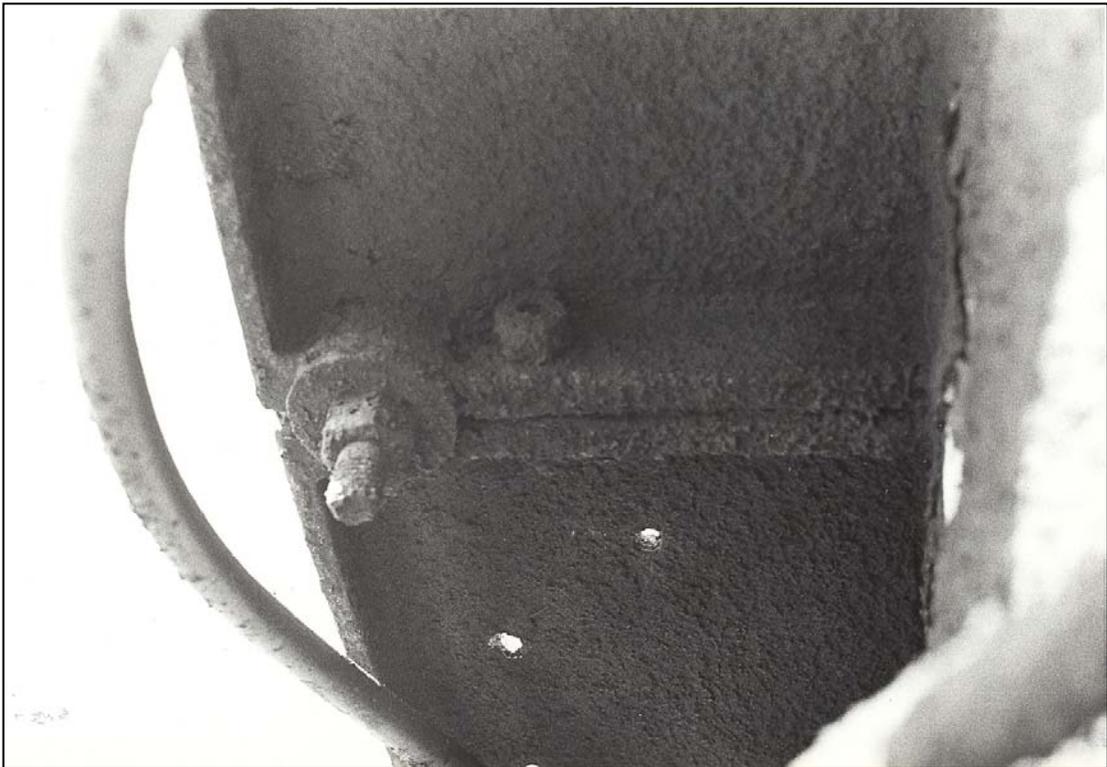
Figure 202. Tower exterior: underside of deck of upper balcony, with bolt for railing (1983).

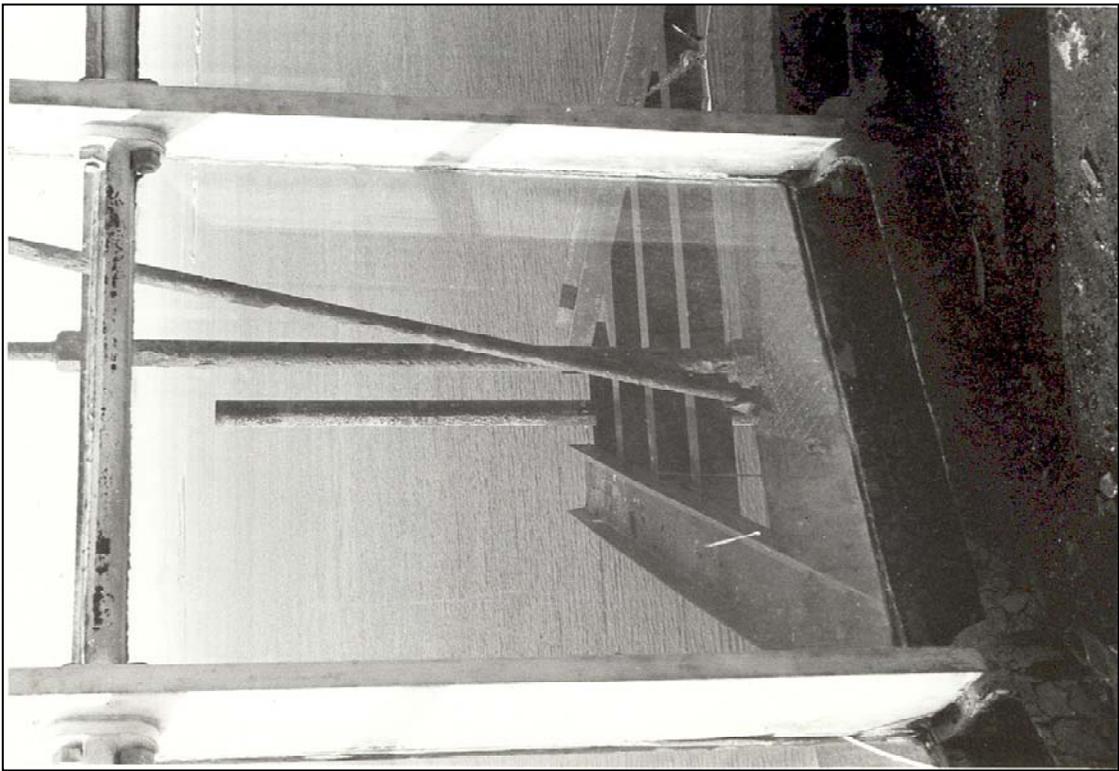
Antenna Brackets There are three pairs of triangular brackets attached to the balconies of the lighthouse. The pairs on the northeast and southeast sides are probably those installed in 1958, as per figure 58. These are triangular in shape and horizontally oriented, with their feet attached to the edges of the balconies. The ones attached to the upper balcony are larger, having to project out farther to align with the brackets on the larger lower balcony. Each pair of brackets holds an antenna pipe, which formerly supported Coast Guard radio signal reflectors. These are now missing. Another set of similar brackets is found on the northwest side of the tower. This pair appears to be related to the partial use of the tower by a commercial radio station.

Figure 203. Tower exterior: reflector antenna bracket (1982).

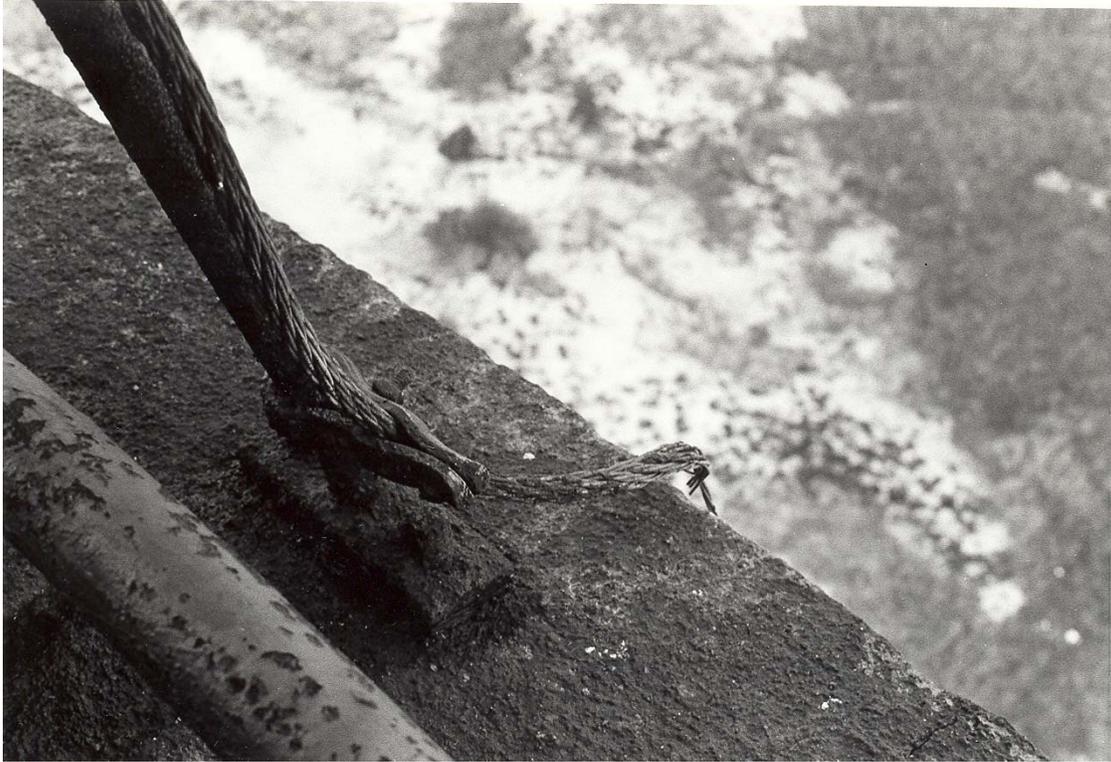
Figure 205. Tower exterior: lightning-rod cable at lower balcony (1983).

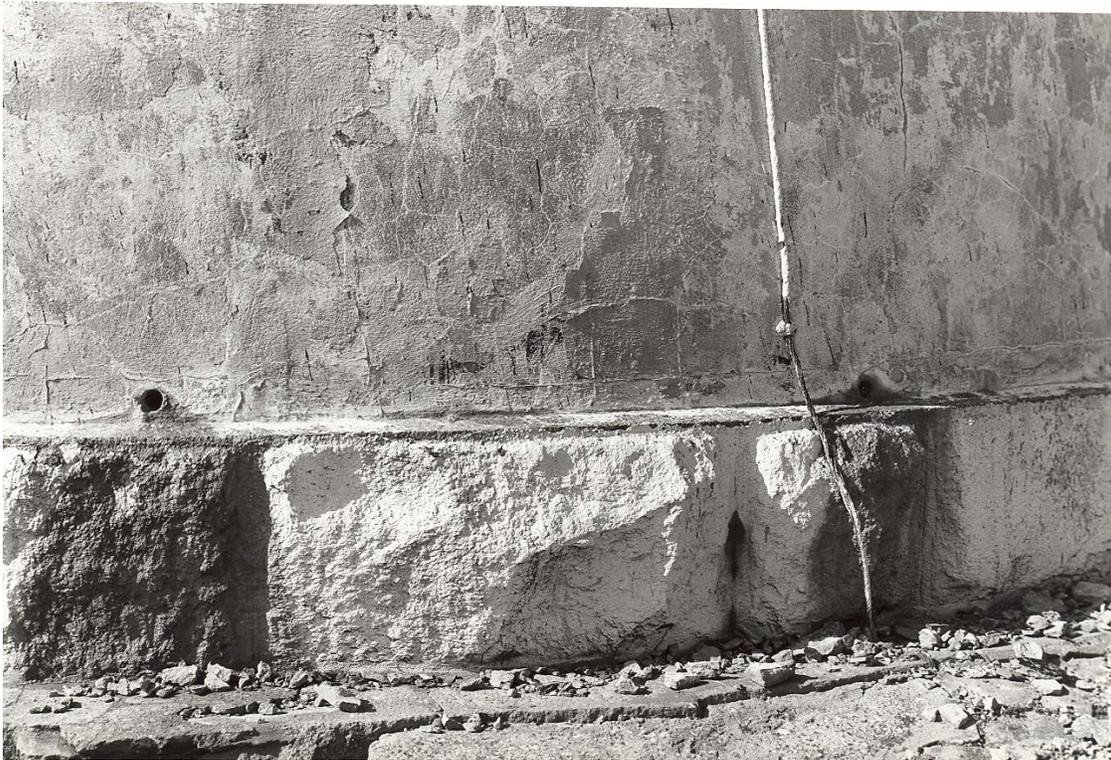
Figure 206. Tower exterior: lightning-rod cable at tower base (1983).

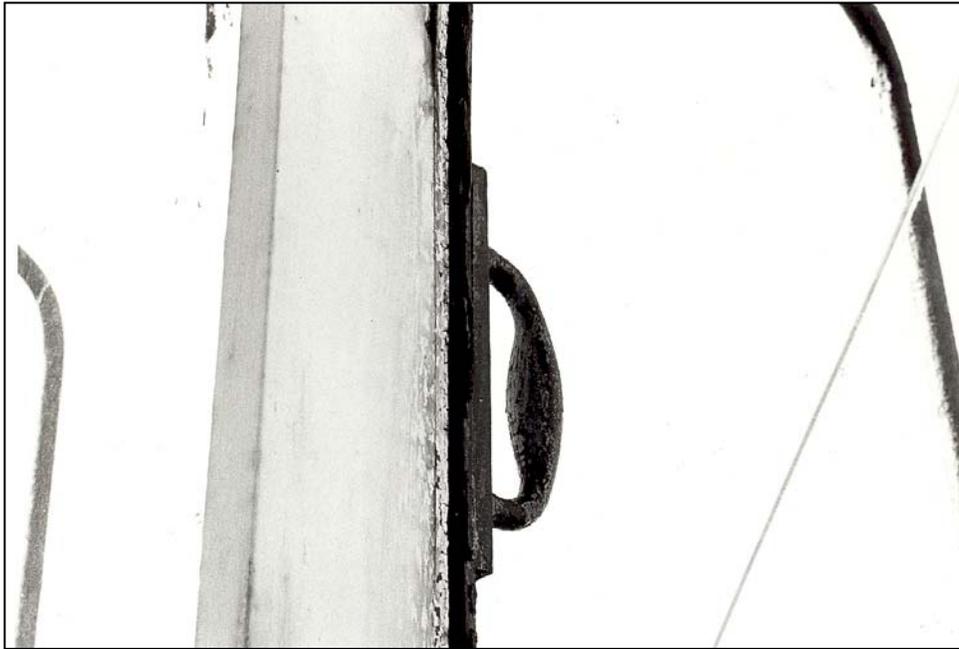
Originally 32 bronze handles were secured to the outside glass stops of the lantern. The upper set remains in place, while the lower set was removed in the 1970's.

Figure 209. Tower exterior: detail of bronze handle (1983).

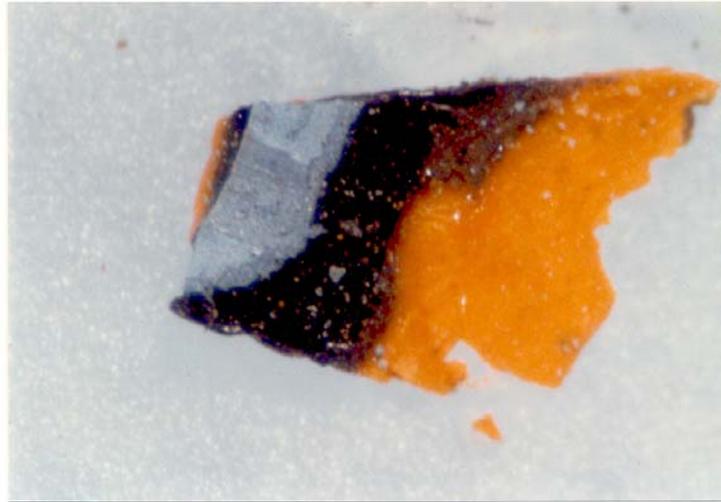
SAMPLE NO.: FIIS 13 P050
LOCATION: Watch Room - 1930's Pedestal

1. Bright orange
2. Bright orange
3. Rust brown
4. Medium brown
5. Gray
6. Gray

Figure 210. Tower interior: paint sample #FIIS 13 P050, Watch Room pedestal (1983).

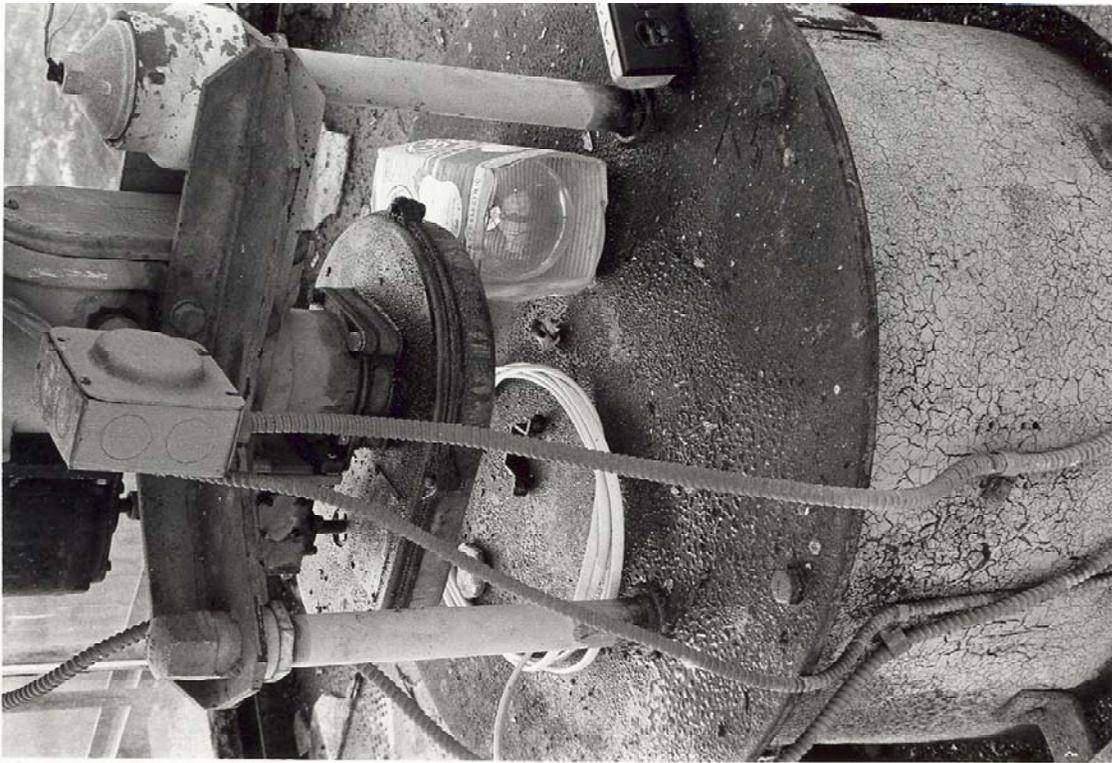
Figure 211. Tower interior: extant lighting apparatus (1982).

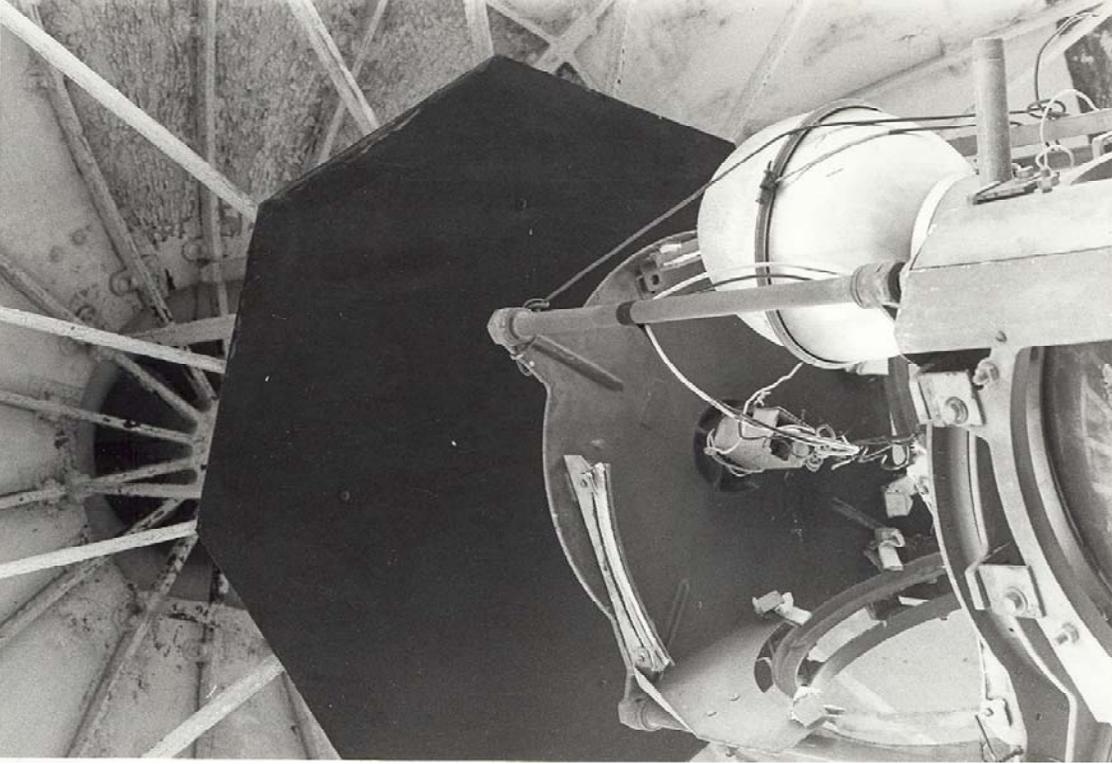
Figure 212. Tower interior: extant lighting apparatus (1982).
