SPECIAL HISTORY STUDY
MASONRY FORTS
OF THE NATIONAL PARK SERVICE

Prepared by
F. Ross Holland, Jr.
Russell Jones

DENVER SERVICE CENTER
HISTORIC PRESERVATION TEAM
NATIONAL PARK SERVICE
UNITED STATES DEPARTMENT OF THE INTERIOR
DENVER, COLORADO

AUGUST, 1973

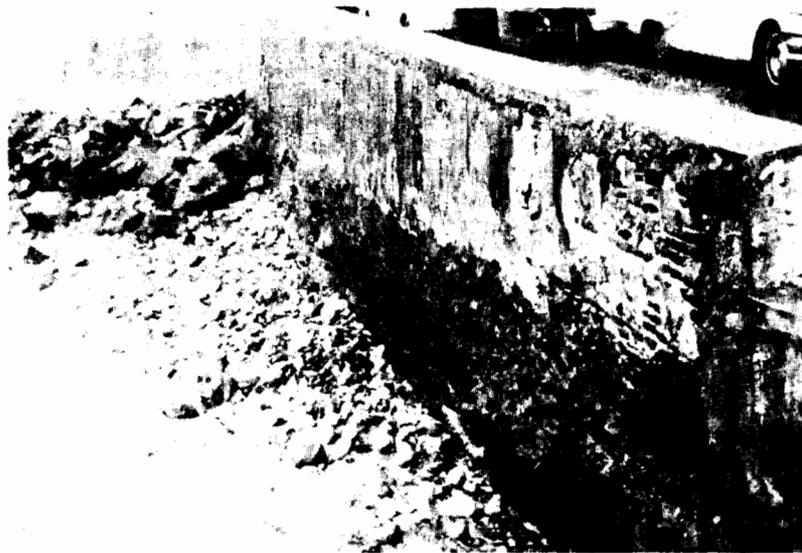
The erosion of the plaster from the face of the City Wall leaves the brick and stone work exposed to destructive weathering.

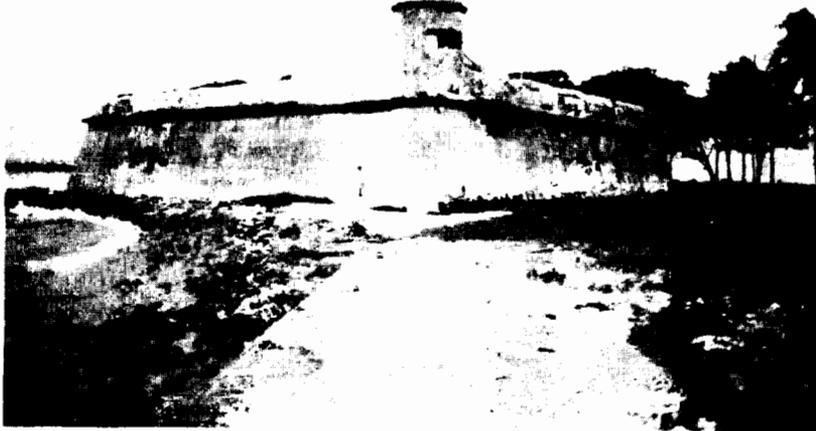
The Battery was built across the harbor entrance to prevent hostile landings on the western side of the harbor. General deterioration has reached a serious level.

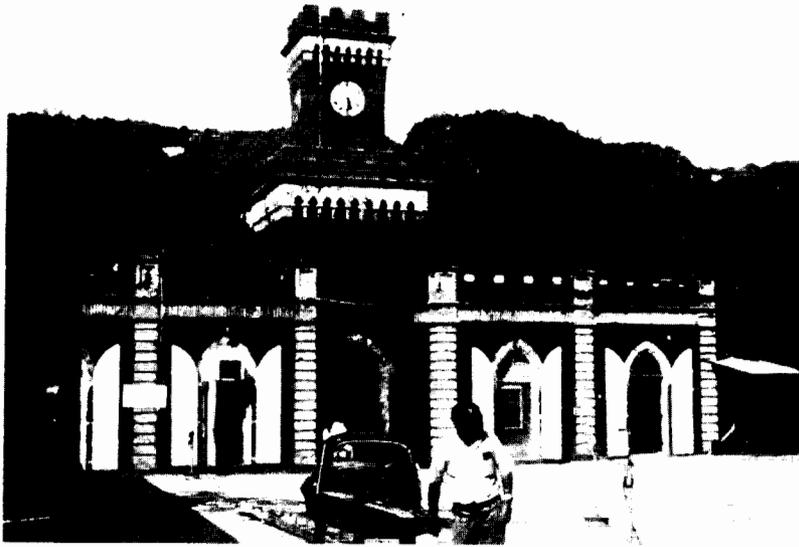
The entire structure has been extensively altered for modern use.

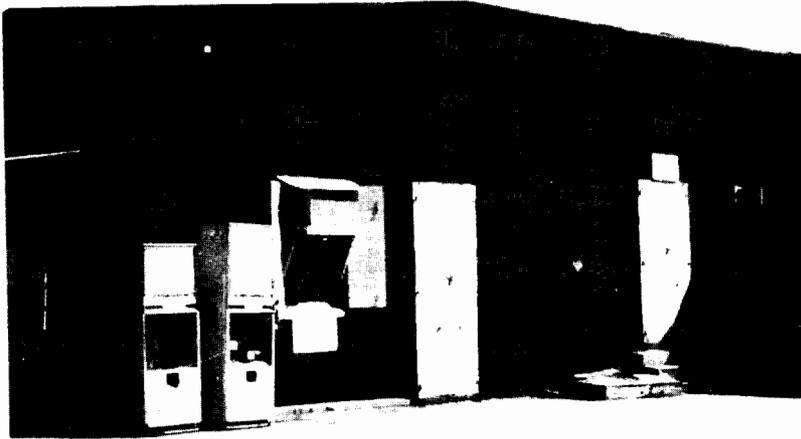
The complete lack of respect for historic fabric is apparent.

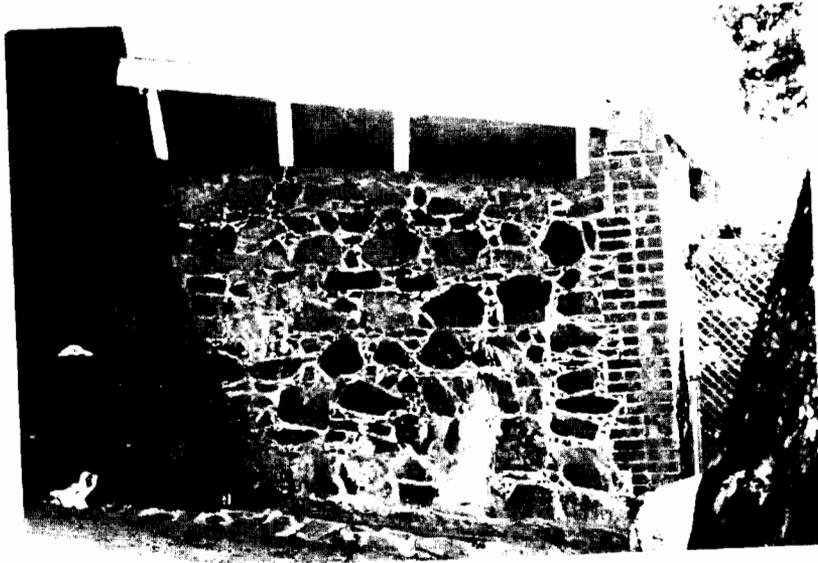
This is one of several modern structures attached to the fort.

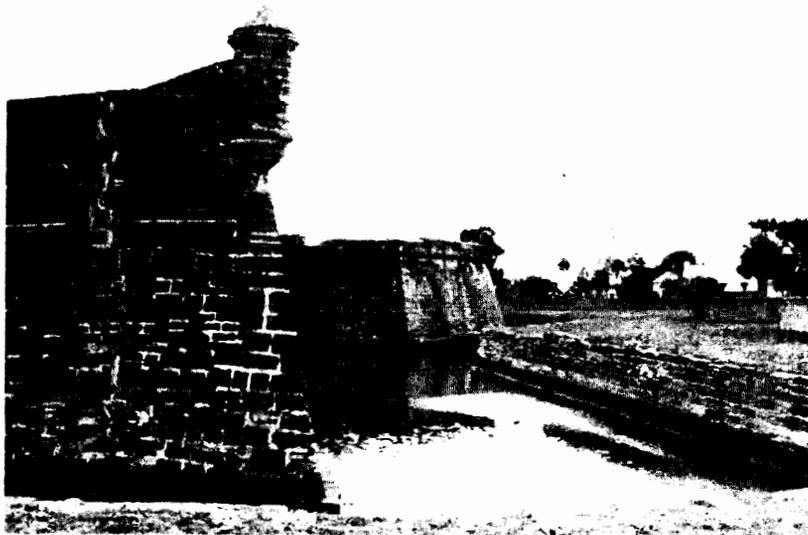
Cracking of the comina walls is undoubtedly due to foundation failure or movement over the years. The more serious areas will require repair and reinforcement to the foundation, in other areas repair and repointing will be sufficient to correct this damage.

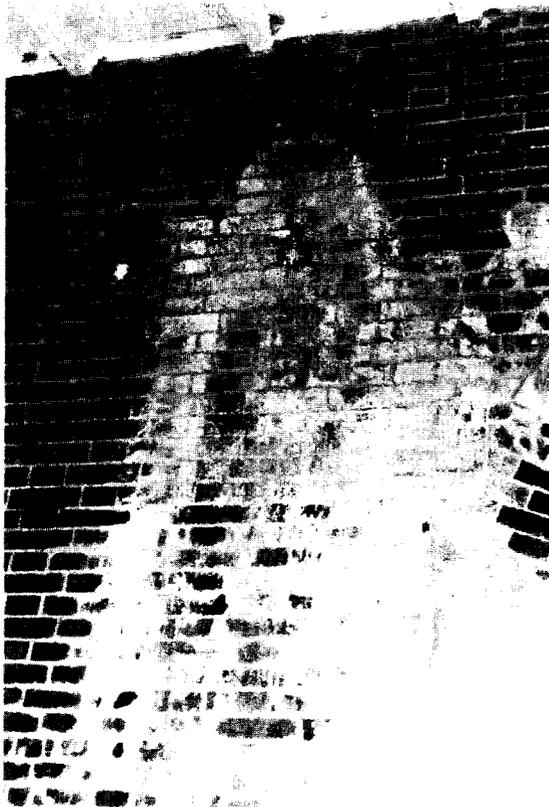
Conditions such as this have been caused by water entering from the terrace and roof. Waterproofing and flashing repair is needed.

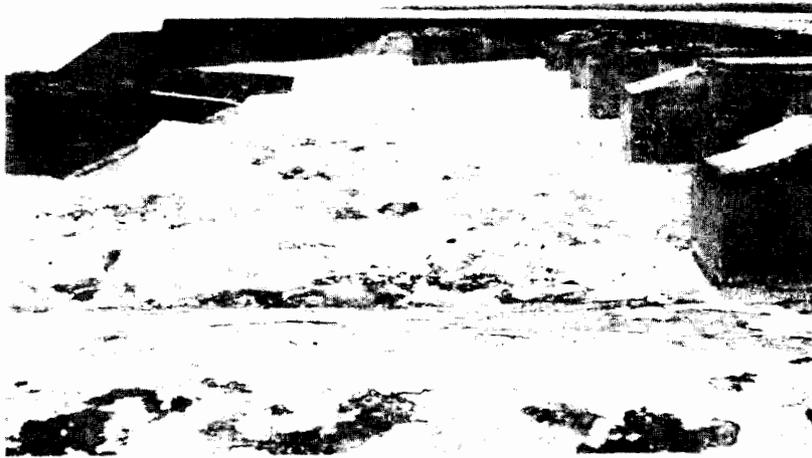
The exposed second floor, now acting as the roof, must be waterproofed and repaired if deterioration of the historic fabric is to be stopped.

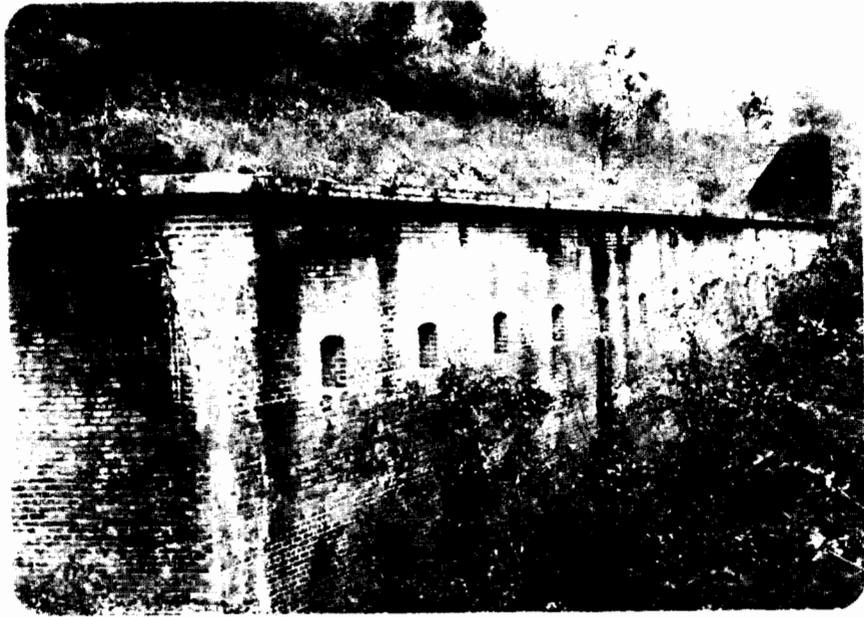
Lower part of masonry structure was in poor condition and repair to those parts was not reported until the late 1920's. It is proposed removal of the upper portion of structure to reduce excessive pressure on the masonry walls and to provide for the proper operation of the dam.

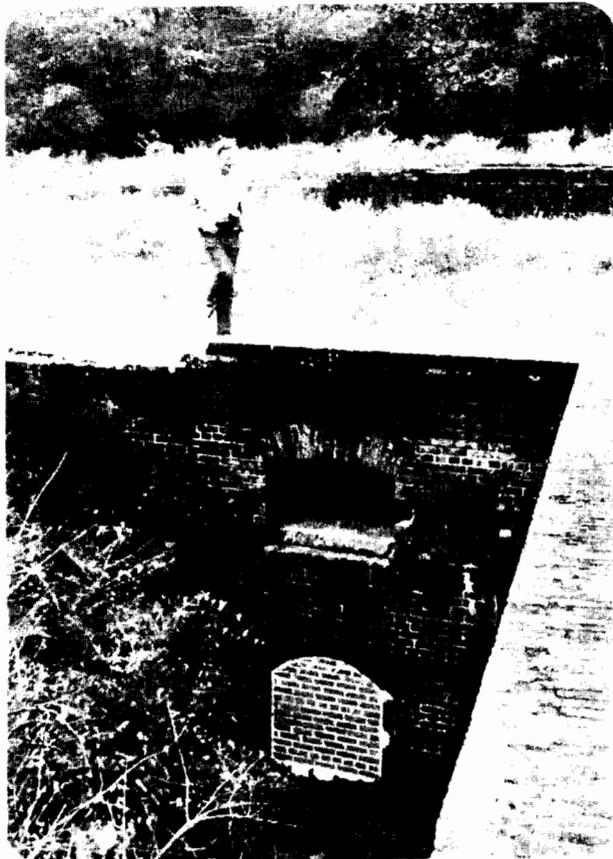
One of the lower spillways has been closed to prevent flooding of the dam. It will be opened and restored. Spillways will be built where shown on plan.

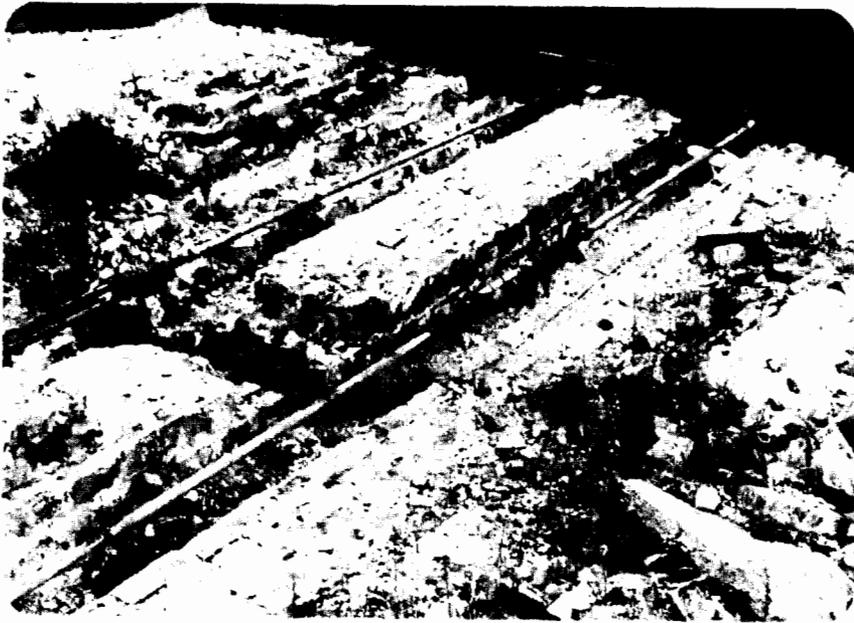
This section was used in the past as a filler to prevent the collapse of the face wall.

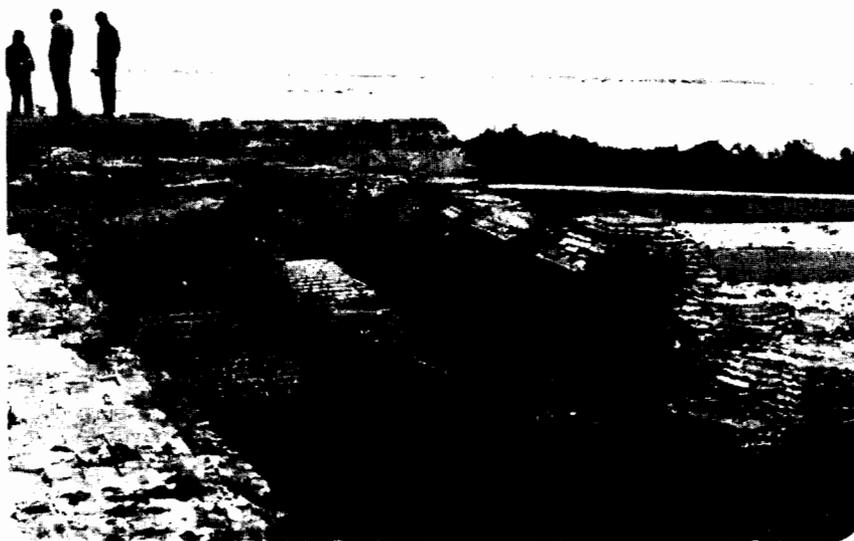
This section of the fort was destroyed by the Army for gun fire clearance. It will only be stabilized in its present condition.

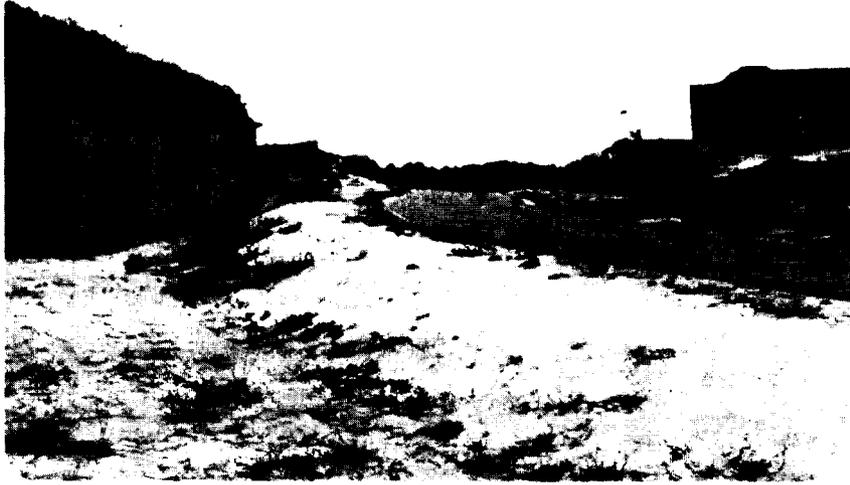
The present entrance road was cut through the dry moat of Fort Pickens. It will be replaced by a road several feet above the level of the moat.

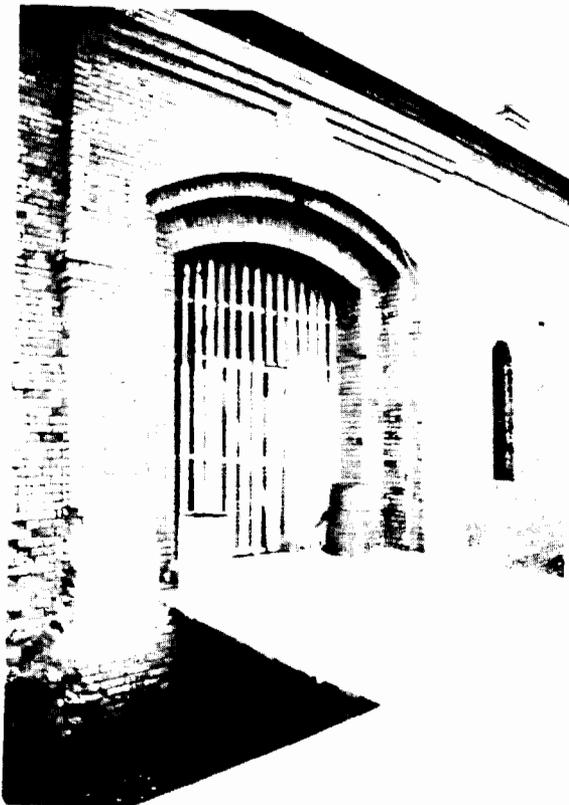
The salient port will be restored as an operating feature of the fort.

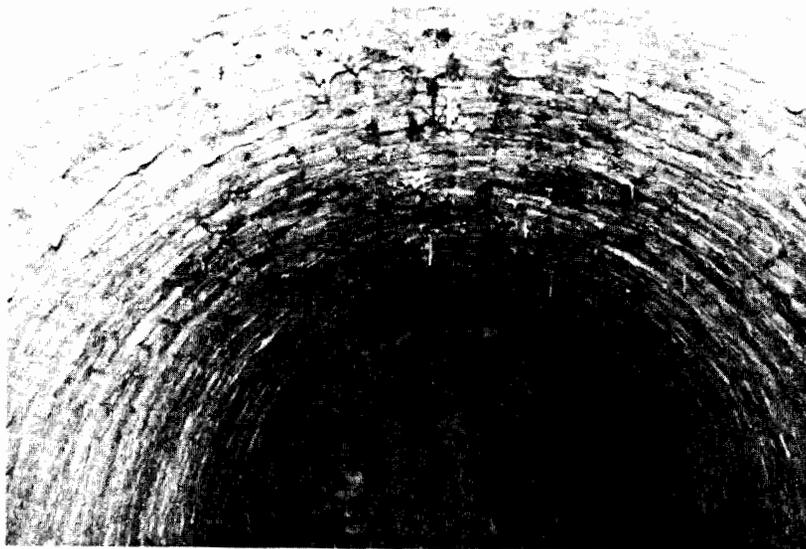
Stalactites in main cell off guard room.

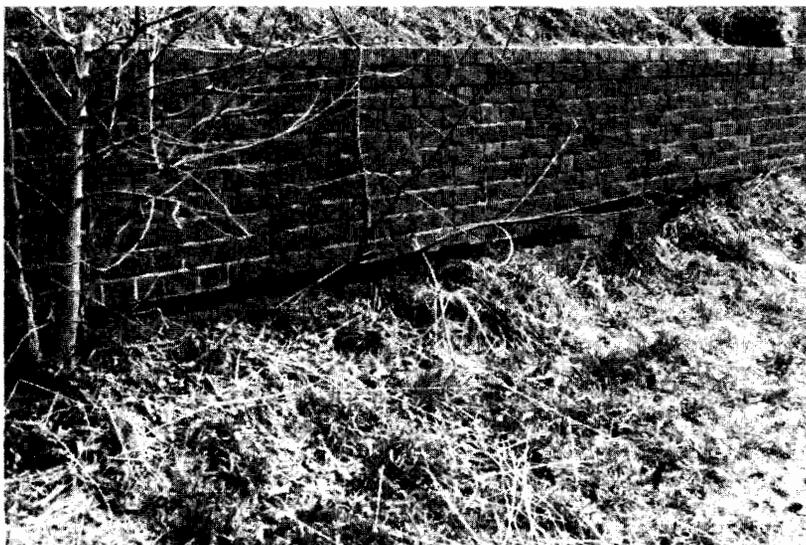
Note missing brick in east wall of southeast flank bastion.

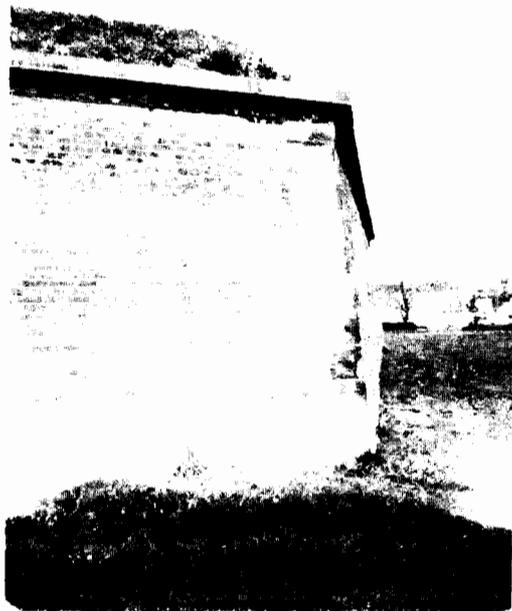
The internal pressure of the earth fill and deteriorating mortar joints have forced the masonry wall and capstone out of place.

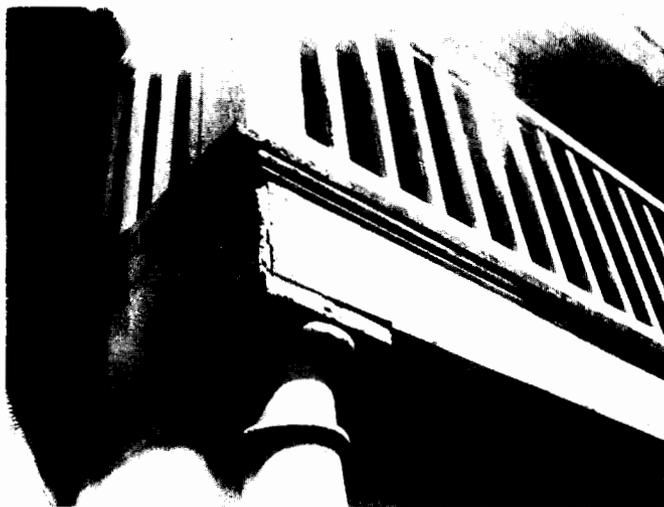
The wood portions of the buildings are in very bad condition. Such areas must be promptly repaired or replaced.

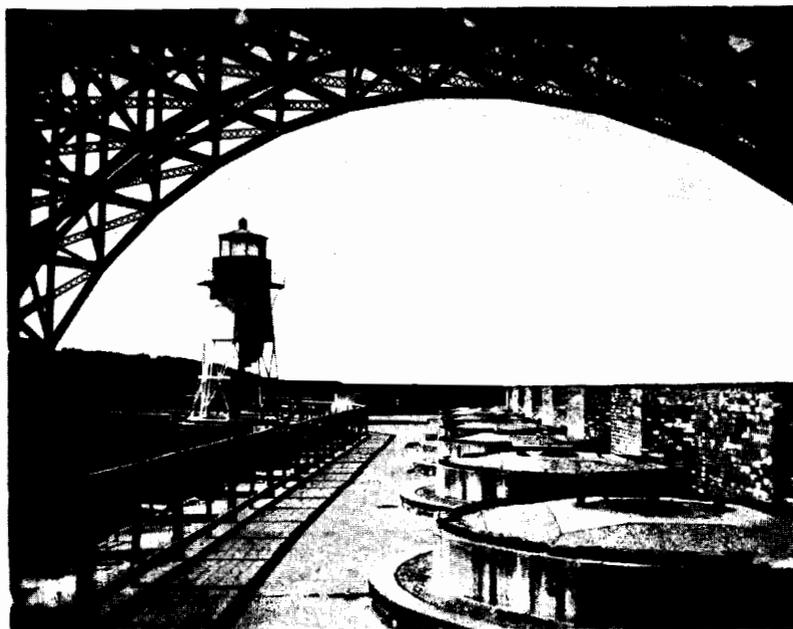
Restoration of the lighthouse was recently completed. Temporary safety railings on the battlement will be replaced with permanent construction.
