Historic Maintenance and Warehouse Complex

Historic Structure Report for 11 Buildings

Grand Canyon South Rim Historic Maintenance and Warehouse Complex

February 1, 2008

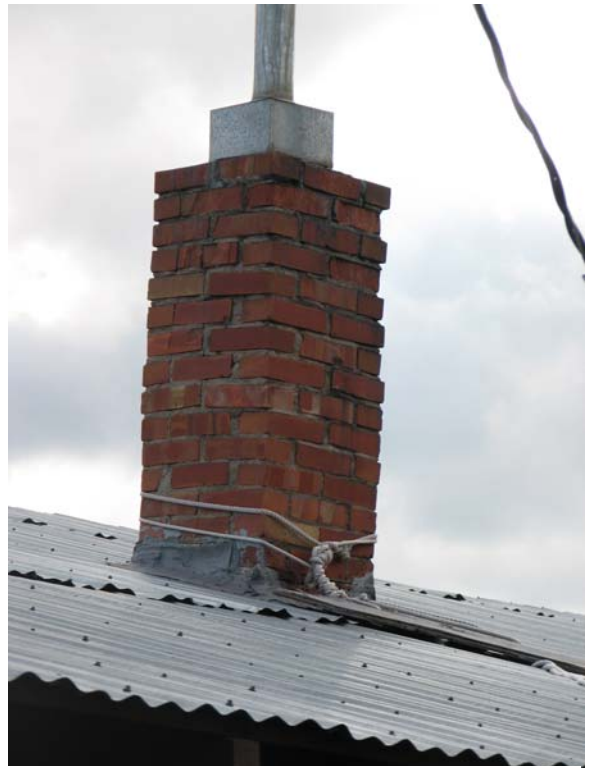
East Chimney 0069 - 112

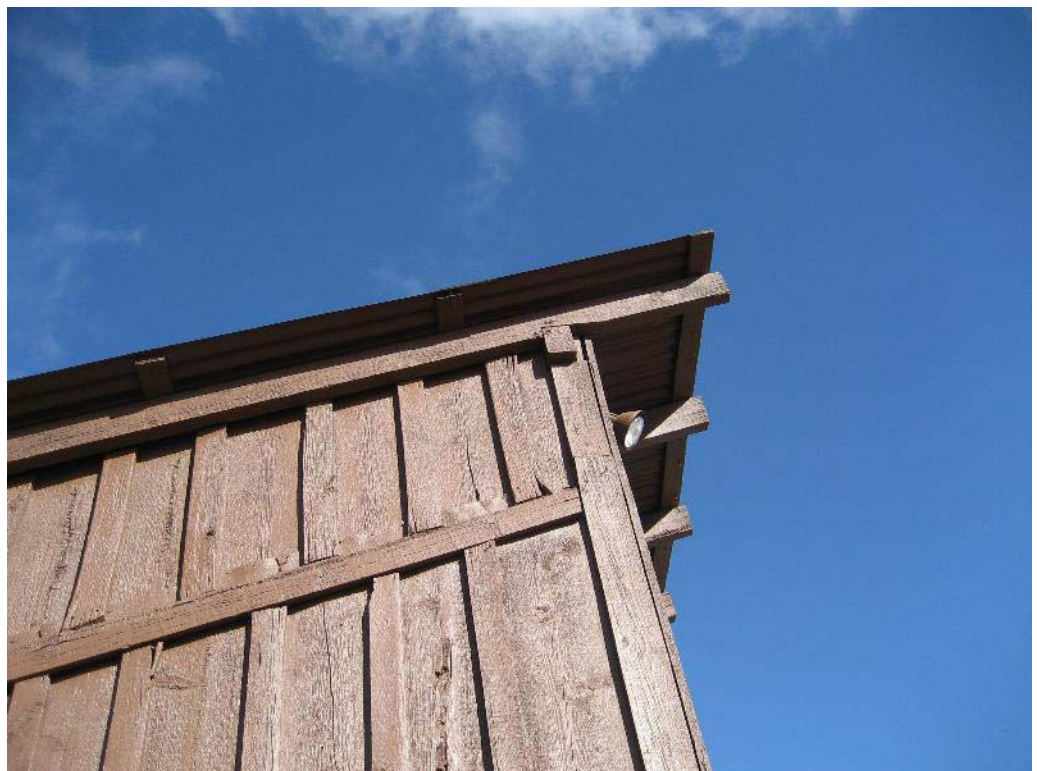
Typical Rafters and Supporting Beam 0069-129

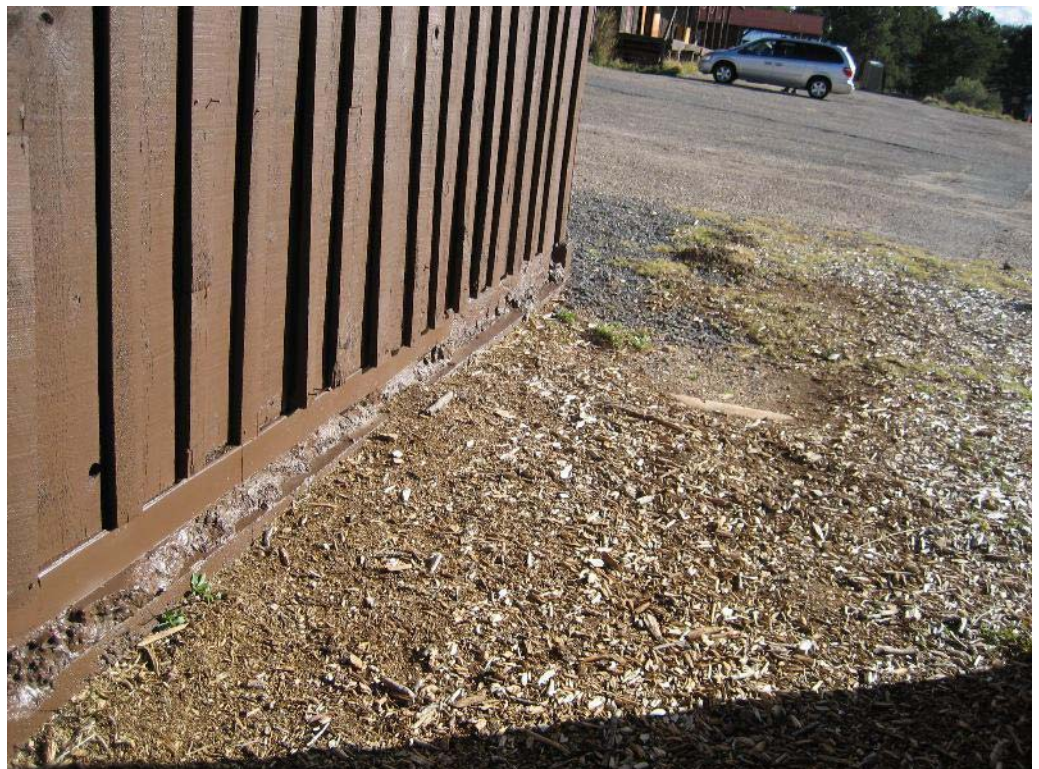
West Wall Concrete Footing and Rubble Stone Wall 0069-131

The perimeter foundation requires replacement or repair around most of the building. Soil should be removed around the building such that no wood is within 6" of soil. Sill plates, anchor bolts, wall sheathing and wall framing should be repaired or replaced where deteriorated.

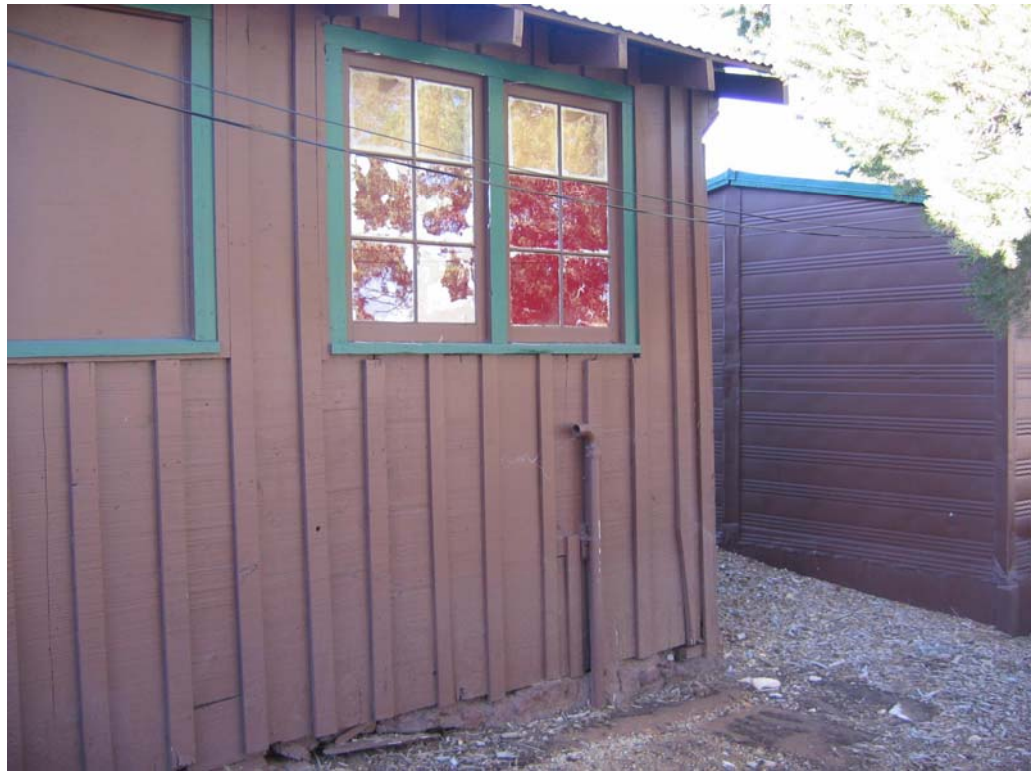
Abandoned Waste Pipe 0069-132

If use of waste pipe is desired in the future, the pipe should be scoped with a video camera to assess the condition of the pipe below grade and verify that it is in good working order. This pipe should be capped to keep debris and animals out.

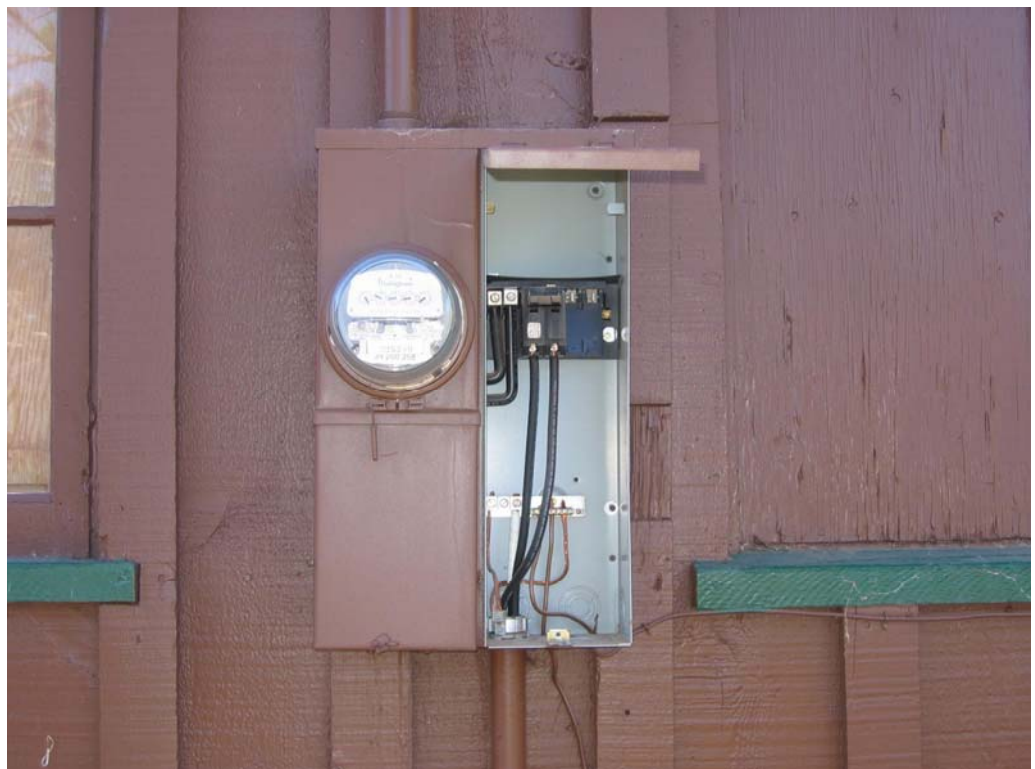
Electrical Service Disconnect 0069-133

Replace entire electrical service and associated branch circuit wiring, and provide grounding of the electrical system to be code compliant and for increased user safety.

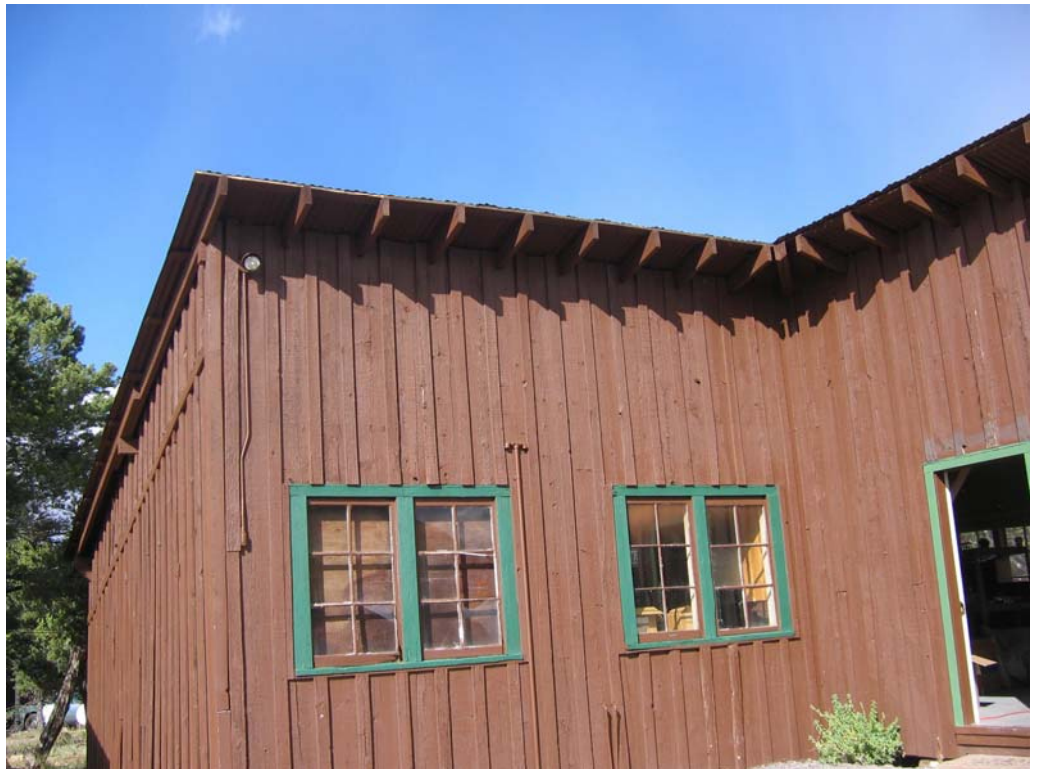
Exterior Lamp Holder 0069-135

Replace exterior light fixture with a fixture that complies with the "Grand Canyon National Park Night Sky Protection and Exterior Lighting Policy" (01/04).

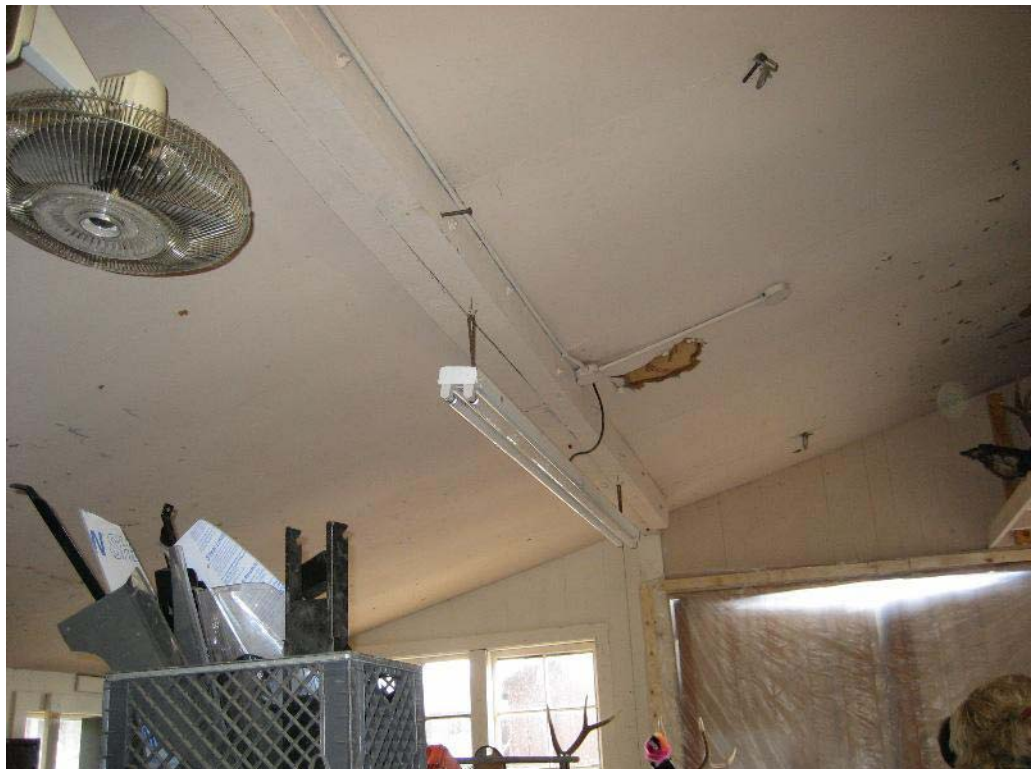
Spliced Ridge Beam 0069-202

The spliced ridge beam over the eastern portion of the structure should be investigated for capacity to carry required gravity loads. Strengthening is likely required. The condition of the rafters deserves further investigation, particularly where water staining was noted around the interior chimney.

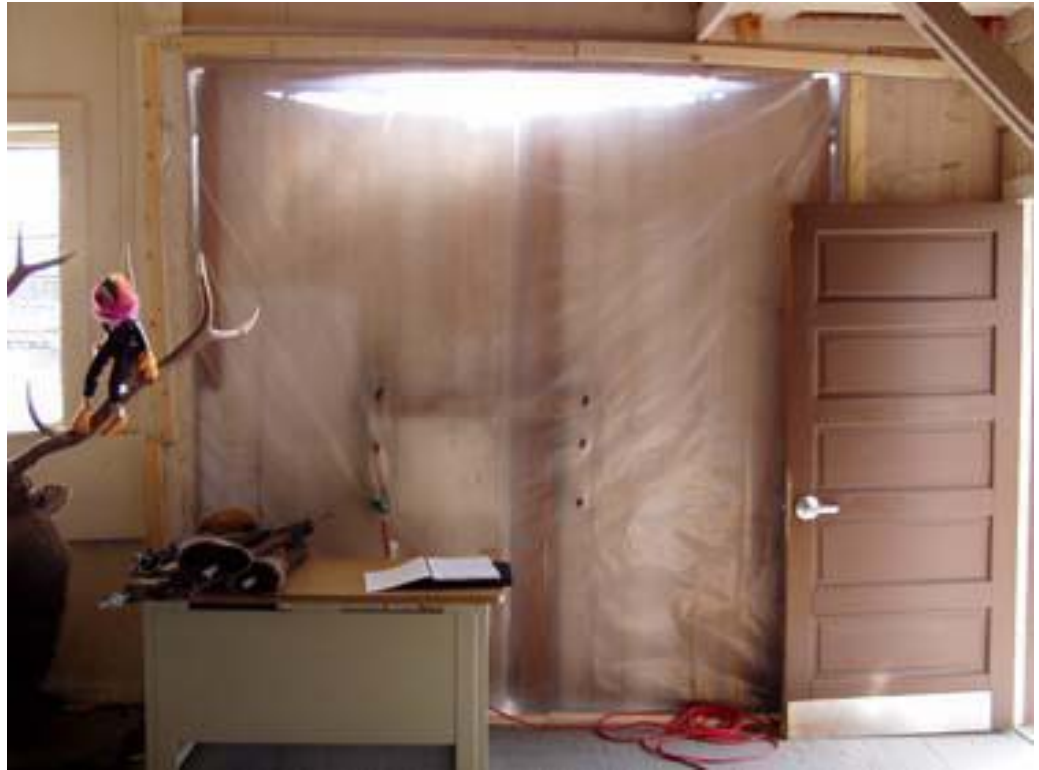
Plastic sheathing obscures interior face of Door B 0069-209

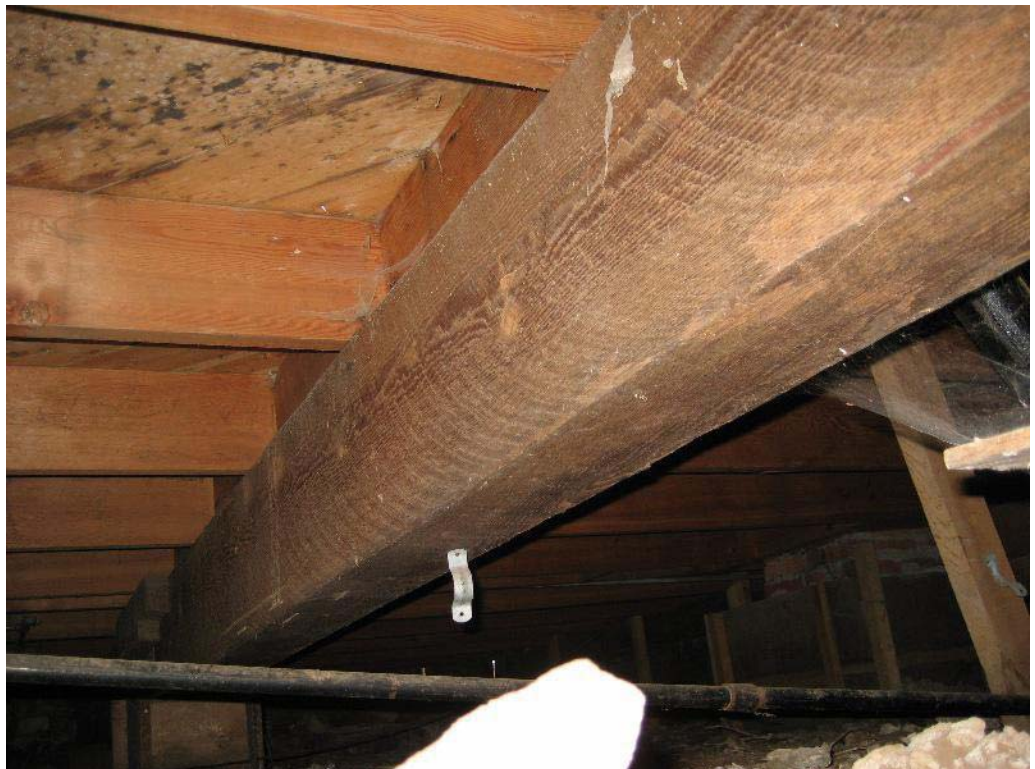
Floor Framing at West Half of Building 0069-220

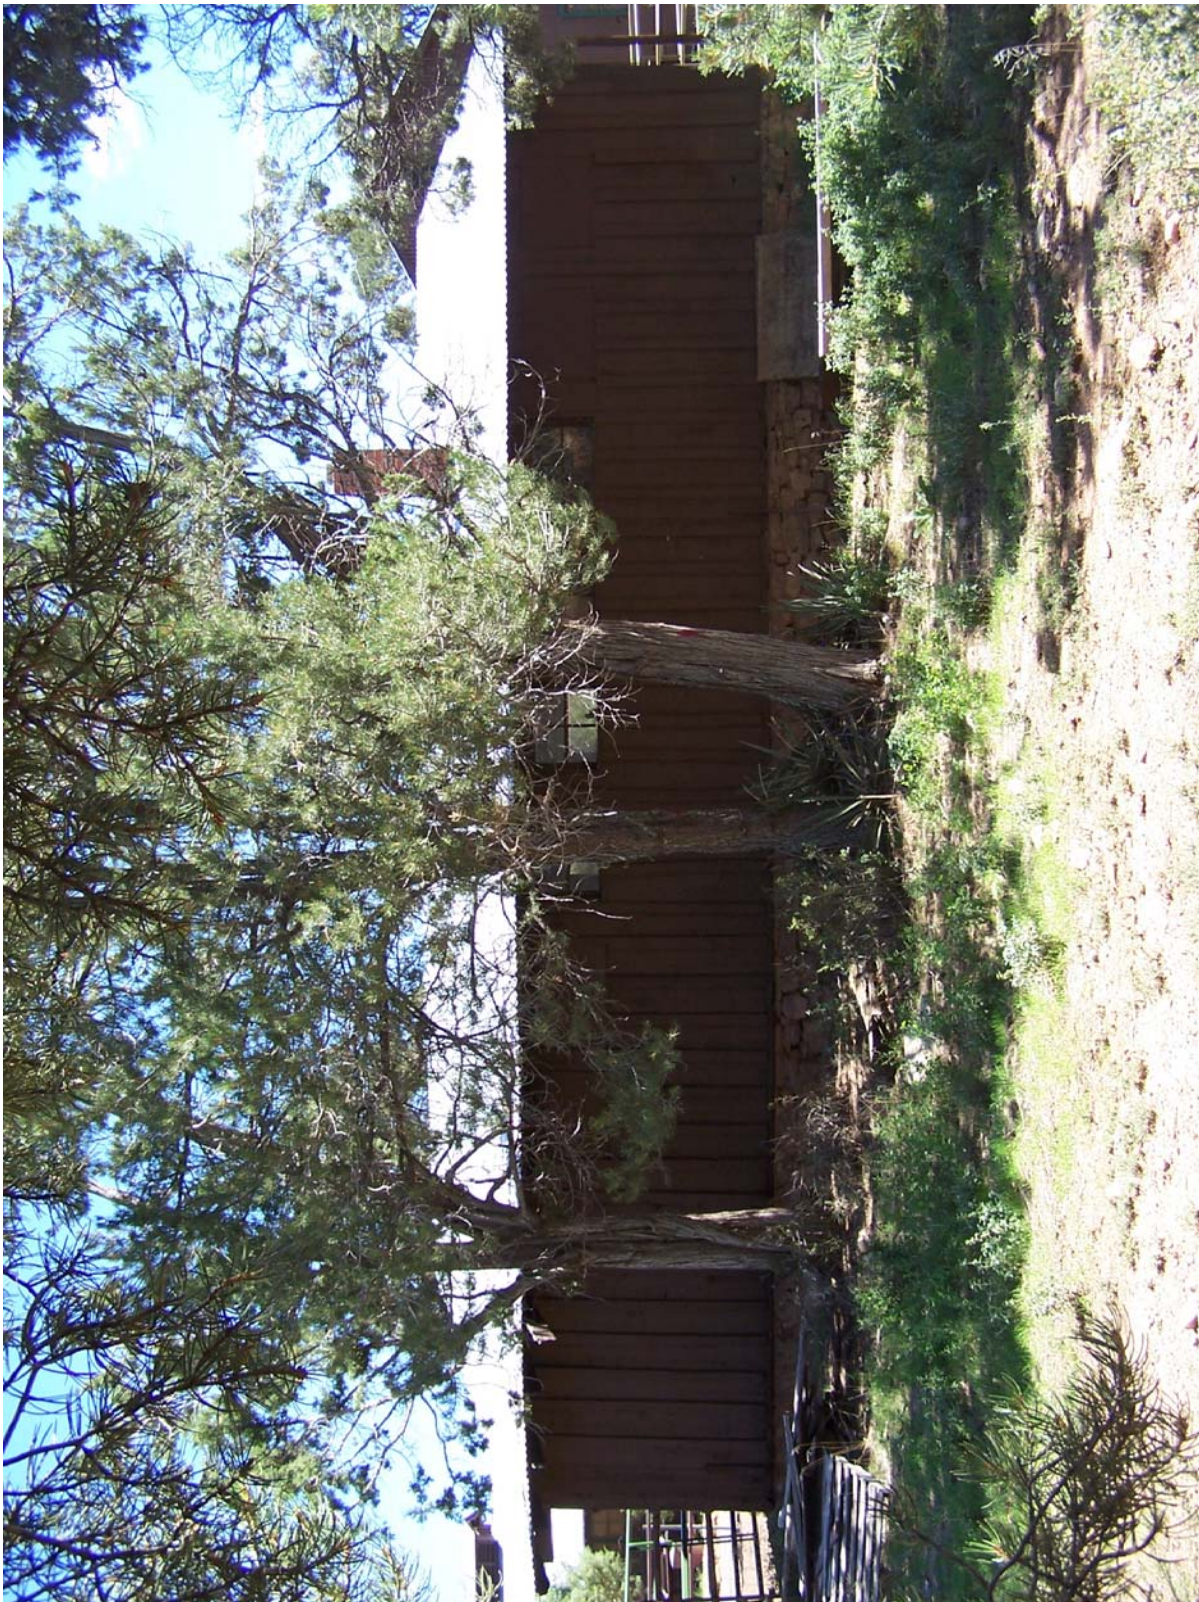
West Façade Exterior Overview 0074 - 101

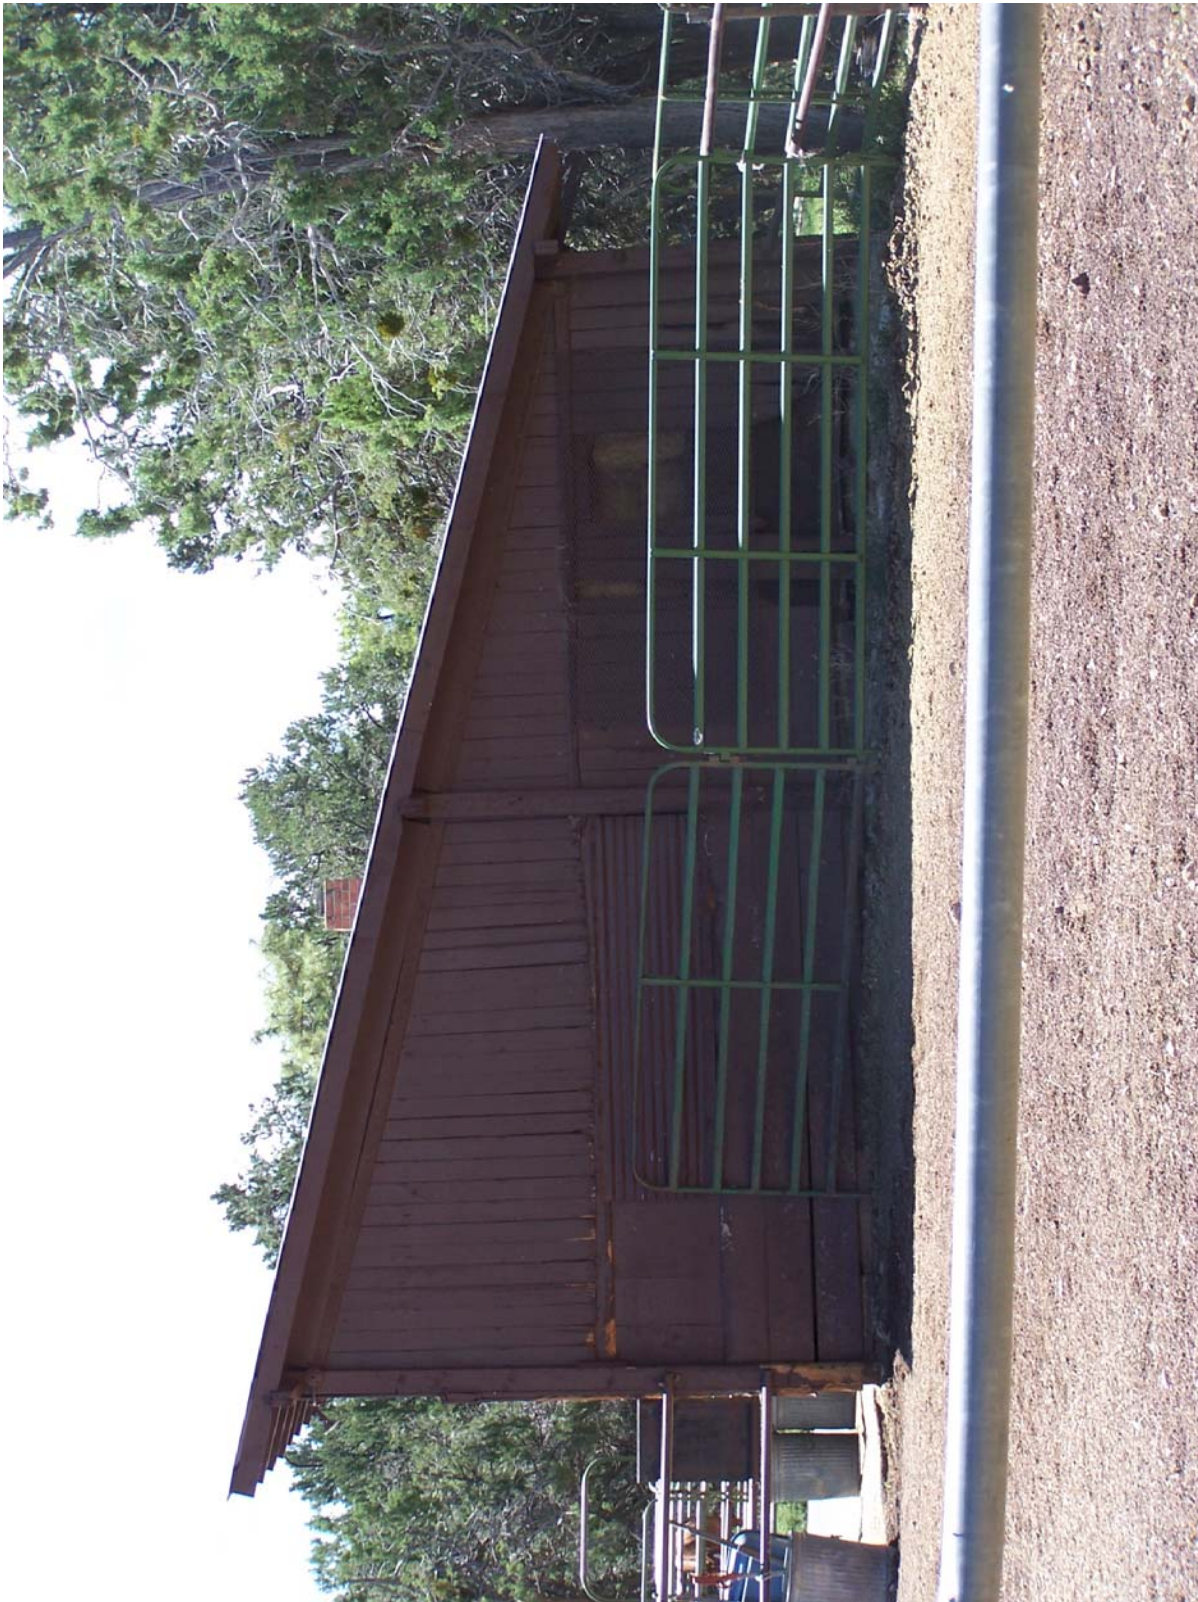
North Façade Exterior Overview 0074 - 102

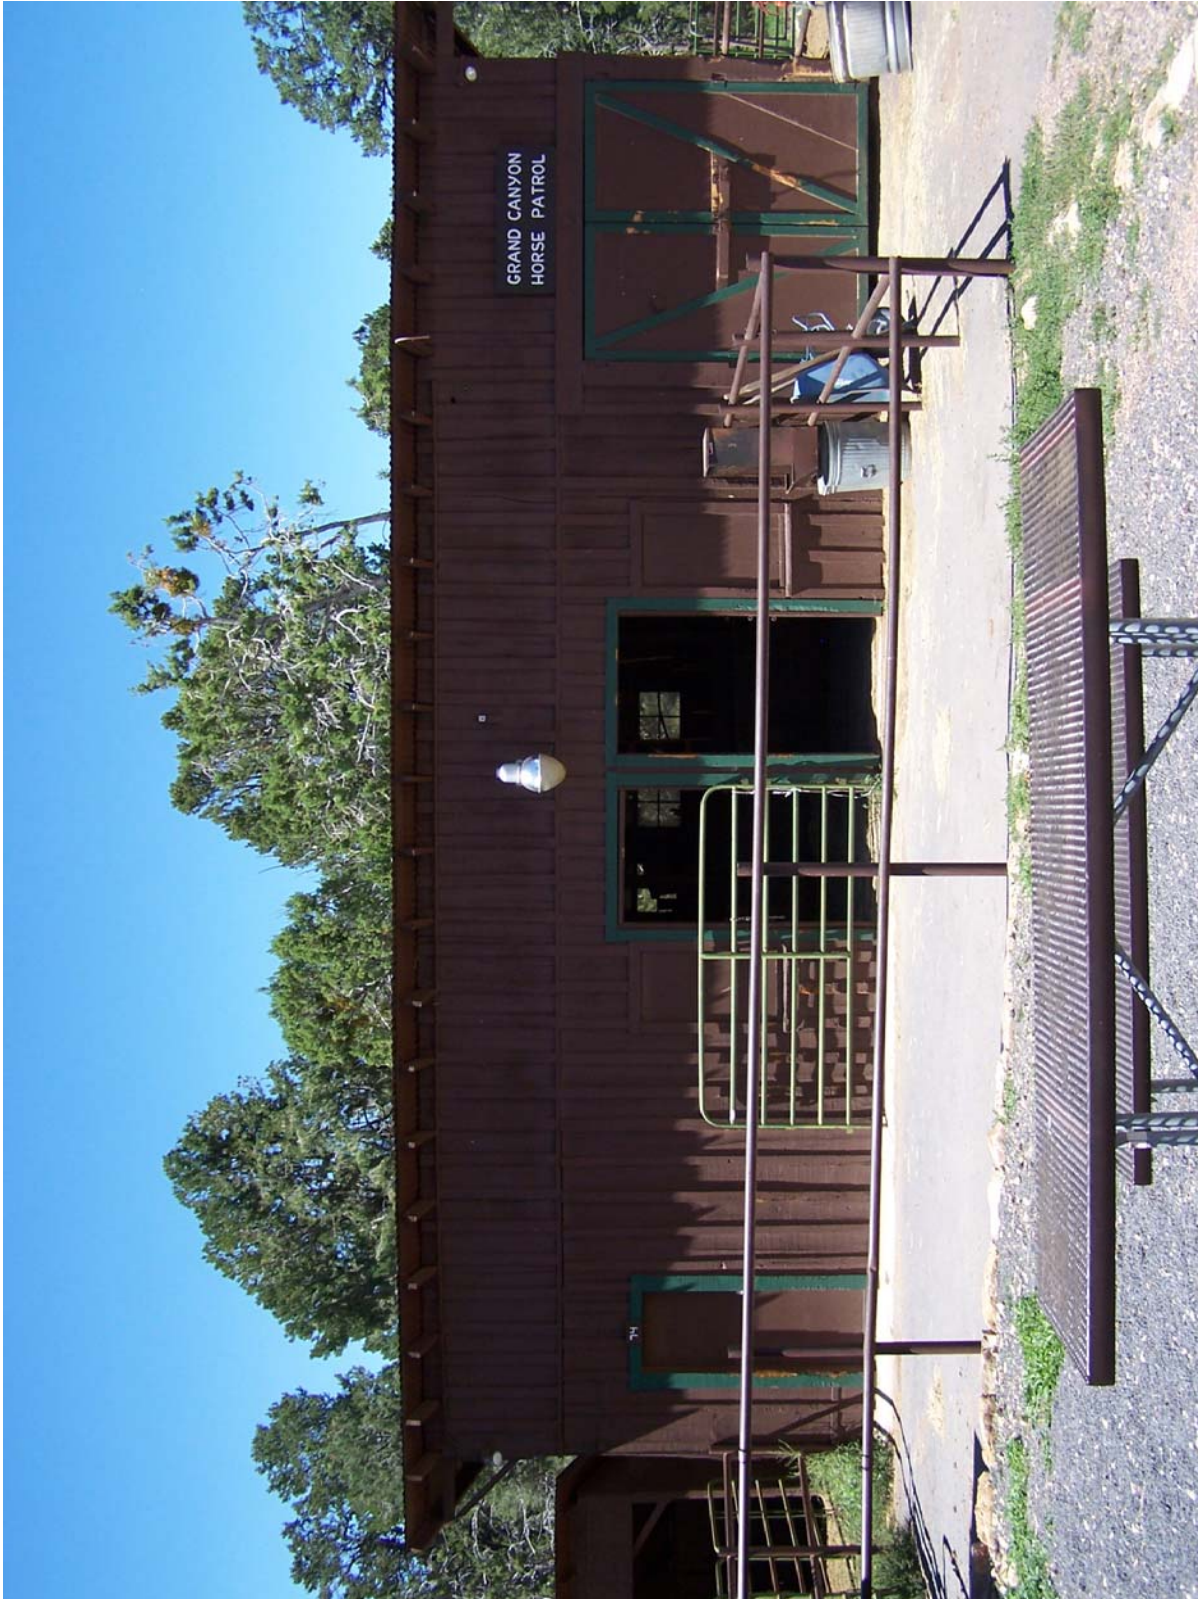
East Façade Exterior Overview 0074 - 103

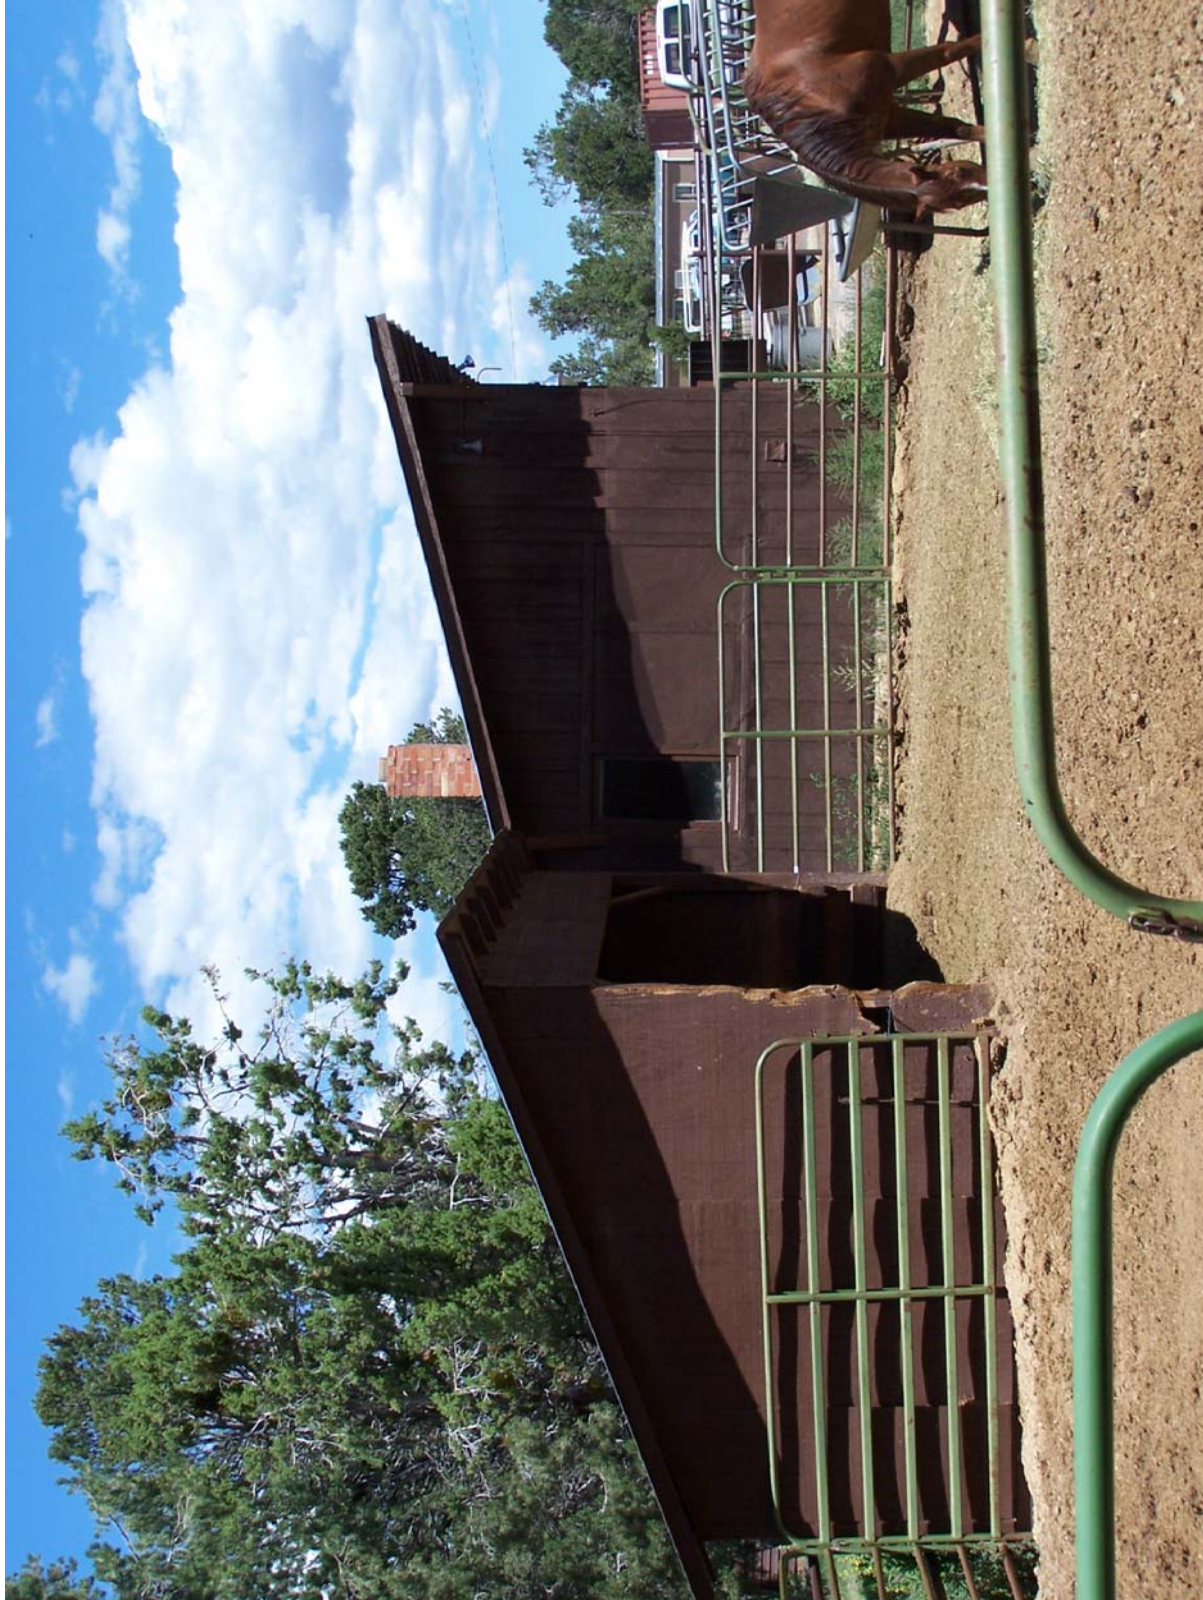
South Façade Exterior Overview 0074 - 104

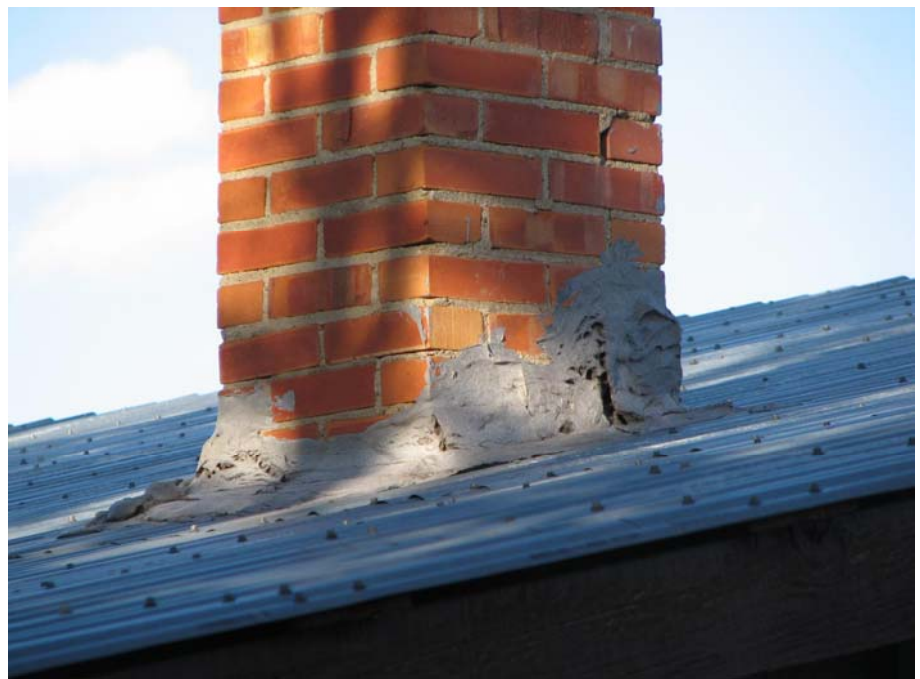
Sheet Metal Roof & Flashing at Chimney 0074-106

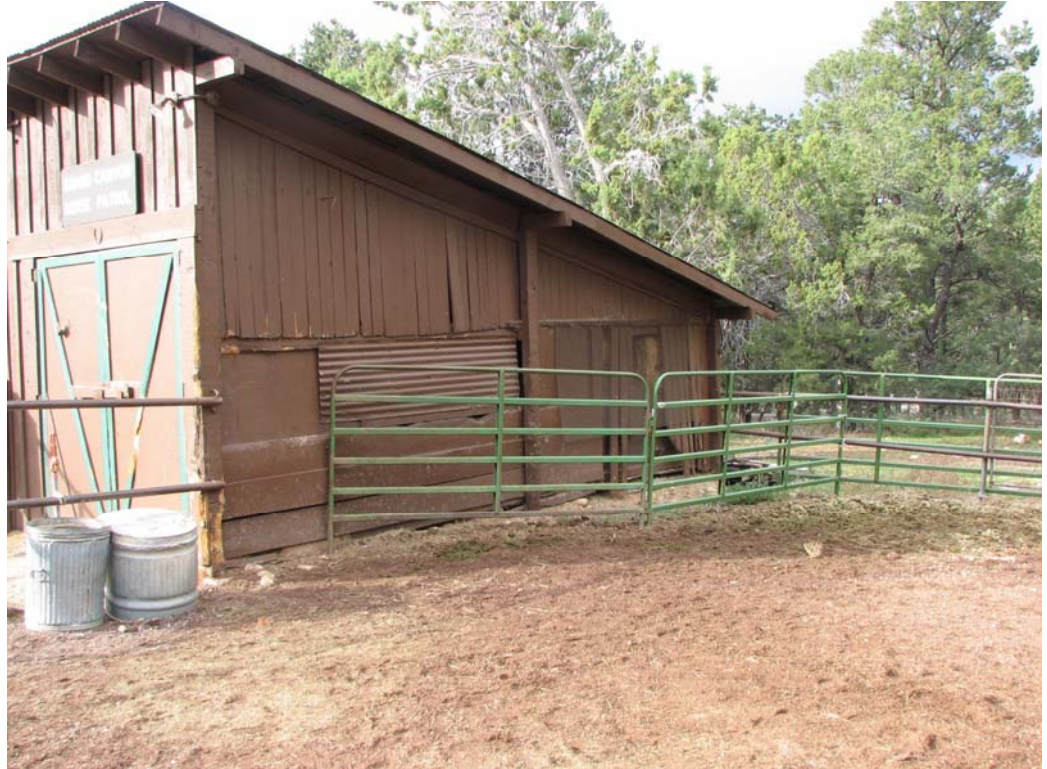
Mixed Rough Sawn Siding on North Elevation 0074-109

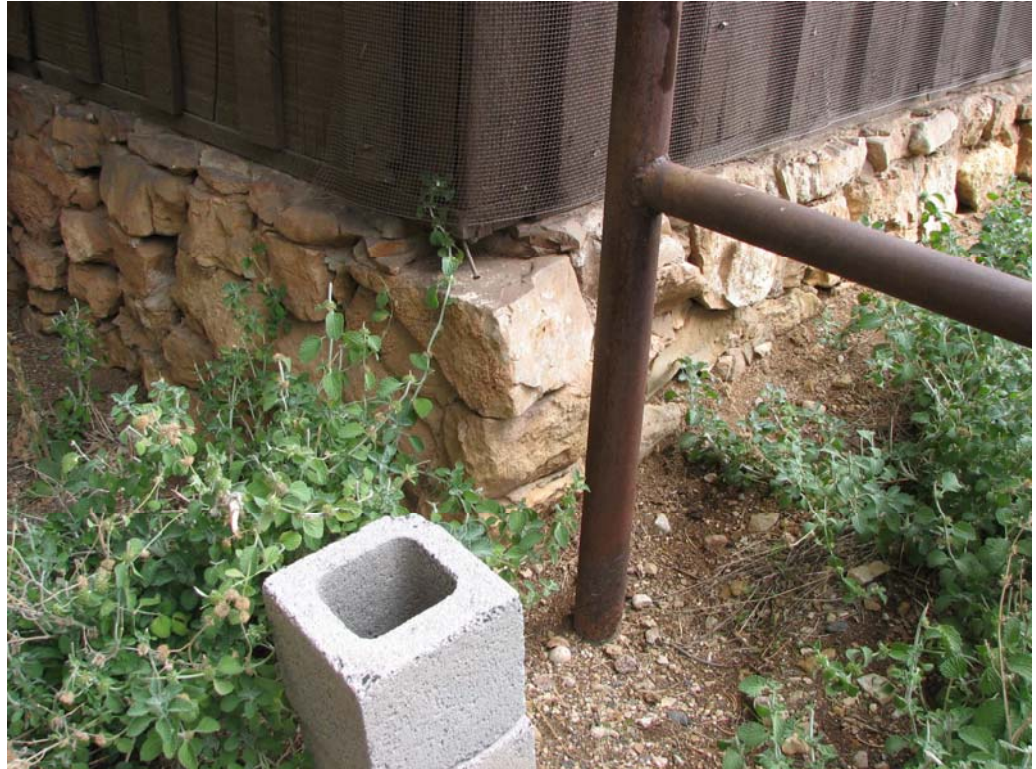
Stone Foundation at Southwest Corner 0074-113

Wear and tear from horses is the biggest contributor to damage on this building. Efforts have been made to minimize the damage, but it will continue to be a factor as long as it remains a horse barn (its current use). The building needs some roof maintenance, and a north foundation should be constructed.

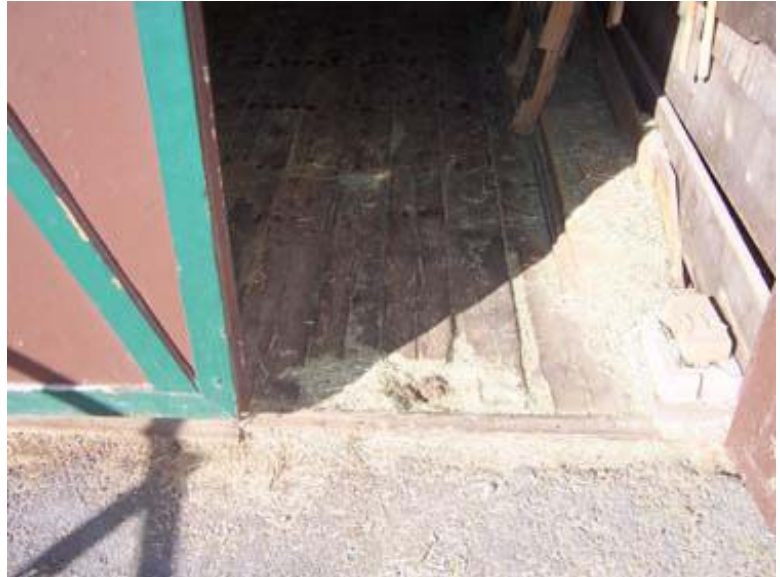
Damaged Wood Flooring at Threshold 0074-127

The wood flooring and structure should be removed (individual flooring pieces may be salvageable) and the dirt should be excavated to a level that will allow clearance for a new, treated wood floor structure to be installed. (Installing a layer of building paper before installing the flooring and designing a simple venting system for the floor structure would both control the infiltration of debris around the structure and improve the system's longevity.)

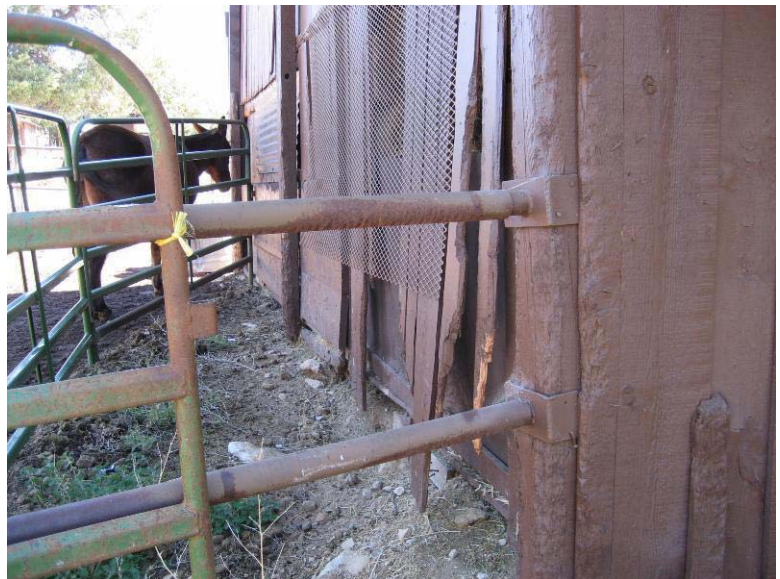
North Wall Damage 0074-132

The north wall will likely require removal and replacement to restore its structural integrity. Any repair should consider mitigation of future damage from livestock.

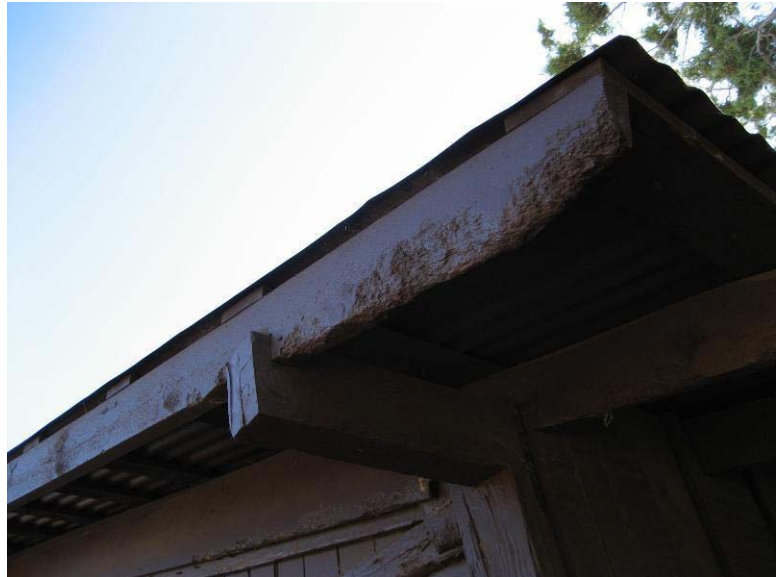
Livestock Damage to North Barge Rafter 0074-133

Barge rafters will require repair where damaged. Kickers should be replaced where missing.

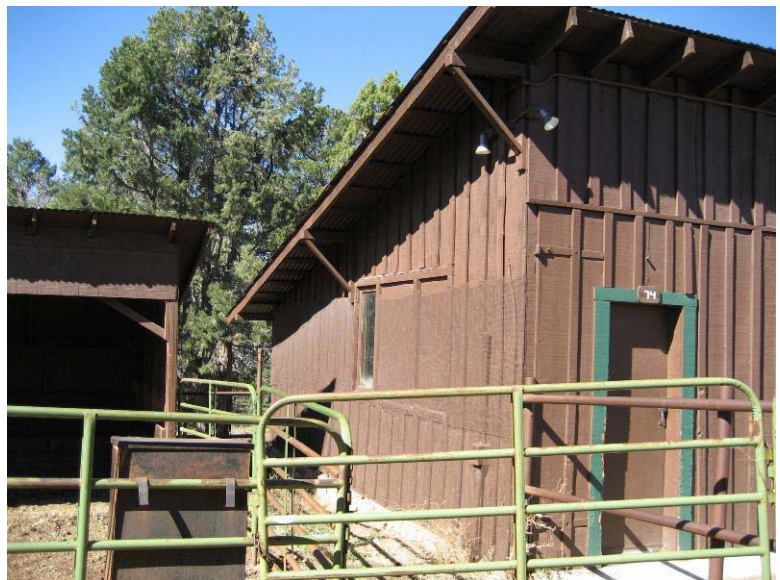
South Wall with Missing Kicker to Barge Rafter 0074-134

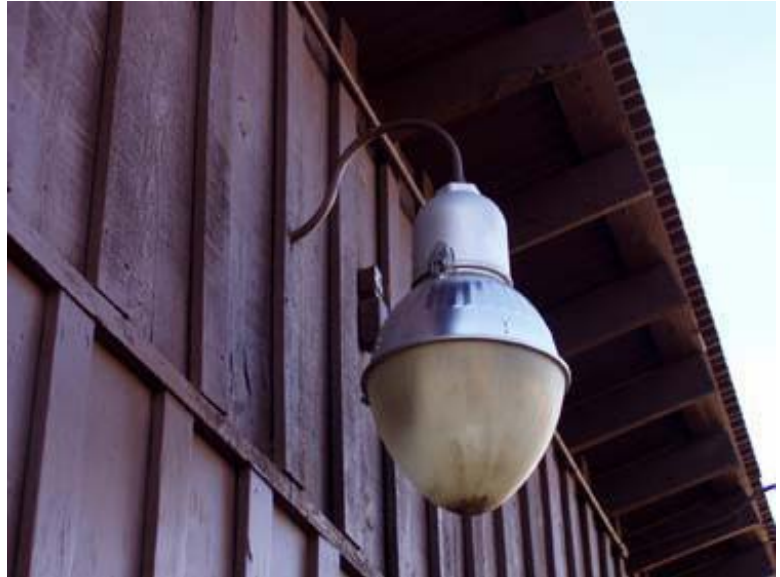
Mercury Vapor Fixture 0074-139

Replace the modern mercury vapor fixture on the historic shepherd's hook with an incandescent lamp and shade that would be more consistent with the building's historic character. We recommend a fixture similar to those on the gas station.

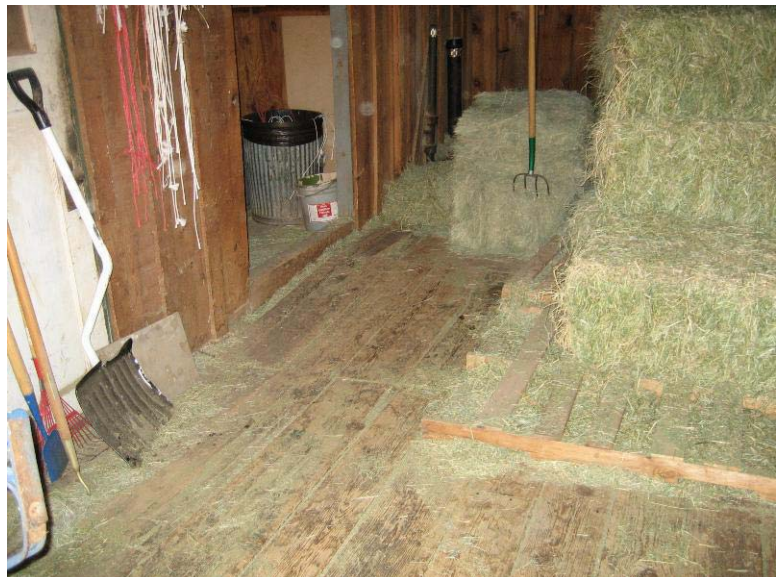
Deflected Floor in Hay Storage Area 0074-220

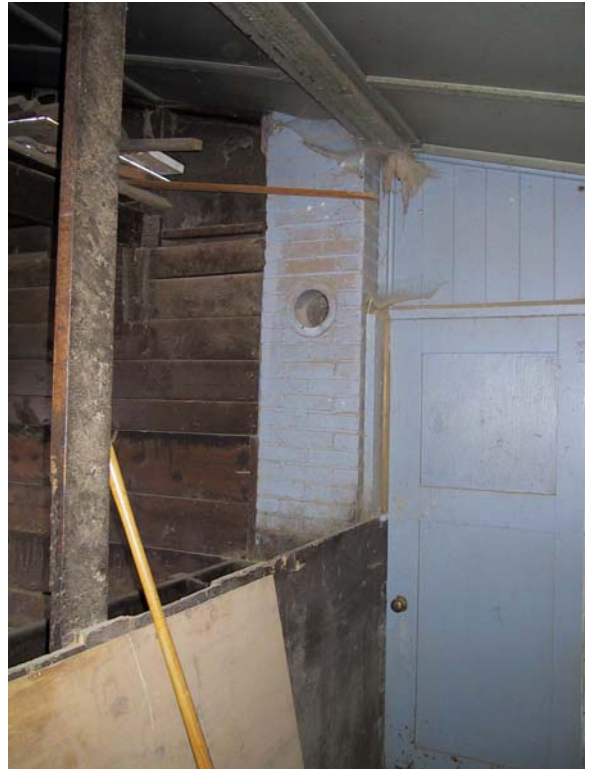
Abandoned Historic Brick Flue 0074-221

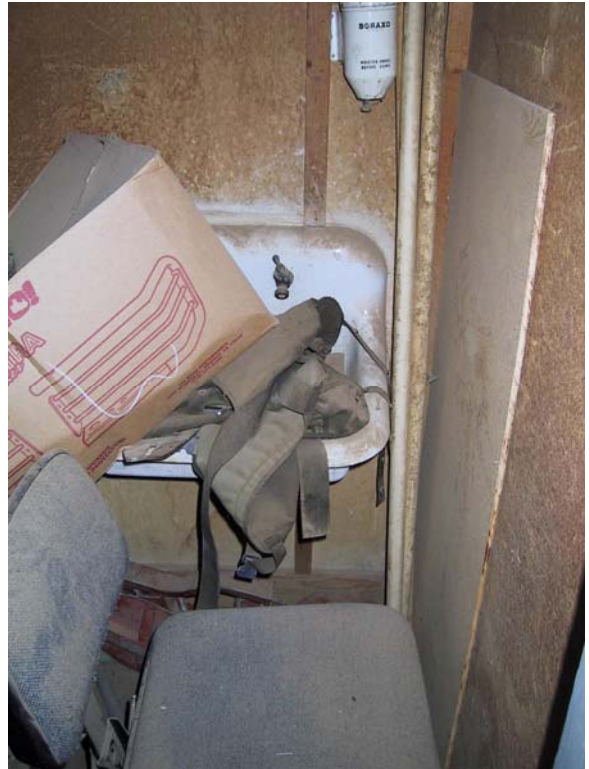
Abandoned Wash Sink 0074-223

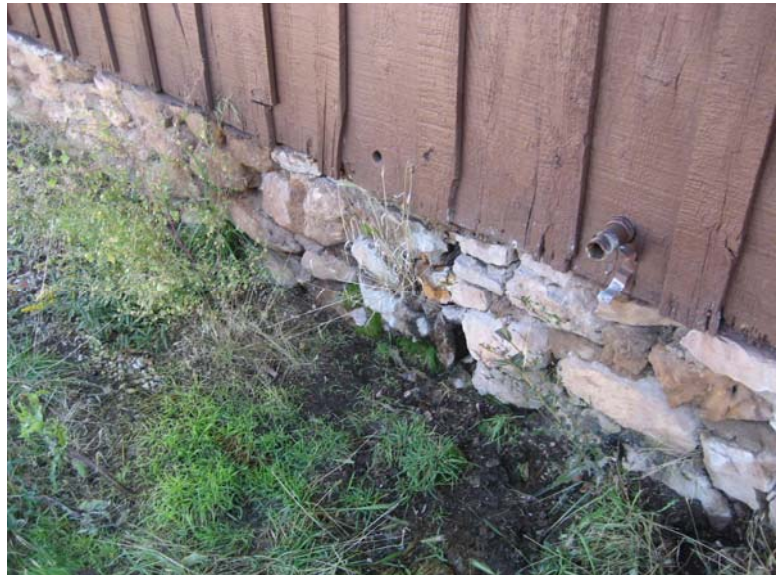
West Wall: Perimeter Foundation. Note Water Damage 0075-131

The slab, wall and foundation at the leaking faucet will require repair. Replacement of the sill plate and the lower portion of the studs in the area will likely be required.

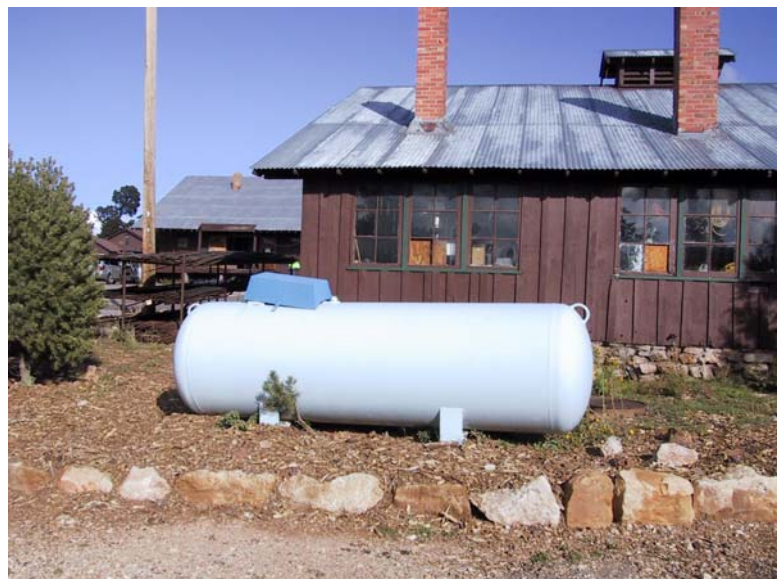
Propane Tank on West 0075-133

Check the LPG tank and valve assembly for leaks and repair any found leaks. Paint gas piping to prohibit rust. Remove debris from area of propane tank to restore access to the shutoff valve.

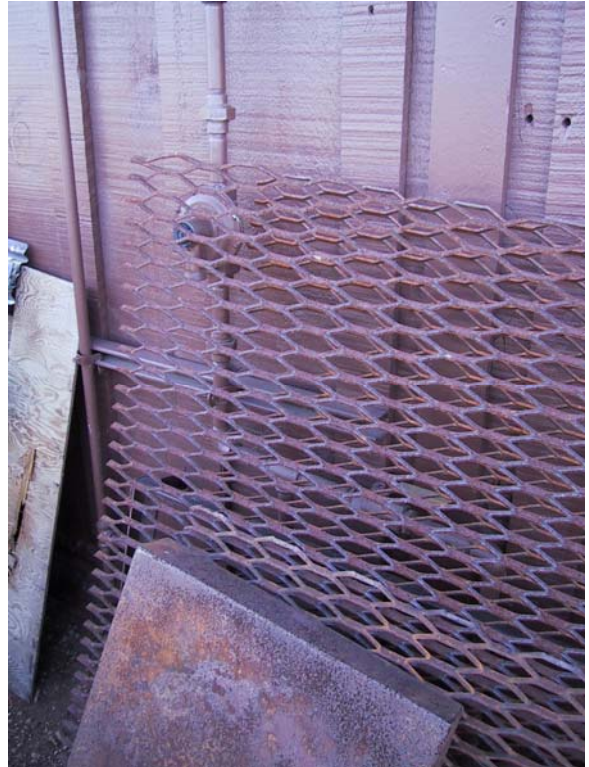
Propane Shut-off Valve 0075-134
