Historic Maintenance and Warehouse Complex

Historic Structure Report for 11 Buildings

Grand Canyon South Rim Historic Maintenance and Warehouse Complex

February 1, 2008

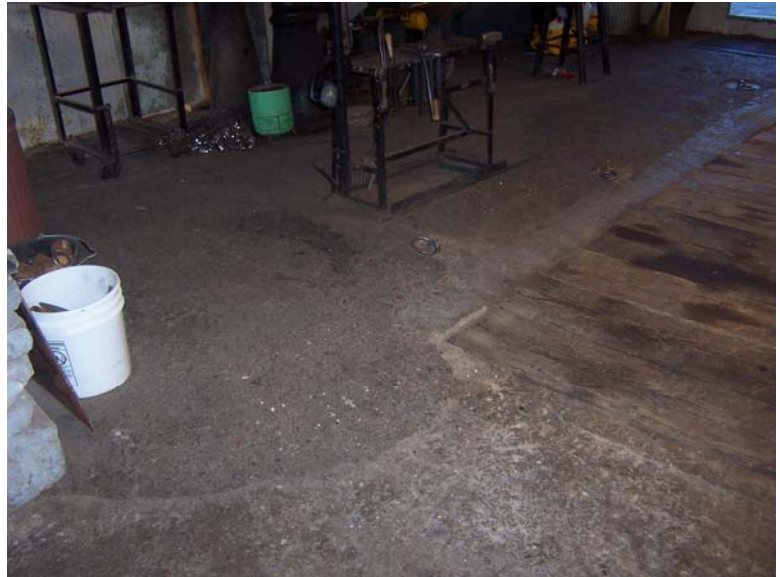
The wood framed portion of the floor is rotting due to direct contact with the soil. While this does not pose an immediate hazard to life safety, it will eventually become a serviceability concern. Considering the use of the space, replacement with a slab-on-grade is likely the best long term solution.

Asphalt Overlaying Conc. Floor; 2x12 Plank Floor 0075-205

If an even, level work surface is desired, the asphalt and concrete flooring would have to be removed and replaced with new slab-on-grade - leaving a curb/border around the 2x flooring and resetting the three steel rings to the north side of the 2x floor.

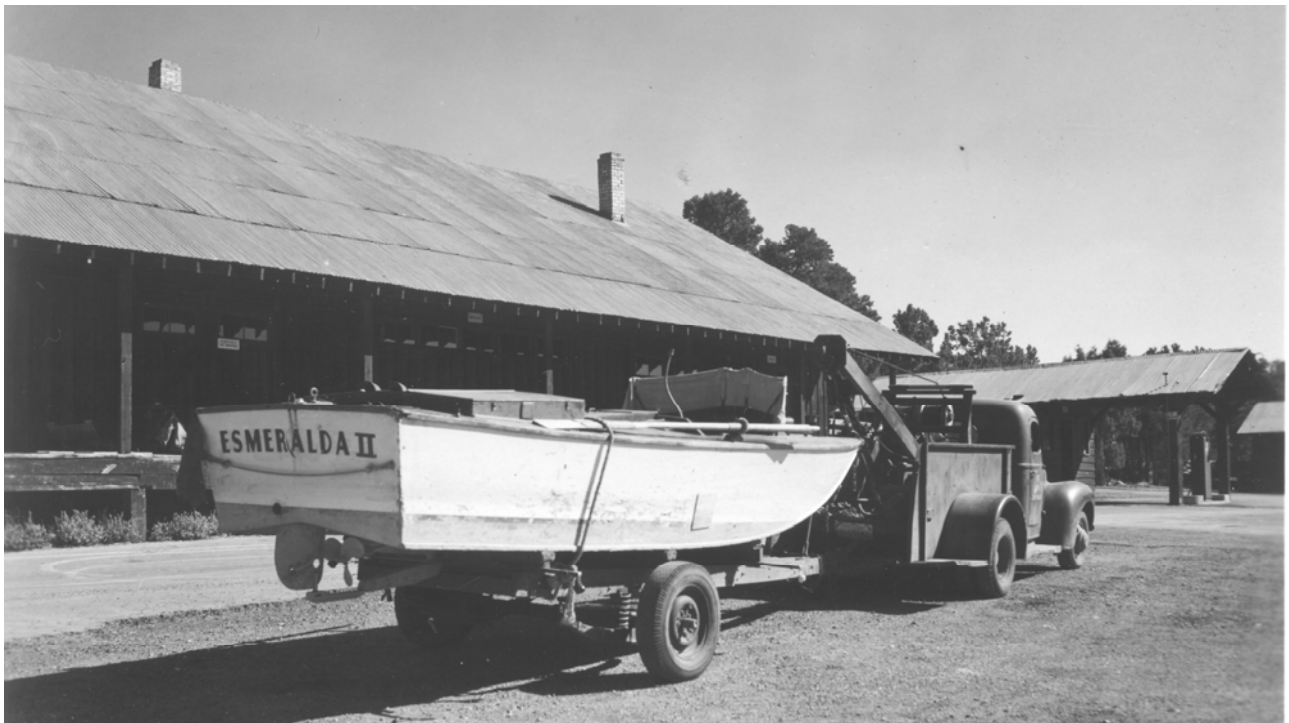
Very little archival information could be found related to this building. There are no construction drawings and few photos (only the 1949 survey drawings). Two historic photographs taken in the 1930s illustrate a building that looks much as it does today. (Photos 02017 and 07688 from the Grand Canyon Museum Collection. Photo 02017 was taken after the jail was completed in 1937. The vehicles in 07688 suggest the photo was taken before 1940.) However, on visual inspection, the east loading dock appears to have been enclosed sometime between 1926 and 1949. Stairs to the second floor were relocated after 1949.

Bldg SRB-0078 – date unknown
National Park Service Grand Canyon Museum Collection (Photo # 02017)

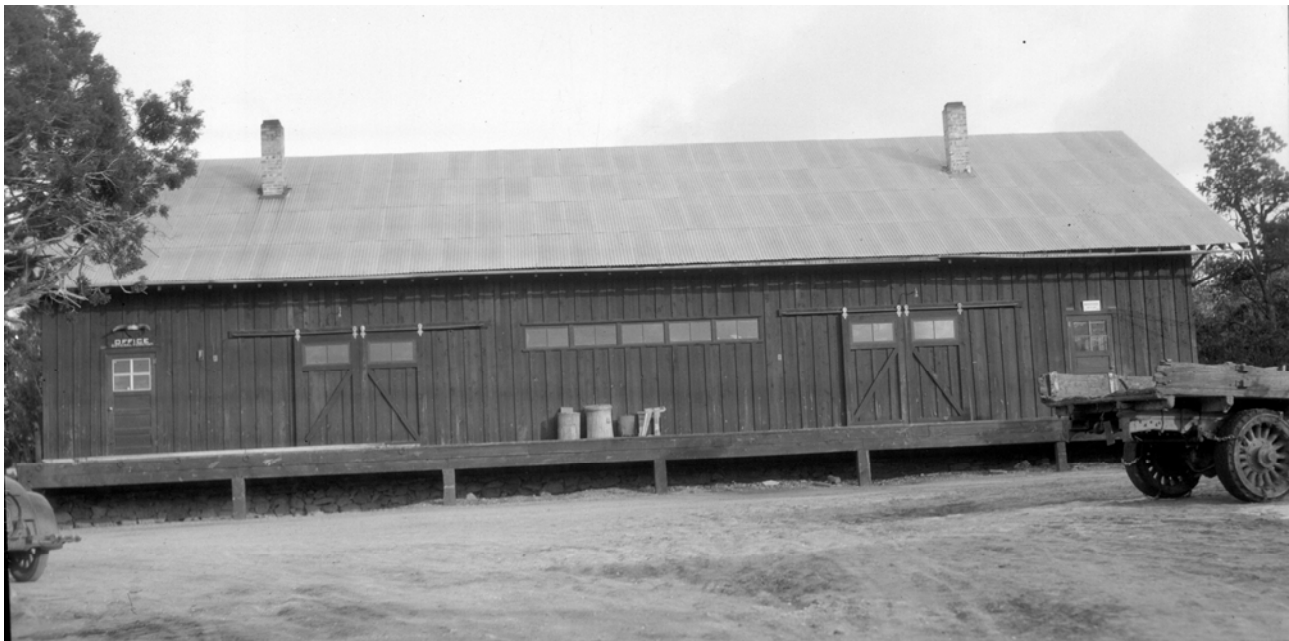
Bldg SRB-0078 – date unknown
National Park Service Grand Canyon Museum Collection (Photo # 07688)

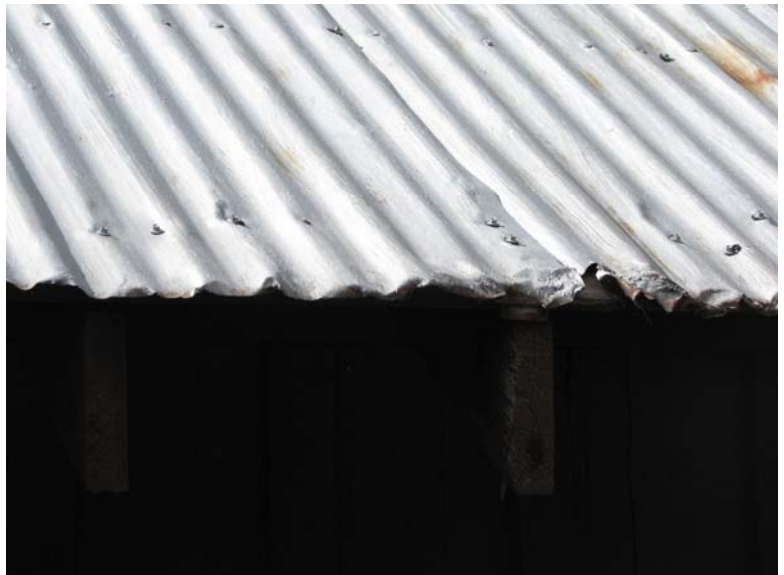
Damaged Edge of Sheet Metal Roofing 0078-108

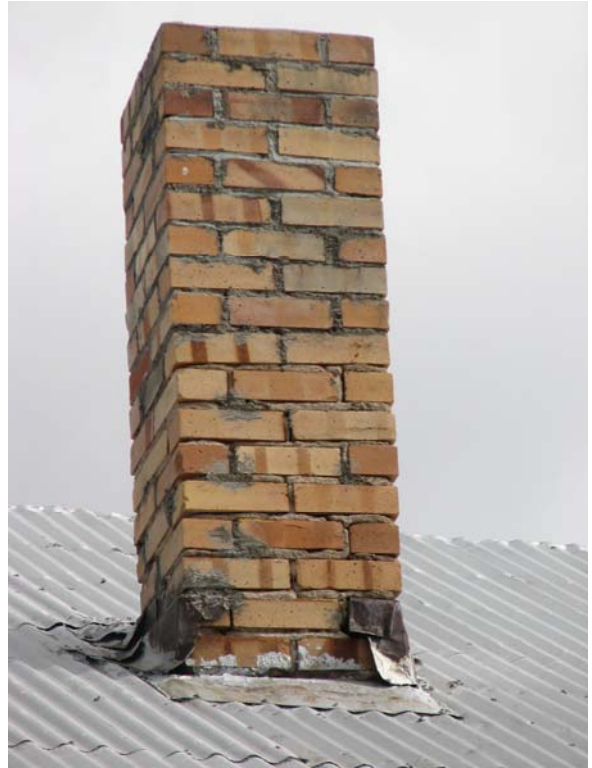
The foundation on the south, west, and part of the north sides consists of a random, rubble sandstone with mortar, at least in the top courses. The foundation on the east half of the north side is formed concrete and what is visible of the east foundation is also formed concrete. The foundations on the north and south sides are painted brown. The rest of the foundation is un-painted. The west loading dock is supported by un-mortared concrete masonry units (cmu) (see "Arch - Loading Docks"). (Photos 0078-107, 0078-116, 0078-143).

Brick Chimney 0078-116

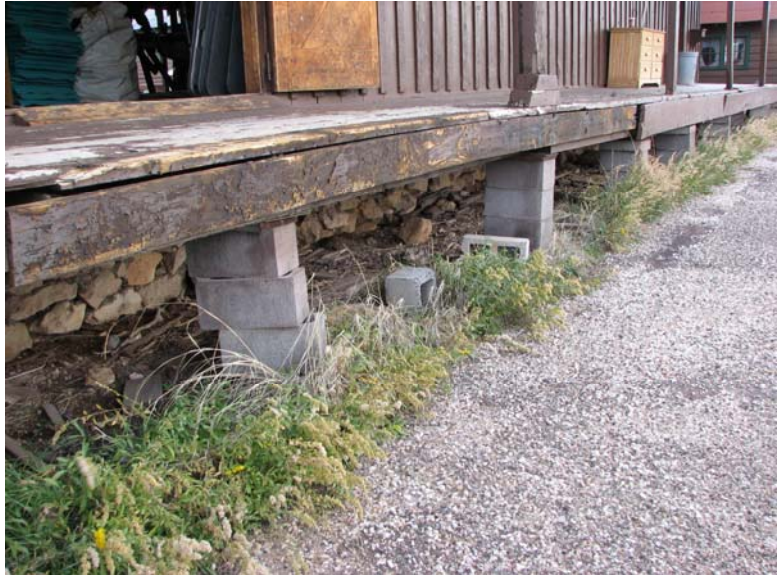
Porch Supported on Loosely Stacked 8x16" CMU 0078-118

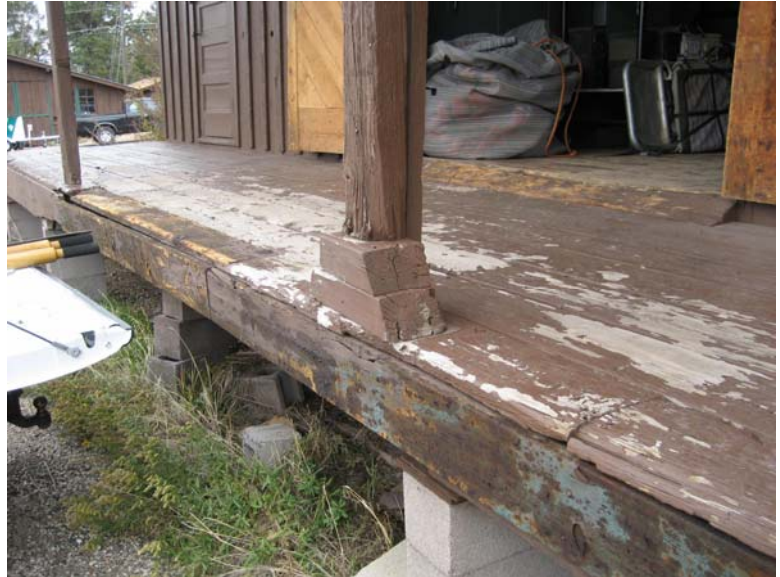
West Porch. Note Failing CMU Pier, Damaged Post 0078-142

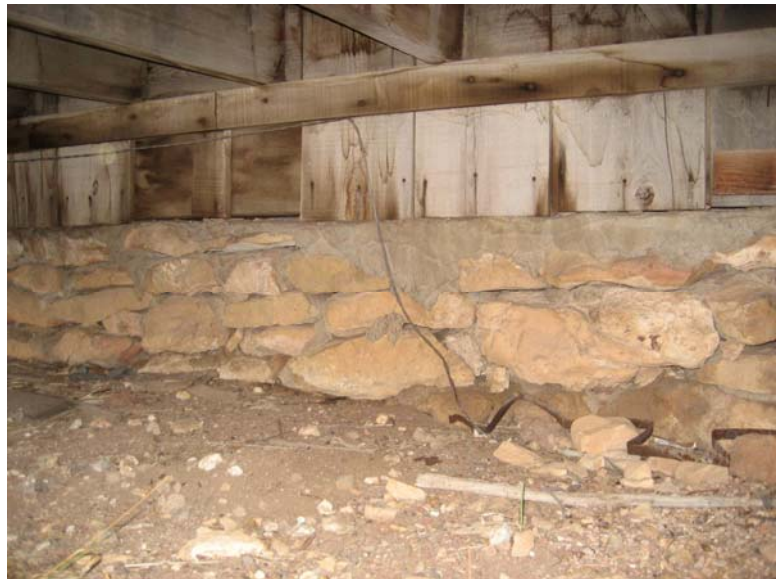
West Porch Ledger, Typical Perimeter Foundation 0078-143

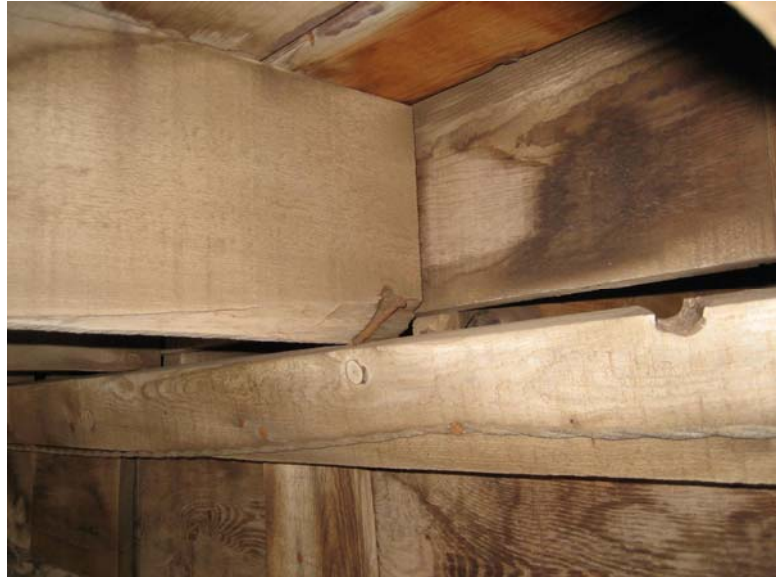
Failing Ledger at West Porch 0078-144

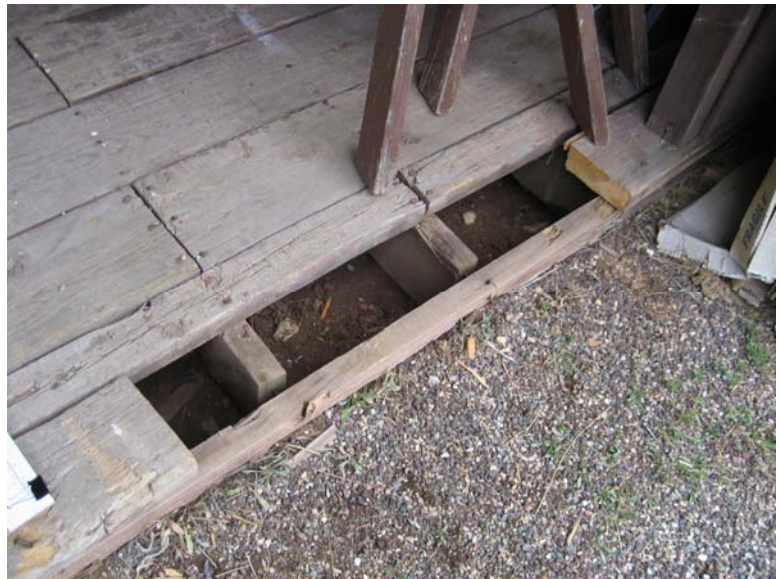
East Porch Missing Decking, Deteriorating Framing 0078-145

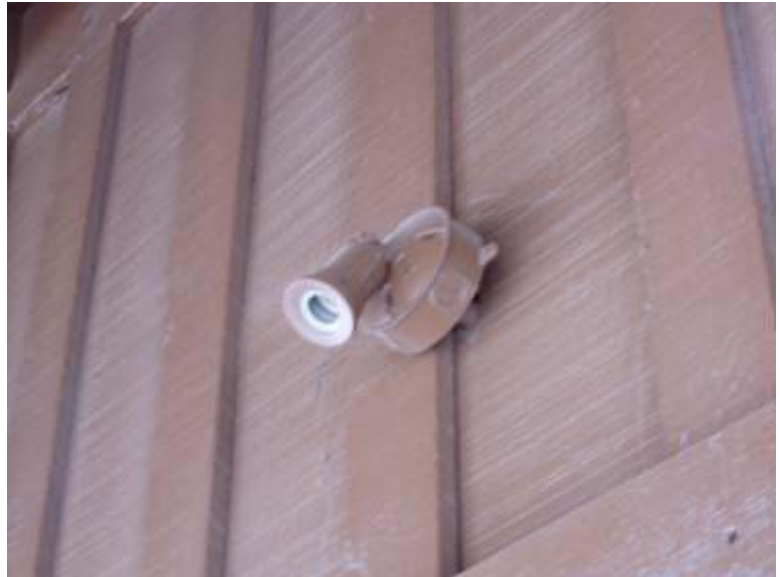
Floodlight on West Façade - No Lamp 0078-154

Replace the exterior light fixture with a fixture that complies with the "Grand Canyon National Park Night Sky Protection and Exterior Lighting Policy" (01/04) and support existing conduit as required to comply with NEC conduit supporting requirements.

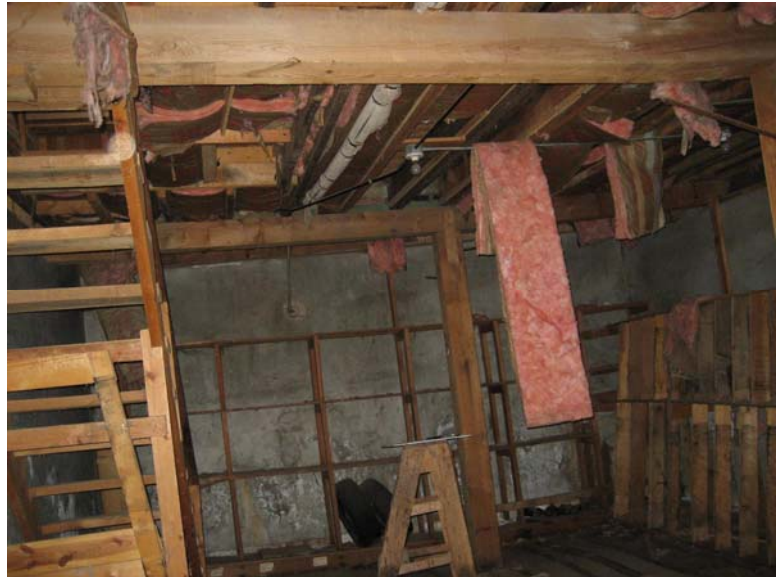
Basement Interior Overview with Failed Girder 0078-200

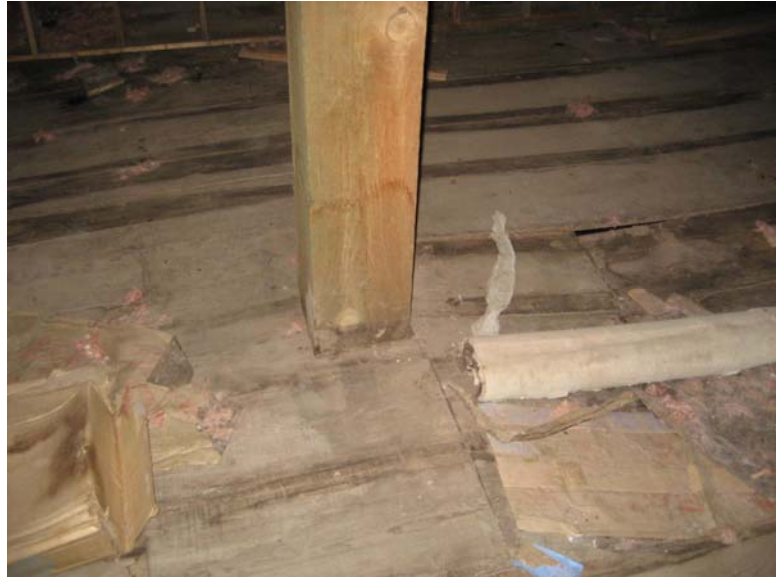
Failed First Floor Girder at Basement 0078-205

The greatest impact to this building, and most of the others in the complex, is the risk of benign neglect through delayed maintenance if treatment is not undertaken. Unstable flooring on the east loading dock has already compromised the building's use, and the potential for damage as a result of the failing girder breaking completely is very real. The added risk to human safety should be considered as well. (Note: the girder was repaired in Summer 2007).

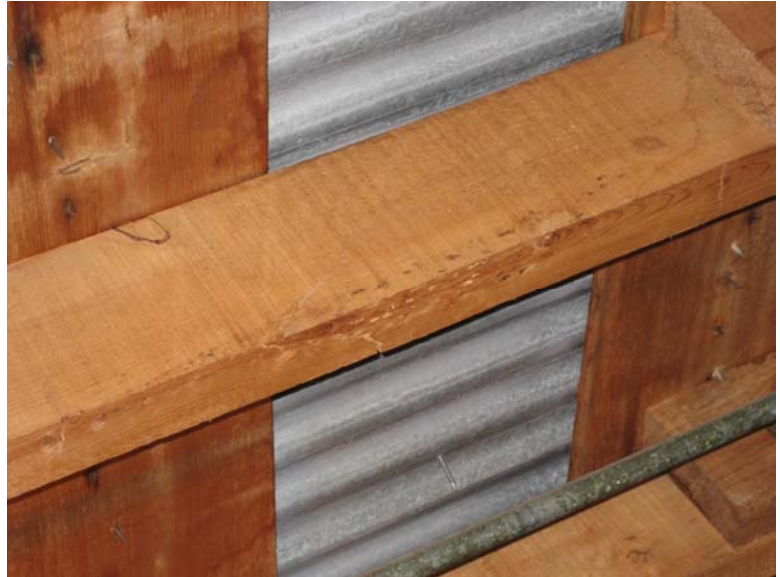
Cracked Rafter 0078-262

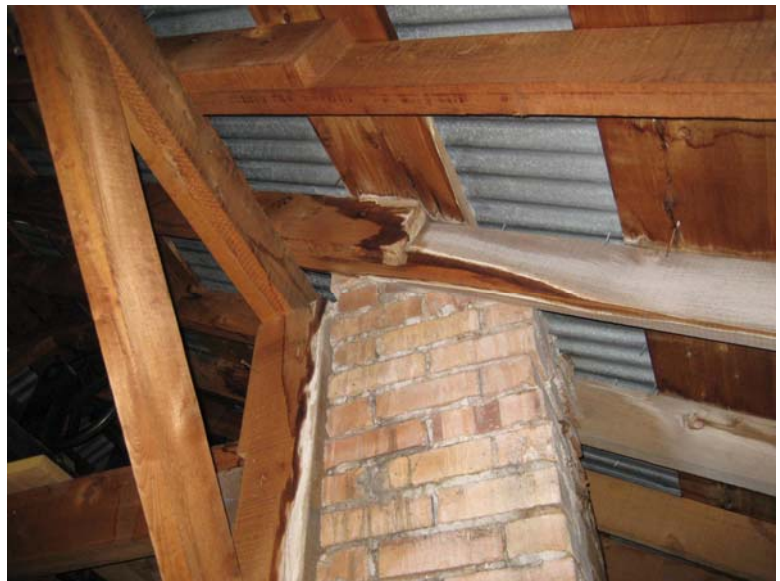
Water Damage Around North Chimney 0078-263

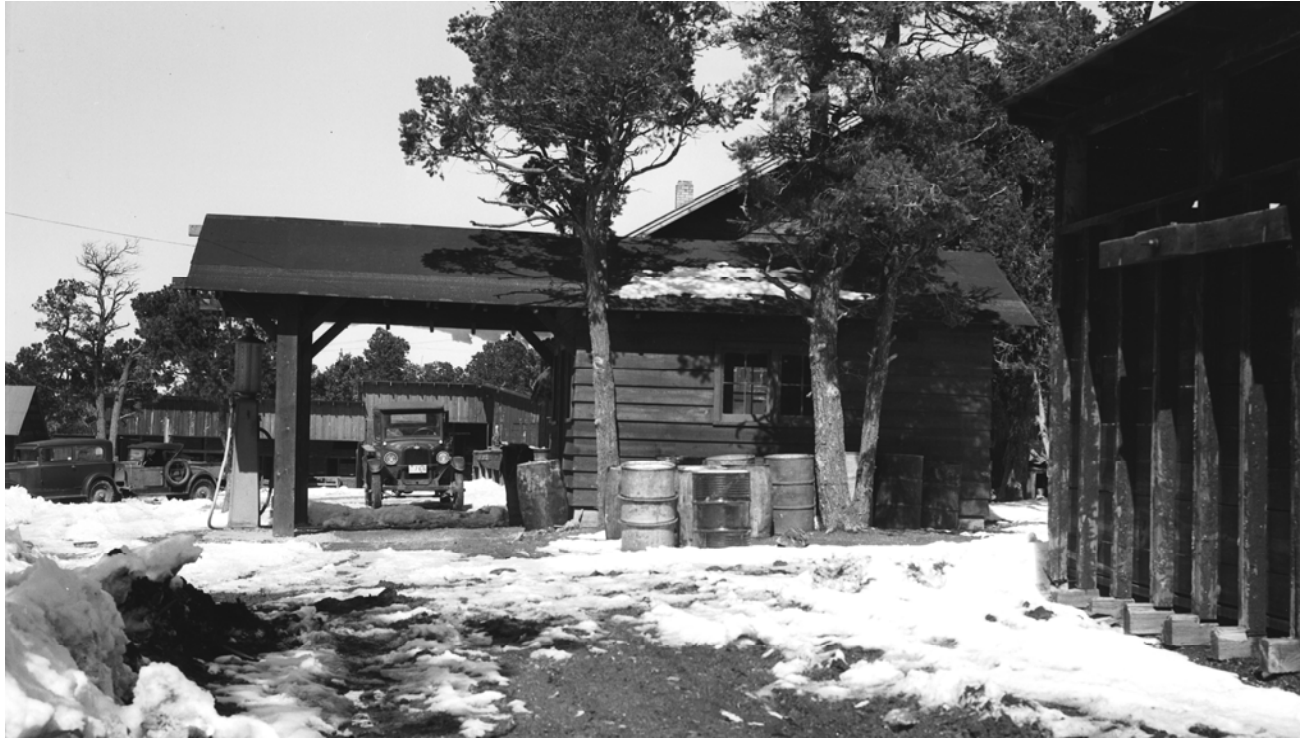
The original plans for the Park Service Gas Station were approved in 1930. (Drawing 309 Grand Canyon Museum Collection). A historic photograph, taken in 1932, shows the completed building (Photo 00143 from the Grand Canyon Museum Collection). The 1949 building inventory on file at the Grand Canyon National Park Office of Cultural Resources indicates a construction cost for the project of \$483.71.

Bldg SRB-0079 – 1932
National Park Service Grand Canyon Museum Collection (Photo # 00143)

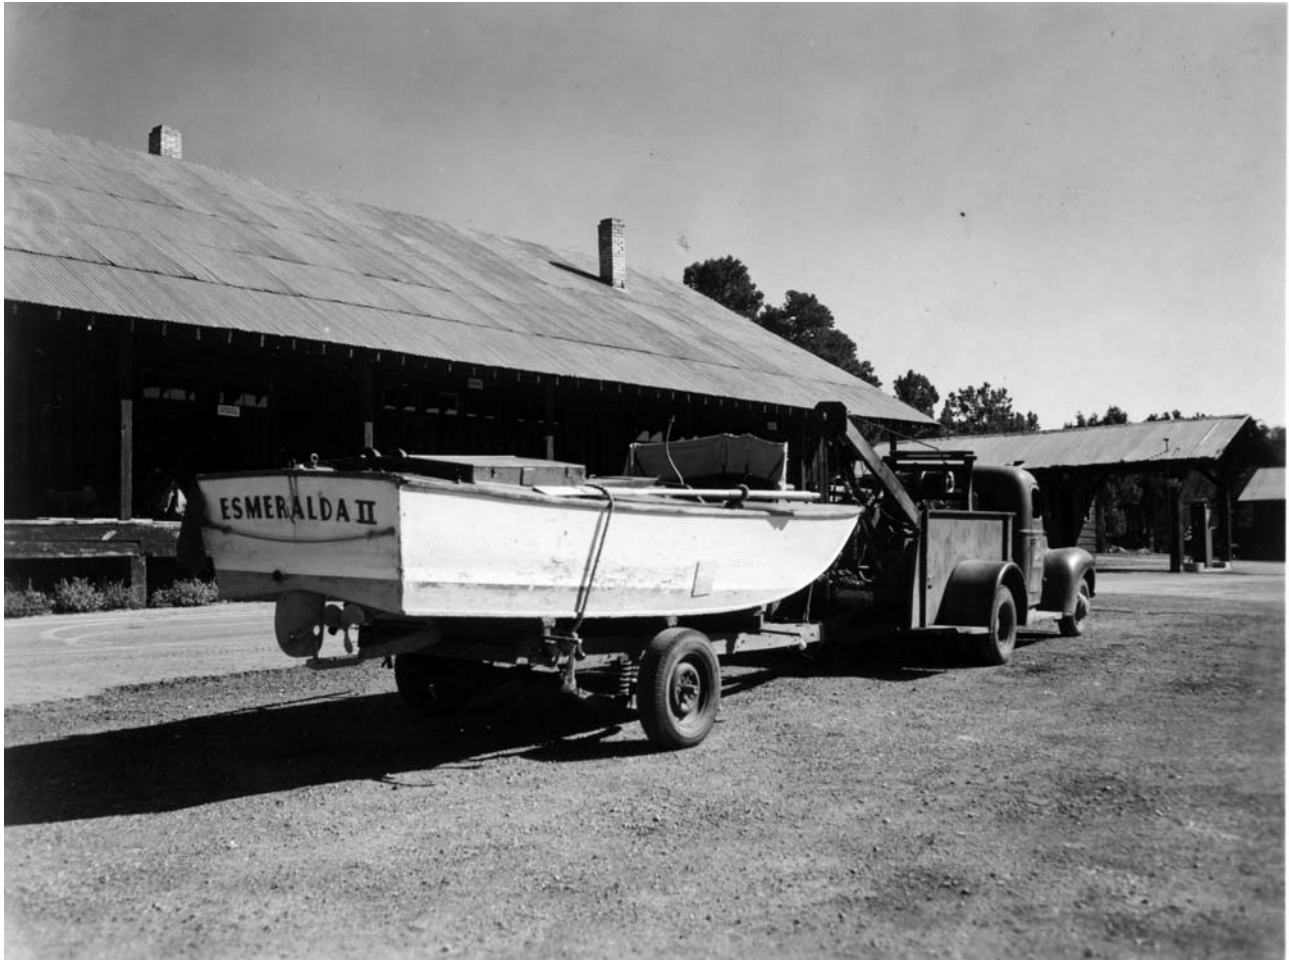
The roofing consists of granulated, asphalt rolled roofing on each side of an east-west running simple gable roof. The original roof is possibly corrugated metal (see photo 02017). Although photo 02017 is not conclusive, it does suggest a material other than roll roofing, possibly corrugated metal was installed. Conversely, other historic photos (00143 and 07815) indicate horizontally orientated roofing, much like the current roll roofing. Further detailed examination of the roof framing may provide additional evidence on original roofing material.

Bldg SRB-0079 in background – date unknown
National Park Service Grand Canyon Museum Collection (Photo # 02017)

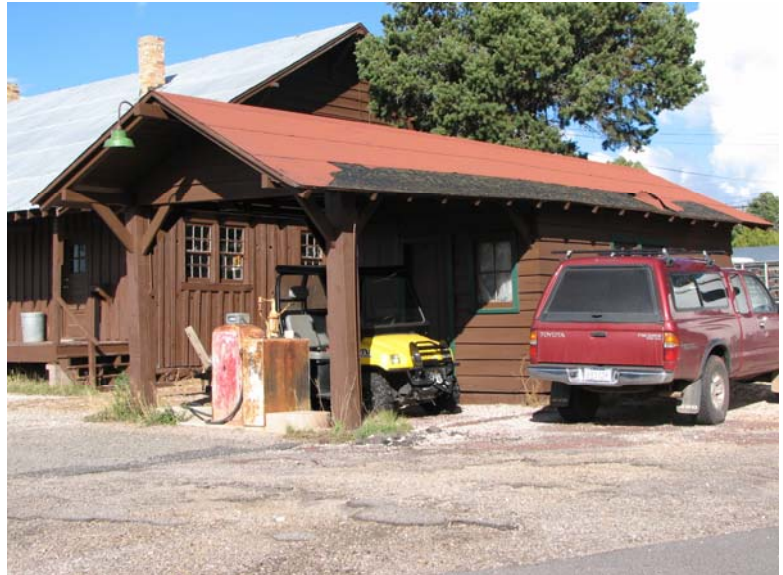
South Side Roof with missing sections of roofing 0079-105

Given that historic photographs seem to indicate that the building may have had both corrugated sheet metal roofing and roll roofing historically, either may be acceptable replacement materials. (Note that the original drawing indicates horizontal roofing, e.g. roll roofing, but that may or may not have been what was installed originally.

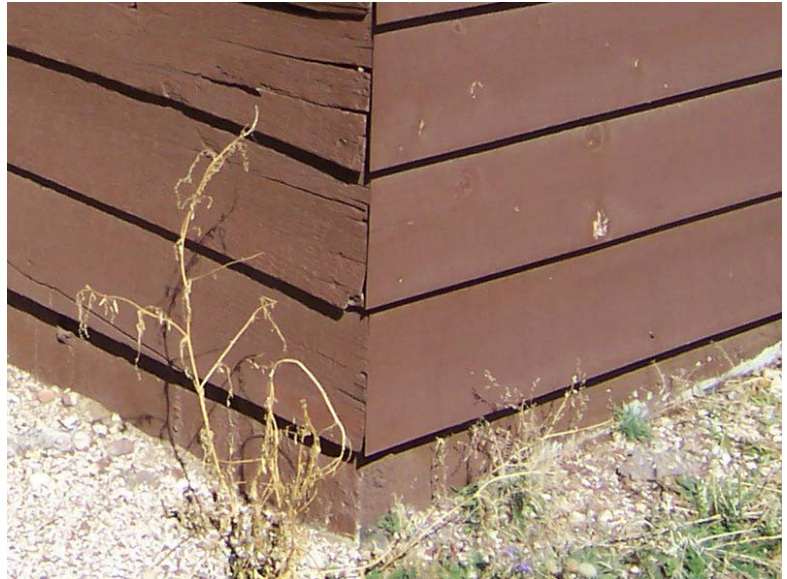
Split Siding at Mitered Corners 0079-111

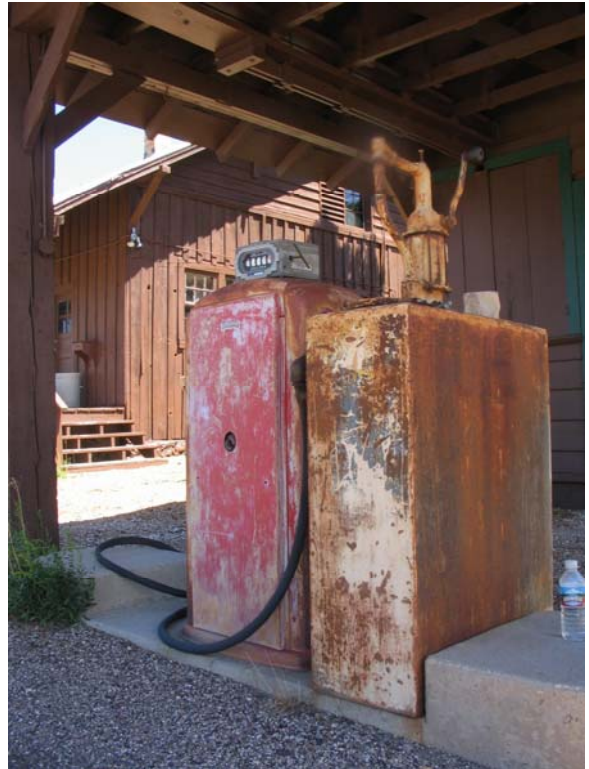
These pumps are currently out in the open where they are subject to damage from traffic activities. They should be protected with bollards, at a minimum.

Gas Pump at Porte Cochere 0079-115

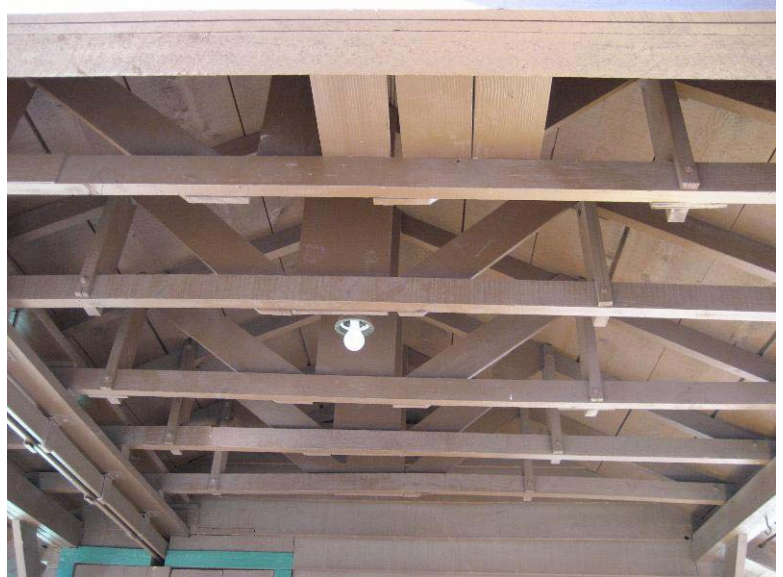
Typical Roof Truss 0079-123

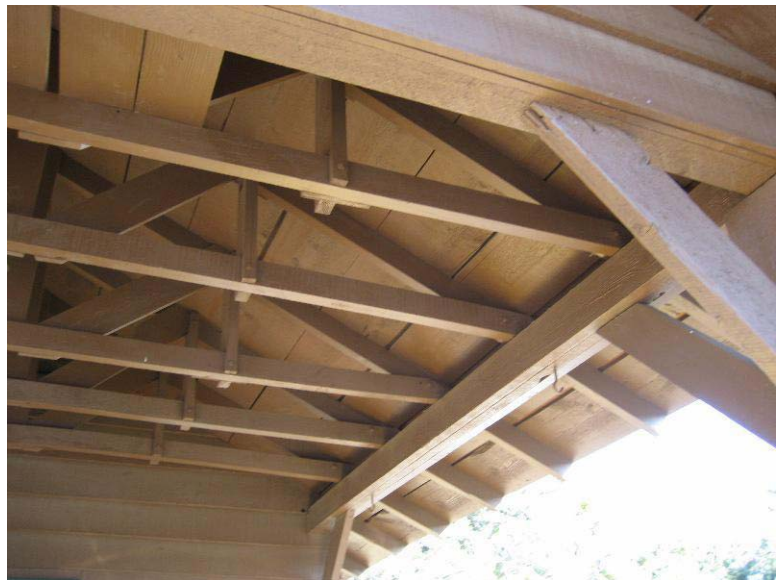
Exterior Girder Supporting Trusses 0079-124

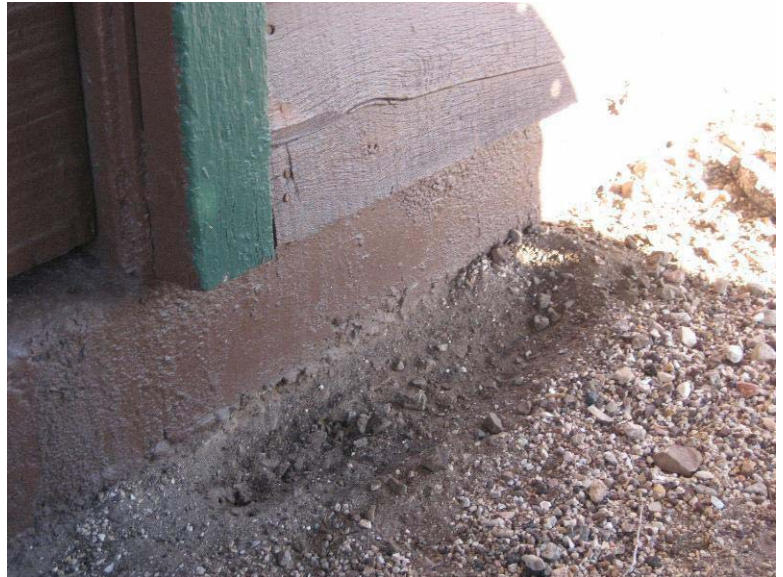
Perimeter Foundation 0079-125

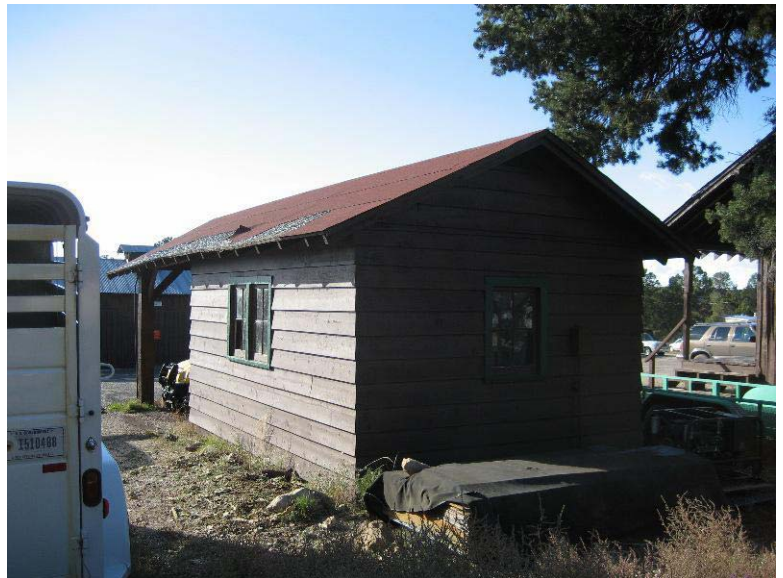
Southwest Elevation. Note Deflected Roof at Canopy 0079-126

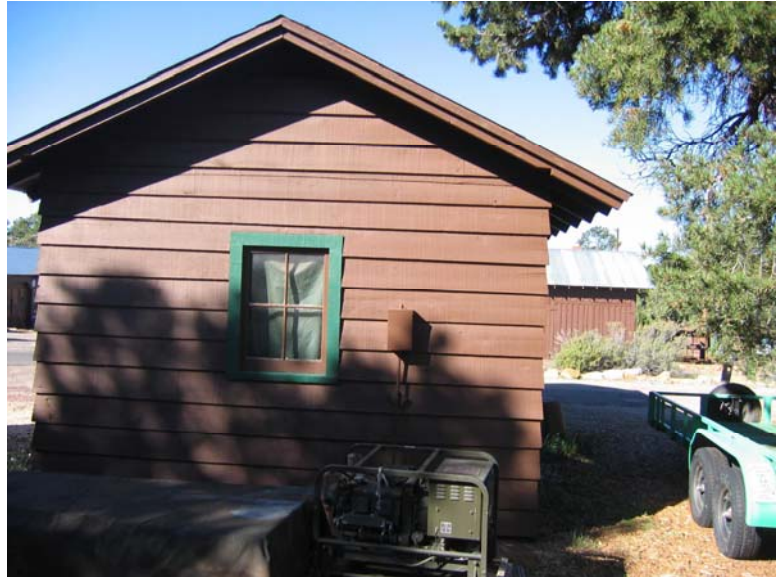
Service Disconnect 0079-127

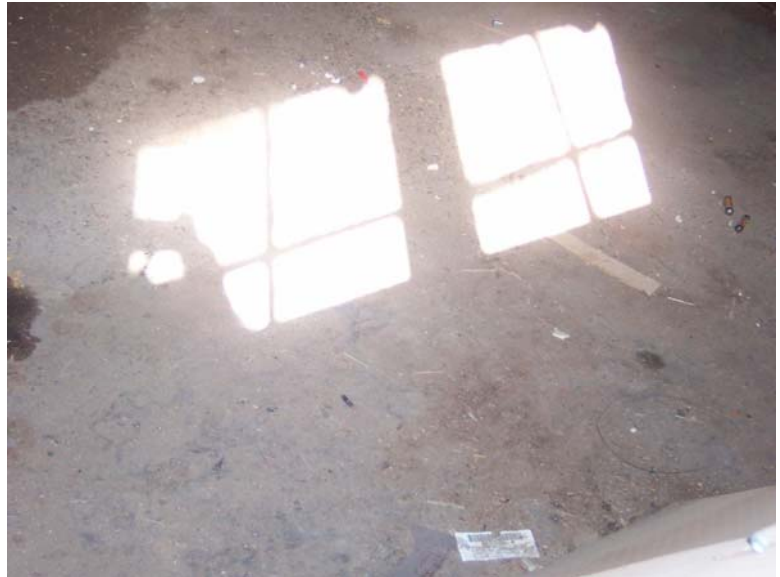
Concrete Slab Floor 0079-201

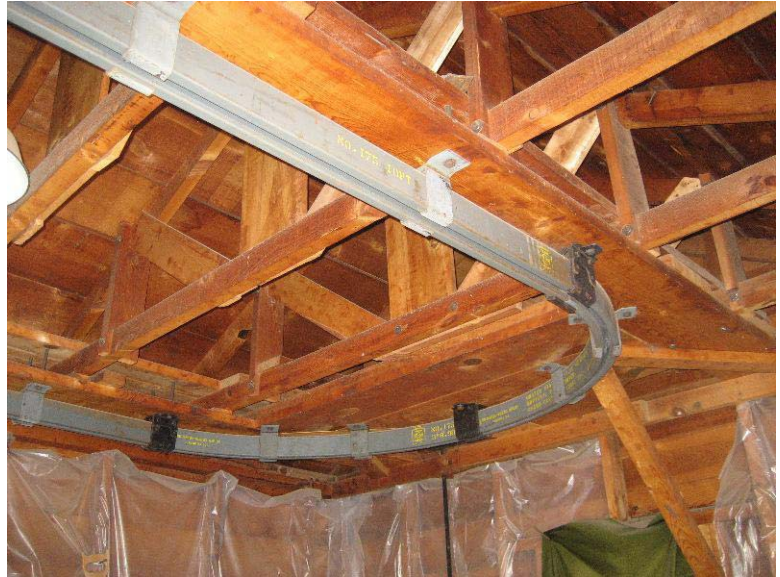
Interior Roof Framing, Crane Support 0079-203

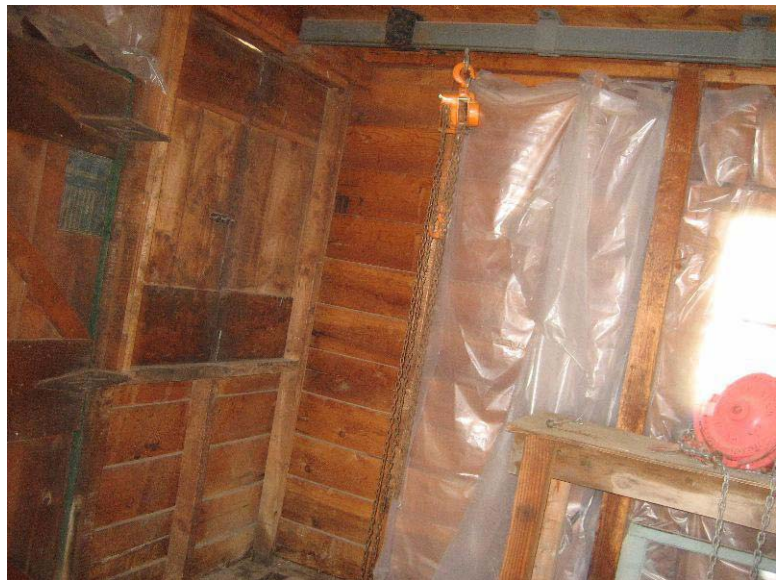
Northeast Corner, Interior Wall Construction 0079-204

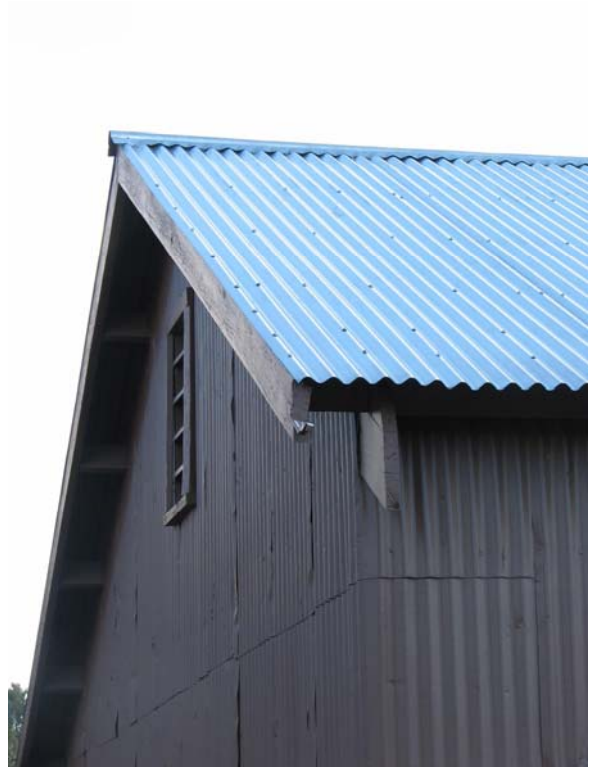
Roof @ Northeast Corner 0080-105

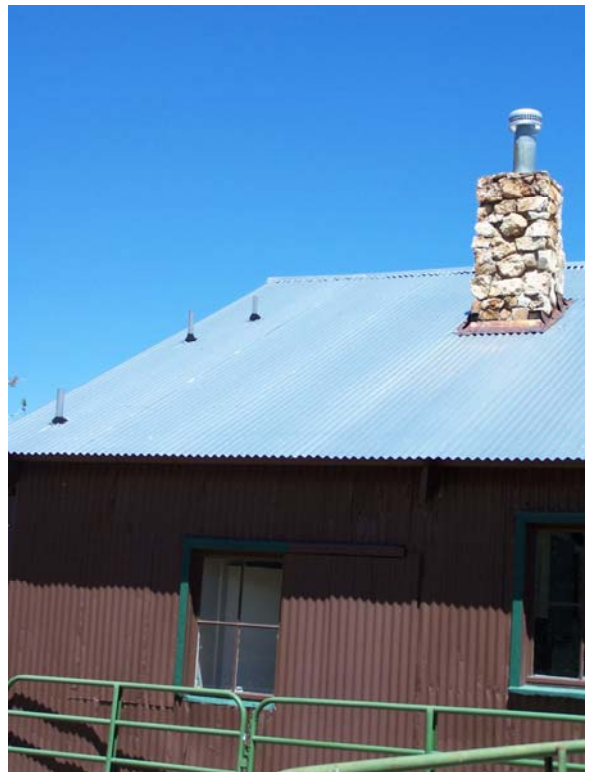
The roofing consists of corrugated, galvanized sheet metal on 2x6 purlins at 32" o.c. (An historic photo of the building indicates similar roofing, with a panel lap midway down the slope of the roof. This has obviously been replaced with panels that continue from the ridge to the eave.) The roofing has a formed, round over cap flashing and no gutter or downspouts. There are false rafter tails at the north and south overhangs. The roofing is attached with neoprene gasketed roofing screws at 8-10" o.c.

Corrugated, Galvanized Steel Sheet Metal Roofing 0080-106

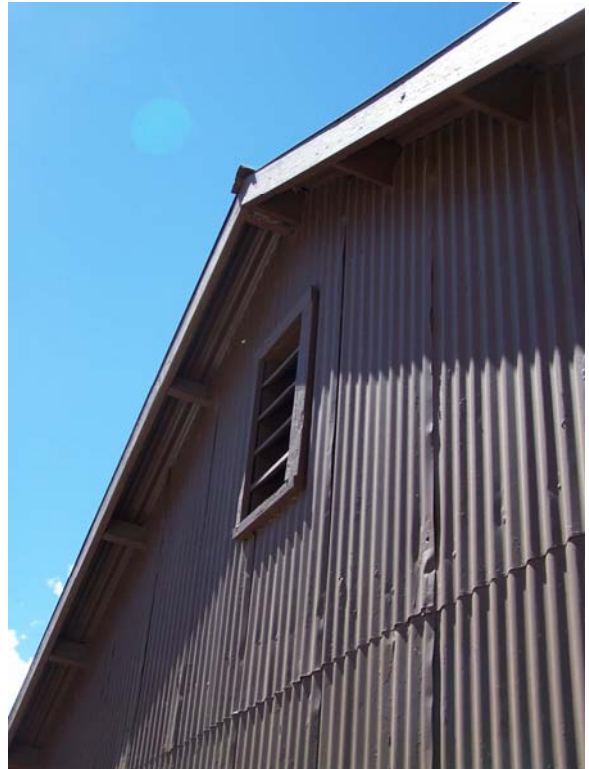
The overhangs are in good condition.

Shallow Roof Overhang 0080-107

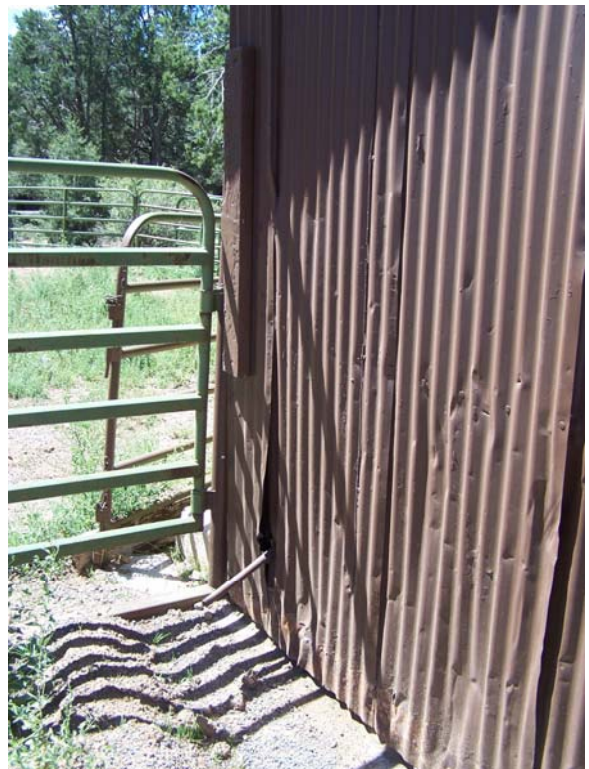
The exterior wall finish is vertically-installed corrugated, galvanized sheet metal attached to wood blocking in the wood frame walls. Similar siding appears in an historic photo of the building. The sheet metal is attached with roofing nails and extends to the underside of the roofing. The siding is cut to fit around purlins, rafters and door and window frames. Flashing is installed under the siding and over the window head at the east and west ends. The siding extends down to the top of the concrete ledge on the east side of the building, over the concrete foundation on the north and over the stone foundation on the west and south sides. All of the siding is painted brown. There is no evidence of insulation in the exterior walls.

The Park Service Vehicle Paint Shop is in fair condition with the exception of a few items. The exterior metal siding is in bent and dented. The windows have some minor deterioration specifically at glazing putty.

Corrugated, Galvanized Sheet Metal Siding 0080-108

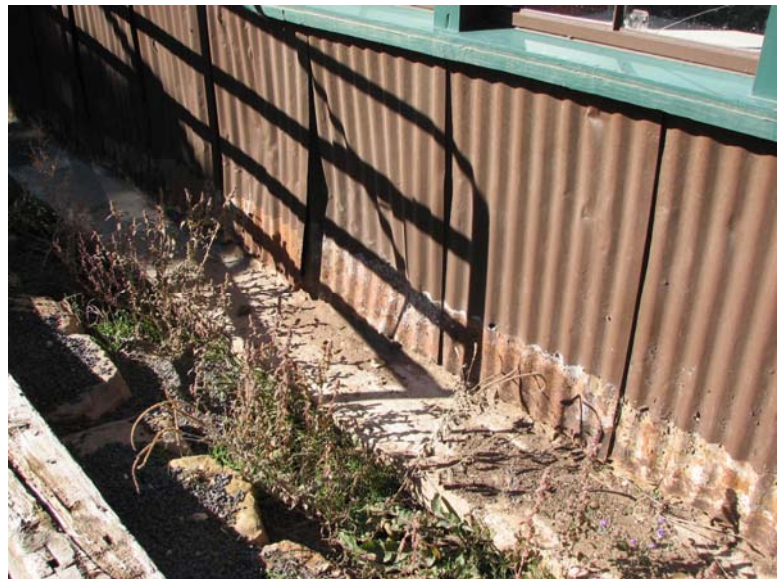
The foundation on the east side consists of a concrete ledge at the south end and appears to be cementitious parging over stone at the north end. There is a concrete foundation along the north wall. The east and south foundations are mortared rubble stone.

Foundation 0080-112

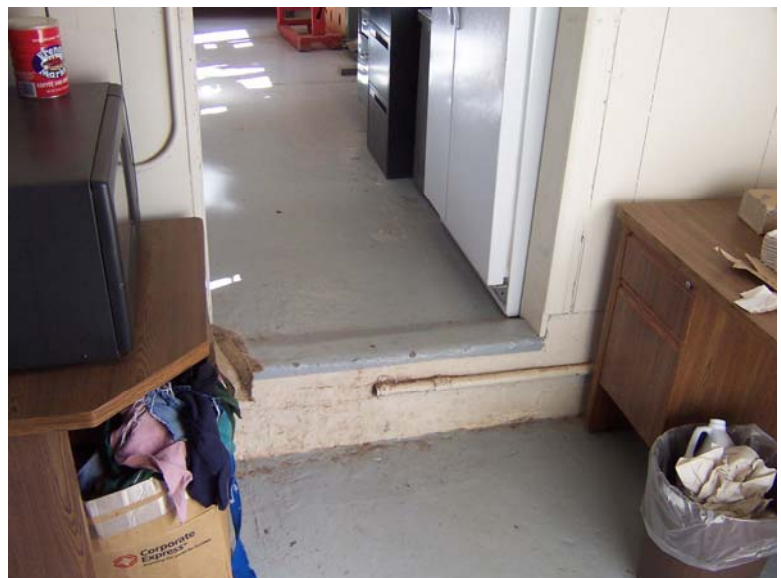
Step and Curb at Entry to Southwest Room 0080-205

The 3/4" curb should be ground off to a level condition. A wood riser should be added to the south stair and both should be retrofit with at least one handrail.

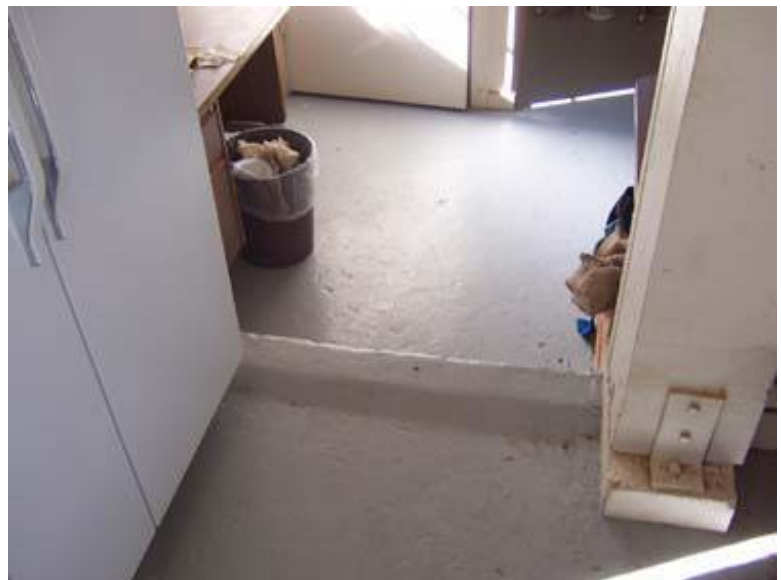
Floor Level Drop 0080-215

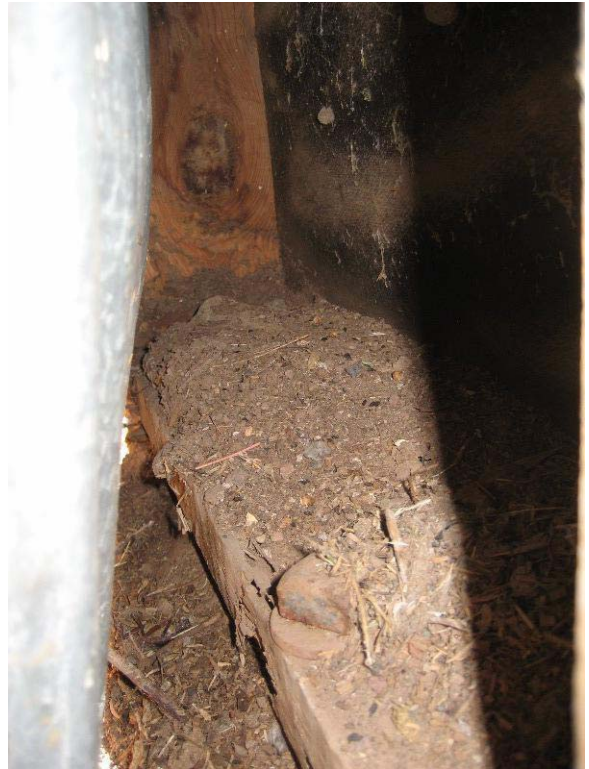
East Wall: Deteriorated Sill and Stud 0080-224

The east wall should be investigated further for extent of structural damage. Replacement of the siding, sill plate, anchor bolts, and sistering of the studs should be anticipated.

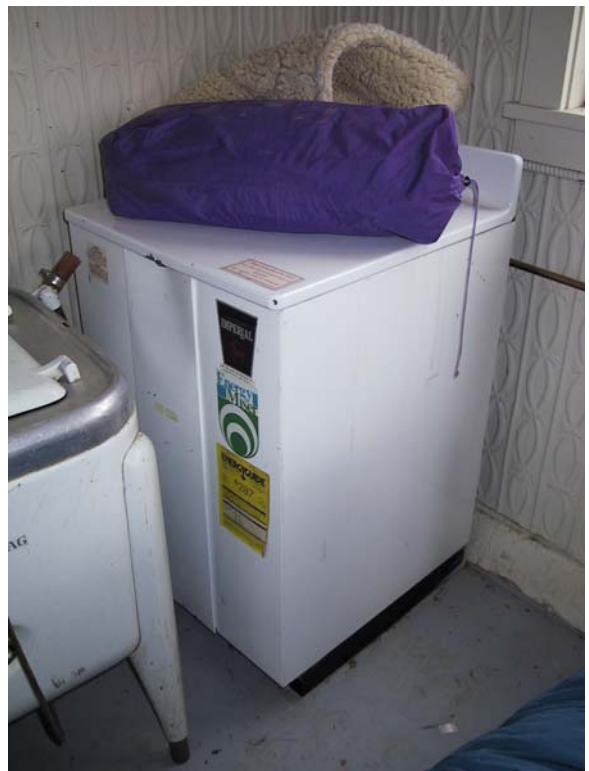
Electric Water Heater 0080-227

The water heater, although it appears to be undersized for its current function, is in working order and does not necessarily need to be replaced. Should the water heater fail, a calculation should be performed to confirm that the replacement water heater is appropriately sized to provide the volume and temperature of water required by the washing machine.

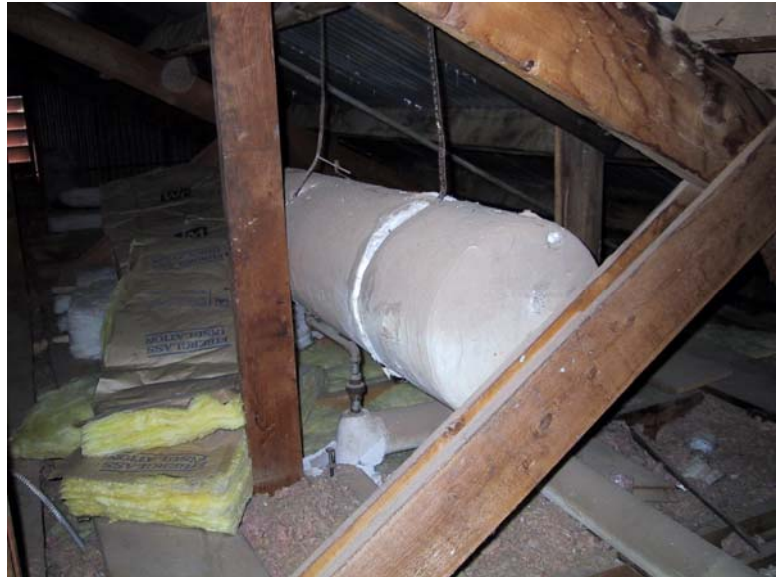
Abandoned Tank in Attic 0080-234

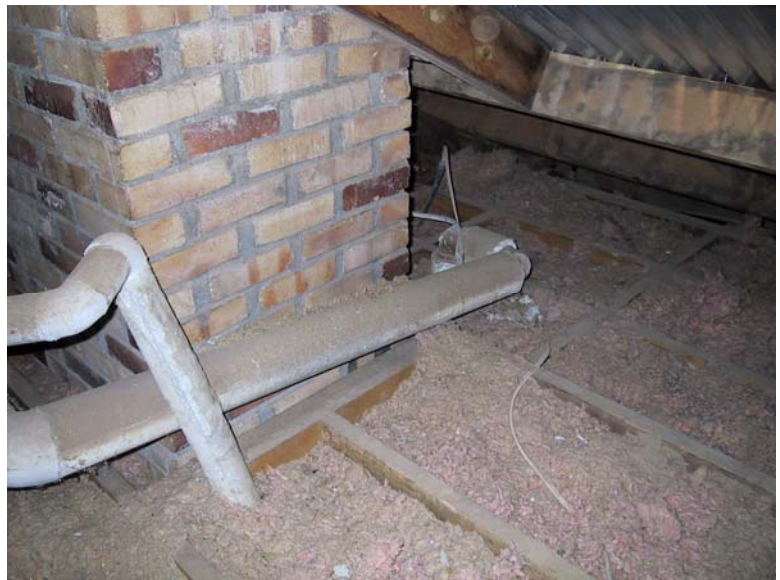
Abandoned Steam Piping in Attic 0080-237

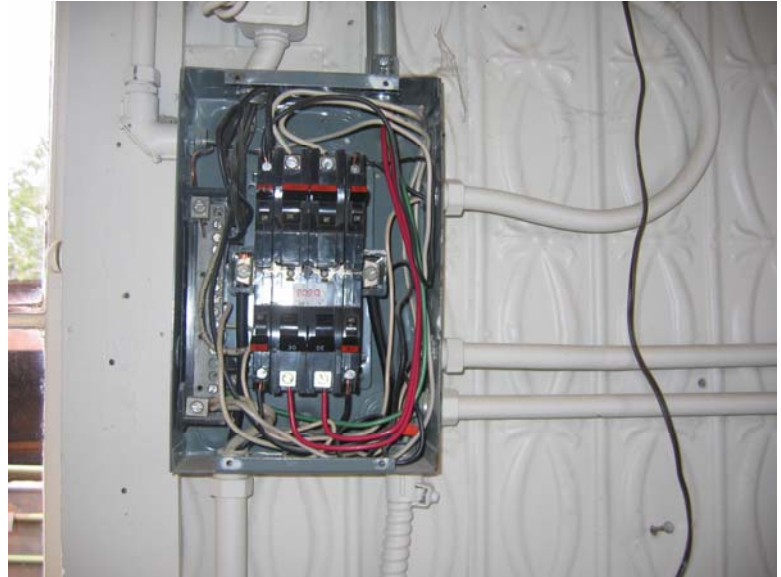
Panel 0080-238

Replace the existing electrical service panel with a panel with a main circuit breaker and with enough circuit breakers to terminate each branch circuit with a dedicated circuit breaker. Replace the obsolete wiring insulation type and correct the branch circuit color indication for the current conductors.

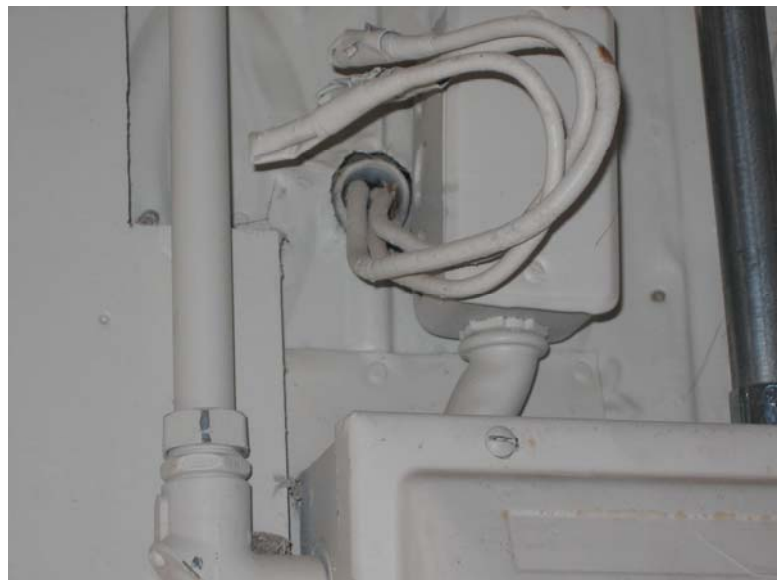
Abandoned Electrical Service 0080-239
