Historic Maintenance and Warehouse Complex

Historic Structure Report for 11 Buildings

Grand Canyon South Rim Historic Maintenance and Warehouse Complex

February 1, 2008

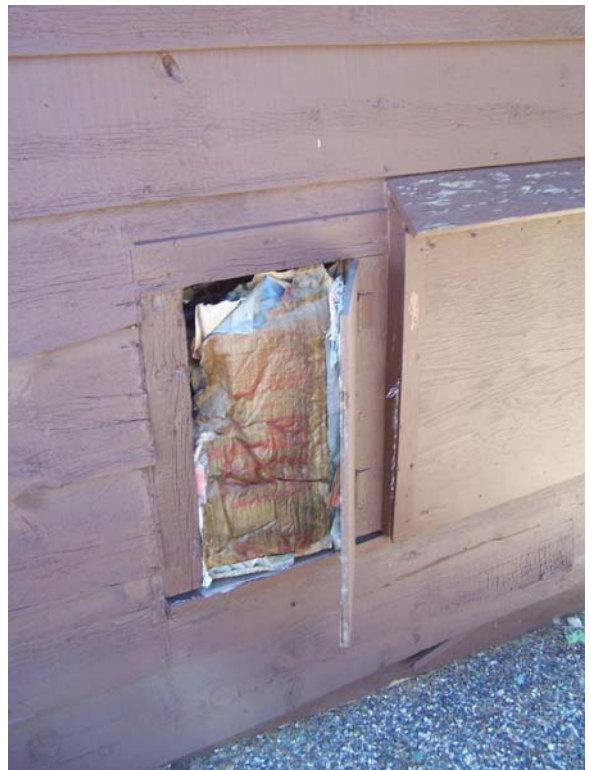
Insulated Plywood Panel on the Southwest Corner 0087-108

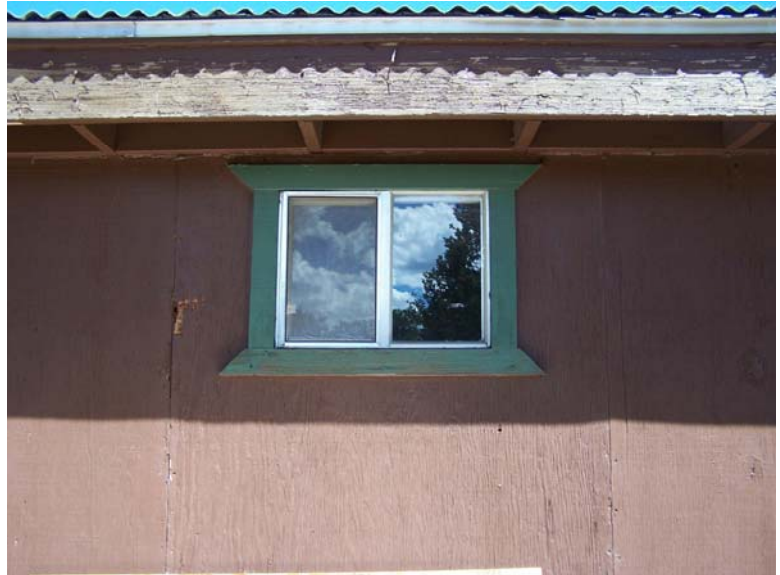
Plywood Siding on South Elevation 0087-109

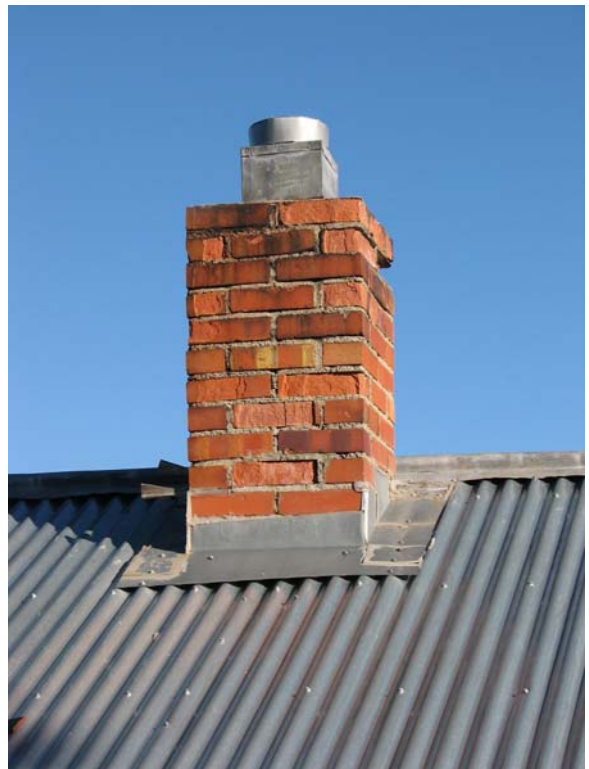
The Park Service Jail is in fair condition with the exception of a few items. The masonry chimney is in poor condition in which several brick faces are spalling and mortar joints have deteriorated. Some deterioration is evident at the east and west elevations with regard to the wood lap siding. The foundation is in good condition.

16"x16" Brick Chimney 0087-110

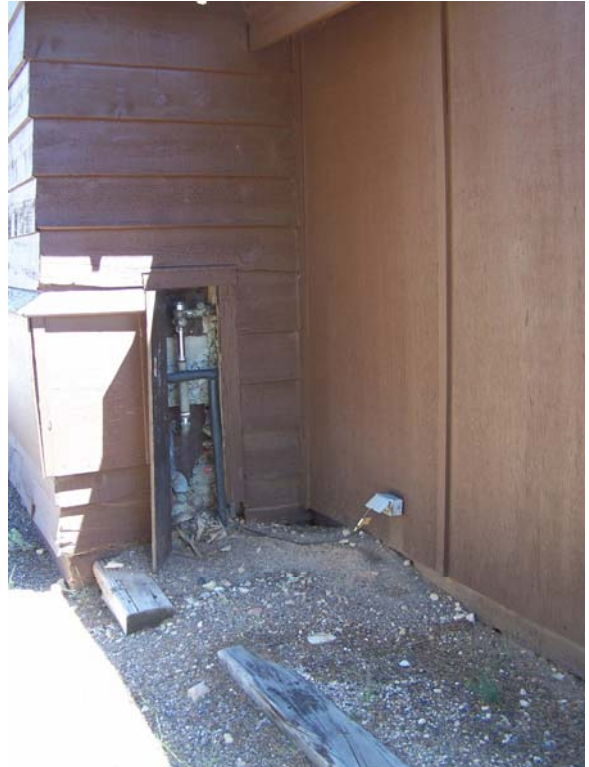
The foundation for the building is concrete. On the original building the foundation is exposed on the west side and there is a gap on the southeast corner where the foundation can not be verified. The foundation on the addition appears to be a slab on grade with no actual "foundation" under it. There are holes under the slab on all three sides that appear to have been made by burrowing animals.

Exposed Foundation on the West Side 0087-111

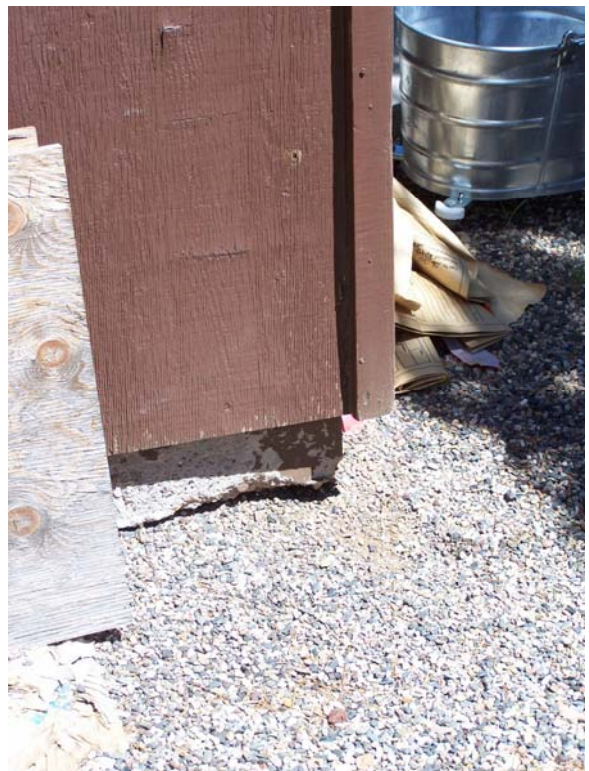
Foundation at Southeast Corner of Jail Cell 0087-112

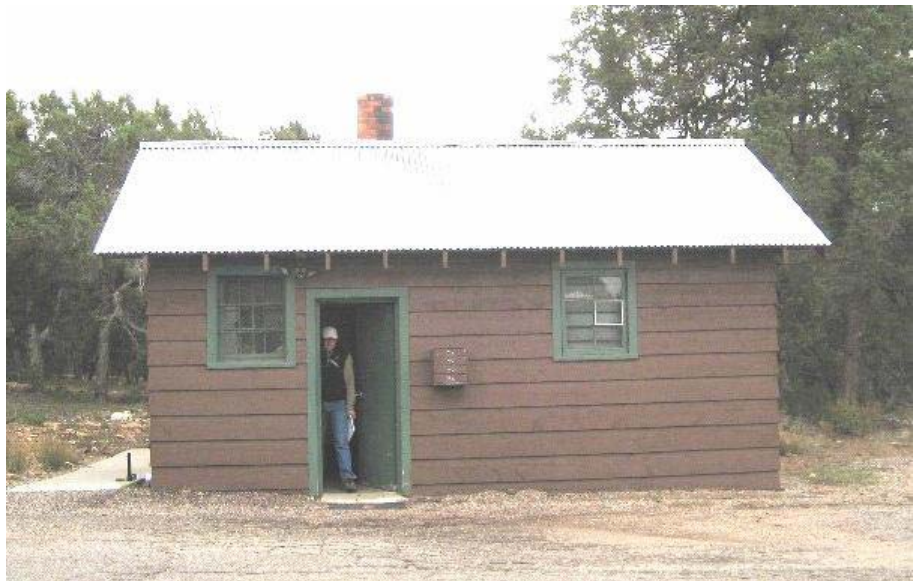
North Elevation: Note Height of Soil on East 0087-124

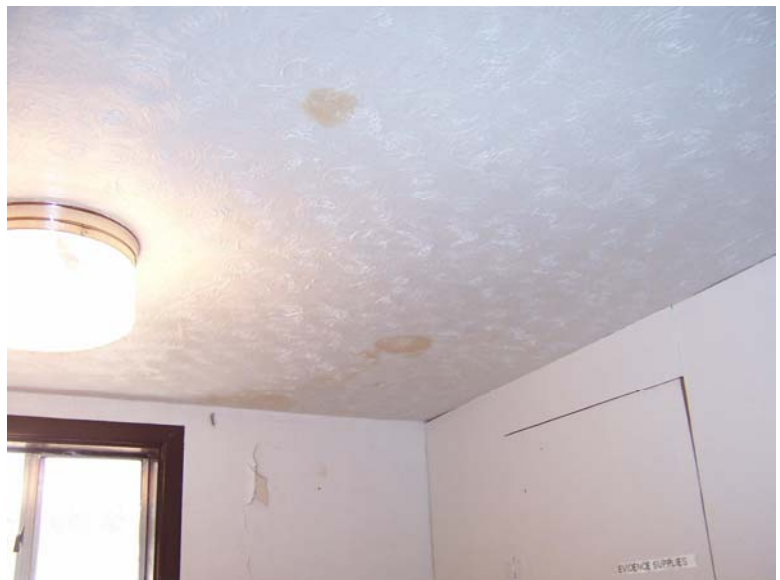
Textured Gypsum Board Ceiling and Wall 0087-209

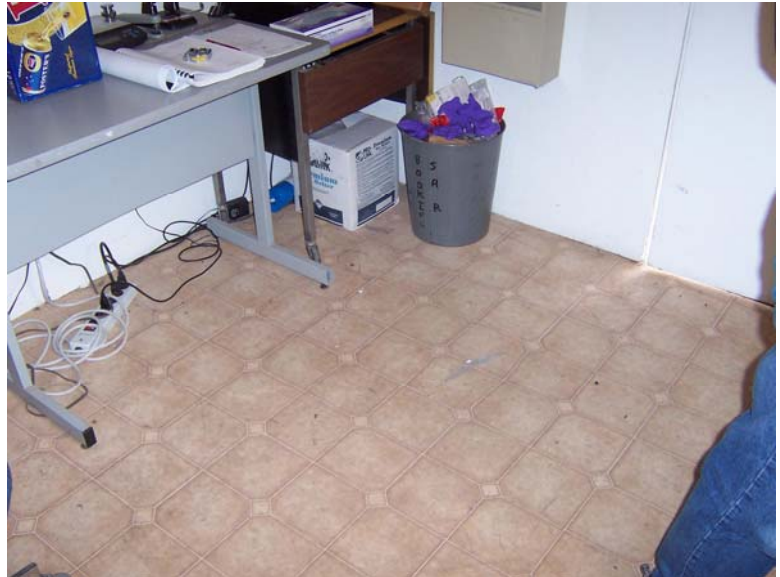
Resilient Sheet Flooring 0087-210

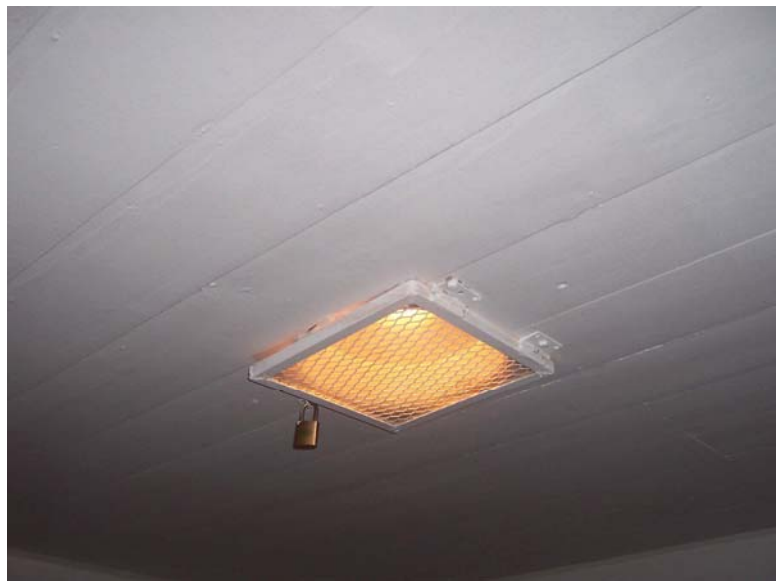
Board-Formed Concrete Ceiling 0087-211

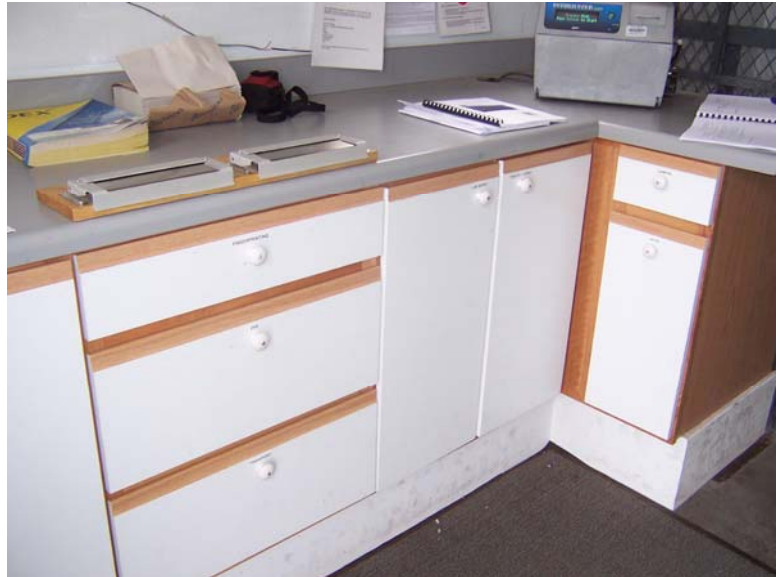
Modern Cabinets 0087-212

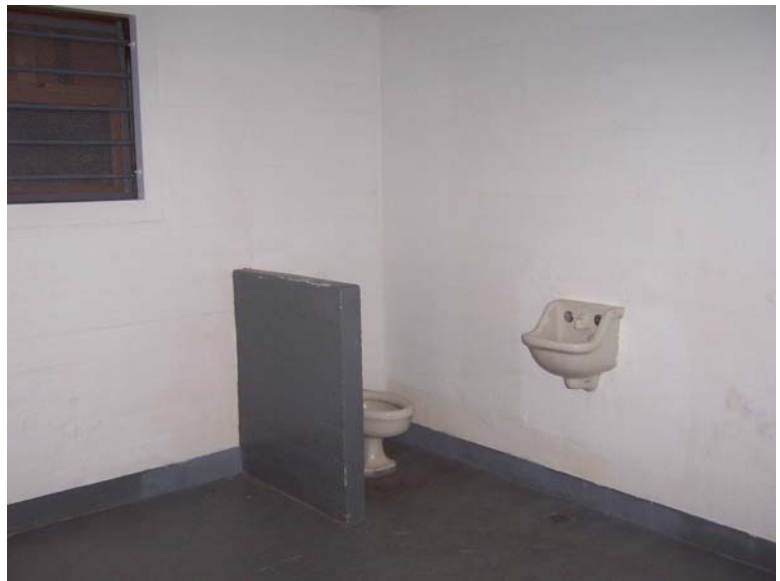
Painted Concrete Floor 0087-213

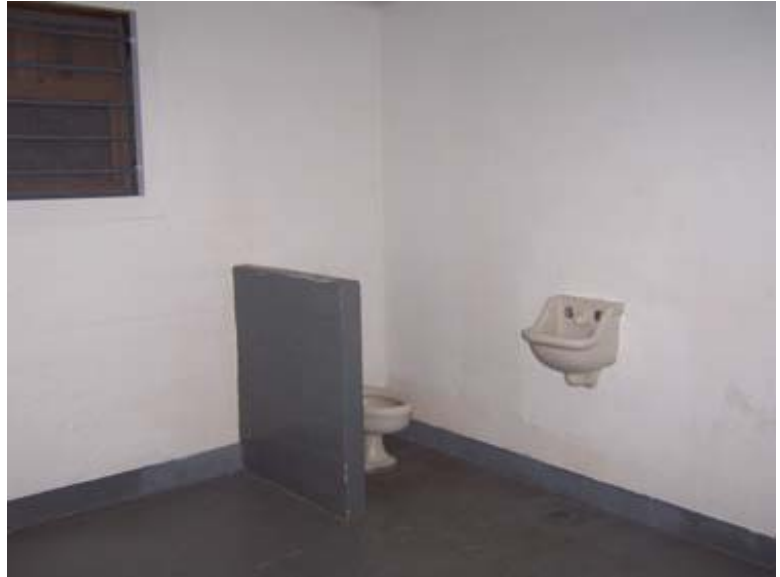
Cell Fixtures 0087-214

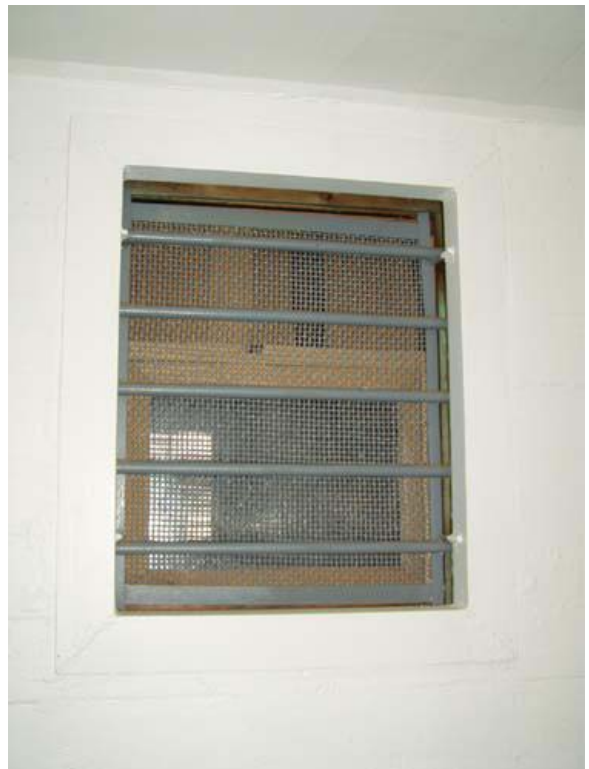
Interior Window 0087-215

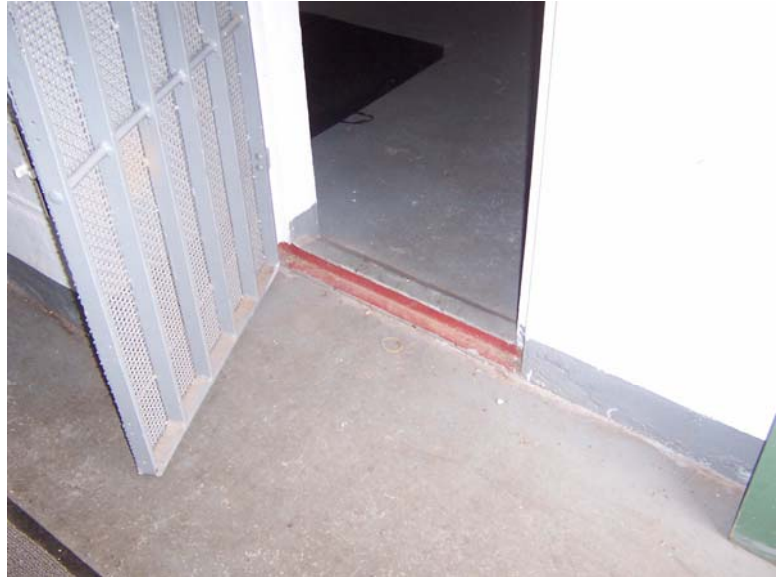
Cell Door 0087-216

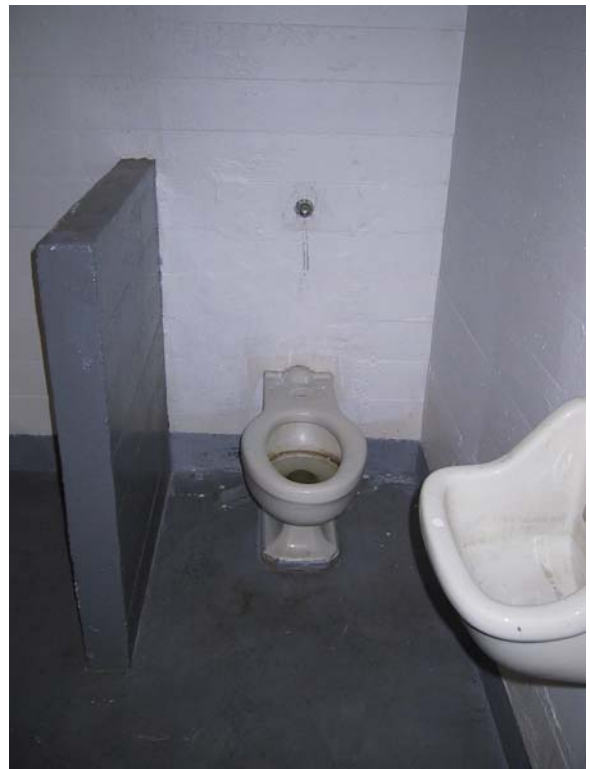
Water Closet 0087-217

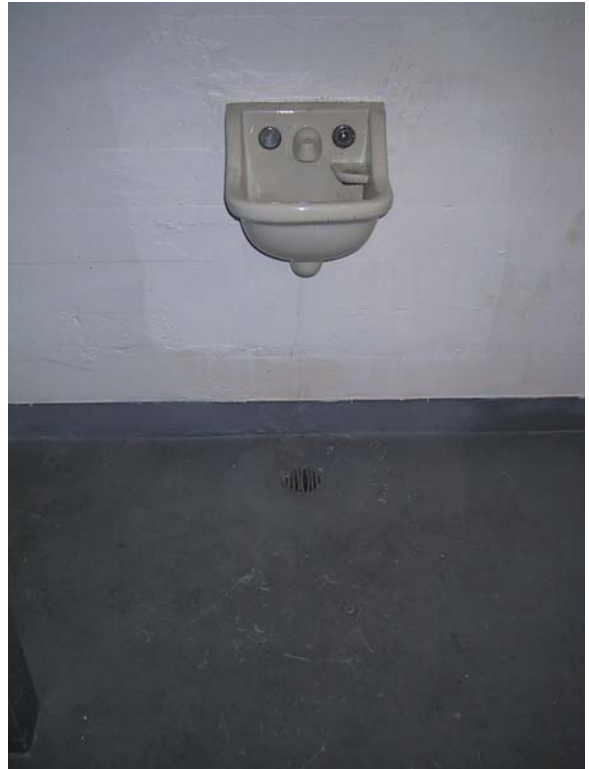
Wall-hung Lavatory 0087-217

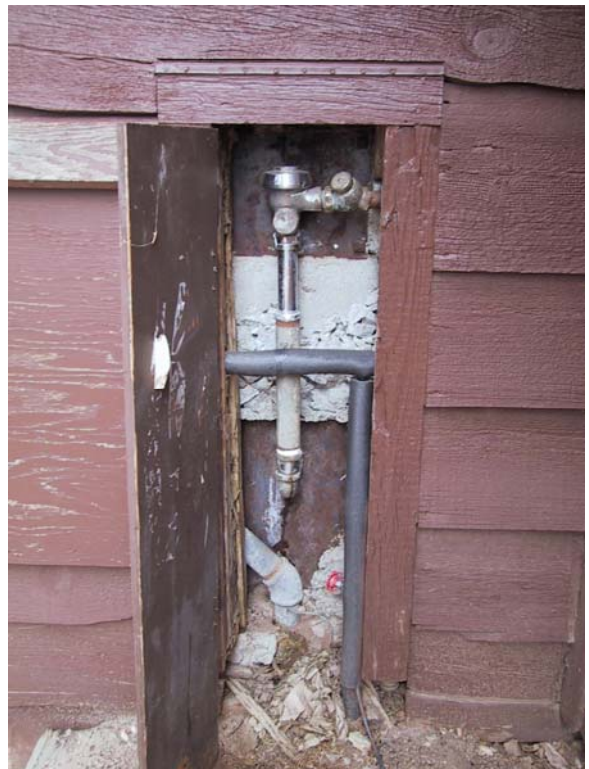
Water Connection to Water Closet 0087-219

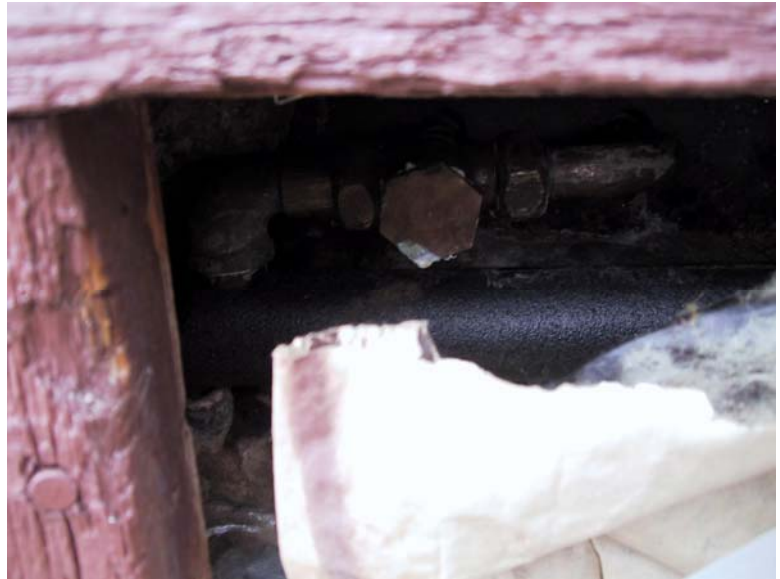
Water Connection to Lavatory 0087-220

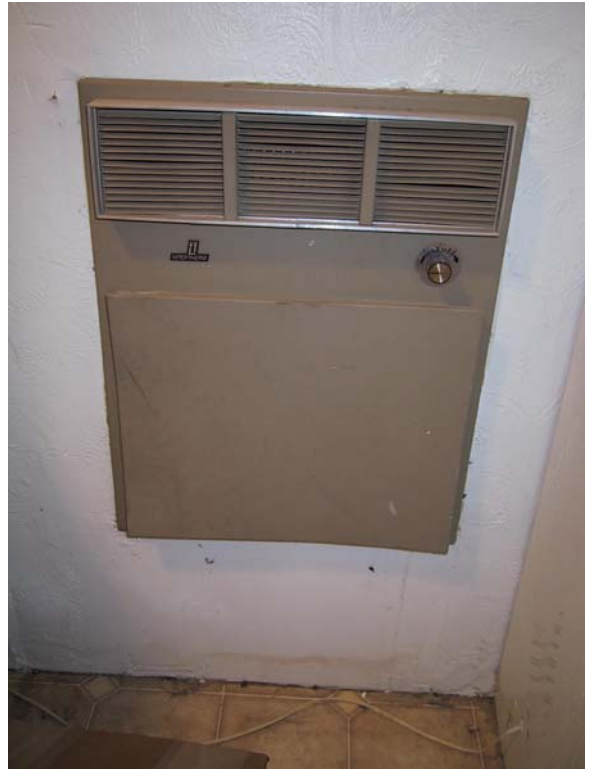
Unit Heater in South Addition 0087-222

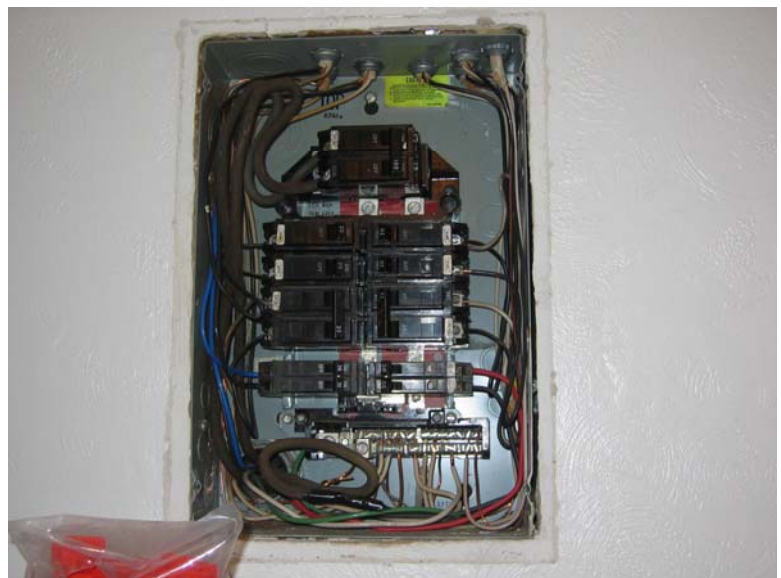
Interior Panel 0087-223

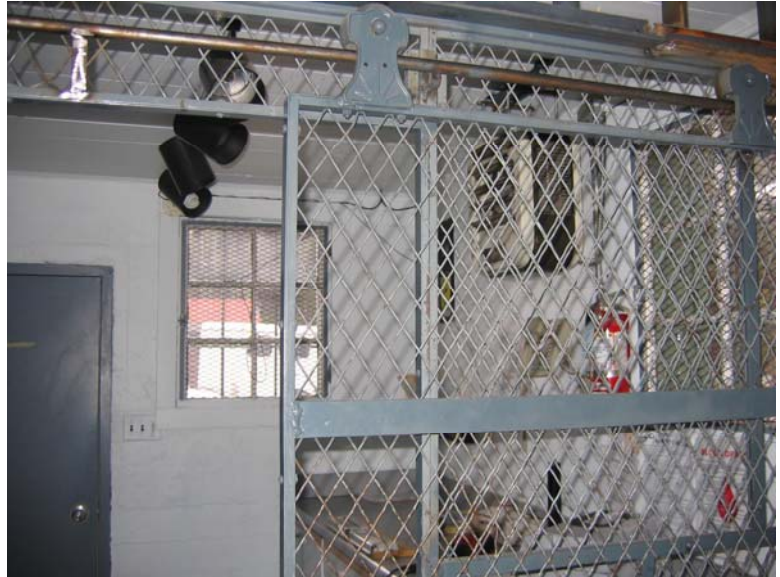
Surface-mounted Track Lighting 0087-224

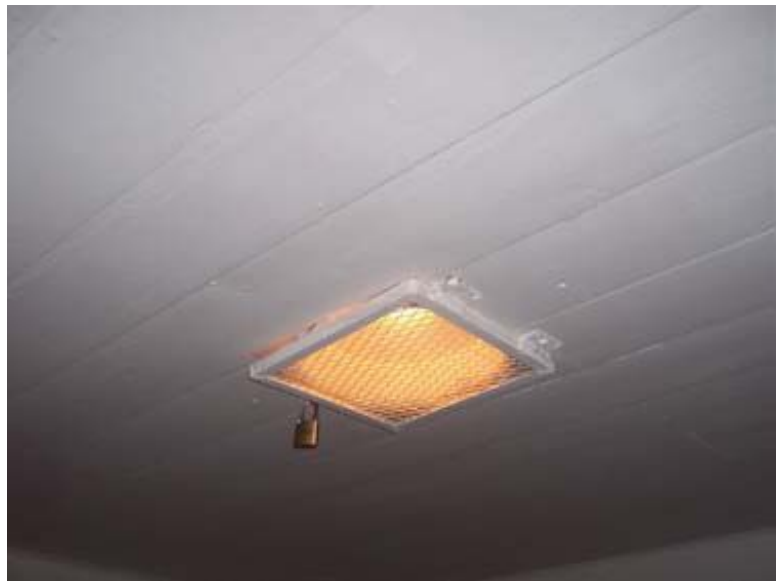
Incandescent Fixture with Grate 0087-225

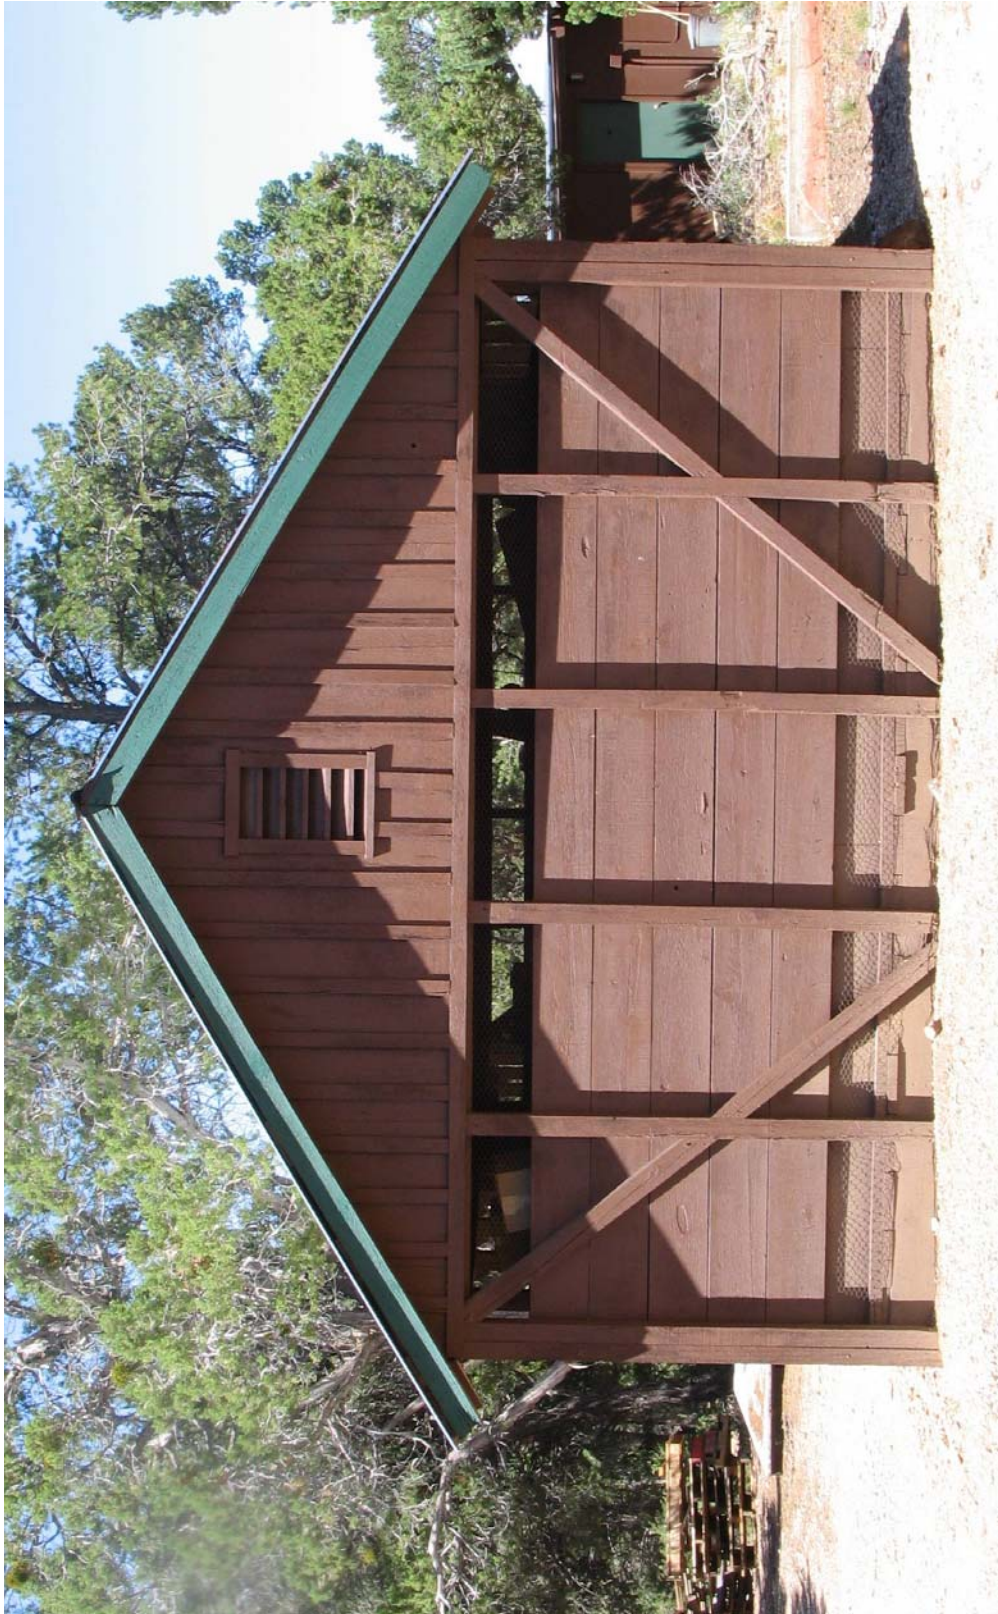
The board and batten siding in the gable ends is in good to fair condition. Some of the battens and a few of the boards are split or cracked but nothing is broken or missing. There is evidence of some woodpecker activity on the west end.

West Elevation Bldg 0088 – 2006

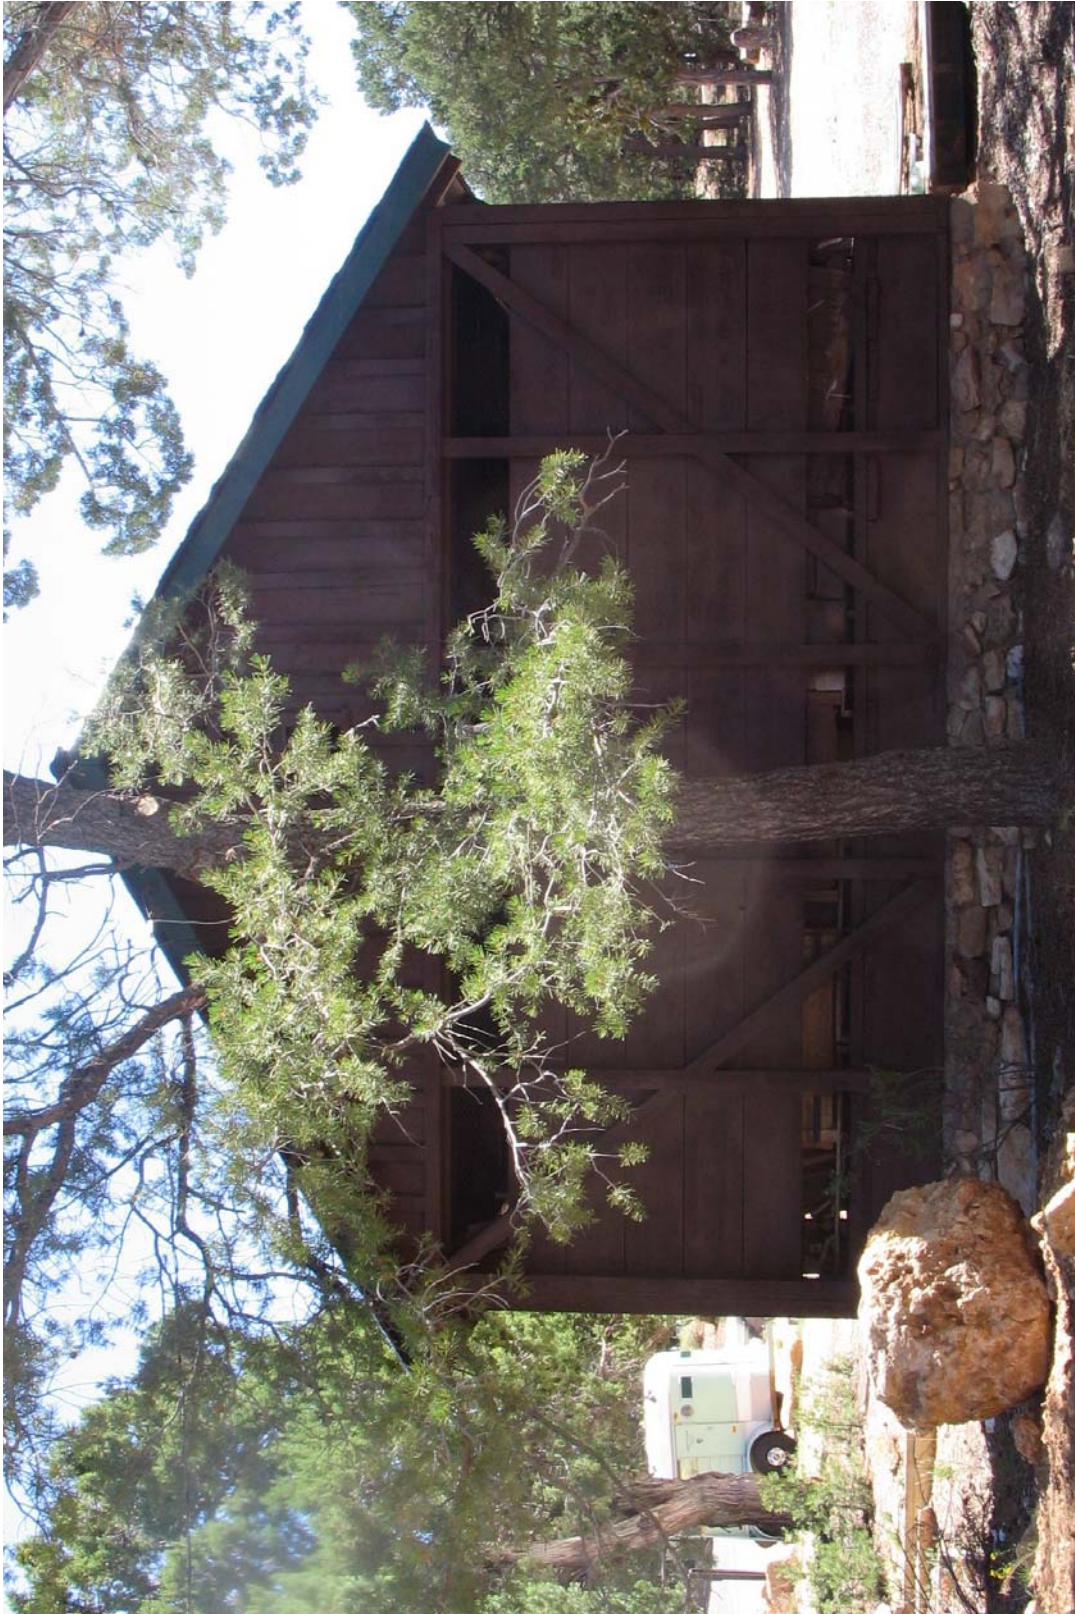
The exposed structure itself is in good condition. The exposed floor structure at the east end of the building is in poor condition as it is exposed to or under grade and has rotted away in several instances. All structure and wood blocking exposed to the dirt is rotting and decomposing or simply non-existent. The horizontal wood planking is in good condition with acceptable gaps between the planks and very few holes.

East Elevation Bldg 0088 – 2006

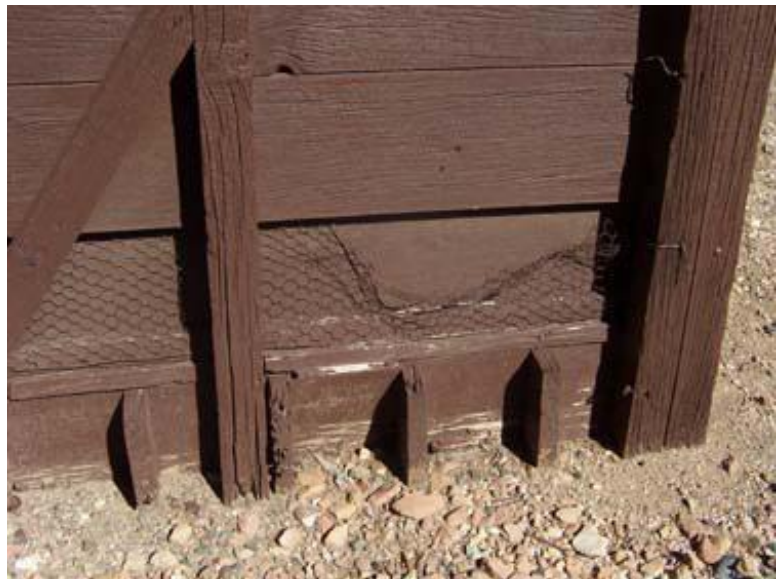
Plywood Over Chicken Wire at the Base of the Wall 0088-113

No work is recommended for the chicken wire. The lower chicken wire no longer serves a purpose, and could be abandoned in situ or removed.

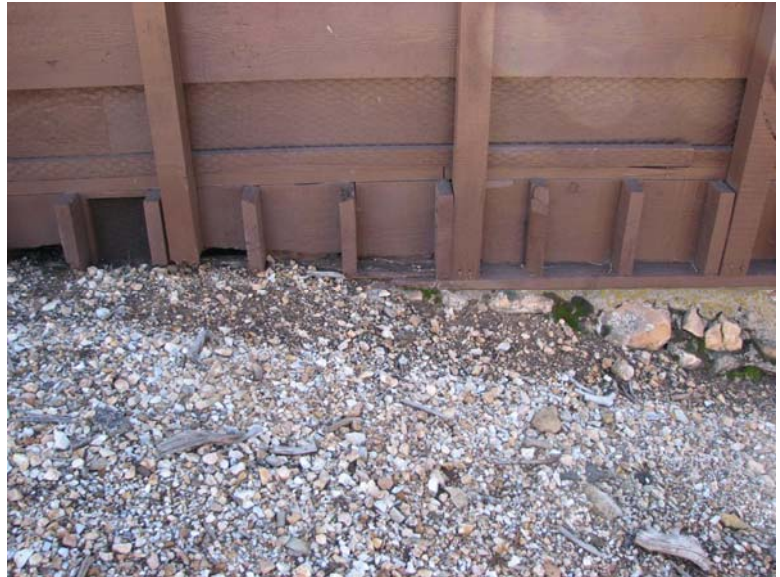
Structure Below Grade on the East End 0088-116

Excavate the east end of the building to expose the foundation. Once the foundation is exposed, the condition of the foundation should be evaluated to determine the condition and any treatment necessary. Loose mortar should be removed from the exposed stone foundation. Missing stones should be replaced and holes and voids filled. Mortar joints should be re-pointed throughout.

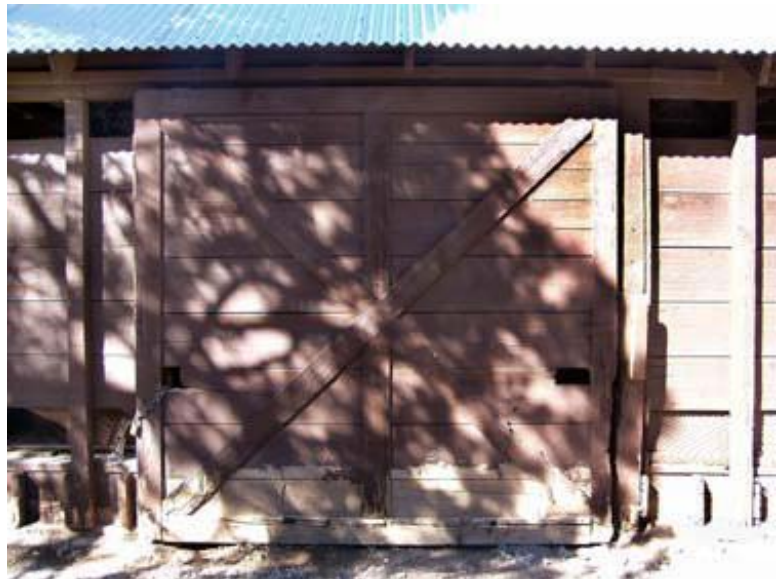
Exterior Door (A) 0088-117

Replace boards where large portions are missing, and paint to match existing. Rebalance the door to facilitate smooth operation. The hardware should be cleaned and oiled. Care should be taken when repainting not to paint the hardware again.

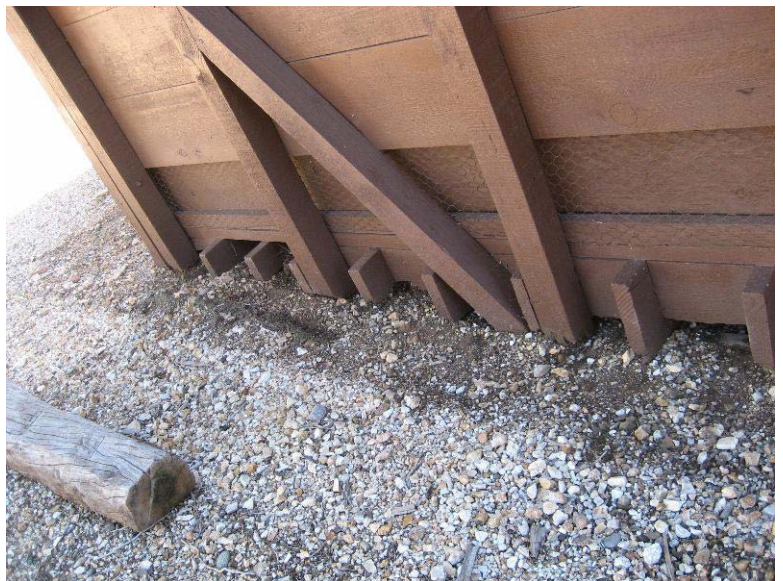
Southeast Corner: Framing Rotted by Soil Contact 0088-121

Excavate the east end of the building to expose the foundation. Rotten or deteriorated wood framing members on both the wall and floor should be replaced with new material to match the original. The sill plate on the east end of the north and south walls, as well as the east wall itself, all need to be replaced with pressure treated lumber. The east-most floor joist should also be replaced. 4x4 posts and bottom diagonal braces need to be replaced on the east wall as well as at the east end of the north and south walls.

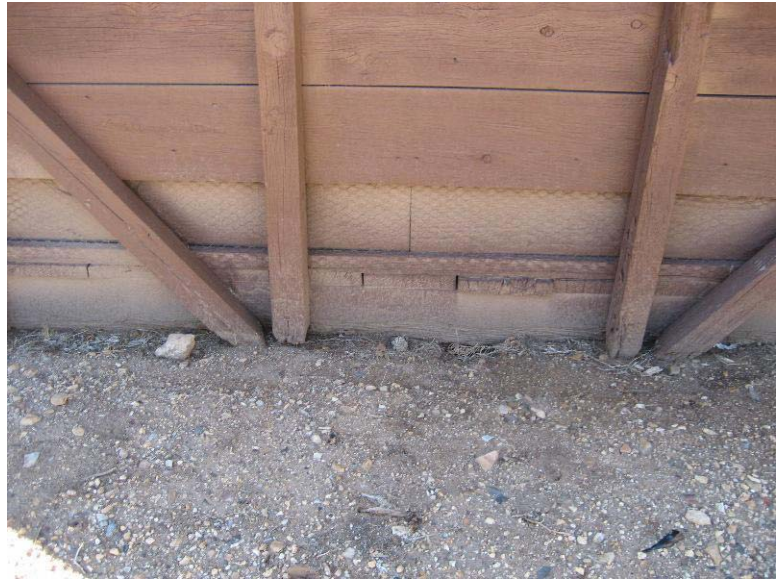
East Wall: Framing Rotted by Soil Contact 0088-122

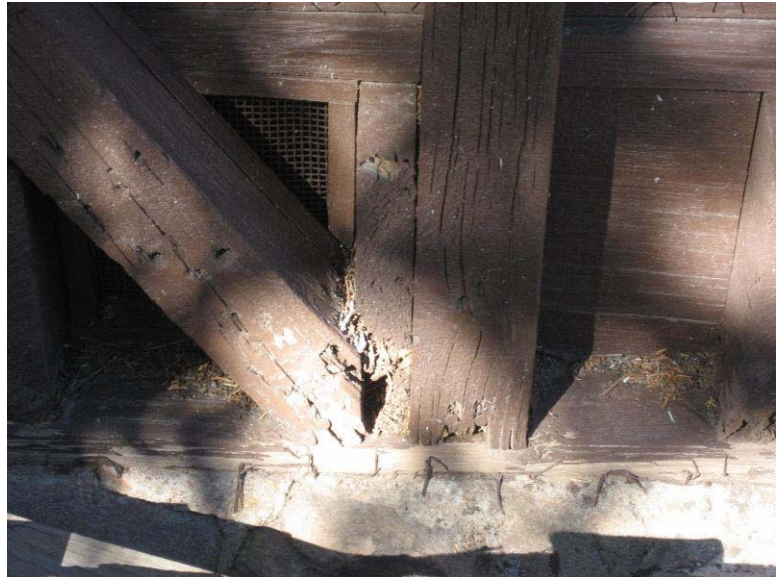
North wall: Brace and Post Rotted 0088-124

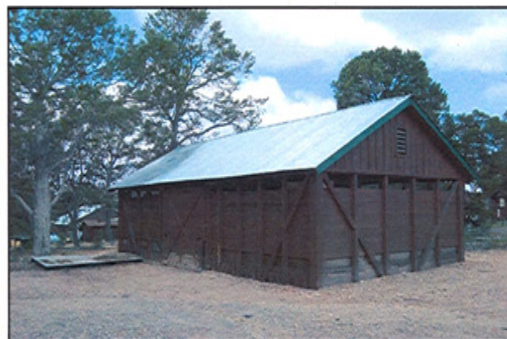
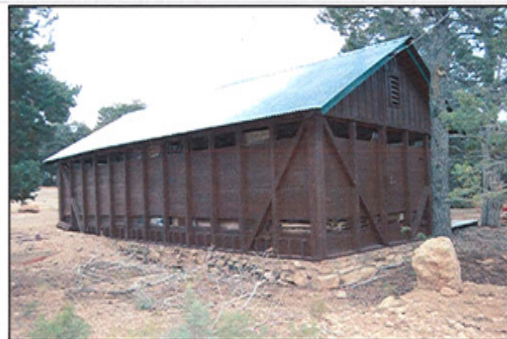
SRB0088, Coal
Shed

Long Management Text: E. elev. deteriorating wood framing at top of stone foundation. Repair framing and move soil away from foundaiton to create positive drainage away from wood framing. (07/2006)

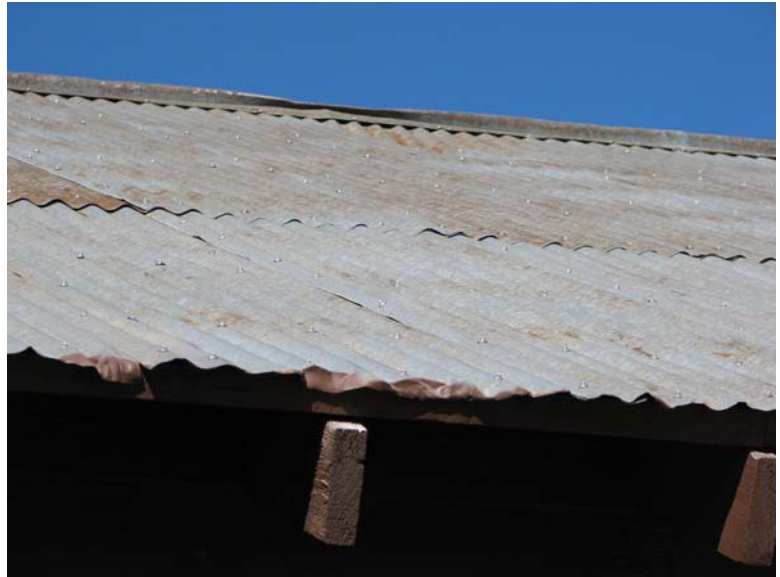
Corrugated, Galvanized Sheet Metal Roof 0090 - 105

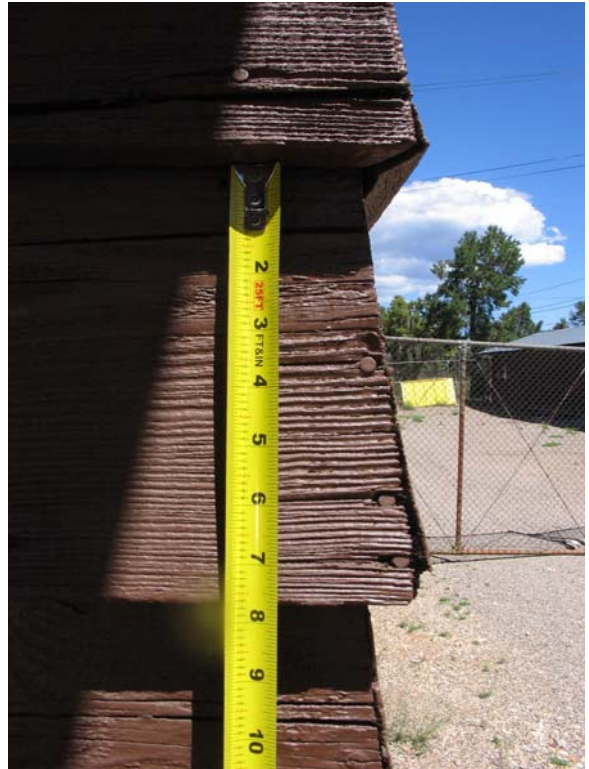
The siding (up to the start of the gable and including skirt boards above the foundation) consists of 1x10 lap siding with an 8" exposure. All the corners are mitered. There is a flat 2x "water table" at the level of the interior floor, the top of which is sloped to provide drainage.

1x10 Lap Siding with Mitered Corners 0090 - 112

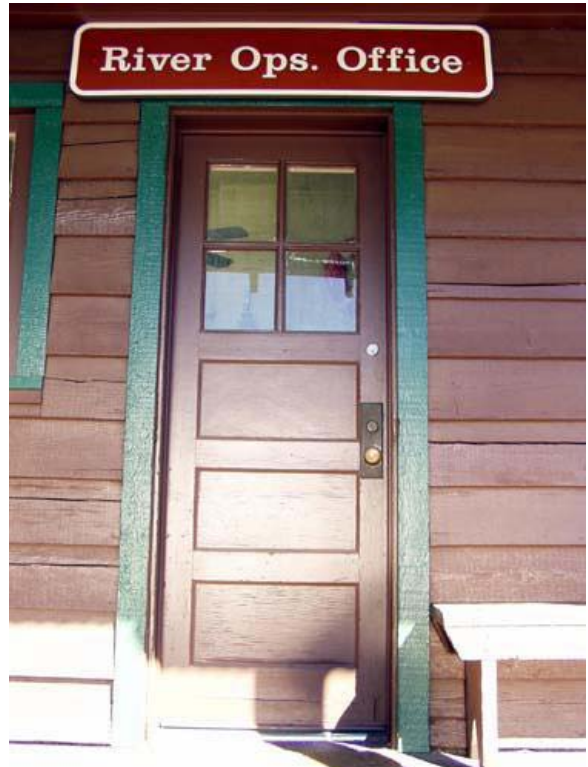
Exterior Door (A) 0090 - 128

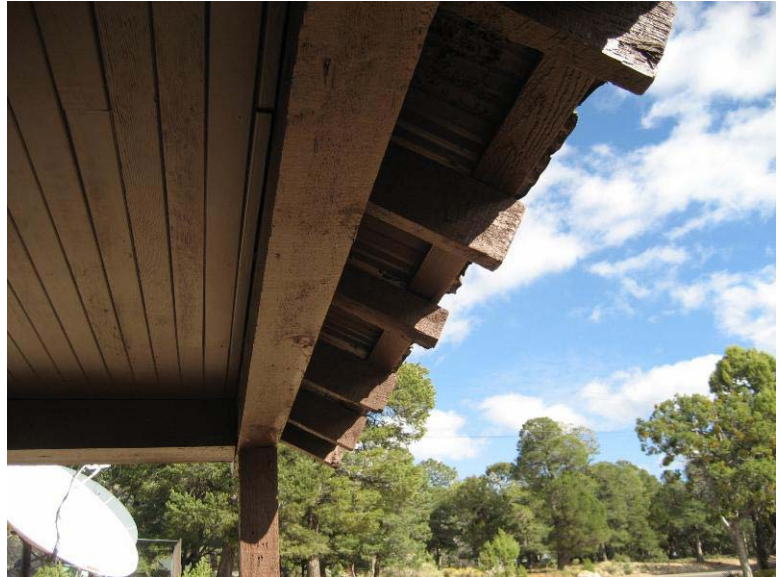
Exterior Girder at South Porch 0090 - 137

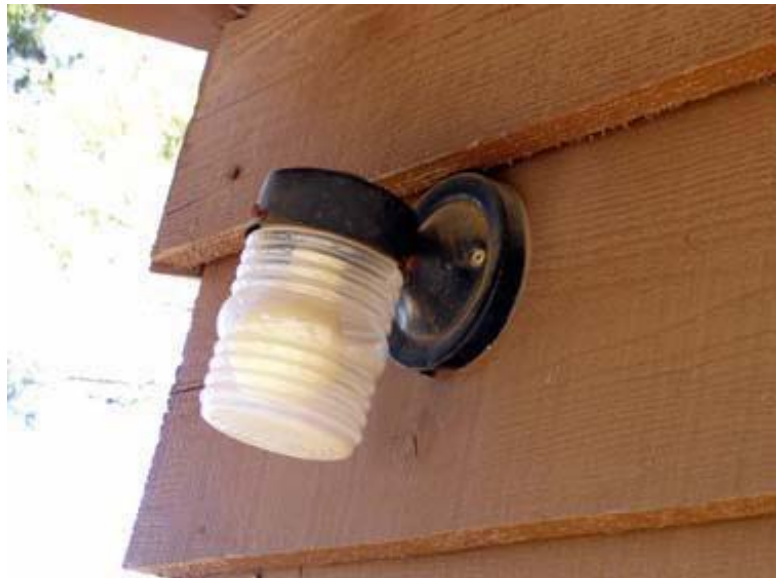
"Jelly Jar" Sconce 0090 - 142

Replace exterior light fixture with a fixture that complies with the "Grand Canyon National Park Night Sky Protection and Exterior Lighting Policy" (01/04).

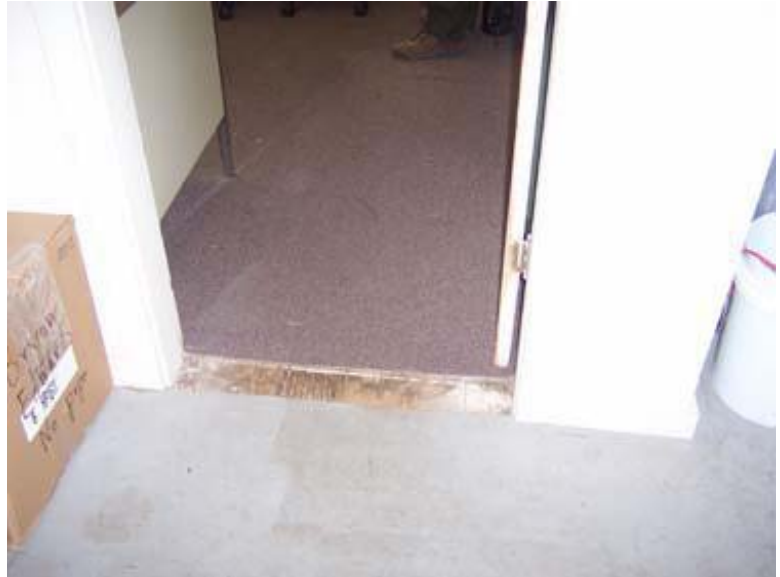
Carpet Over Wood Flooring 0090 - 214

The carpet edge should be finished with an edge strip. Otherwise, no work is recommended.

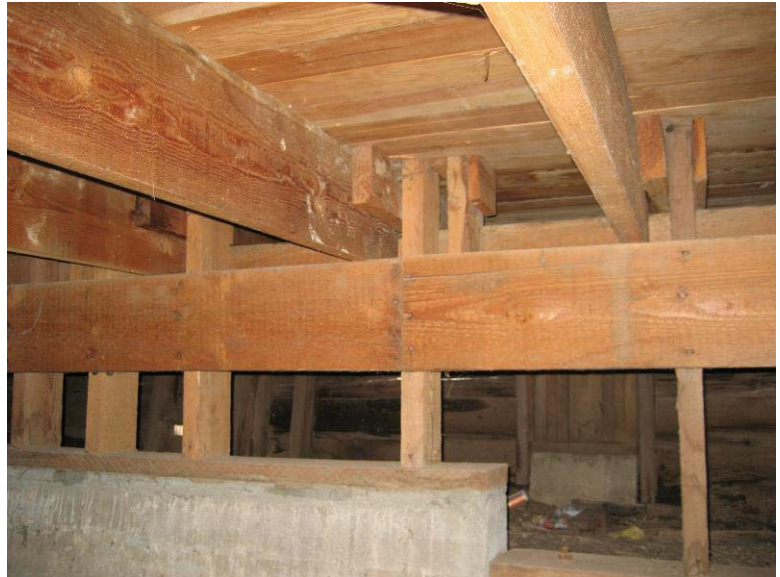
Wall Framing Below First Floor at South Exterior 0090 - 222

The south wall below the porch should be rebuilt on a properly constructed foundation. The south exterior wall should be sheathed or otherwise braced below the first floor.

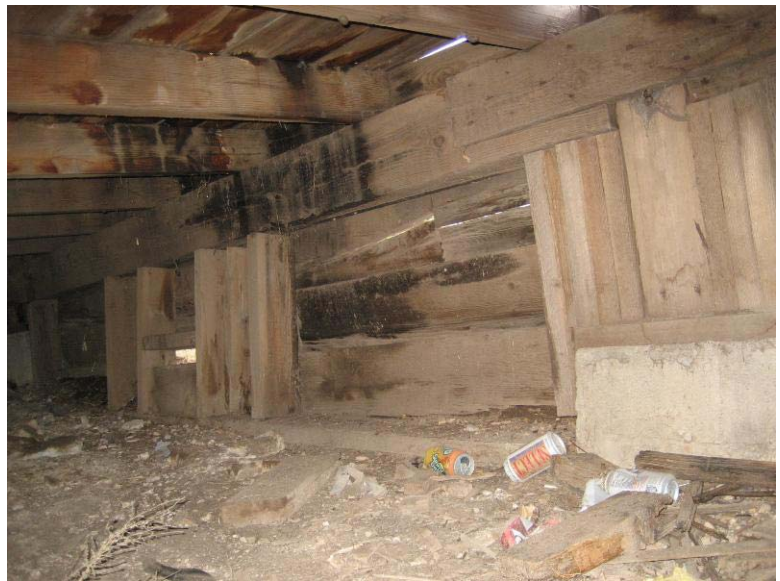
South Wall Under Porch 0090 - 227

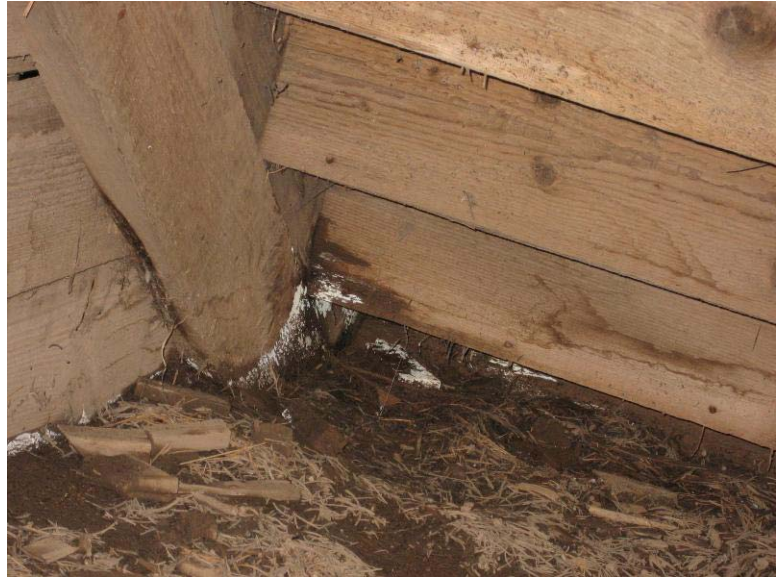
Rotting Stair Stringer at West End of Porch 0090 - 228

Porch joists, decking and stairs should be replaced or repaired where deteriorated.

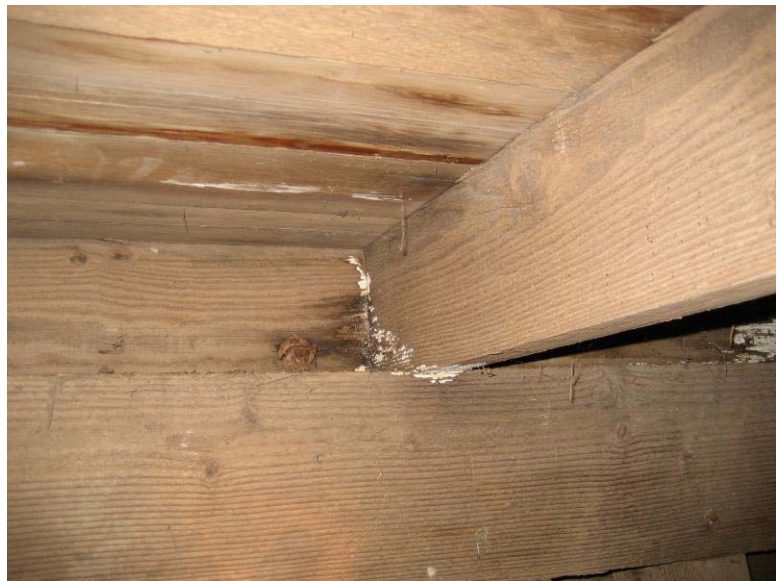
Rotting Porch Joist 0090 - 229

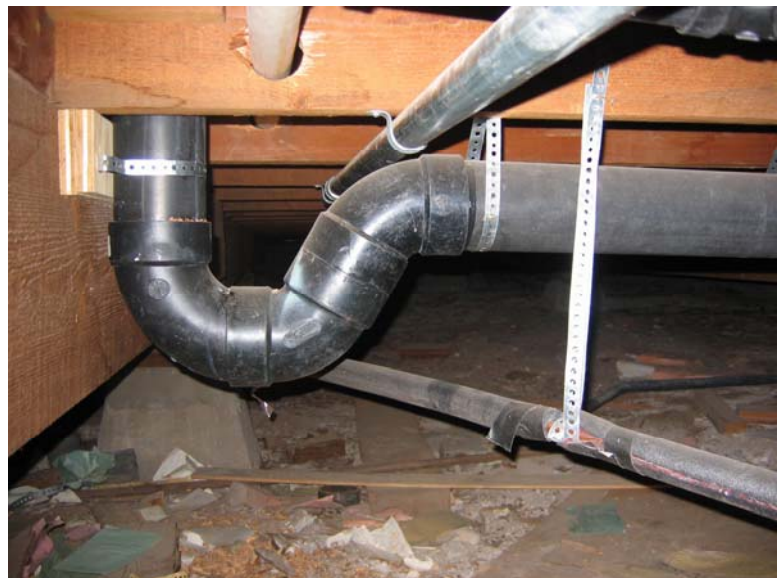
Waste Pipe at Ice Maker 0090 - 236
