Historic Maintenance and Warehouse Complex

Historic Structure Report for 11 Buildings

Grand Canyon South Rim Historic Maintenance and Warehouse Complex

February 1, 2008

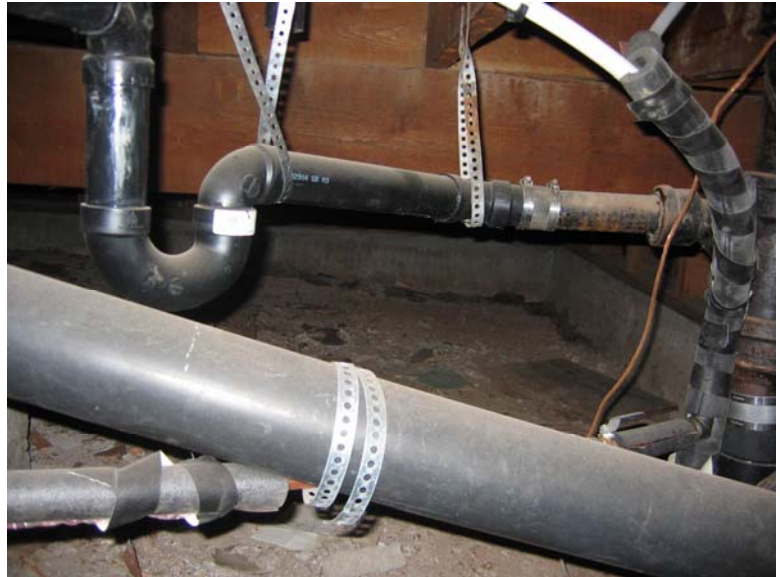
Waste Pipes at Restroom 0090 - 237

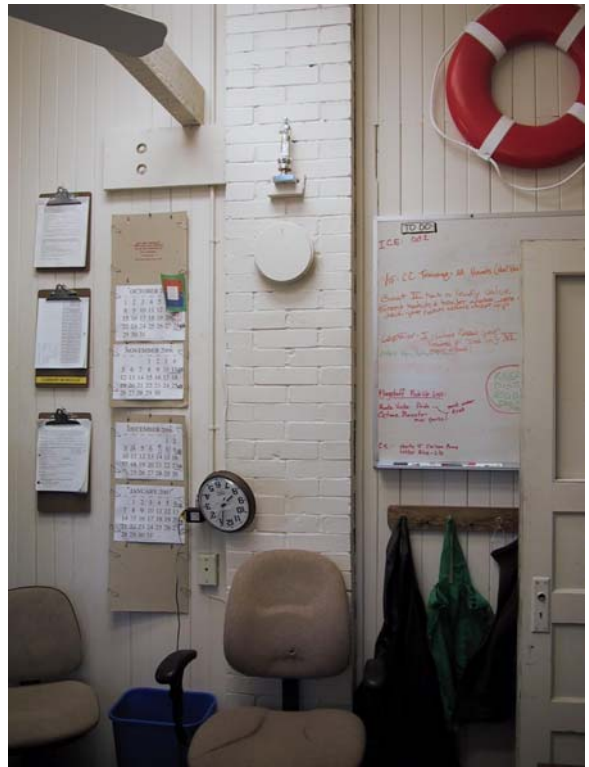
Original Brick Flue - North Wall Room 104 0090 - 242

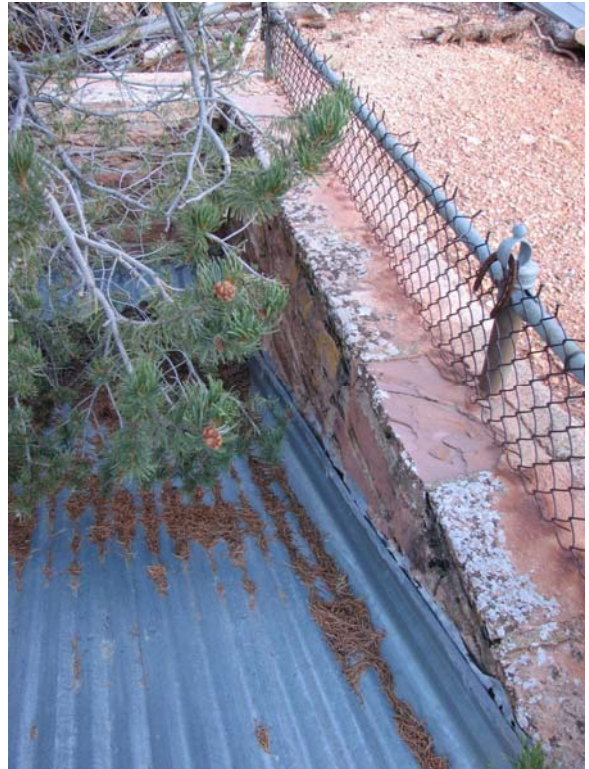
Roofing Attached to Stone Wall 0094 - 107

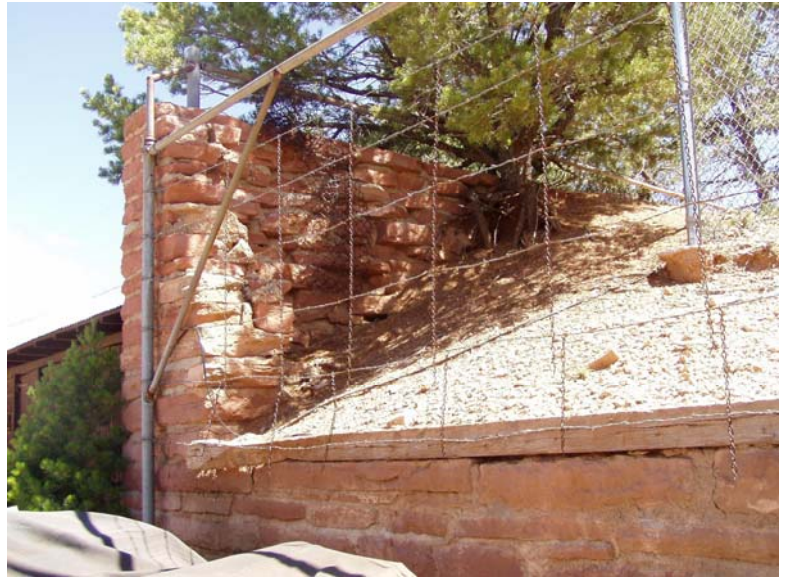
Random Ashlar, Red Sandstone Retaining Wall 0094 - 113

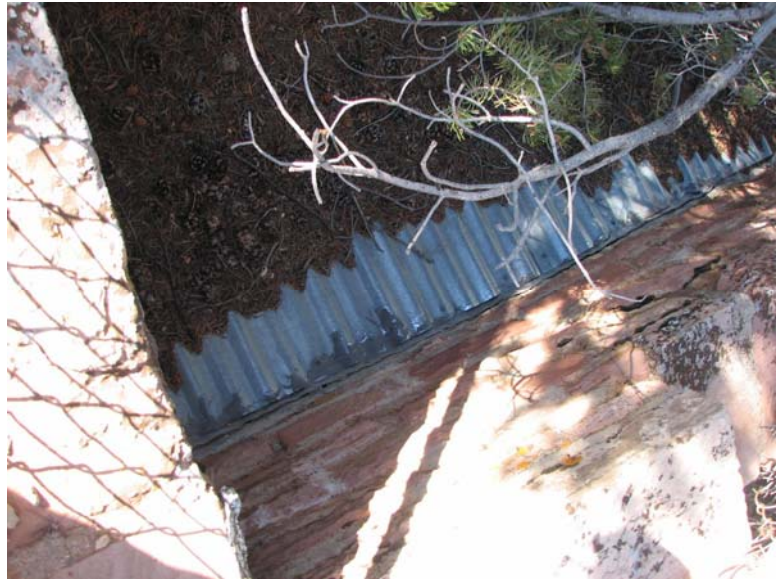
Sandstone Retaining Wall 0094 - 115

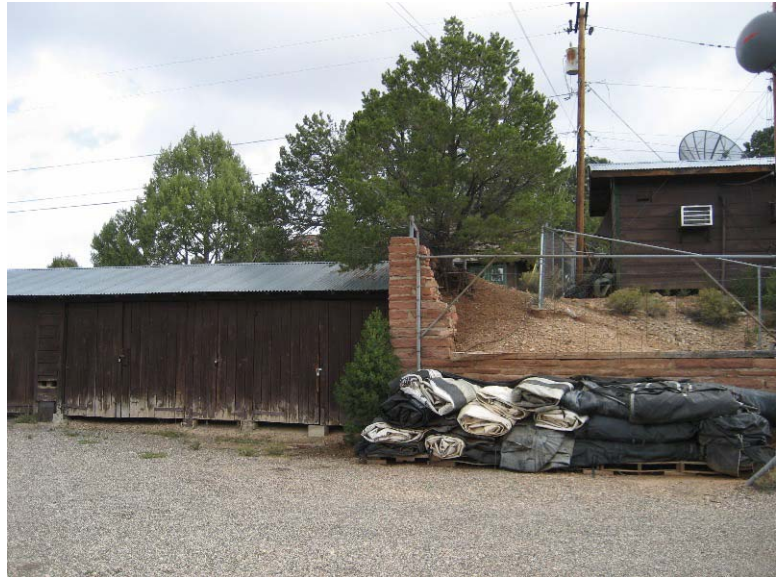
Southwest Elevation Stone and Spot Footings 0094 - 127

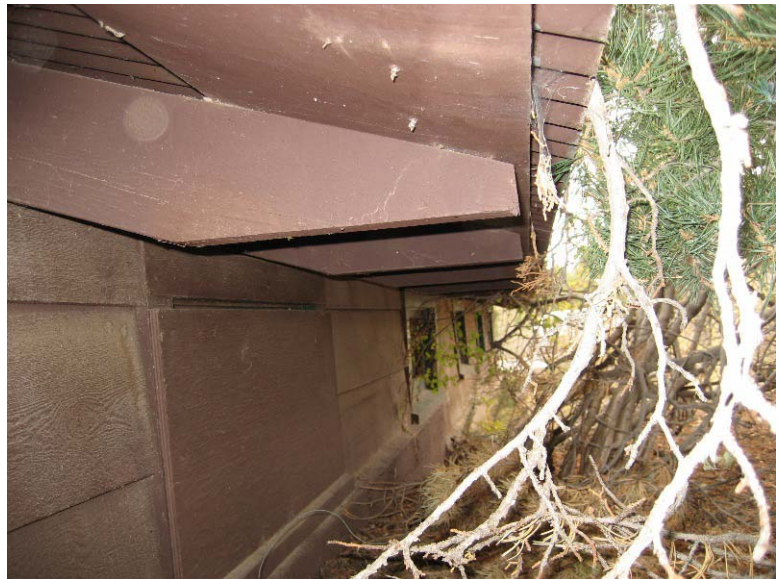
Rafter Tails at East Eave 0094 - 128

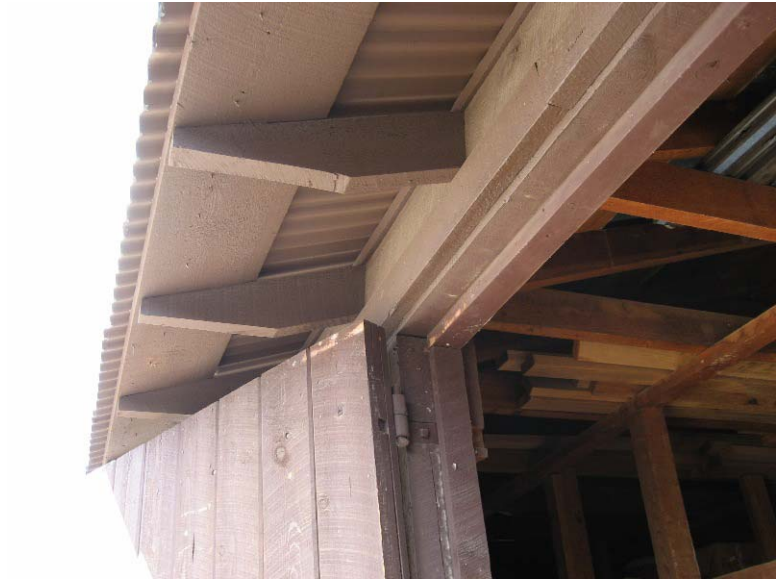
Rafter Tails at West Eave 0094 - 129

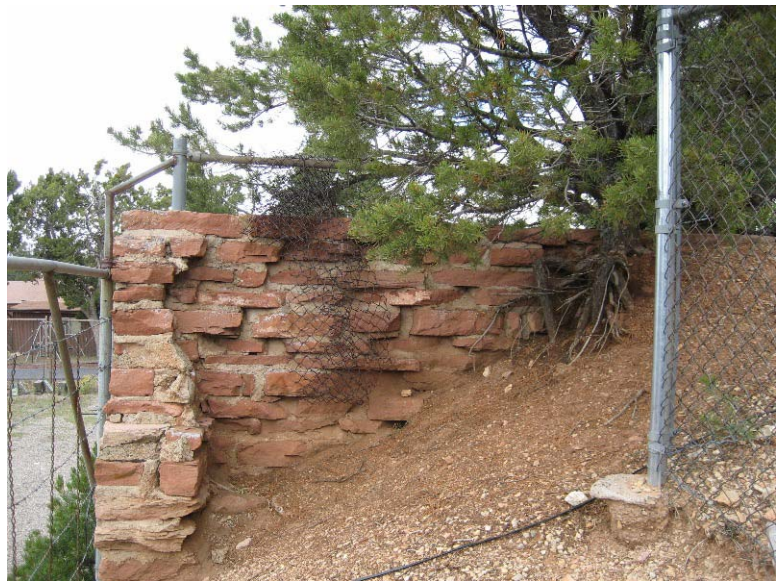
South Elevation of Stone Wall 0094 - 130

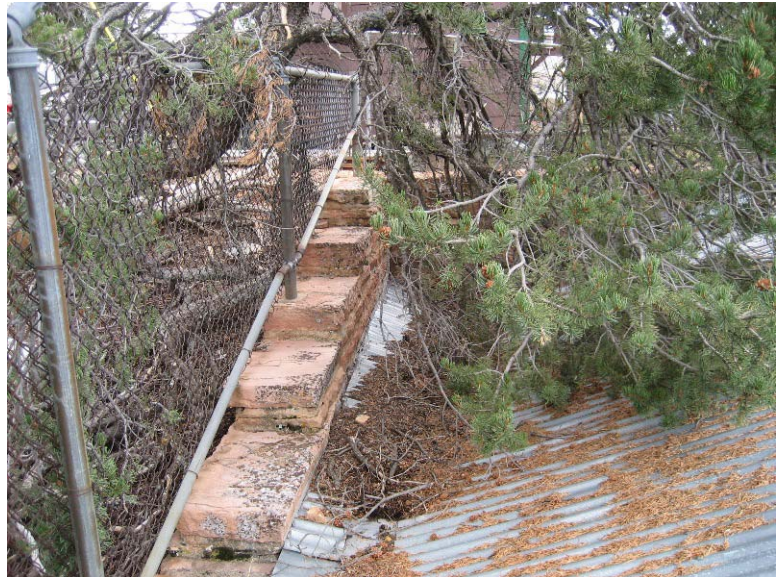
Roof and Stone Wall at Southeast Corner 0094 - 131

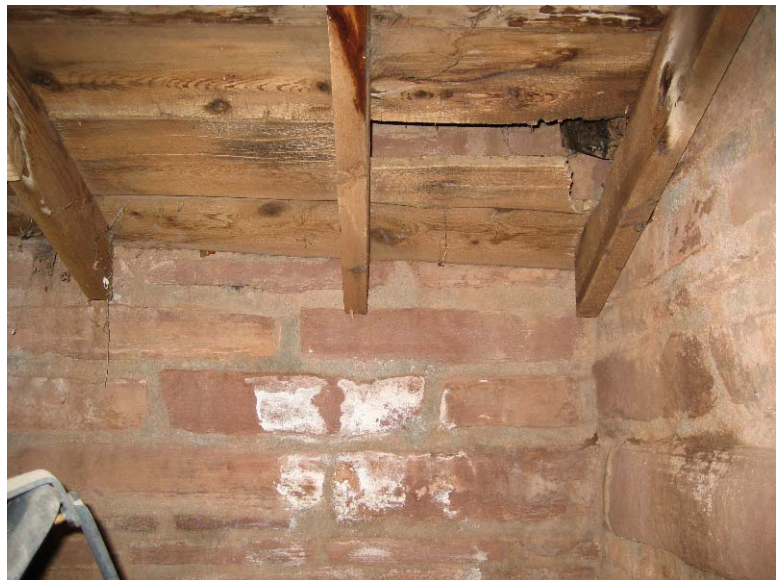
Unsupported Rafters at Southeast Corner 0094 - 132

The rafters and sheathing at the south end of the building should be supported and replaced as necessary. The rafters could be re-supported by adding on to the existing beam to the north with a new post at the south end.

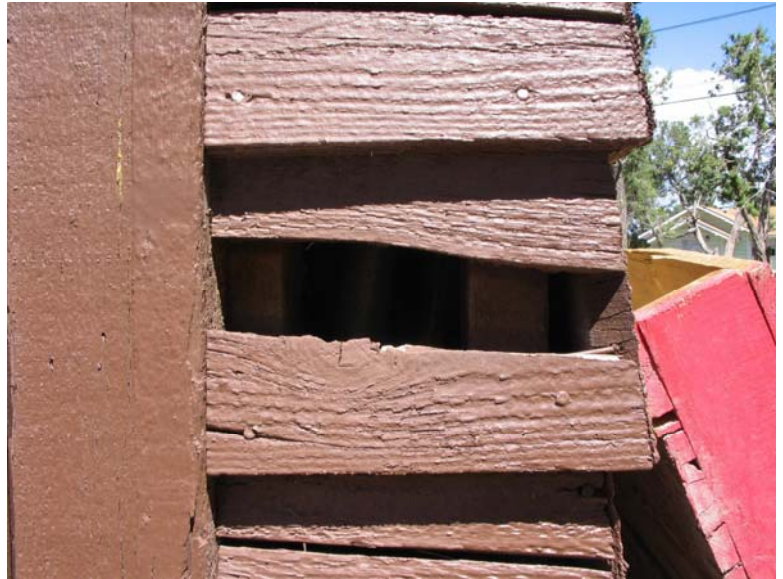
The siding consists of 1x10 rough sawn lap siding with +/-4" exposure. The siding extends up to the bottom side of the roofing. All corner joints are mitered. All end-to-end joints are butt joints. The siding is nailed to 2x4 framing within the 6x6 post and beam structure. The south side of the building only has siding above the 8 double doors and at the very ends. Siding at the east end starts at (or below) grade. Siding at the east end of the north side is at or below grade and at the west end of the north side the siding starts above an exposed concrete foundation.

1x10 Rough Sawn Lap Siding 0099 - 109

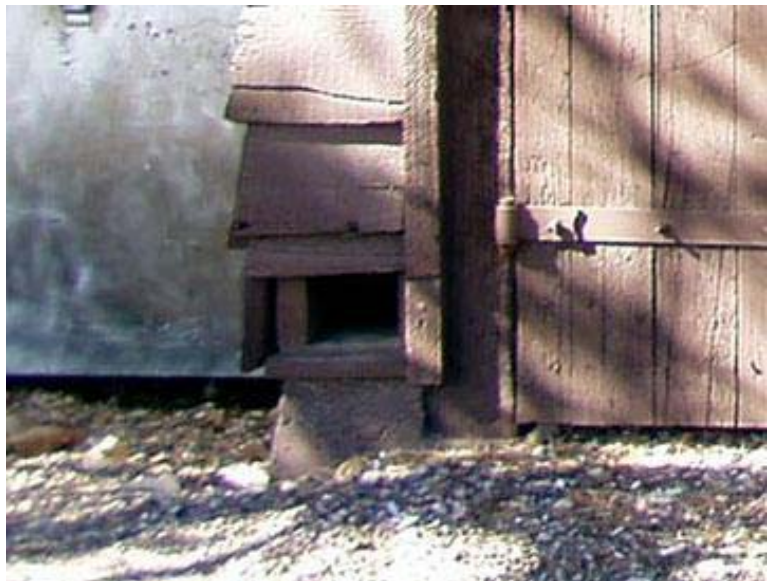
As depicted in the historic construction drawings, there is a canted (sloped) concrete foundation at the west and north walls - and potentially, below grade at the east wall, although it was not visible. The foundation is painted brown. There are also canted foundation blocks at the posts along the south wall.

Canted Concrete Foundation 0099 - 110

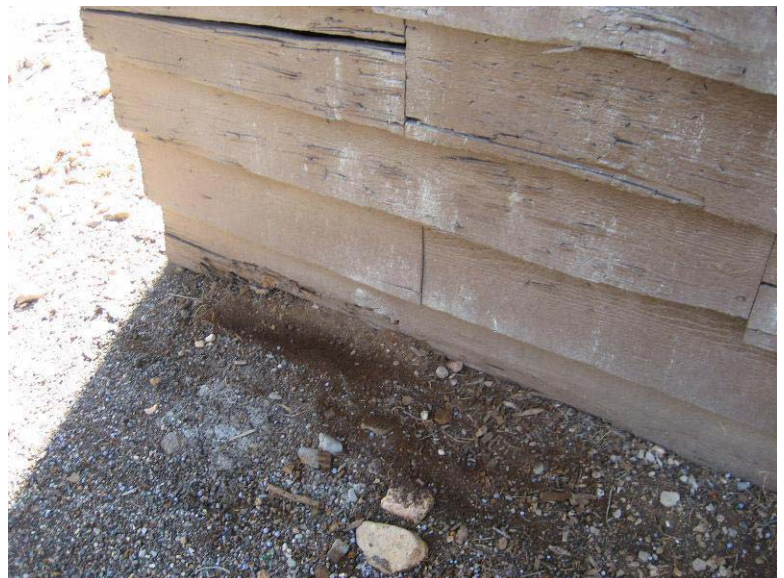
Wall framing is generally in good condition except at the base of the wall along the eastern side of the building. Here, as seen at most other buildings assessed, grade is at or above the sill plate. The wall sheathing has been severely deteriorated wherever soil is in direct contact (Photo-0099-122).

Deteriorated Wall Sheathing at East Wall 0099 - 122

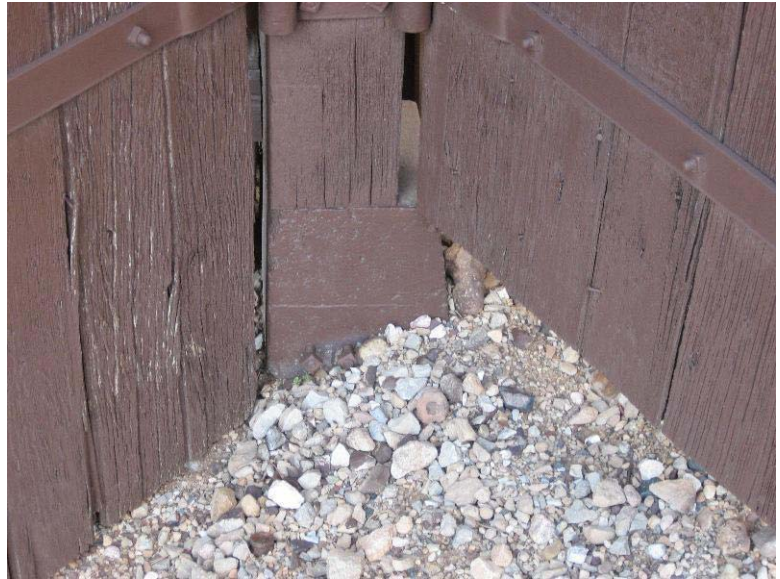
The foundation at the south wall is a series of cast-in-place concrete piers under each column (Photo-0099-207). The pier measures 10" x 8" at the top. It tapers on the inside to an unknown width below grade. Again, the historic drawings do not agree with the as-found condition. There is no visible connection from the piers to the wood columns they support. The historic drawings indicate a blind dowel was to be installed from the pier to the column.

Typical Pier at South Wall Columns 0099 - 207

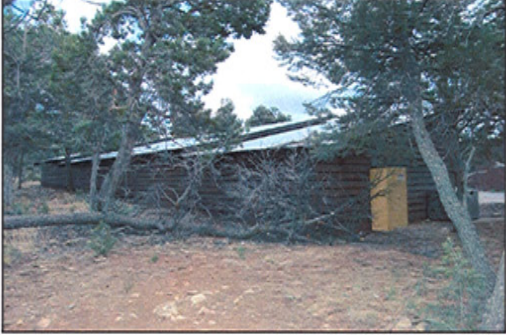
2.

SRB0099, Vehicle Storage Building	08/2006 2
