Lamar Bathhouse

Historic Structure Report

HOT SPRINGS

National Park • Arkansas

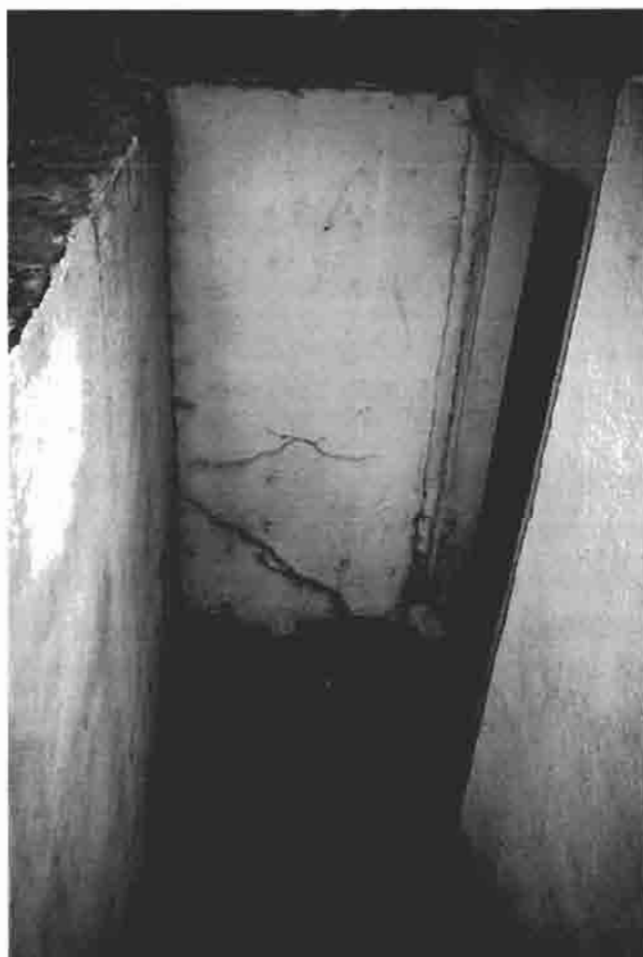
1C-3: North Site.
11/2003

It appears that the areaway drain can become easily blocked, and there is no curb in front of the door. Evidence of a clogged drain is seen in the photo, which shows the presence of dried, cracked mud (See Photo 1C-3). The riser second from the top on the upper set of stairs is cracked.

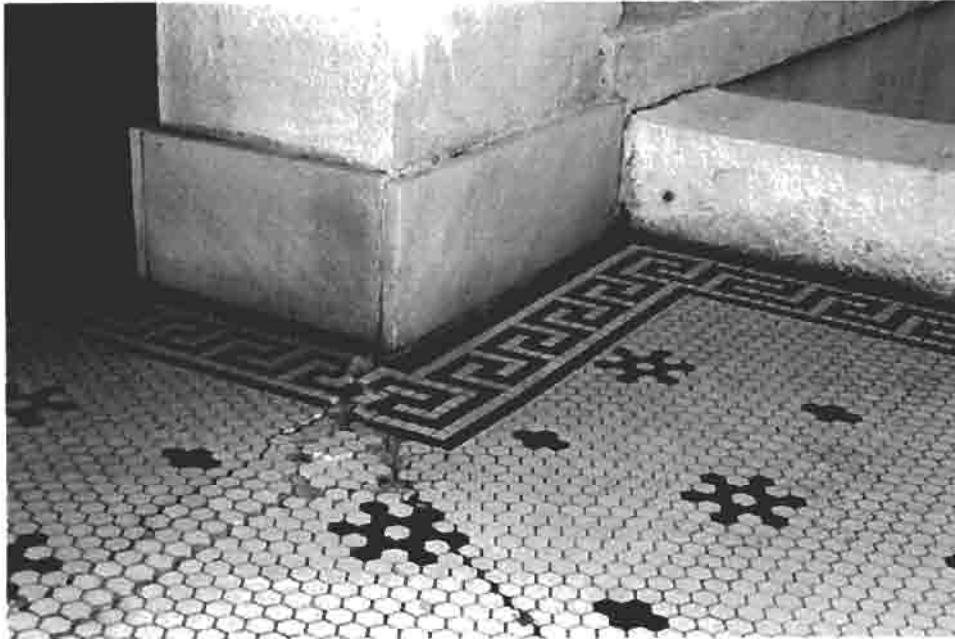
1C-11: West Site.
Typical damage to the
tile at the front entry
alcove. 11/2003

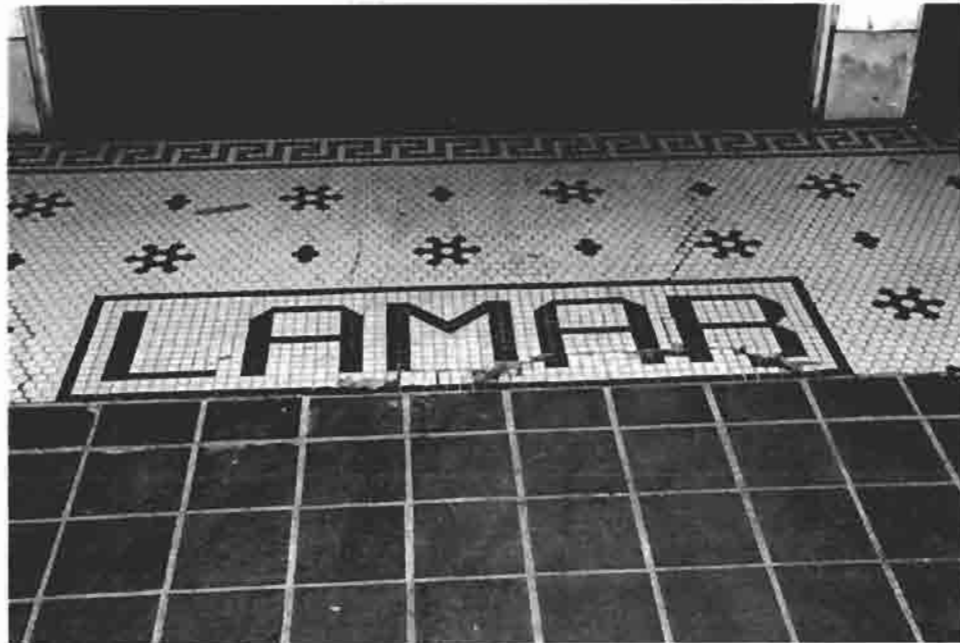
IC-12: West Site.
Front entry tile at
alcove and at stair
entry platform (quarry
tile). 11/2003

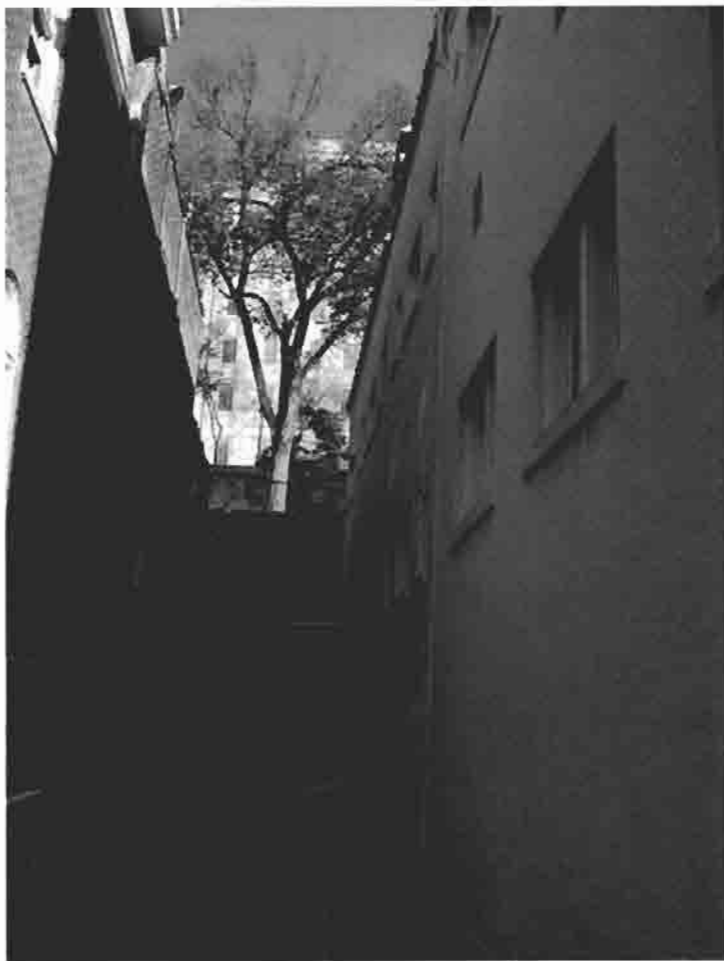
1C-17: North Elevation. 11/2003

The north elevation has one door at the basement level. This door was scheduled to be replaced by a new hollow metal door.

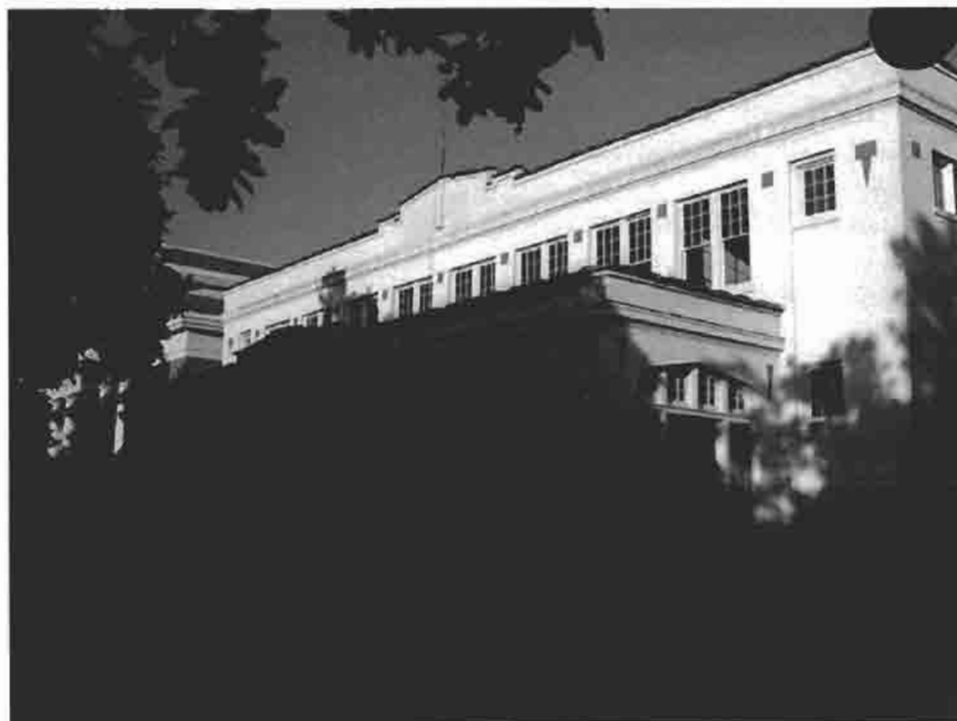
1C-26: West Elevation. An
example of the blue mosaic tile
applied decoration. 11/2003

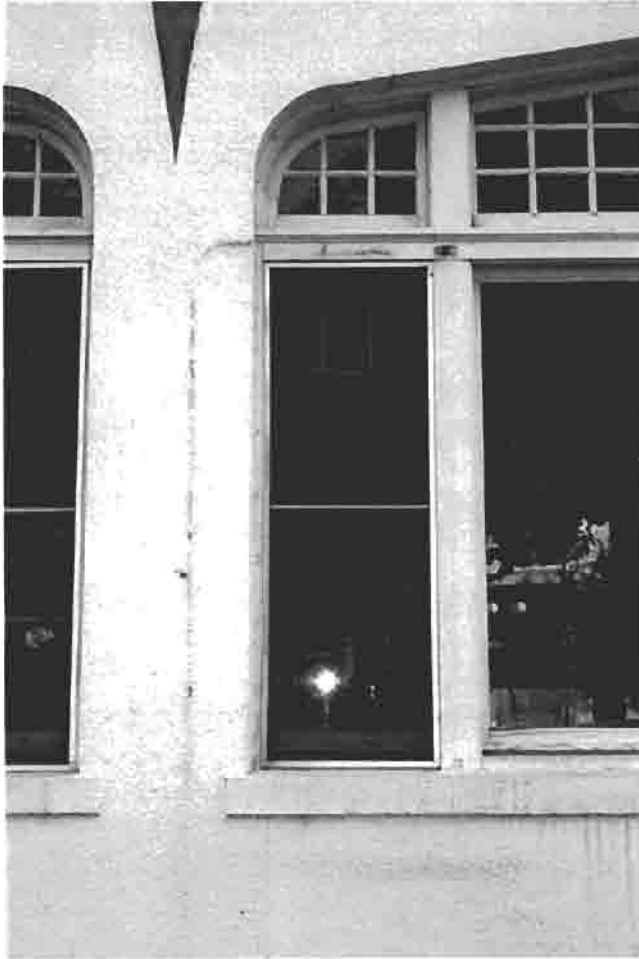
1C-27: West Elevation. Note the ghost of a conduit on the stucco. 11/2003

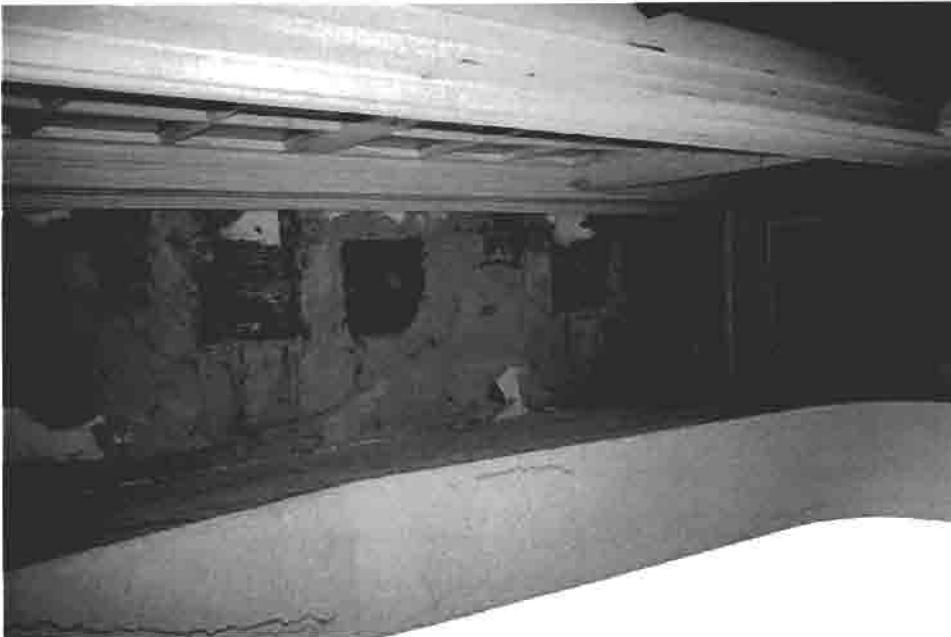
The marble base at the front entry tile is in good condition. The plaster ceiling of this alcove is in poor condition, virtually gone, requiring comprehensive replacement. The cause of the plaster damage is likely to have been the same leakage that has extensively damaged the interior plaster.

1C-28: West Elevation. The ceiling of the alcove has lost most of its plaster. Comprehensive restoration is required. 11/2003

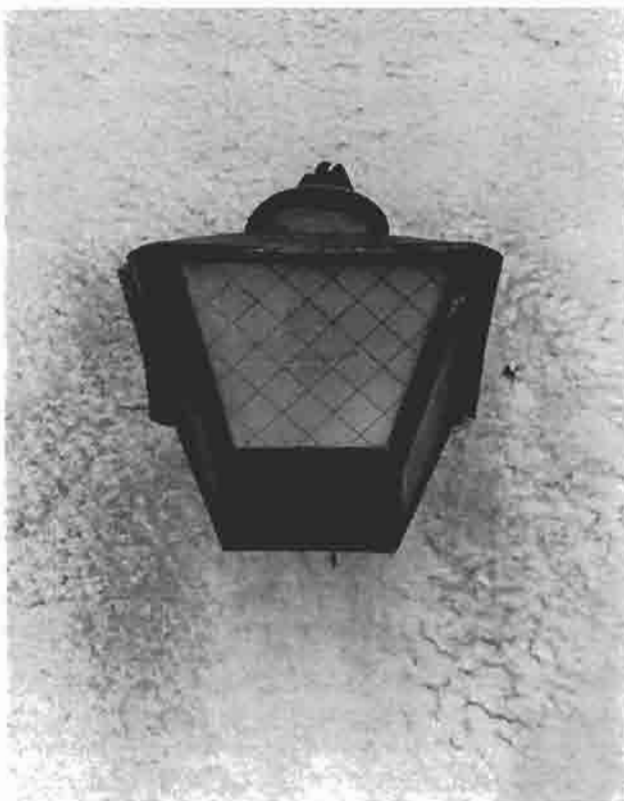
1C-29: West Elevation. Note oxidation in the metal of the light adjacent to the front entry. 11/2003

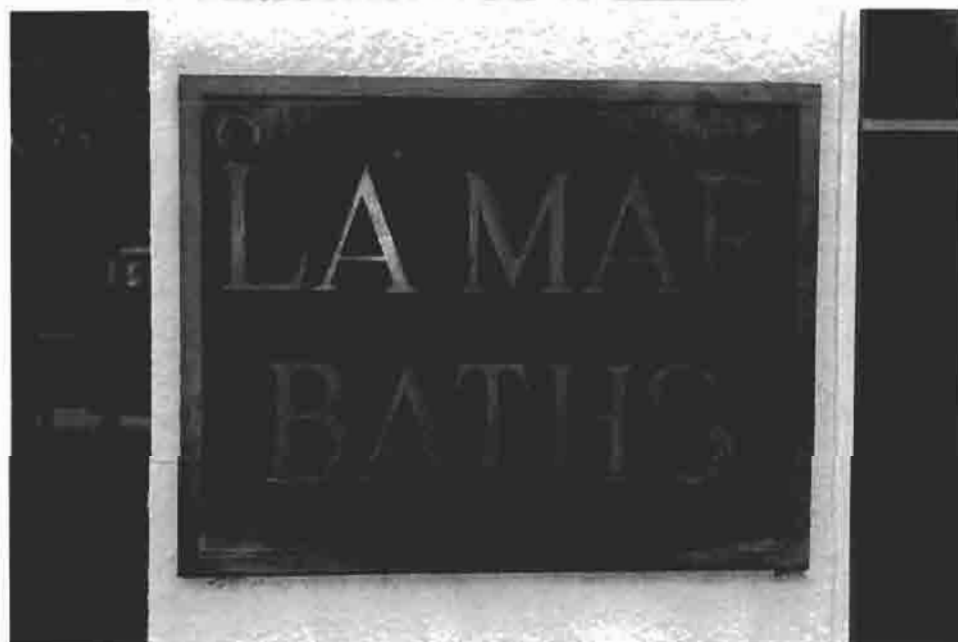
1C-30: West Elevation. Note oxidation at the bronze sign adjacent to the entry. 11/2003

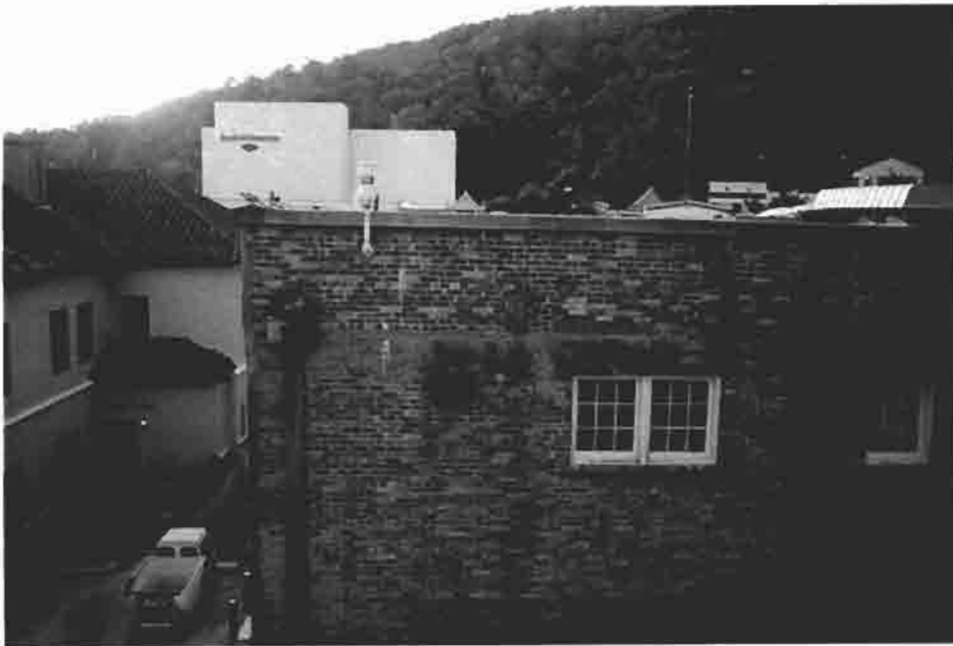
1C-35: East
Elevation. South end.
Condition:

1. Numerous stair step cracks in brick above conductor, and to the right of it.
2. Moisture stains in bond beam evidence past leaks at back of parapet.

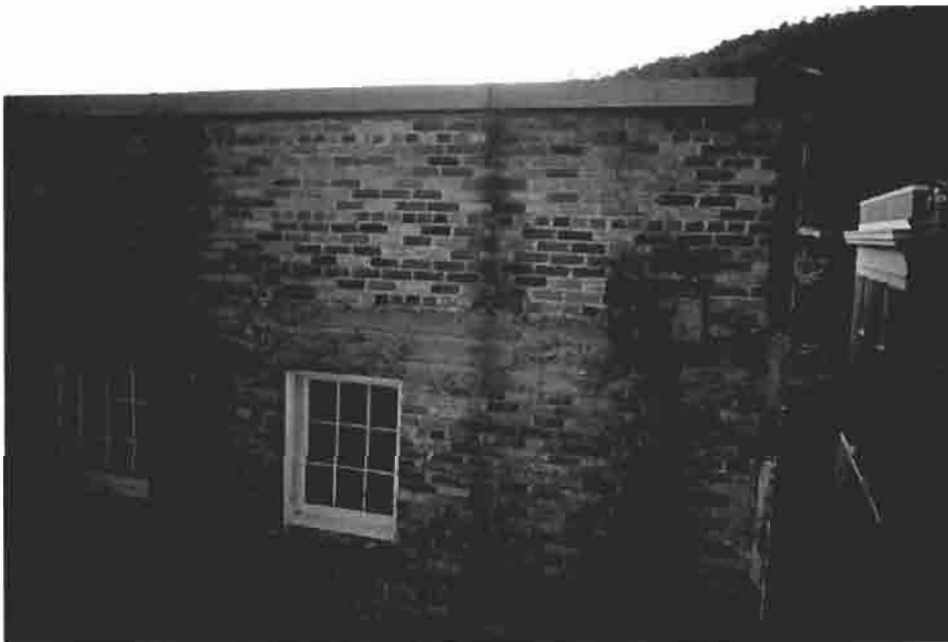
1C-36: East
Elevation, North end.
Condition:

1. Numerous stair step cracks above the conductor in the brick.
2. Very porous concrete of the bond beam. Small cracks.
3. Dark stains in a line with parapet coping joints.
4. Rusted conductor.

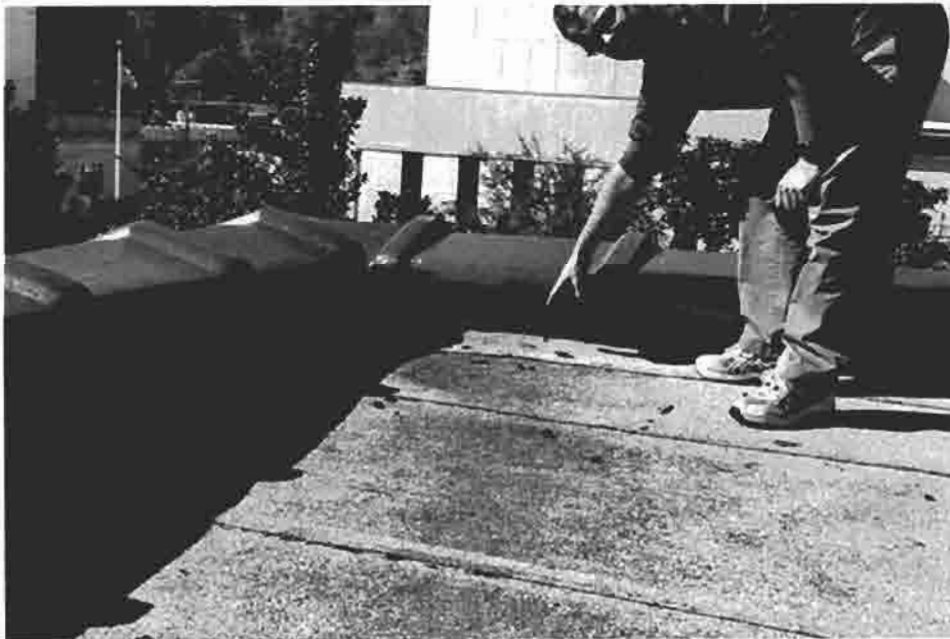
The sheet metal flashing fasteners at the parapet have, in some locations, worked out of the brick. All should be checked, since the presence of loose fasteners might indicate a more prevalent problem.

IC-38: Roof. Roofing, flashing (pointed out), and vitrified clay parapet coping tile. 11/2003

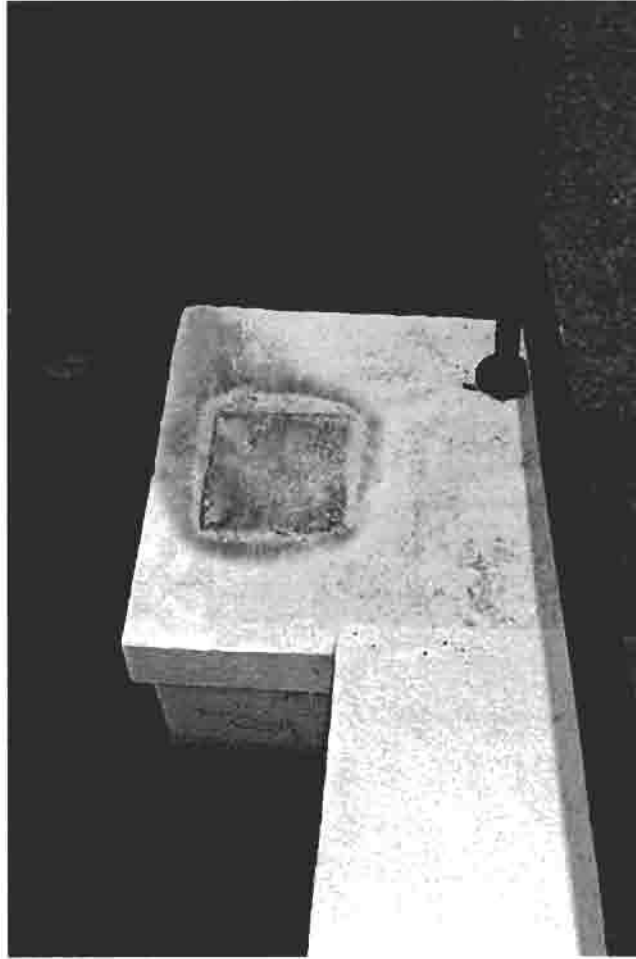
1C-49: Missing element
from the west elevation.
Historic photos show a
garden urn at this loca-
tion. 11/2003

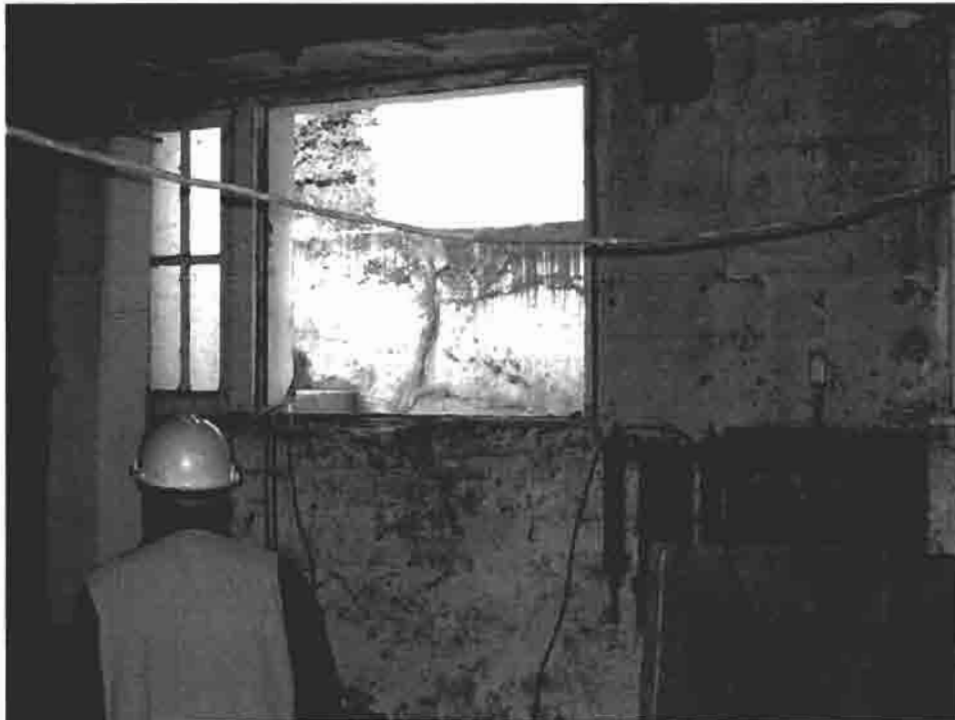
1C-50: Male Attendants Room, Room 03: North Wall in northwest corner. Note: Typical exposed walls. Window: 01. 11/2003

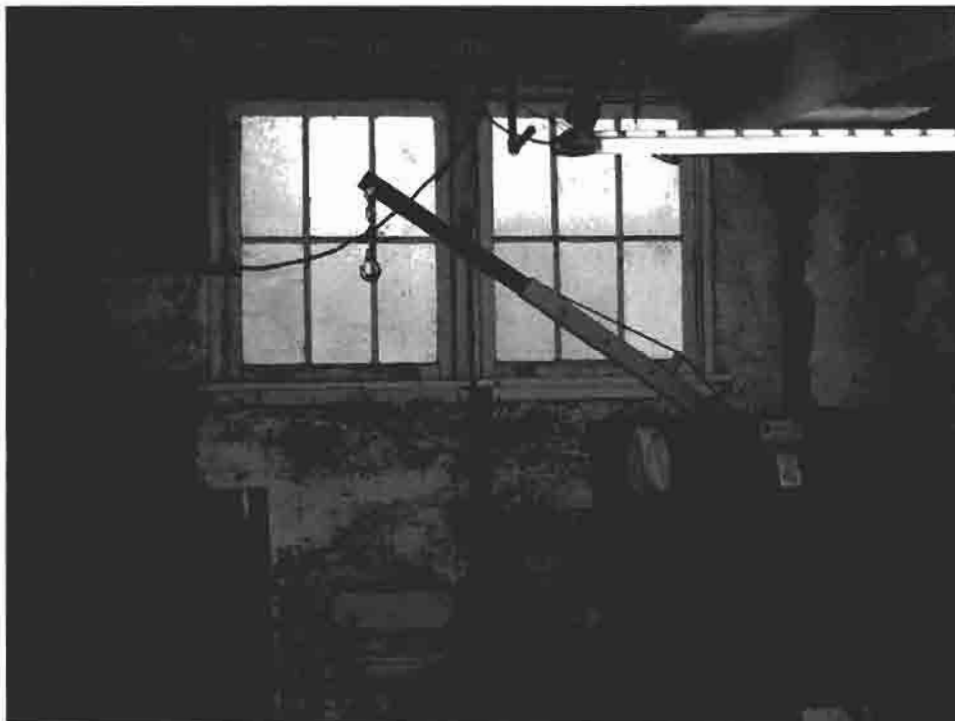
1C-51: Male Attendants Room, Room 03: North Wall. Typical historic window and associated hardware. Original east wall of room (now removed) was under beam in photo at right. Window: 02. 11/2003

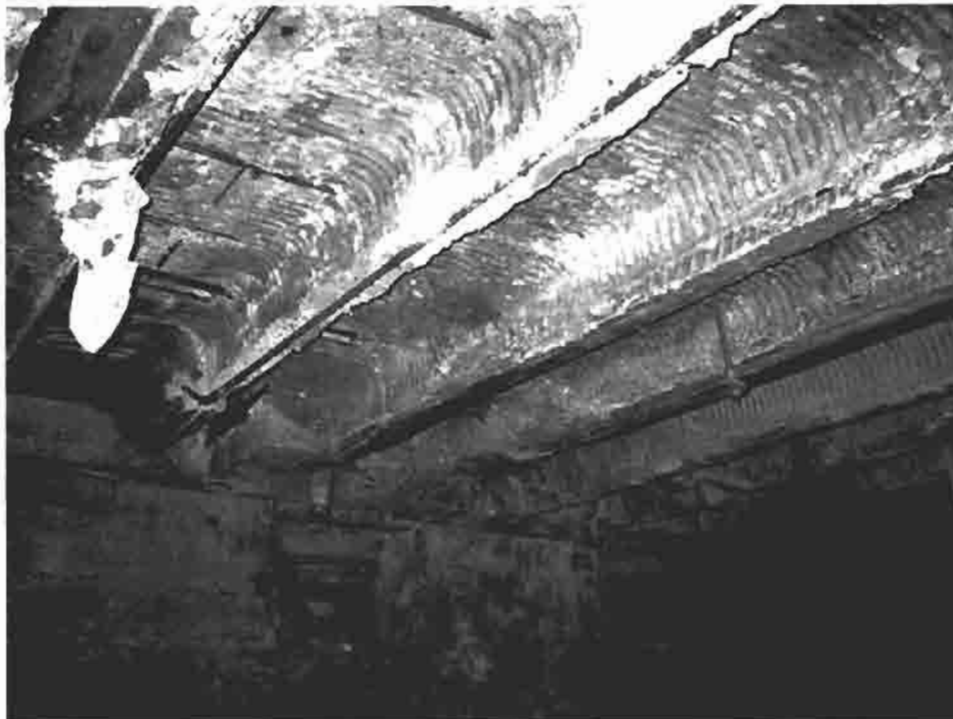
1C-54: Crawl Space: North view: from Fuel Room 01: Note: Exposed underside of the first floor structure & exposed rebar. 11/2003

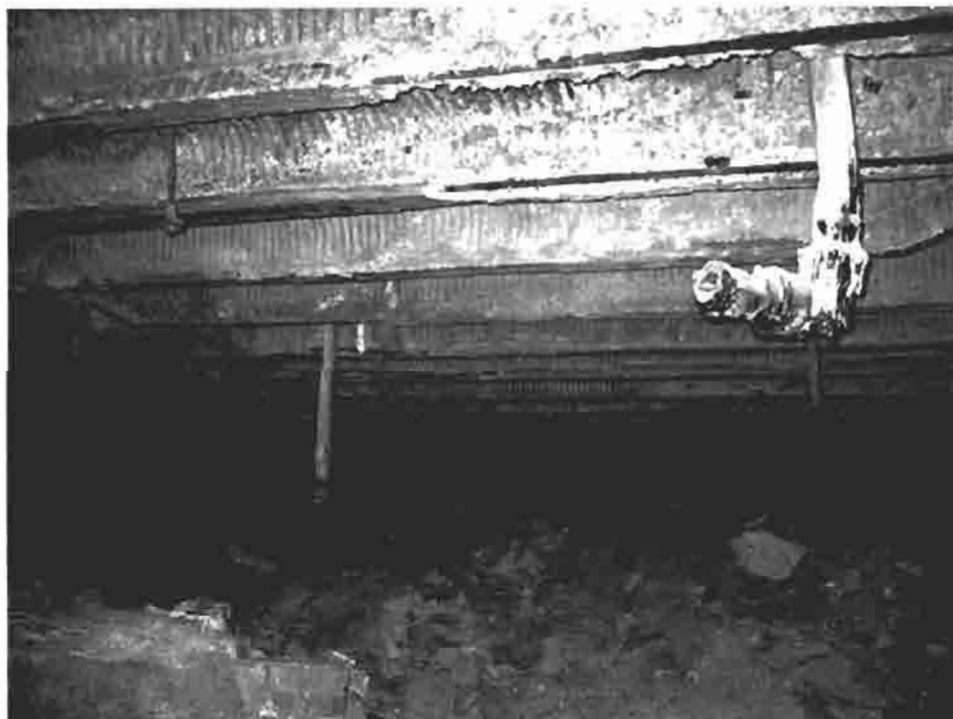
1C-55: Crawl Space: Northeast view: from Fuel Room 01: Note: Exposed rebar in beams. 11/2003

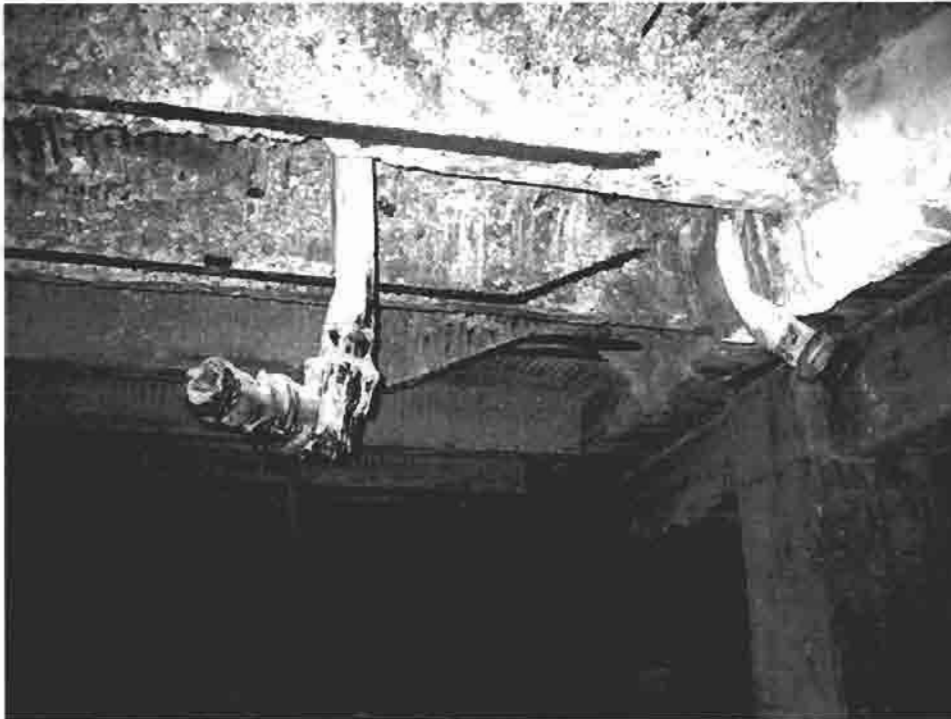
1C-56: Crawl Space: Southeast view from Fuel Room 01: Note: Exposed rebar & substantial loss of material at the south end of the third beam. 11/2003

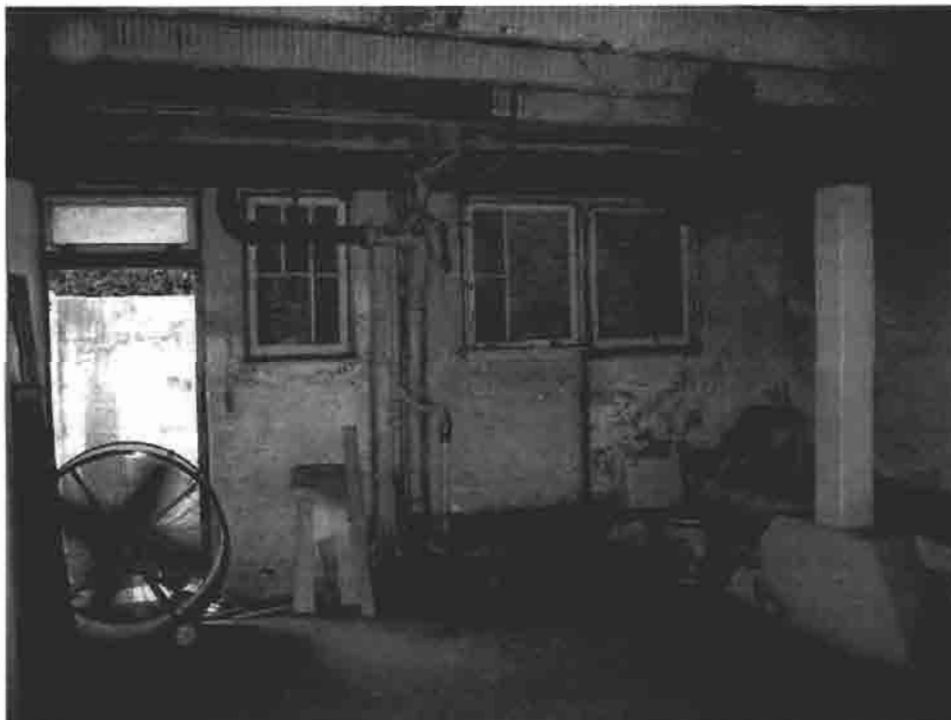
1C-57: Lamar Basement, Female Attendants Room 08: South wall to southwest corner. Door: B08. Windows: 06 and 07. 11/2003

ROOM NUMBER:	08
ROOM NAME:	Female Attendants Room
FLOOR FINISH:	Concrete
WALL BASE:	None
WALLS:	Concrete
NORTH:	
EAST:	
SOUTH:	
WEST:	
OTHERS:	
CEILING:	Concrete
WINDOWS:	3 - See "Window Conditions Schedule"
DOORS:	1 - See "Door Conditions Schedule"
SPECIAL FEATURE:	
KEY CONDITIONS CONCERNS:	
<p>Jacking procedures were being set up for multiple columns in the basement at the time of the field survey.</p>

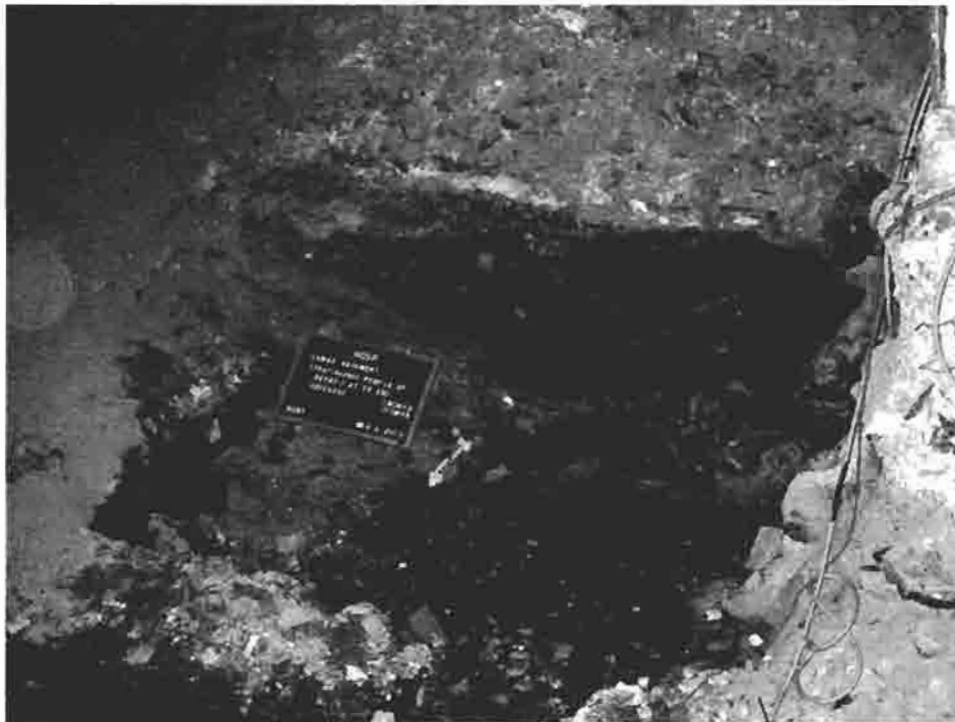
IC-58: Laundry Room 06: Archaeological investigation of ash/charcoal layer near Room 06, to the Southeast. 11/2003

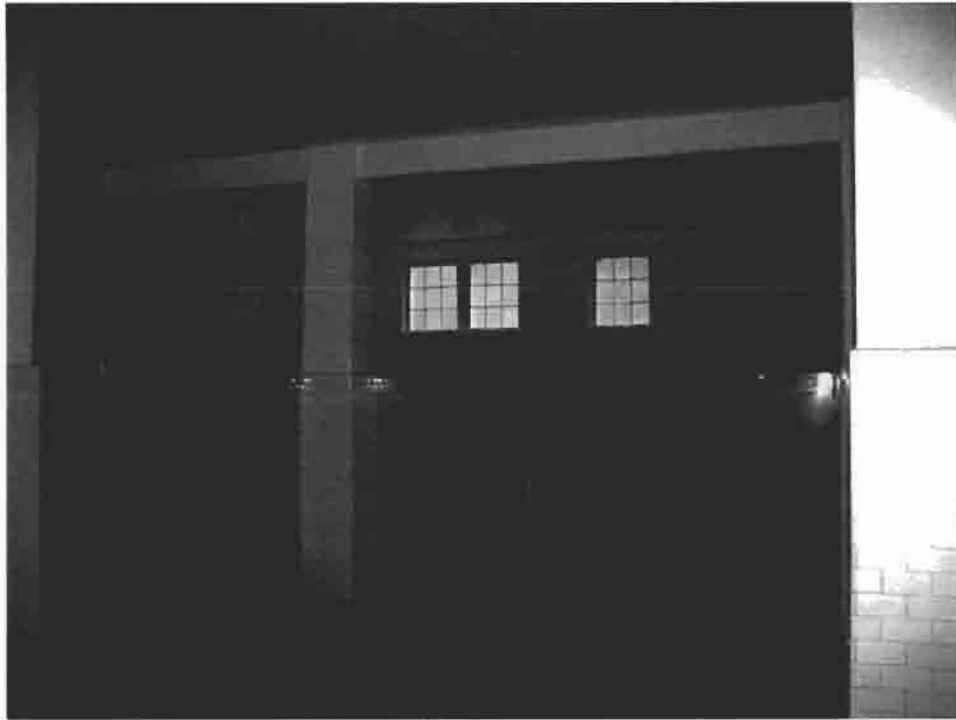
1C-59: Room 101, Men's Bath Hall: Northwest Corner. Windows: 108 & 109. 11/2003
(See historic photos 1B-3 and 1B-4)

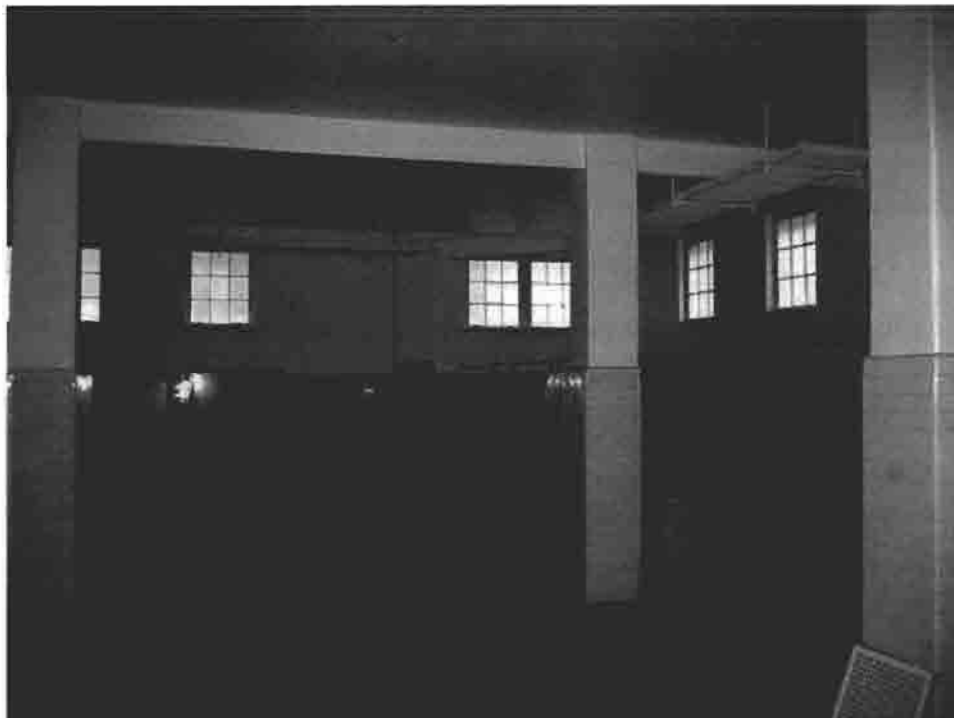
1C-60: Room 101, Men's Bath Hall: North wall to northeast corner. Windows: 109, 110, 111 & 112. 11/2003

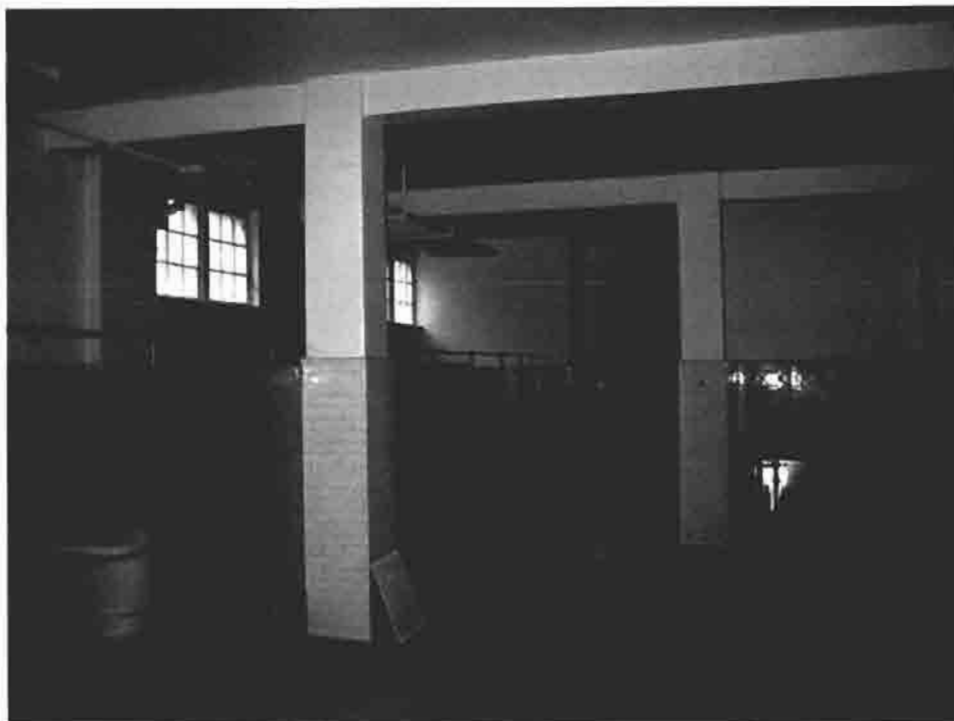
1C-61: Room 101, Men's Bath Hall: East wall to southeast corner. Windows: 114 & 115. 11/2003

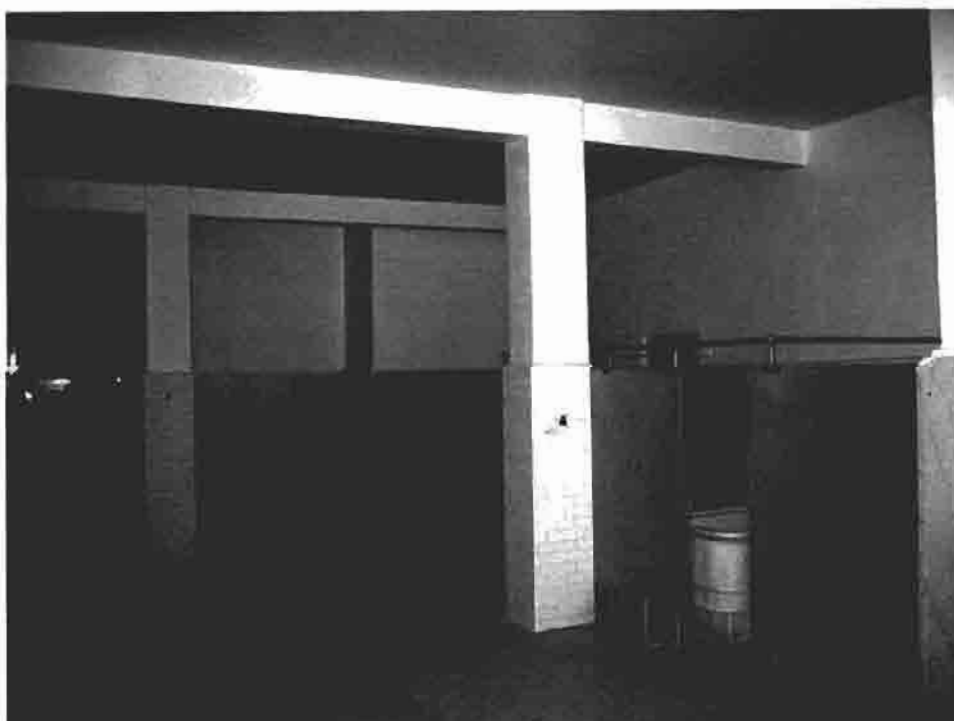
1C-62: Room 101, Men's Bath Hall: Southwest Corner. 11/2003

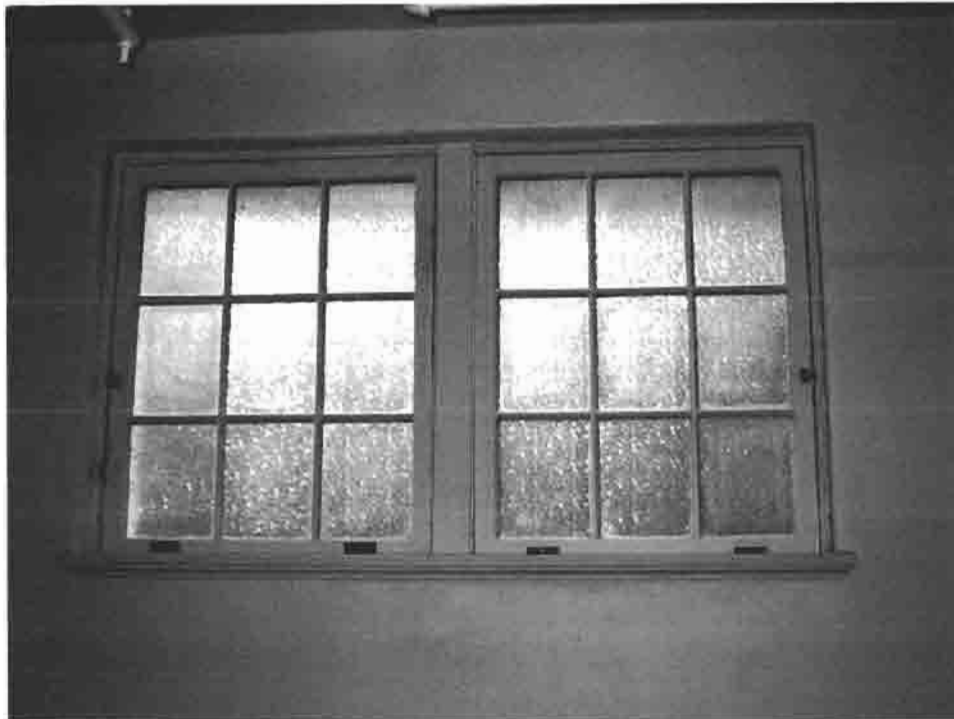
1C-63: Room 101, Men's Bath Hall: Typical windows. 11/2003

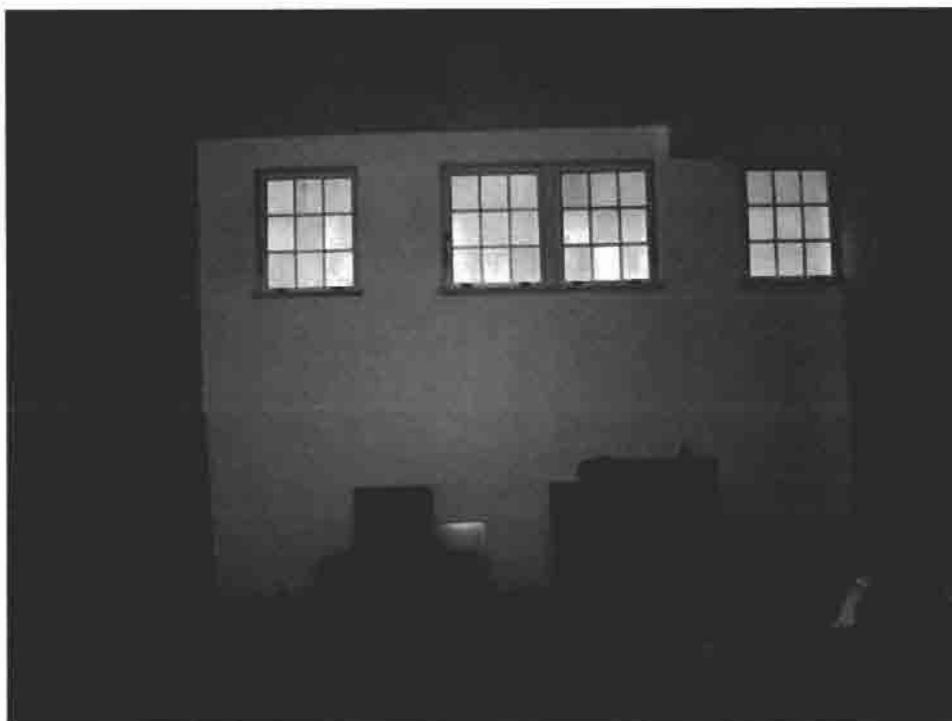
IC-64: Room 102, Men's Pack Room: North Wall. Windows: 104, 105 & 106. 11/2003

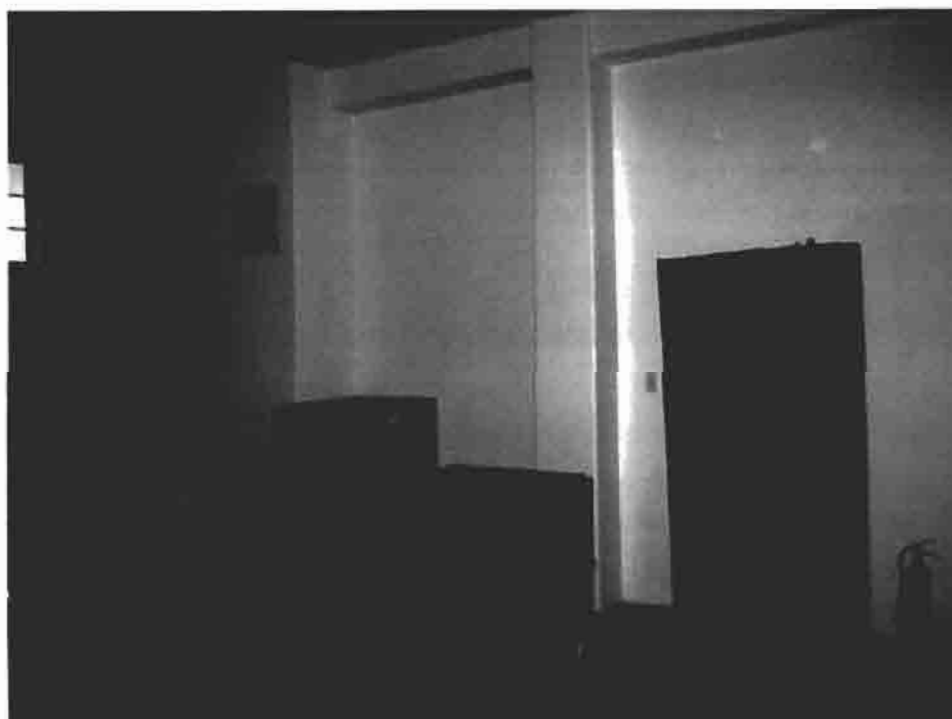
IC-65: Room 102, Men's Pack Room: East Wall. Window: 107. Door: 102B. 11/2003

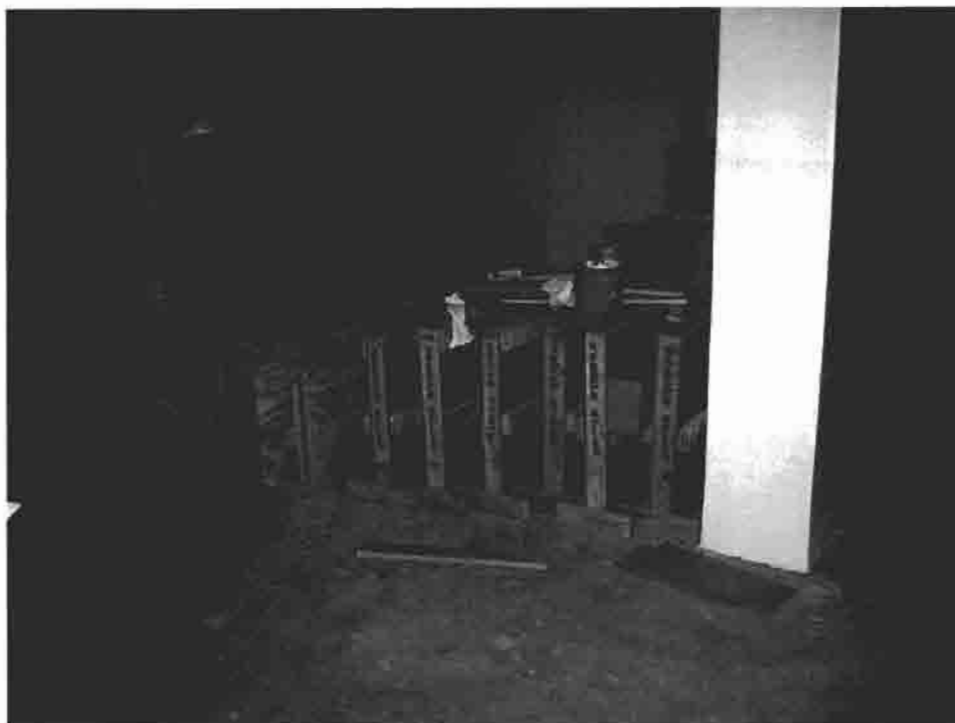
1C-66: Room 102, Men's Pack Room: Southeast Corner. Note: stored skylight glass.
11/2003

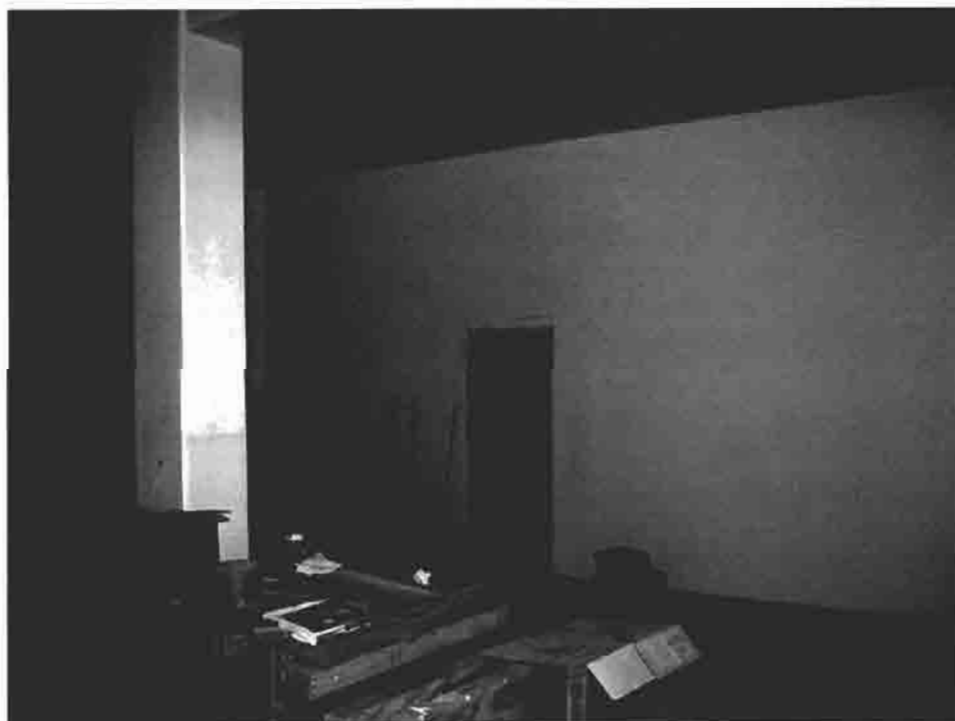
1C-67: Room 102, Men's Pack Room: West Wall. Southwest corner beyond column.
Door: 102A. 11/2003

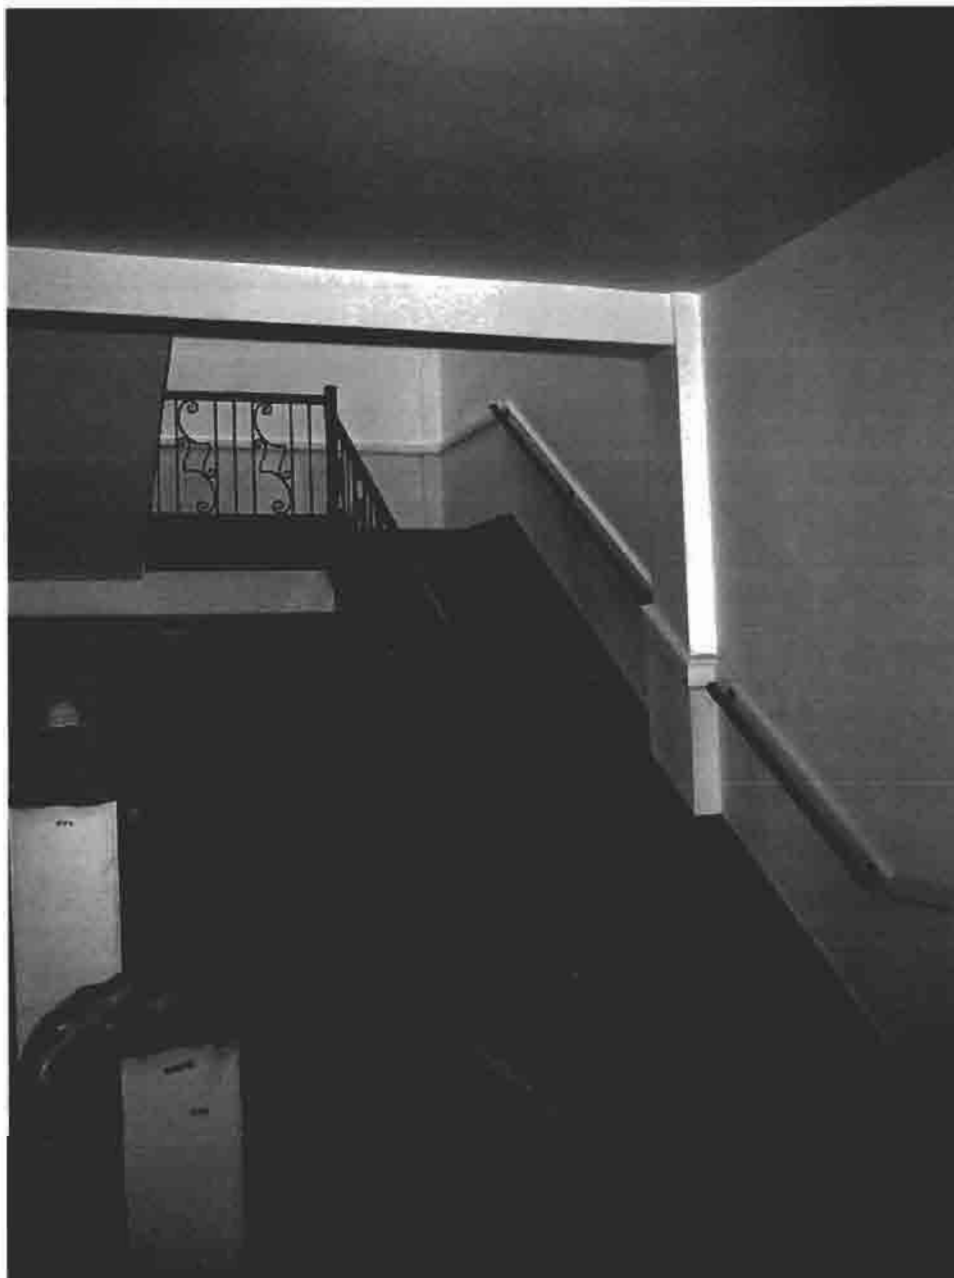
1C-68: Room 103, Men's Hall: Southeast Corner. Staircase: Door: 101A. 11/2003

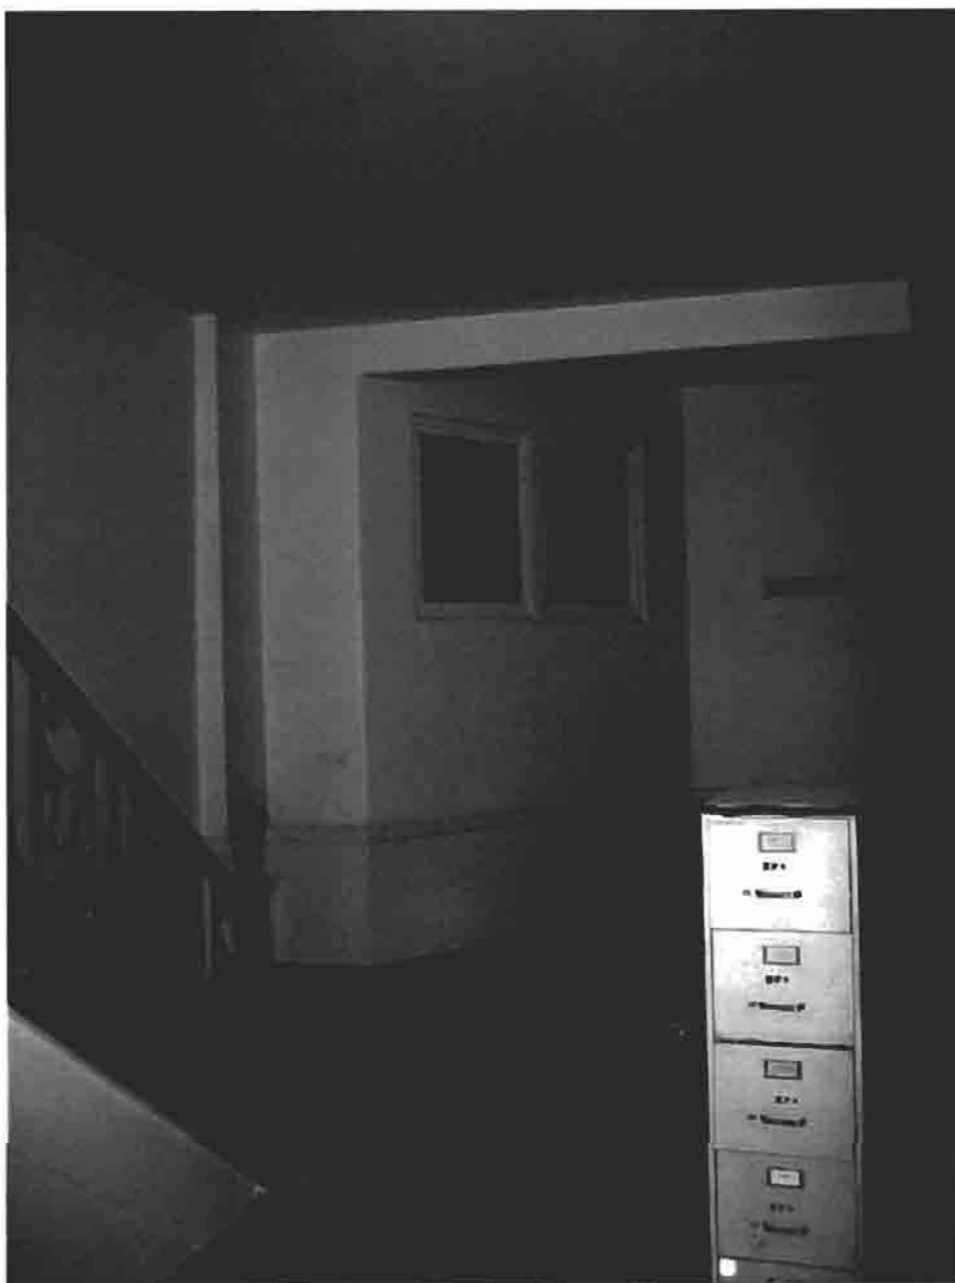
1C-69: Room 103, Men's Hall: South wall to southwest corner to west wall. Window: 141. 11/2003
