Lamar Bathhouse

Historic Structure Report

HOT SPRINGS

National Park • Arkansas

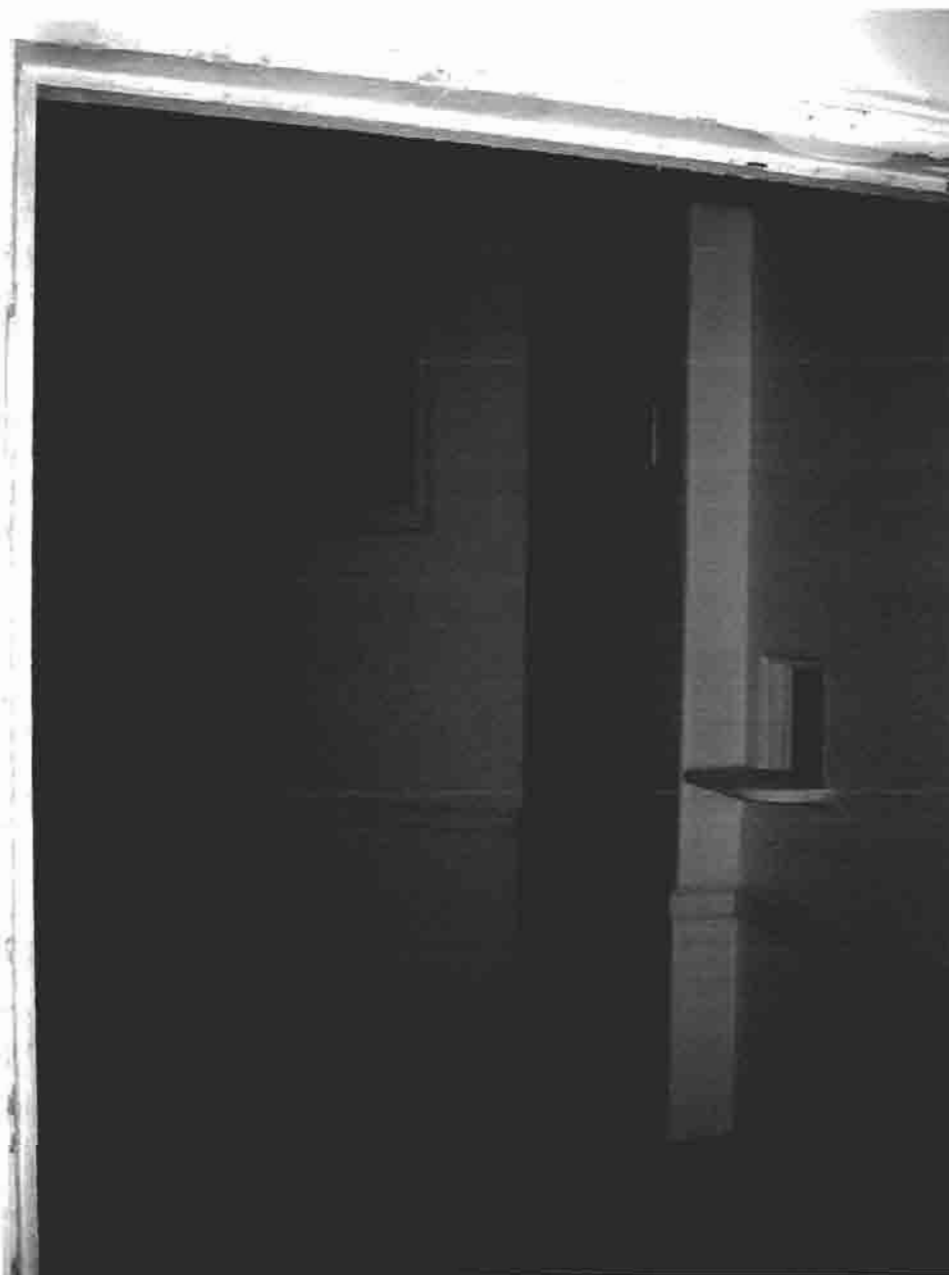
1C-70: Room 103, Men's Hall: Southwest corner to south wall. Note pass through to lobby/front desk. Window: 141. 11/2003

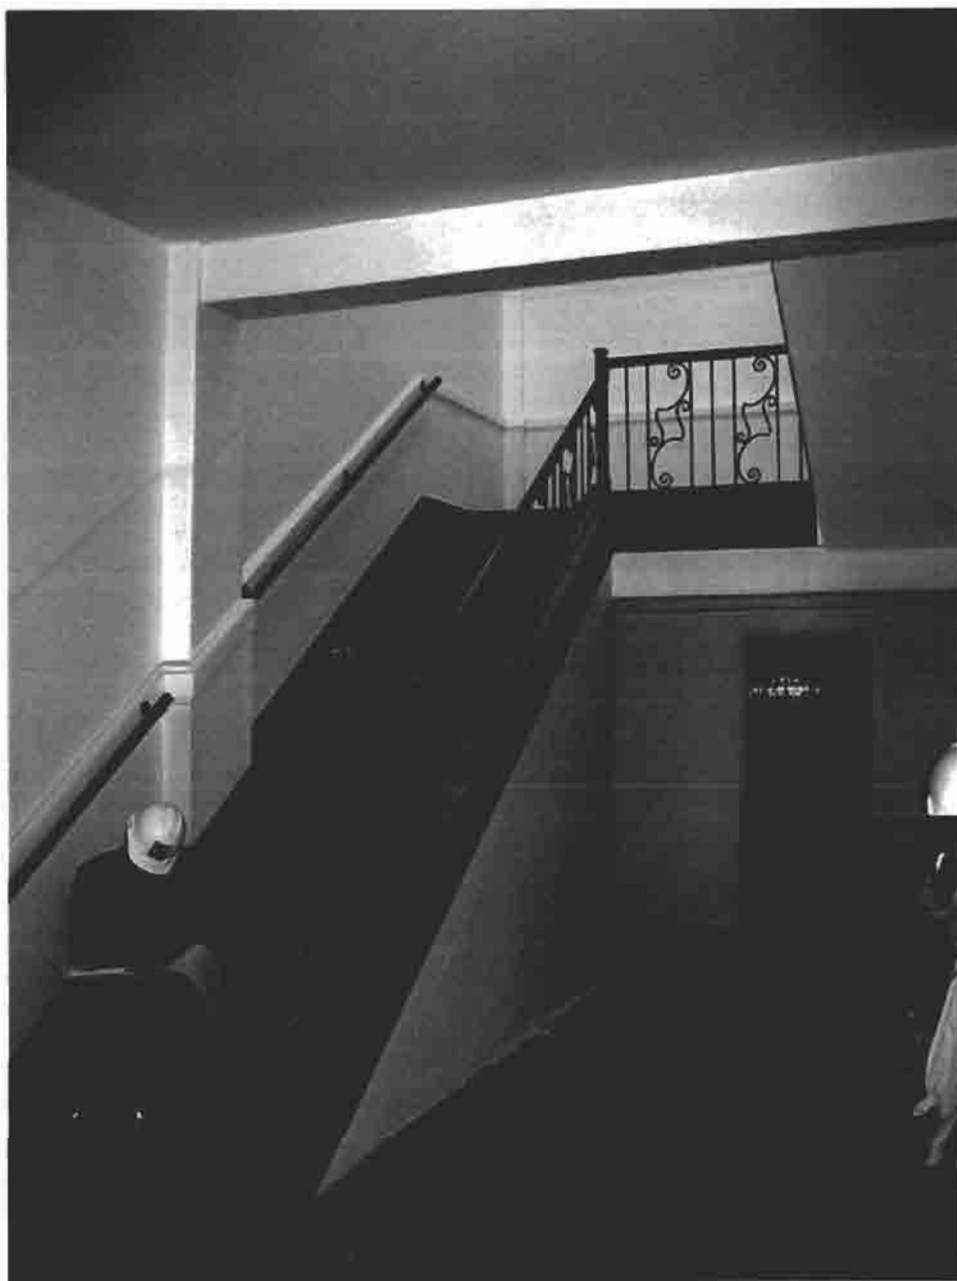
1C-71: Room 104, Women's Hall: North wall to northeast corner. Door: 110A. 11/2003

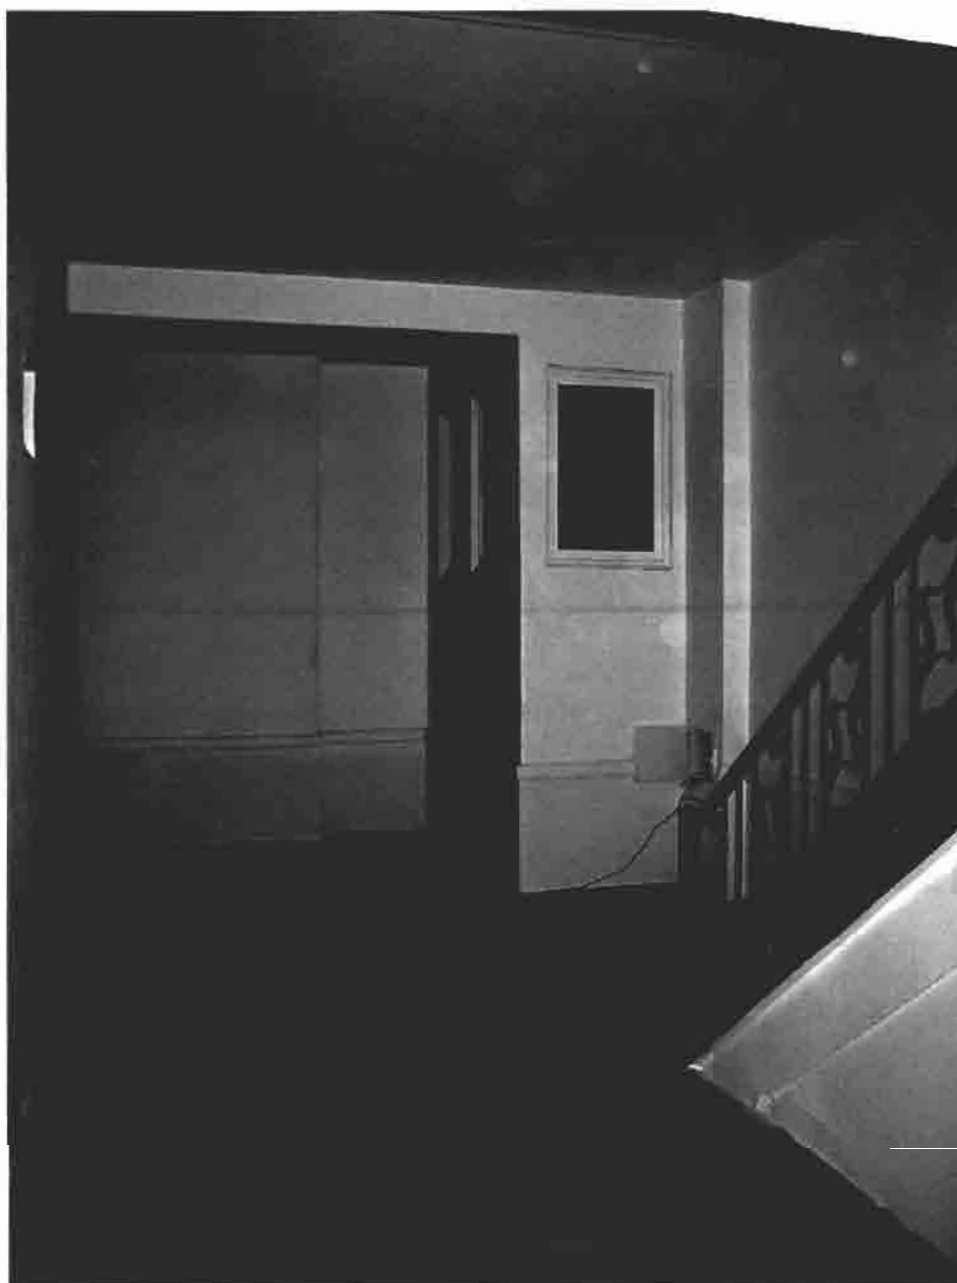
1C-72: Room 104, Women's Hall: West wall to northwest corner. Storage Room 105 at the base of steps. Windows: 143 & 142. 11/2003

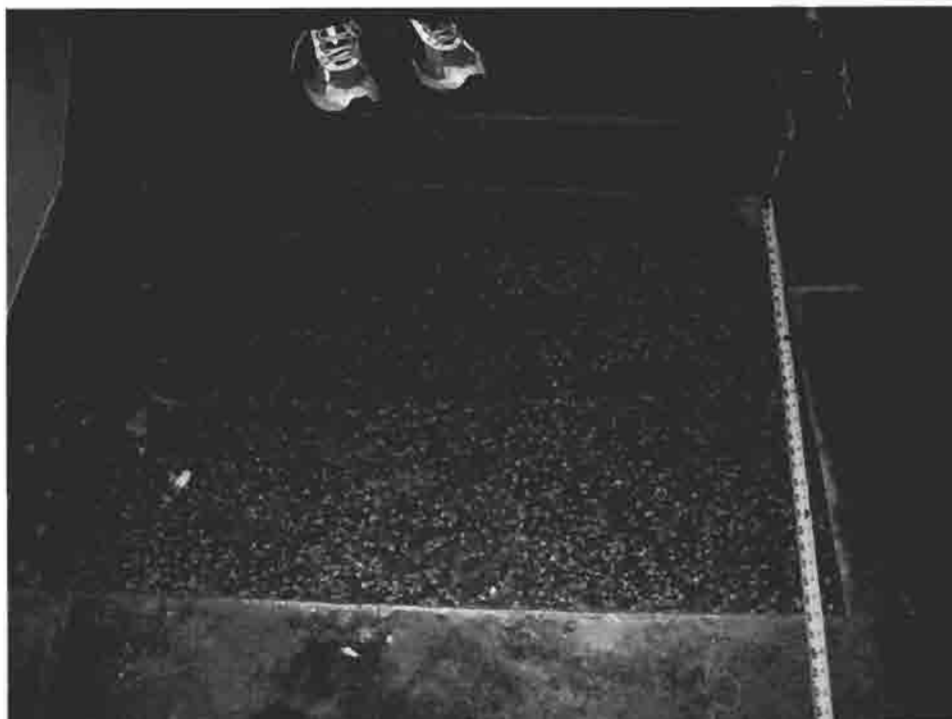
1C-73: Room 104, Women's Hall: Detail: Terrazzo landing at base of staircase. Note matching terrazzo landing in the Men's Hall. 11/2003

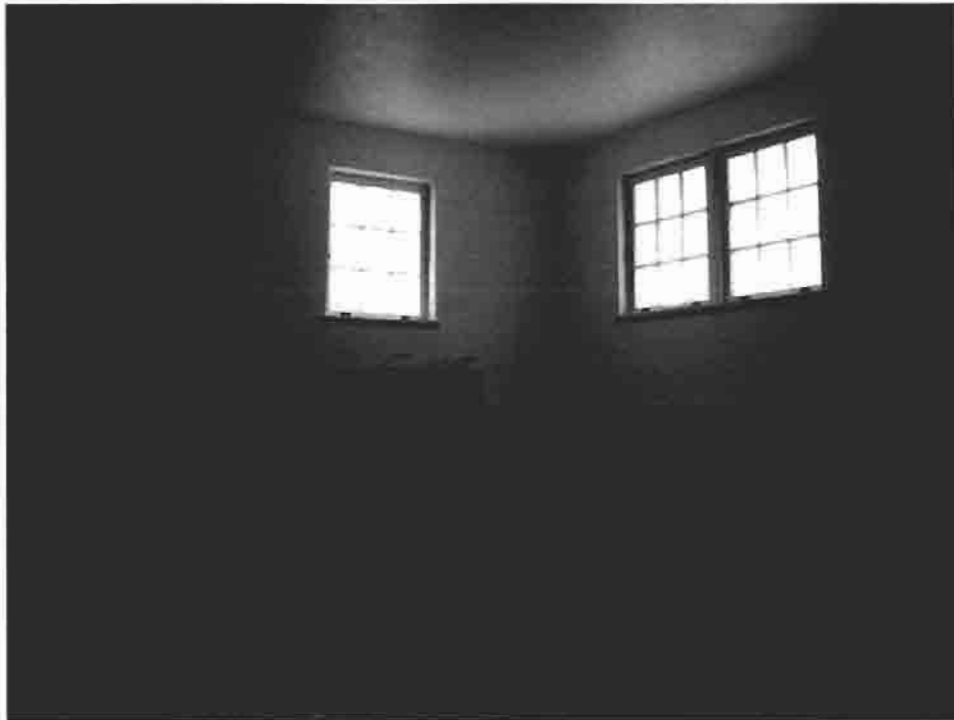
IC-75: Room 106, Men's Cool Room: Northwest Corner. Windows: 140 & 101.
11/2003

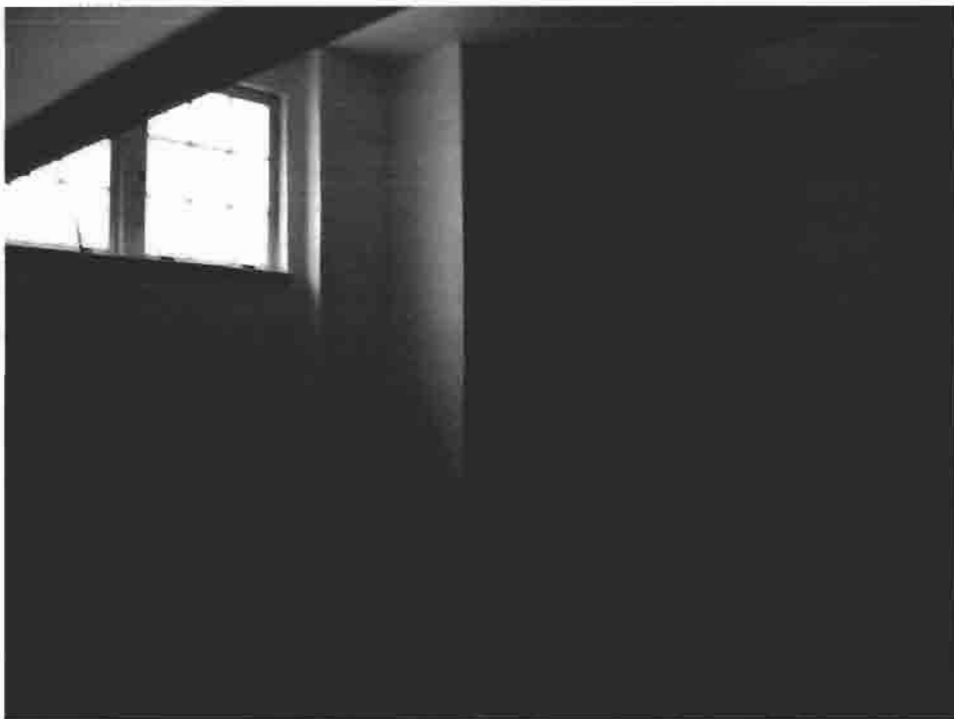
IC-76: Room 106, Men's Cool Room: North wall to northeast corner. Window: 103.
11/2003

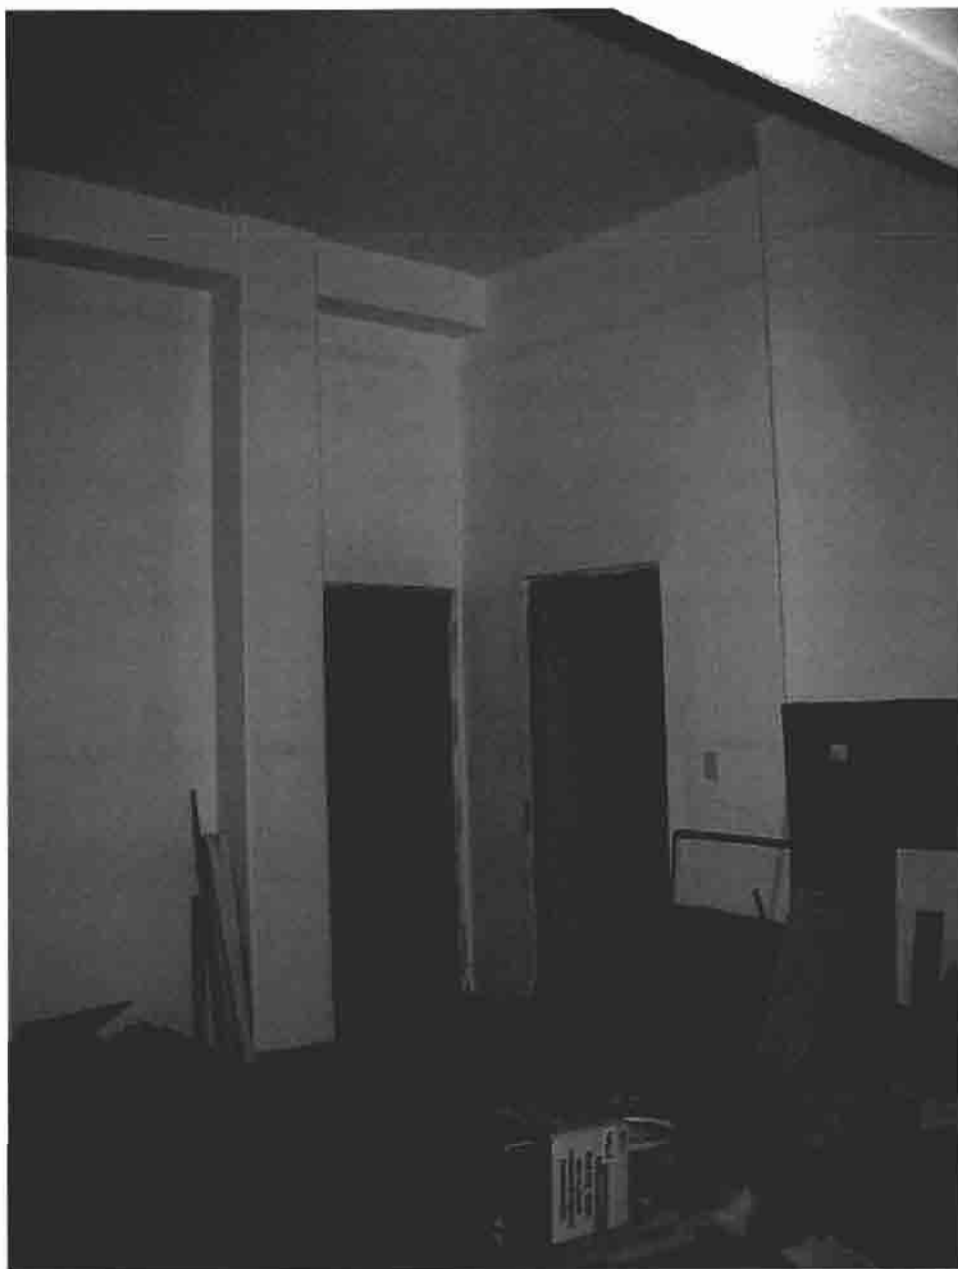
1C-77: Room 106, Men's Cool Room: Southeast Corner. Doors: 102A & 106B. 11/2003

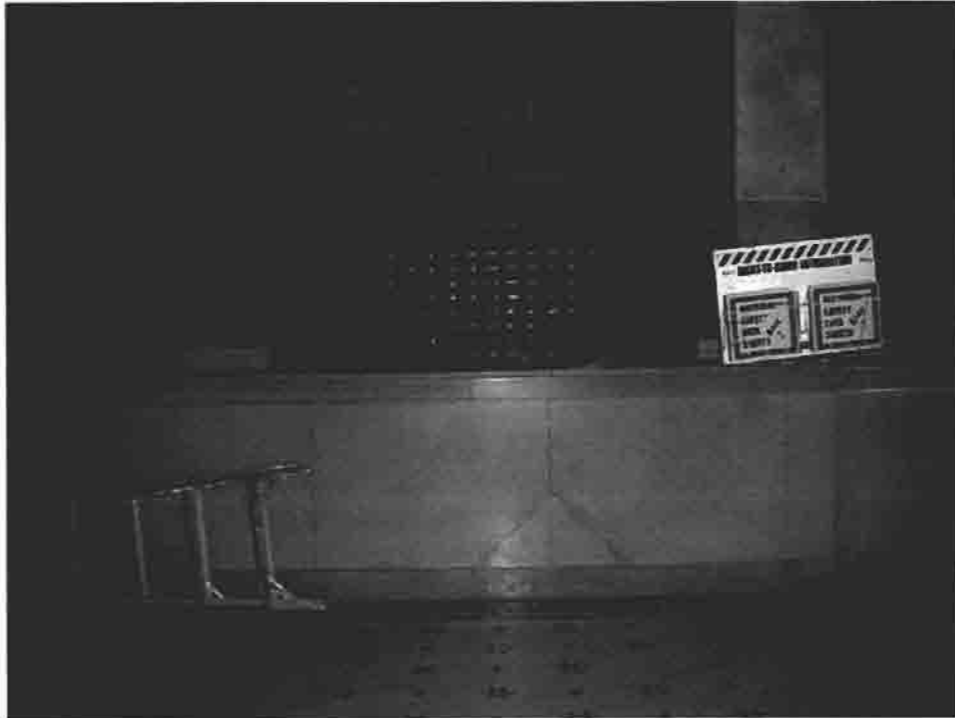
IC-78: Room 107, Lobby and Sun Parlor: East Wall. Marble counter and key holder against wall. 11/2003 (See historic photo 1B-7.)

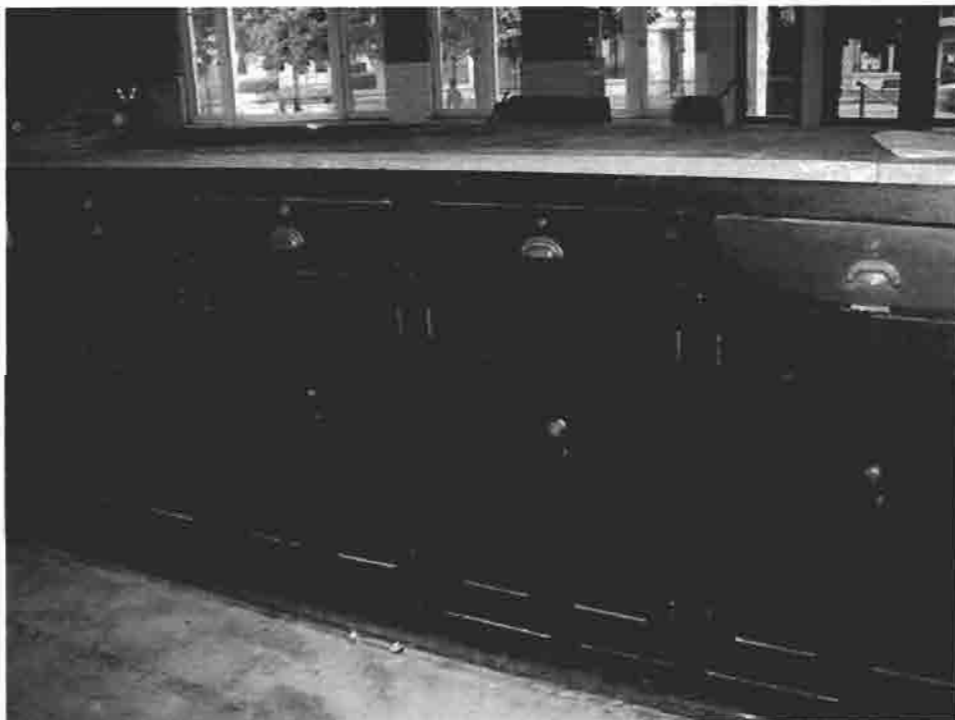
IC-79: Room 107, Lobby and Sun Parlor: Detail of consierge's side of counter with west wall in background. Windows: 131, 132, 134. Door: 107A. 11/2003

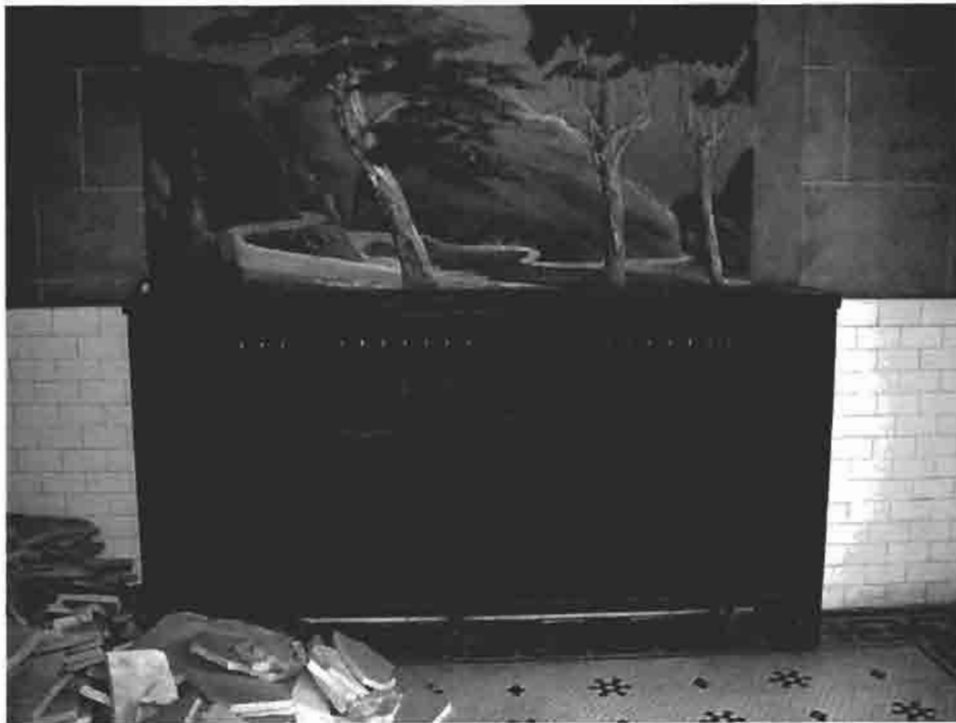
1C-80: Room 107, Lobby and Sun Parlor: Detail of Mural, found on the south portion of the east wall. 11/2003 (See historic photo 1B-6.)

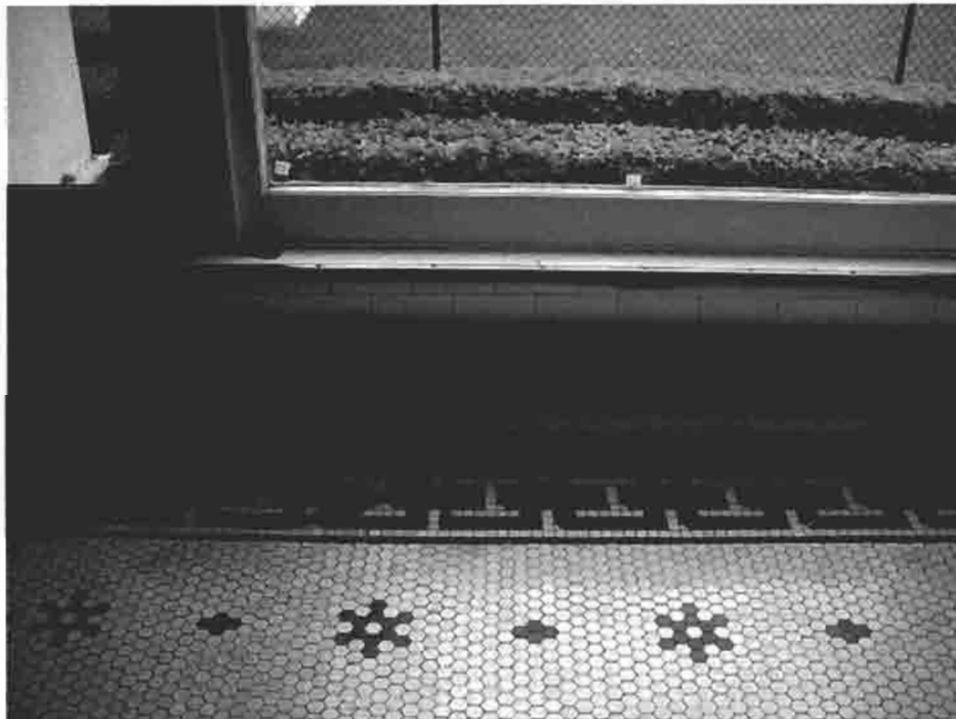
1C-81: Room 107, Lobby and Sun Parlor: Detail of base at west wall. 11/2003

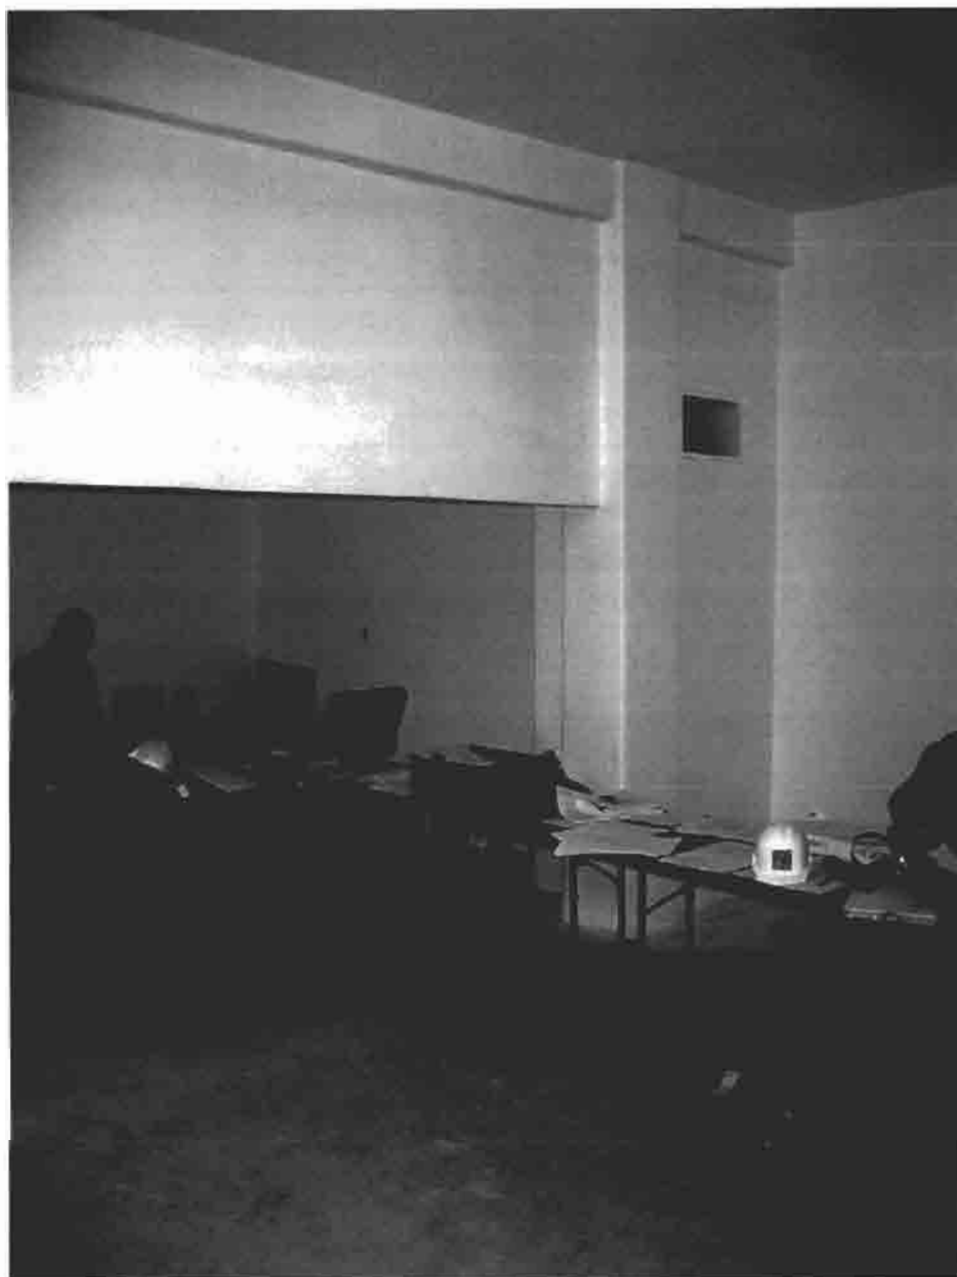
1C-82: Room 108, Women's Cool Room: Northwest Corner. 11/2003
(See historic photo 1B-10.)

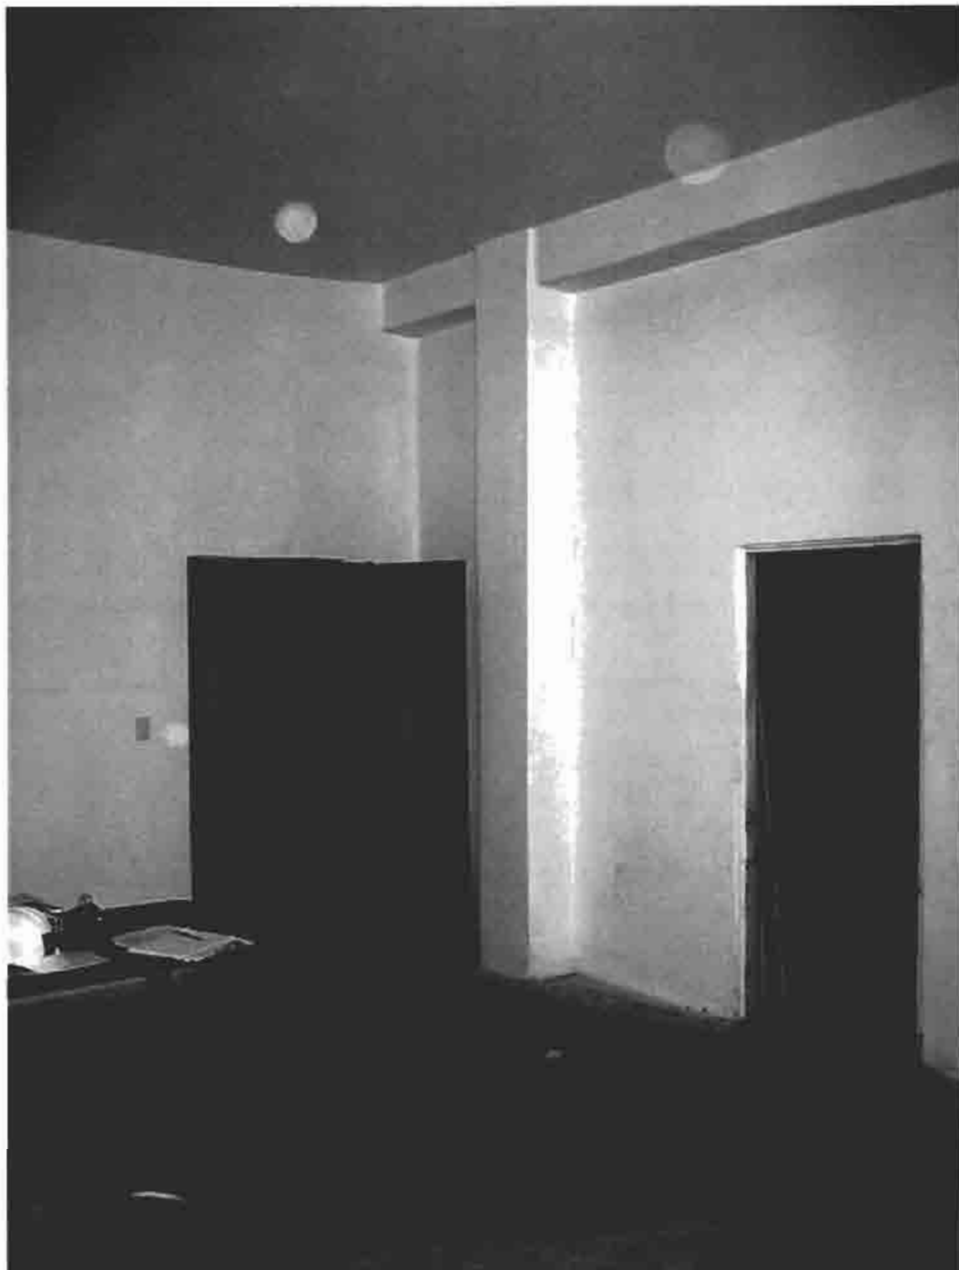
1C-83: Room 108, Women's Cool Room, Northeast Corner: Note original door along east wall. Doors: 108A & 108B. 11/2003

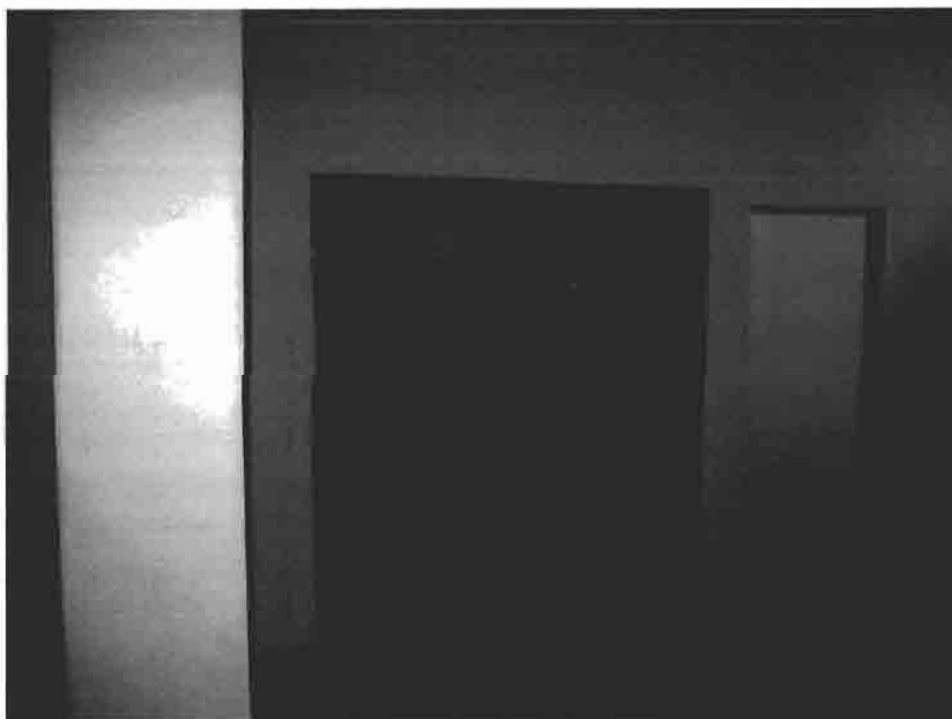
1C-85: Room 109, Women's Pack Room: South end of east wall. Door: 109B. 11/2003

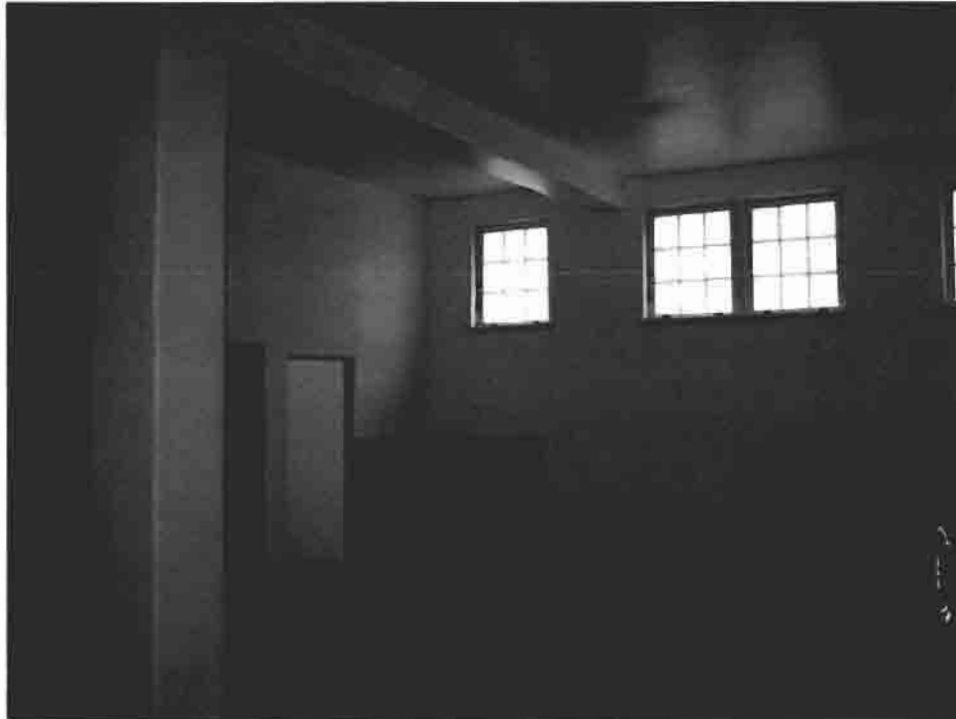
1C-86: Room 109, Women's Pack Room: Southeast Corner. Door: 109B. Windows: 123 & 124. 11/2003

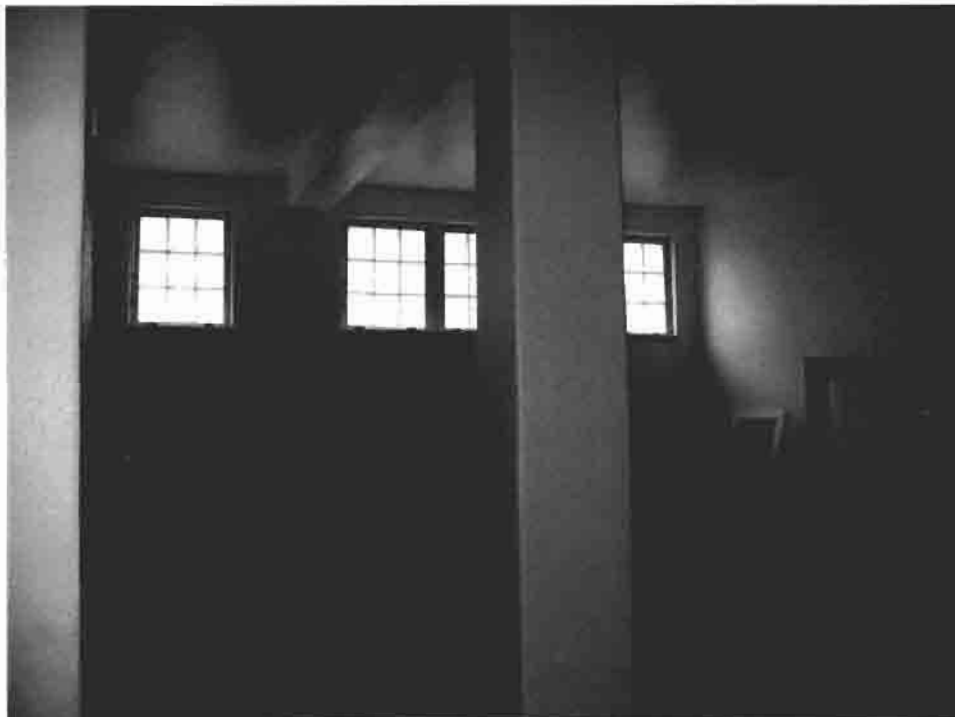
1C-87: Room 109, Women's Pack Room: South wall to southwest corner. Windows: 123, 124 & 125. Door: 108B. 11/2003

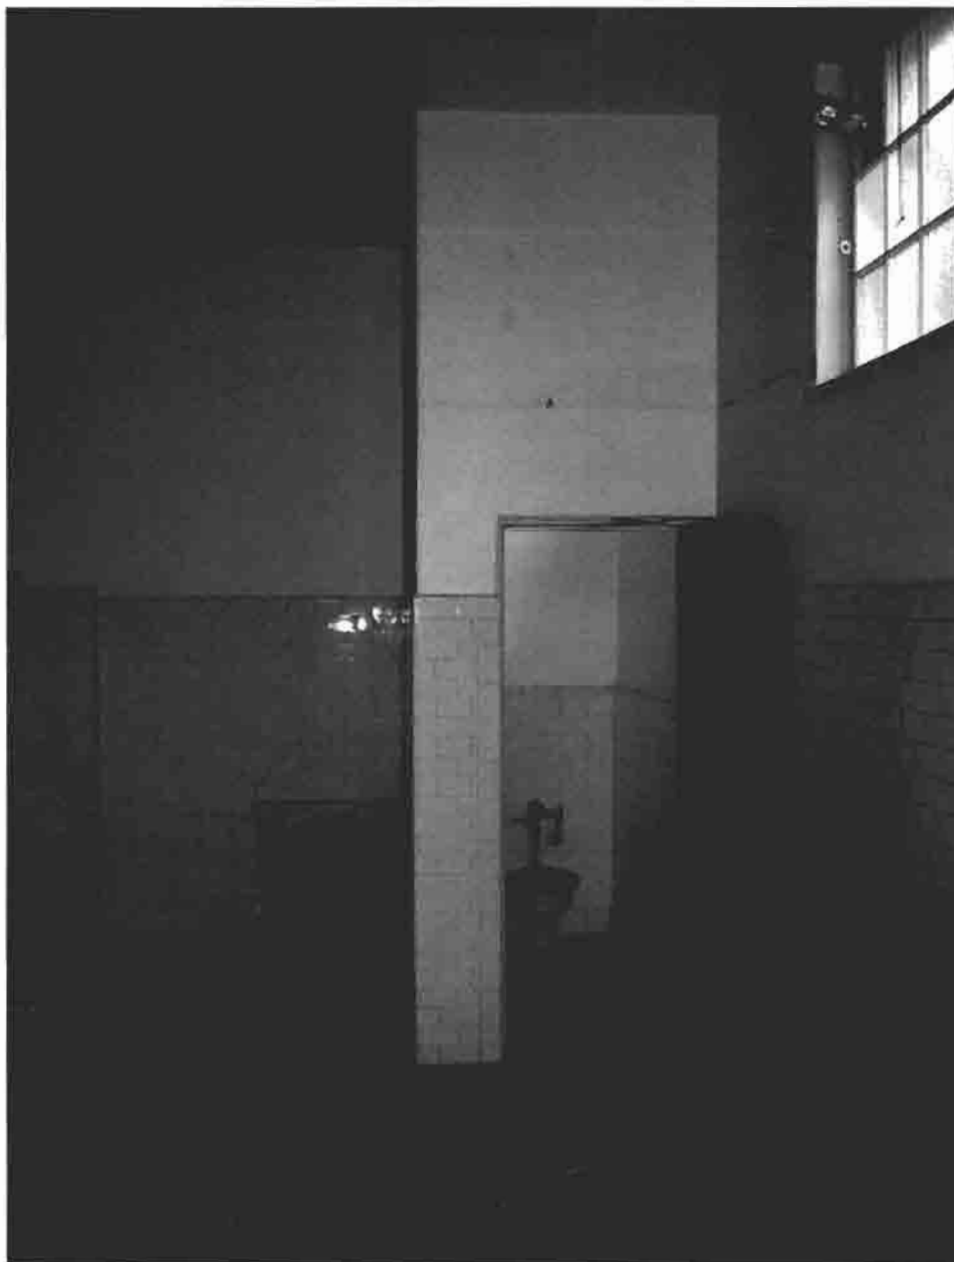
1C-91: Room 110, Women's Bath Hall: North wall in northeast corner looking into adjoining restroom. Note: Ceramic tile wainscot in restroom is lower than Bath Hall: Door: 110B. Window: 117. 11/2003

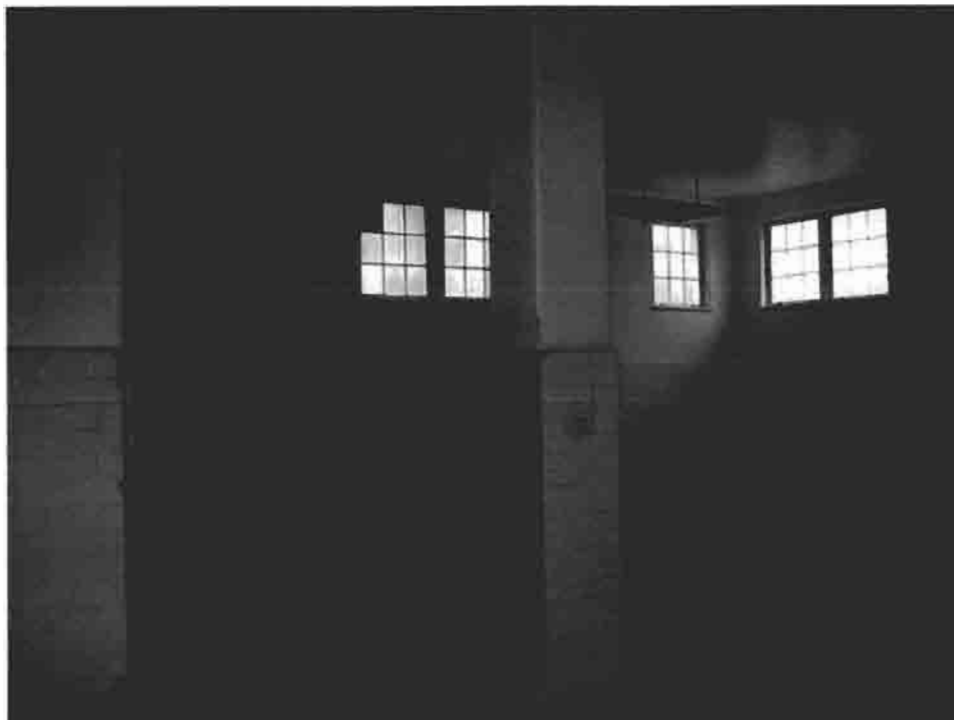
IC-92: Room 110, Women's Bath Hall: East wall to southeast corner. Door: 110B, Windows: 117, 118 & 119. 11/2003

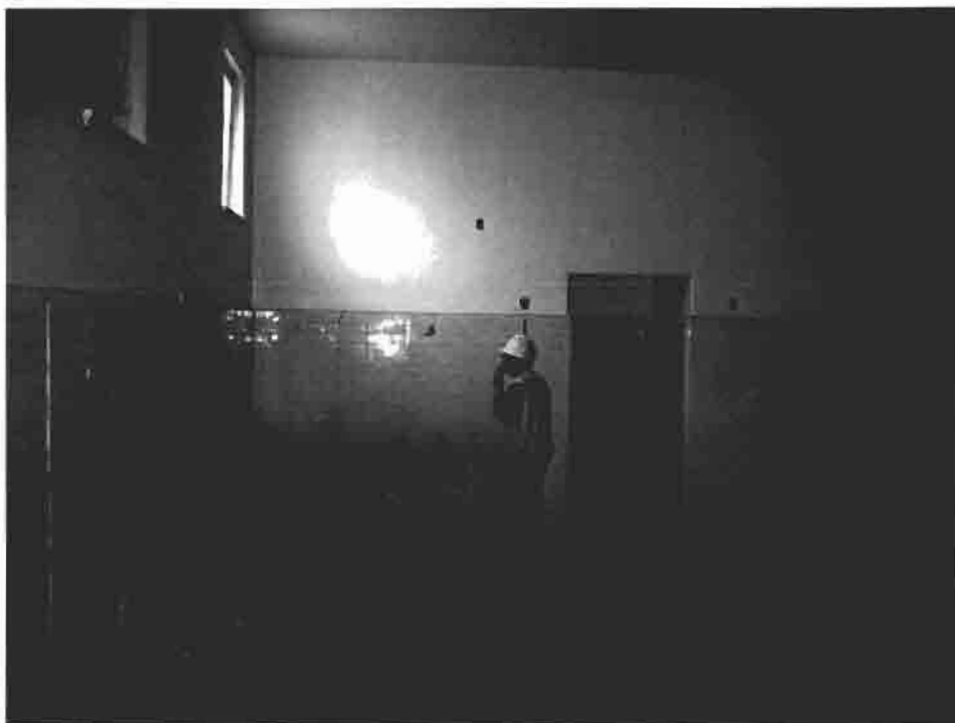
1C-94: Room 110, Women's Bath Hall: Southwest corner to west wall. Windows: 120 (boarded up) & 121. 11/2003

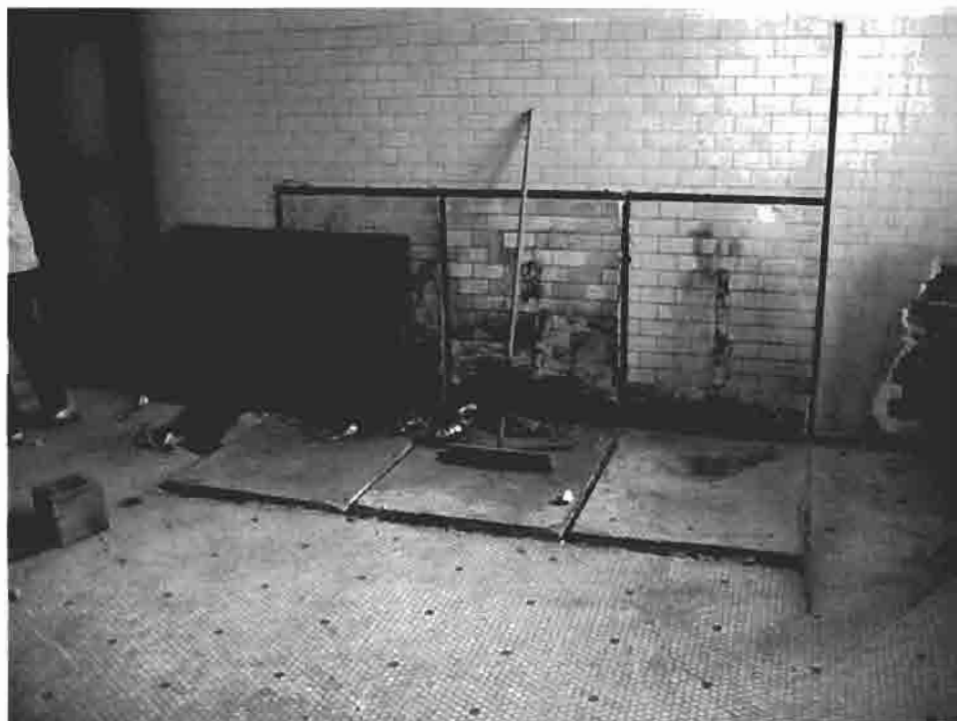
1C-95: Room 110, Women's Bath Hall, East Elevation: The remainder of the steam cabinet's tile bases. Door: 108. 11/2003

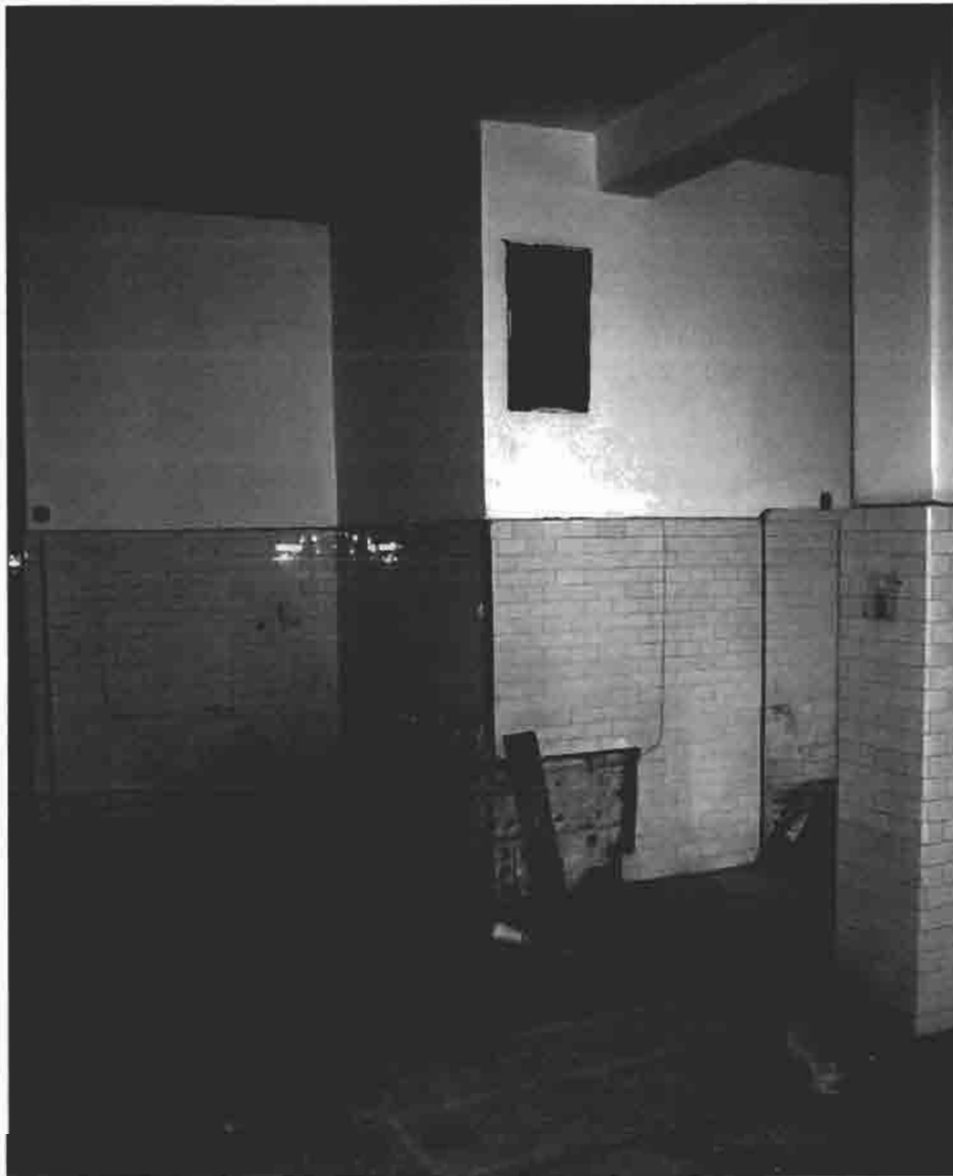
1C-96: Room 110, Women's Bath Hall: Detail: Northeast corner on west end of north wall. 11/2003

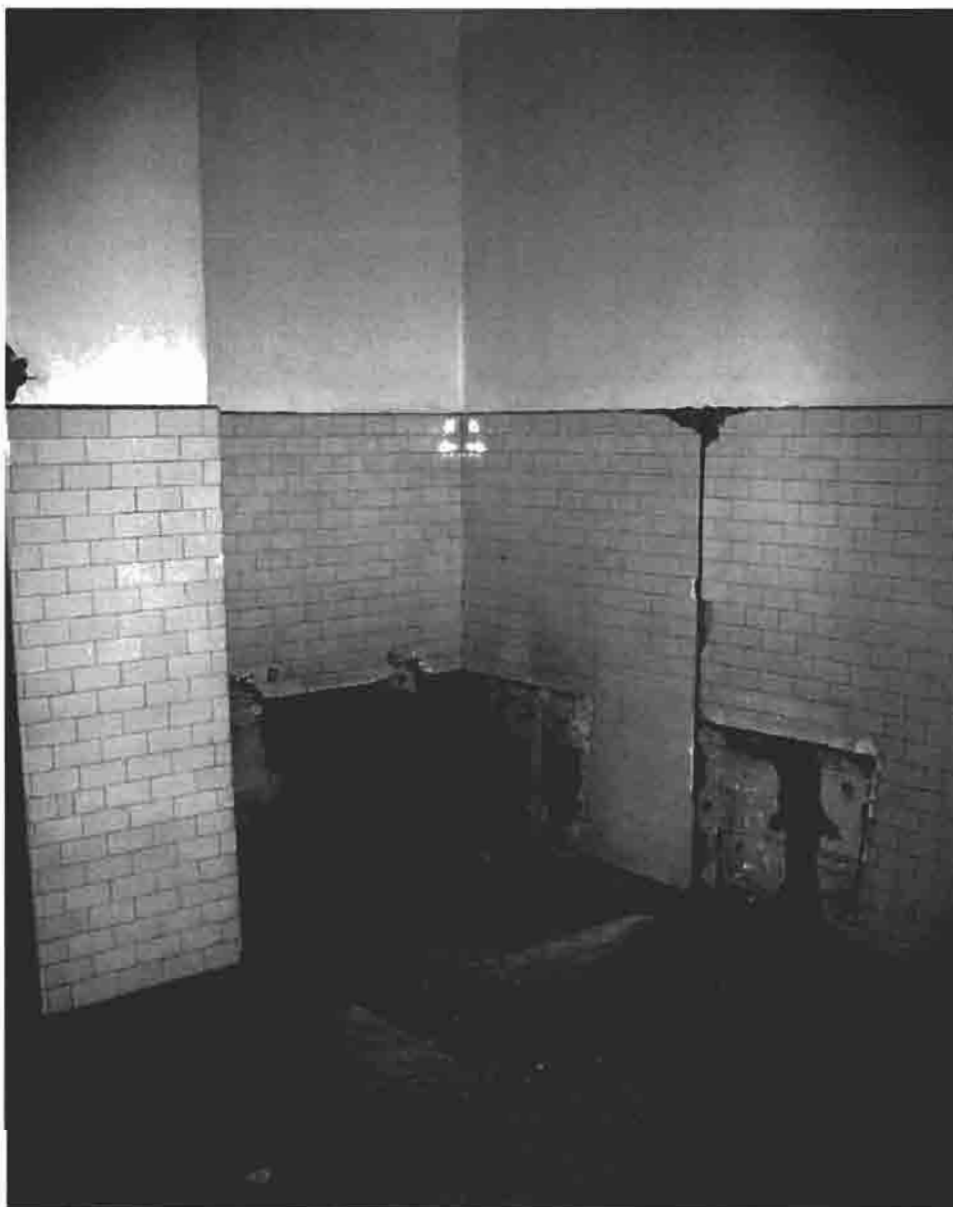
1C-97: Room 110, Women's Bath Hall: Southwest alcove near Door 109A to Women's Pack Room. 11/2003

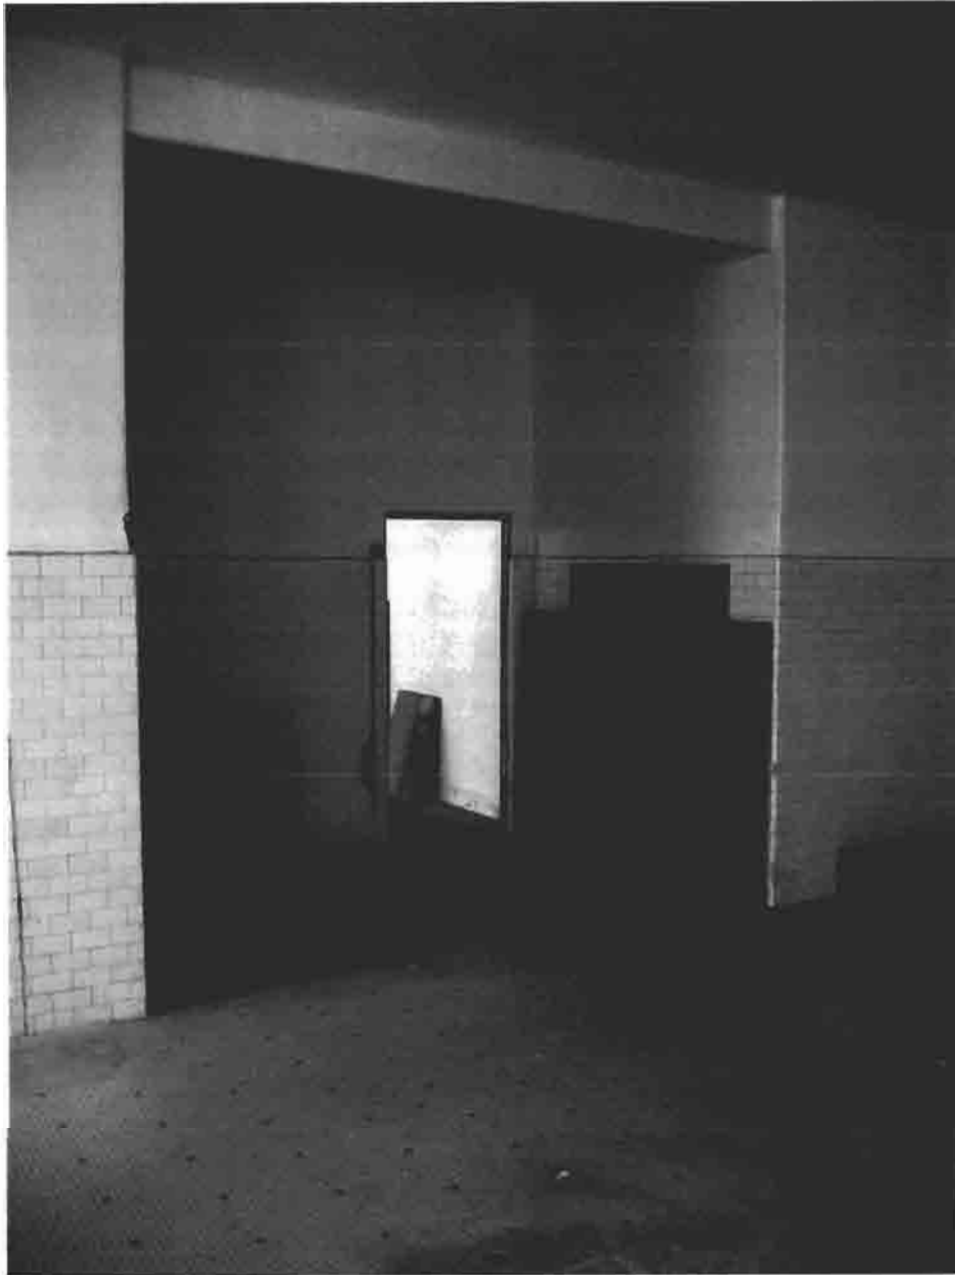
1C-98: Room 110, Women's Bath Hall: West Wall. Door to Room 109, Women's Pack Room. Door: 109A. 11/2003

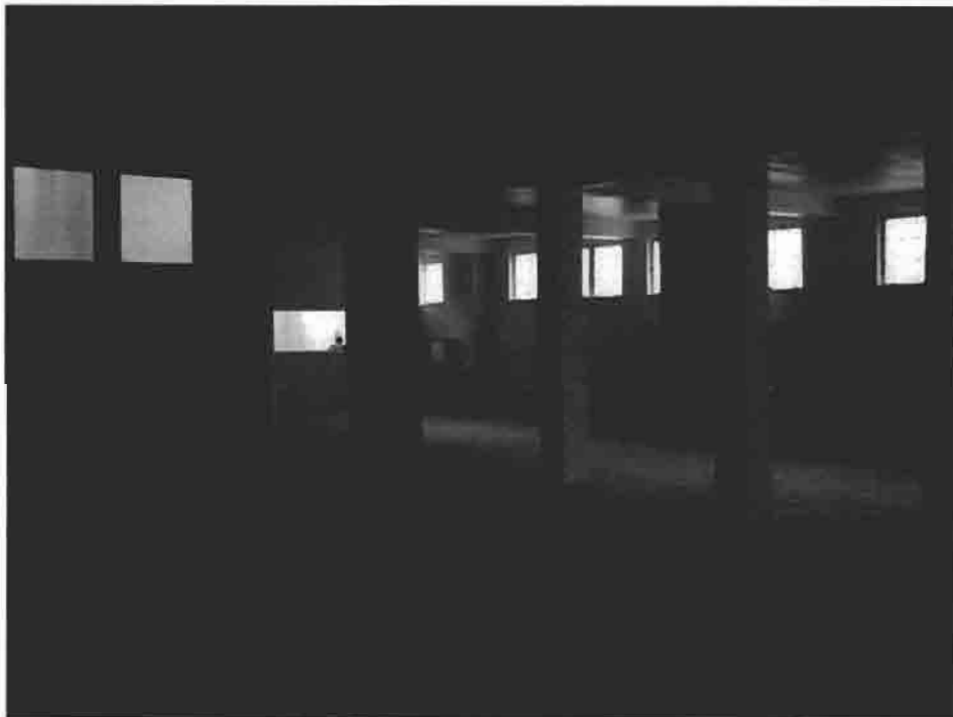
1C-100: Room 201, Men's Dressing Room: Northwest Corner. Windows: Clerestory to stairwell, 203, 204, 205, 206, 207 & 208. 11/2003

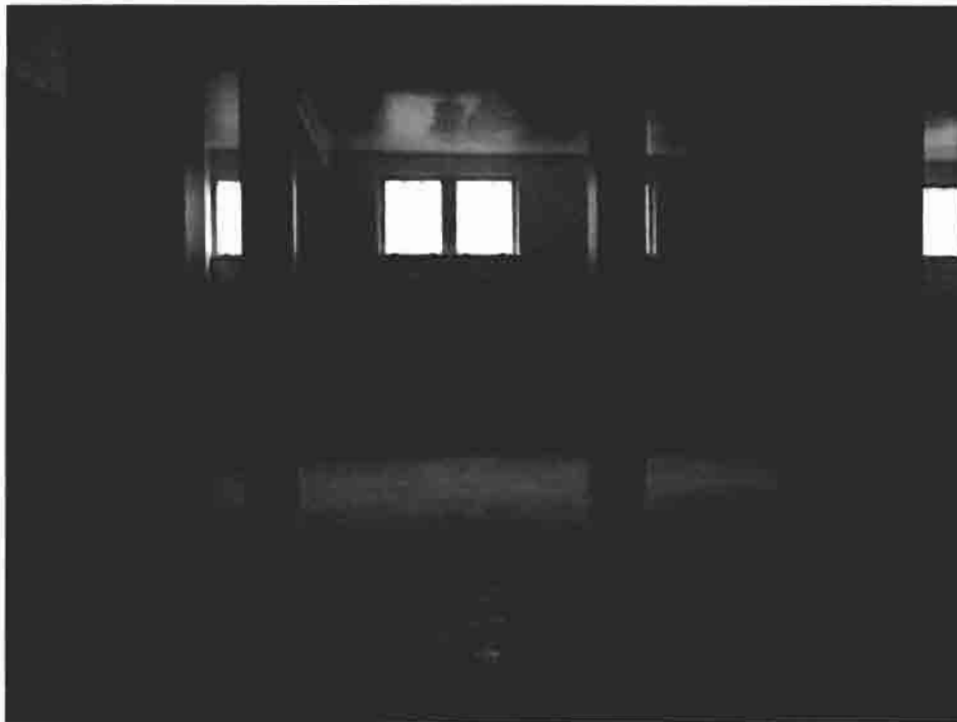
1C-101: Room 201, Men's Dressing Room: North Wall, stair case to left. Windows: 207, 208, 209, & 210. 11/2003
