Lamar Bathhouse

Historic Structure Report

HOT SPRINGS

National Park • Arkansas

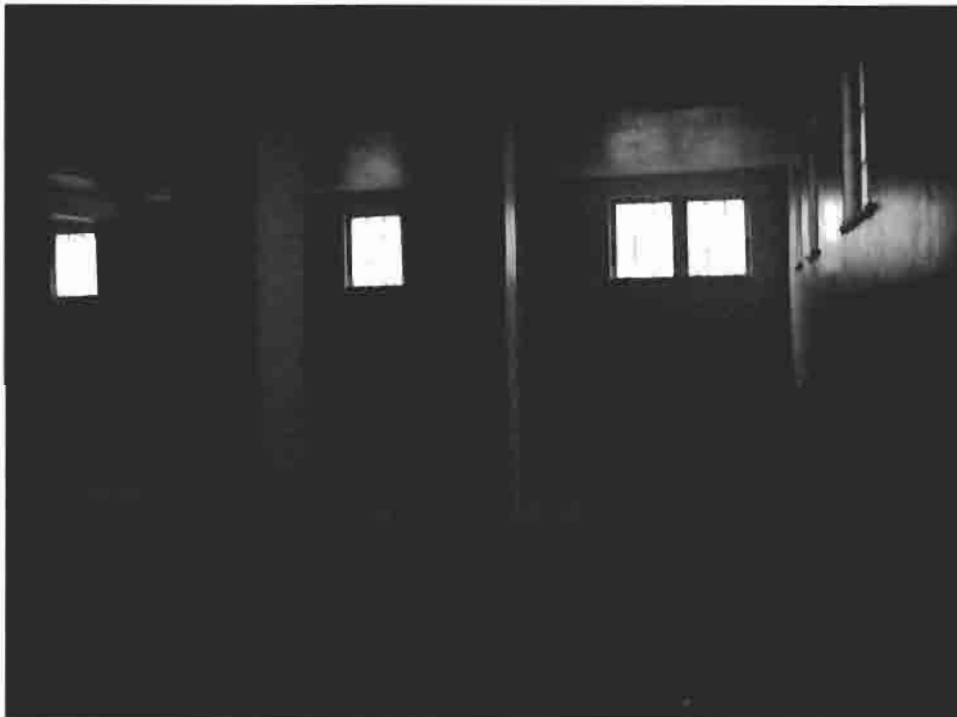
1C-102: Room 201, Men's Dressing Room: North wall at northeast corner. Windows: 207, 208 (concealed behind column), 209, 210, 211, 212 213. 11/2003

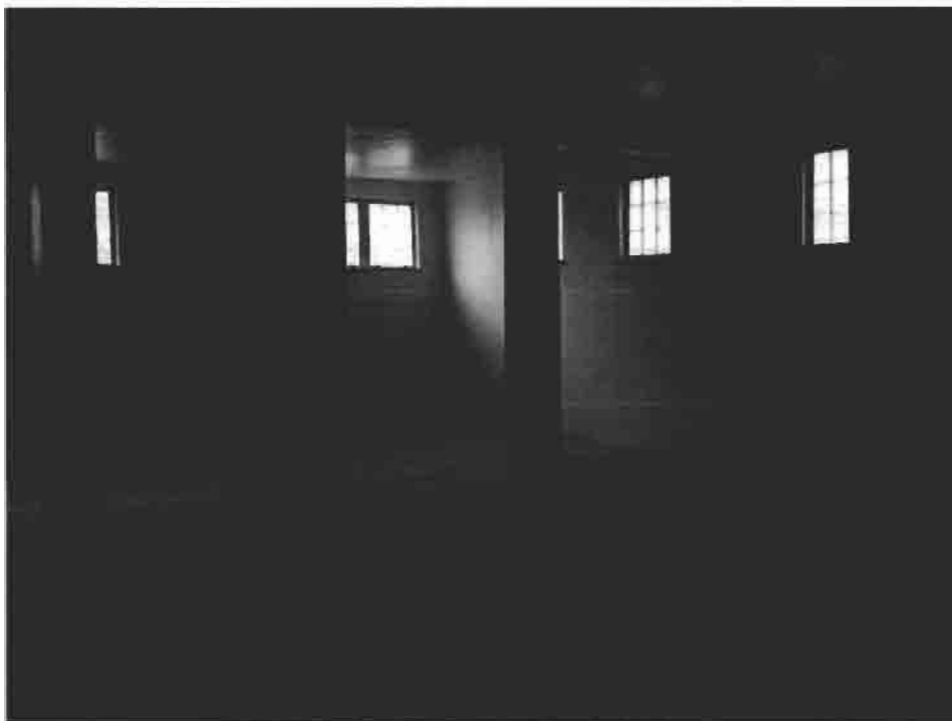
1C-103: Room 201, Men's Dressing Room: Northeast Corner. Windows: 209, 210, 211, 212 & 213. 11/2003

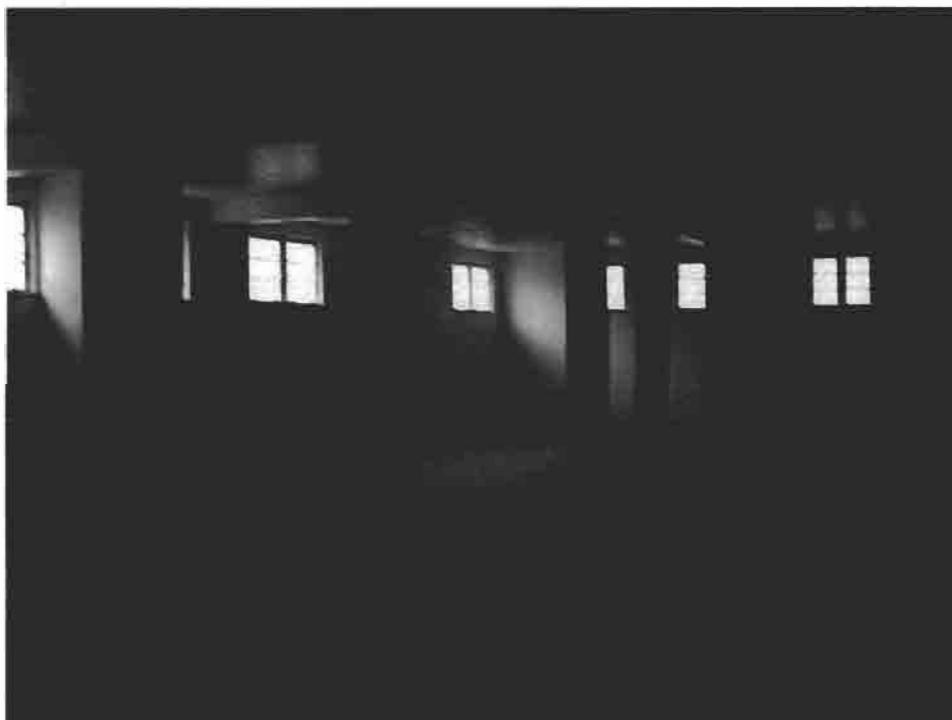
1C-104: Room 201, Men's Dressing Room: North wall to northeast corner. Windows: 206, 207, 208, 209 (concealed behind column) 210, 211, 212 & 213. 11/2003

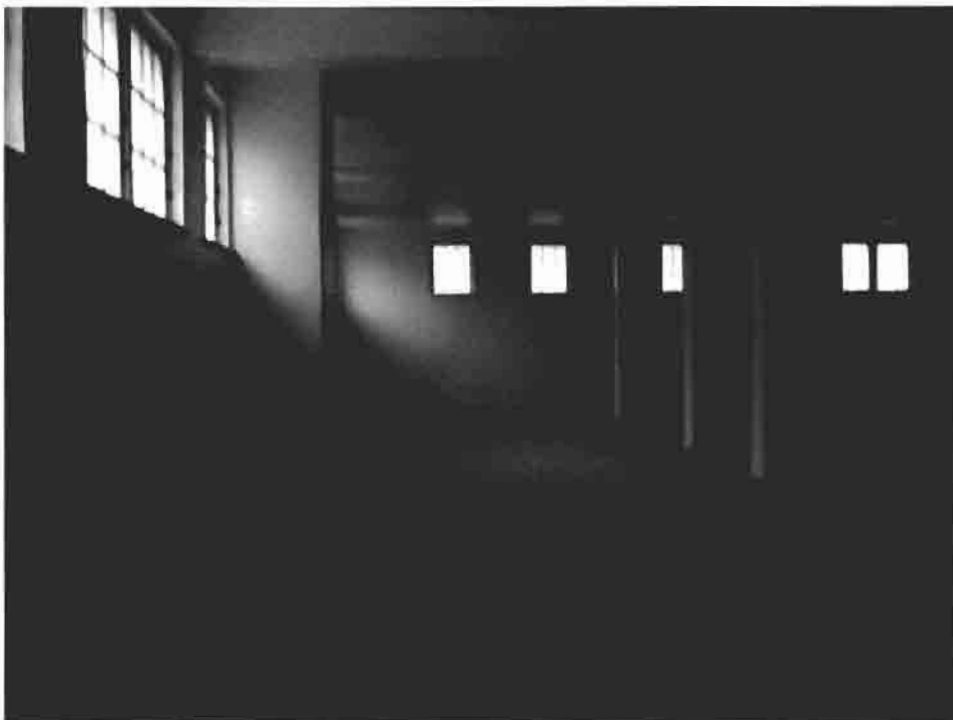
1C-105: Room 201, Men's Dressing Room: North wall to east wall. Windows: 205, 206, 211, 212, 213 & 214. 11/2003

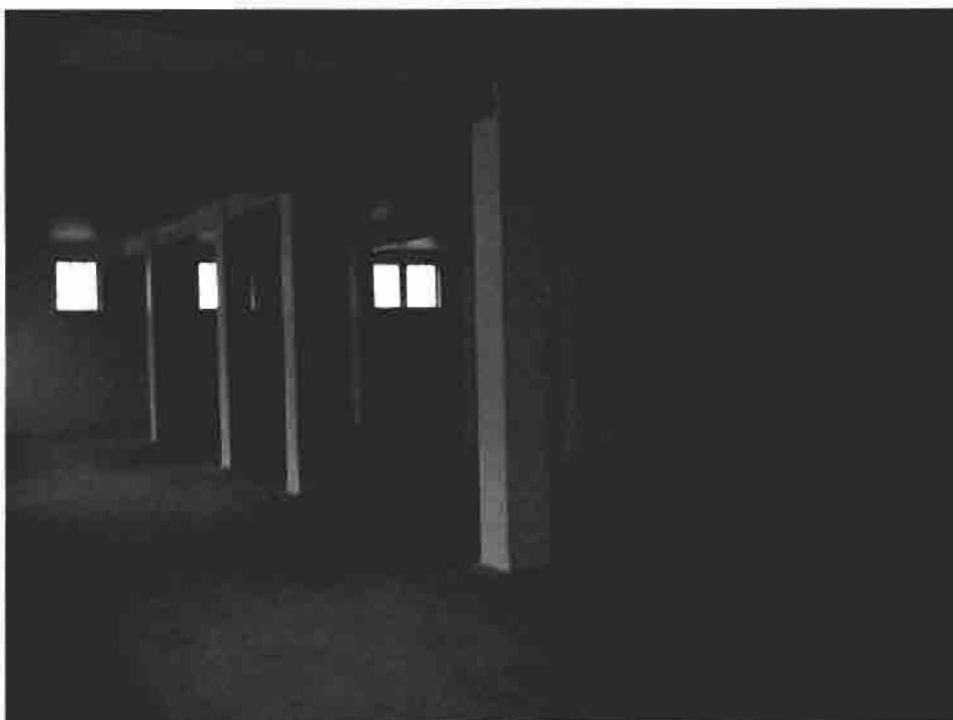
1C-106: Room 201, Men's Dressing Room, Southeast Corner. Windows: 212, 213, & 214. 11/2003

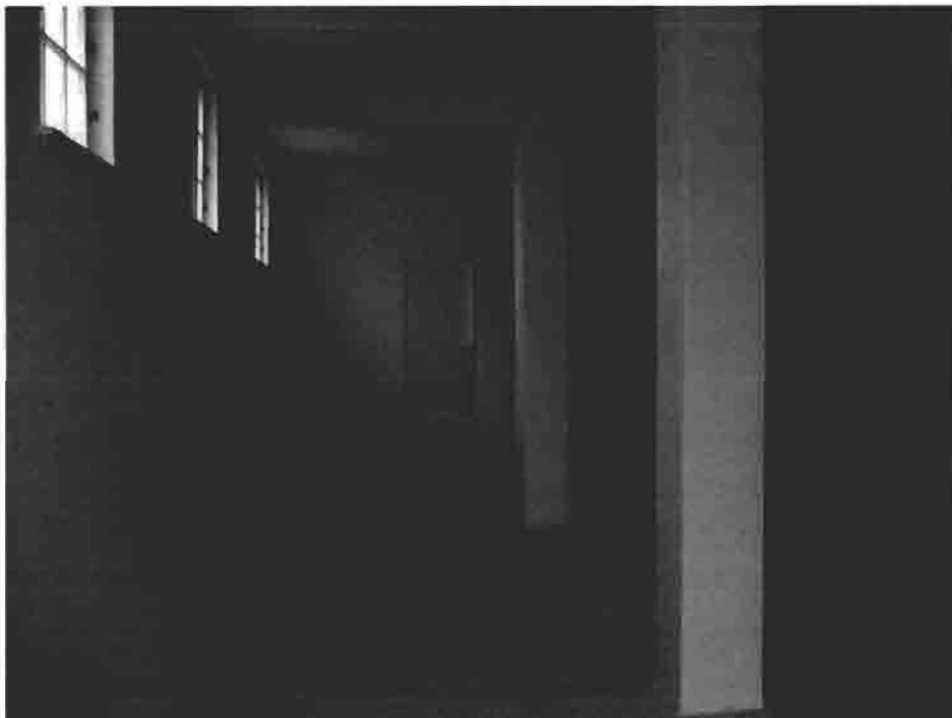
1C-108: Room 201, Men's Dressing Room: Southeast corner into Room 202, Toilet. Windows: 212, 213, & 214. Door: 202. 11/2003

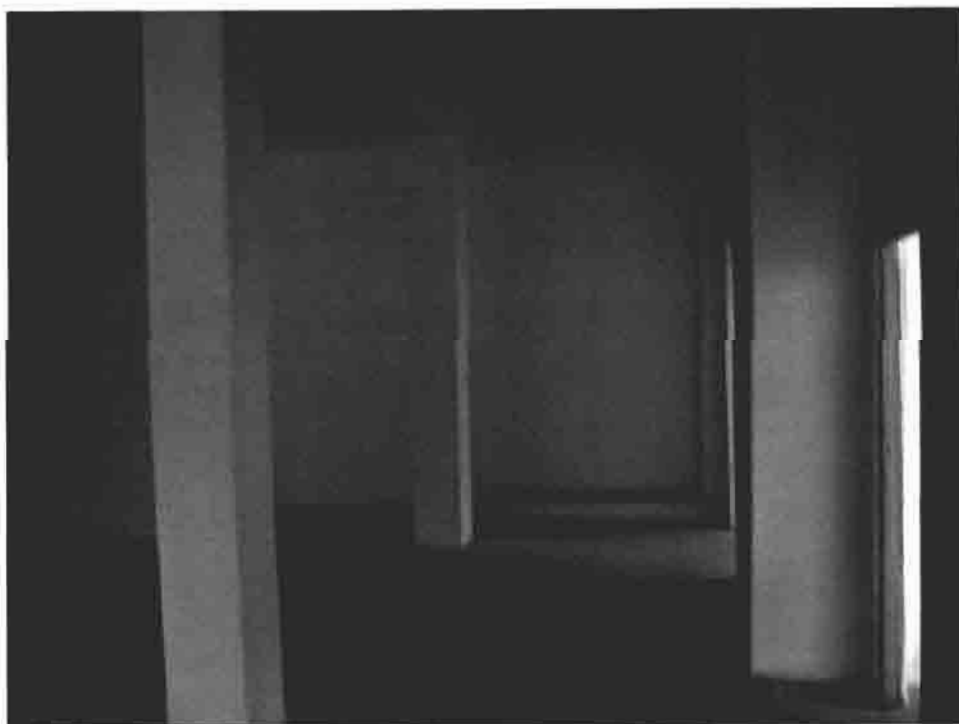
IC-110: Room 201, Men's Dressing Room: South wall at southwest corner. Doors: 210B & 211A. 11/2003

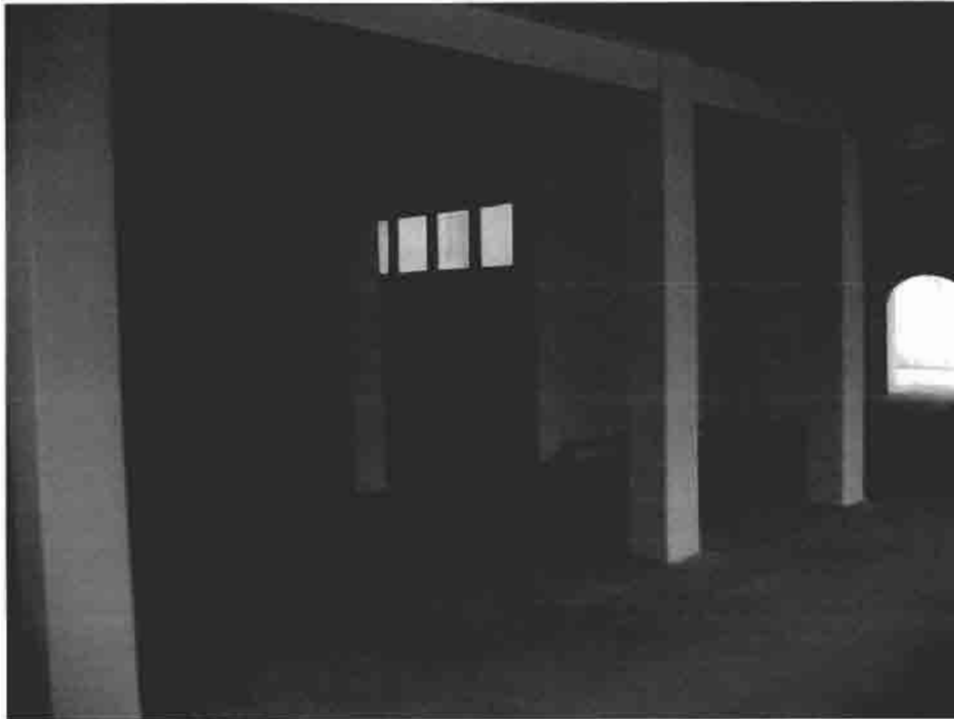
1C-111: Room 201, Men's Dressing Room: Southwest Corner. Windows: Clerestory leading into stairwell. Door: 210B. 11/2003

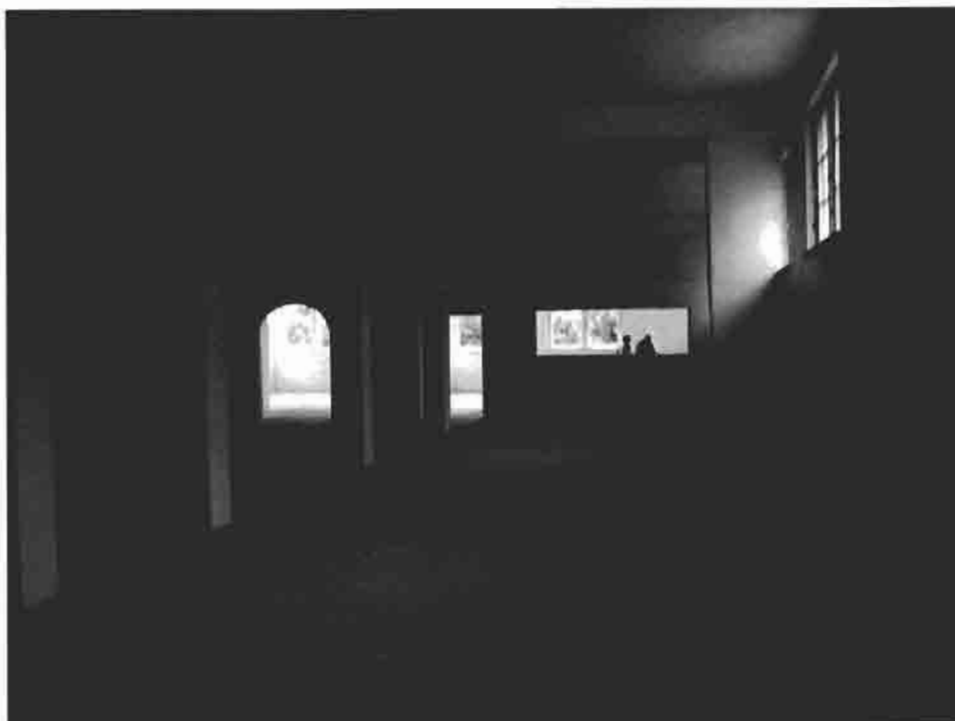
1C-113: Room 201, Men's Dressing Room: West Wall to northwest corner. Doors: 210B & 211A. Windows: 207 & 208, and window to room 211. 11/2003

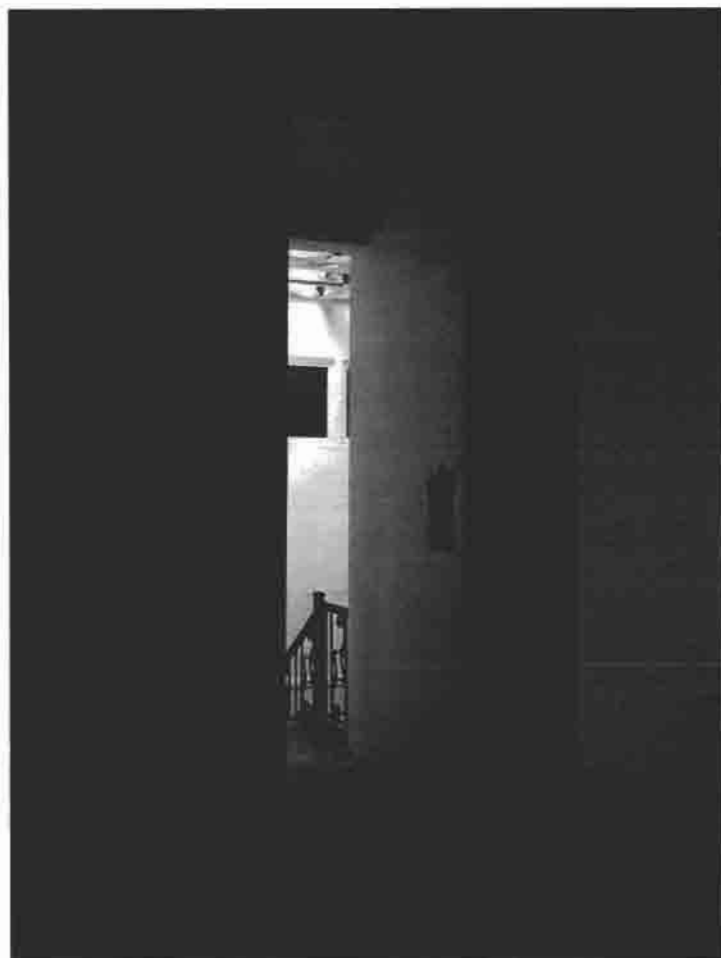
1C-114: Room 201, Men's Dressing Room: Looking into stairwell. Clerestory windows can be seen on far wall. 11/2003

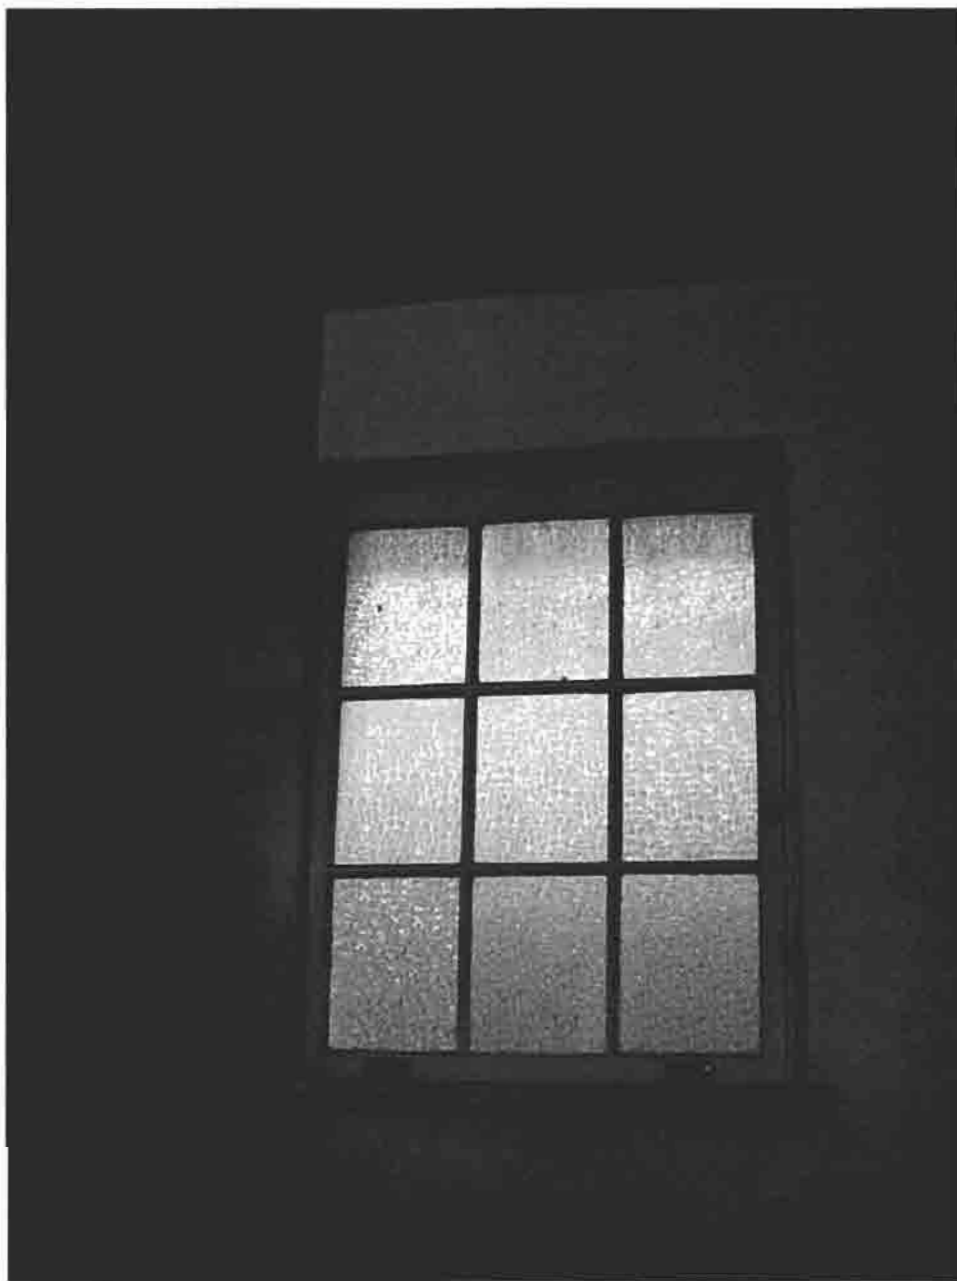
1C-115: Room 201, Men's Dressing Room: Window 203, bisected at the muntin by the wall of the Men's Massage Room. Window sash & hardware are typical of windows on this floor. 11/2003

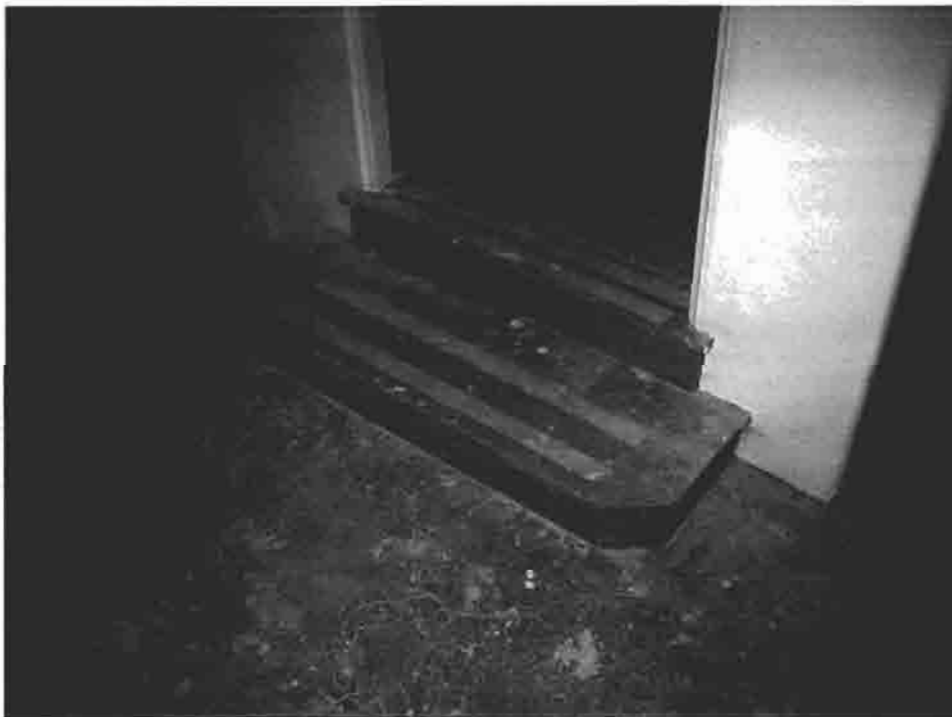
IC-117: Room 201, Men's Dressing Room: Marble steps into Room 202, Toilet. Note: Room 202 floor has hexagonal tiles. 11/2003

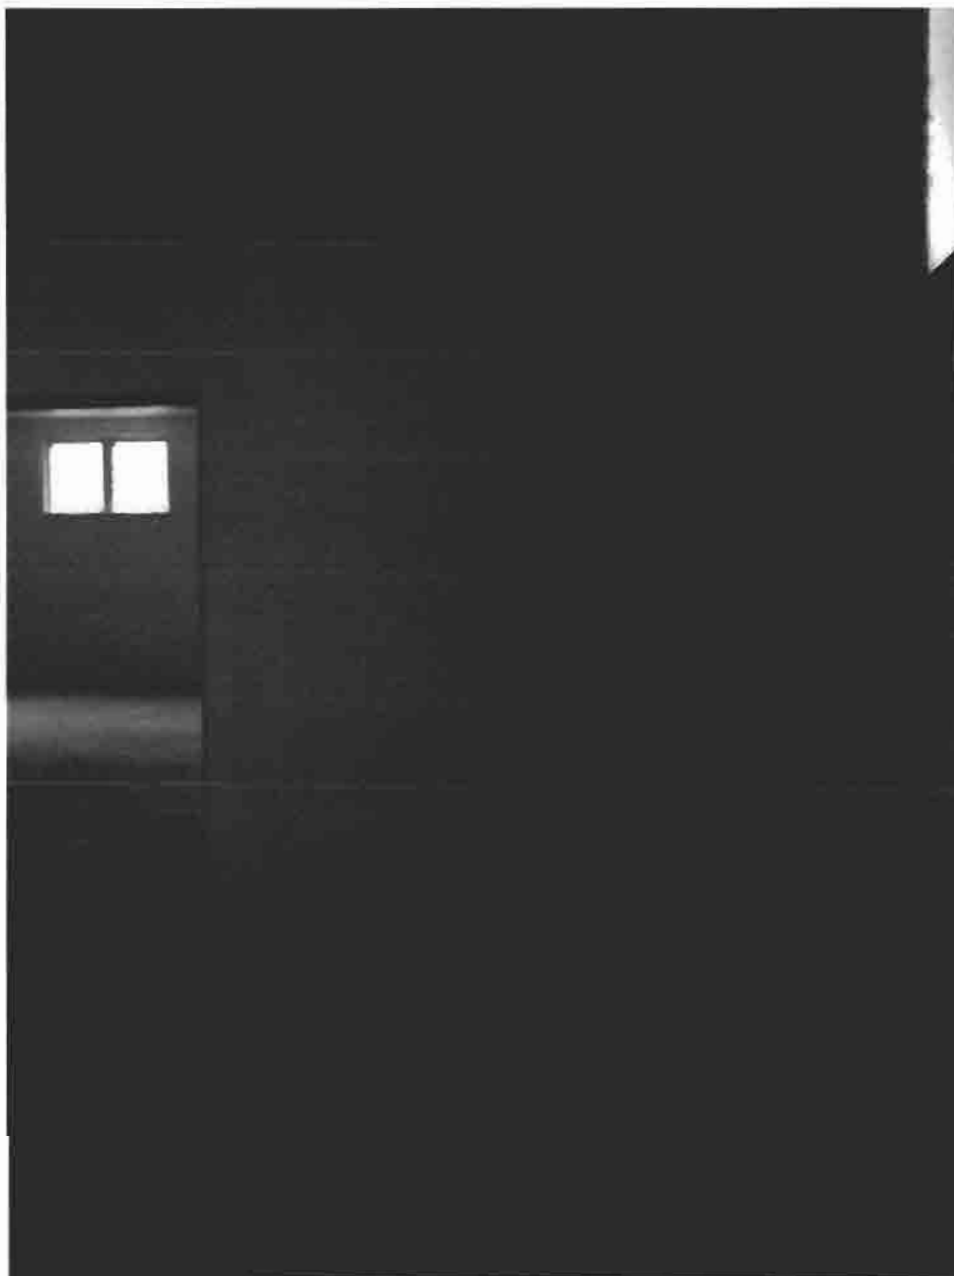
1C-118: Room 202, Toilet: North wall through Door 202 to northeast corner. 11/2003

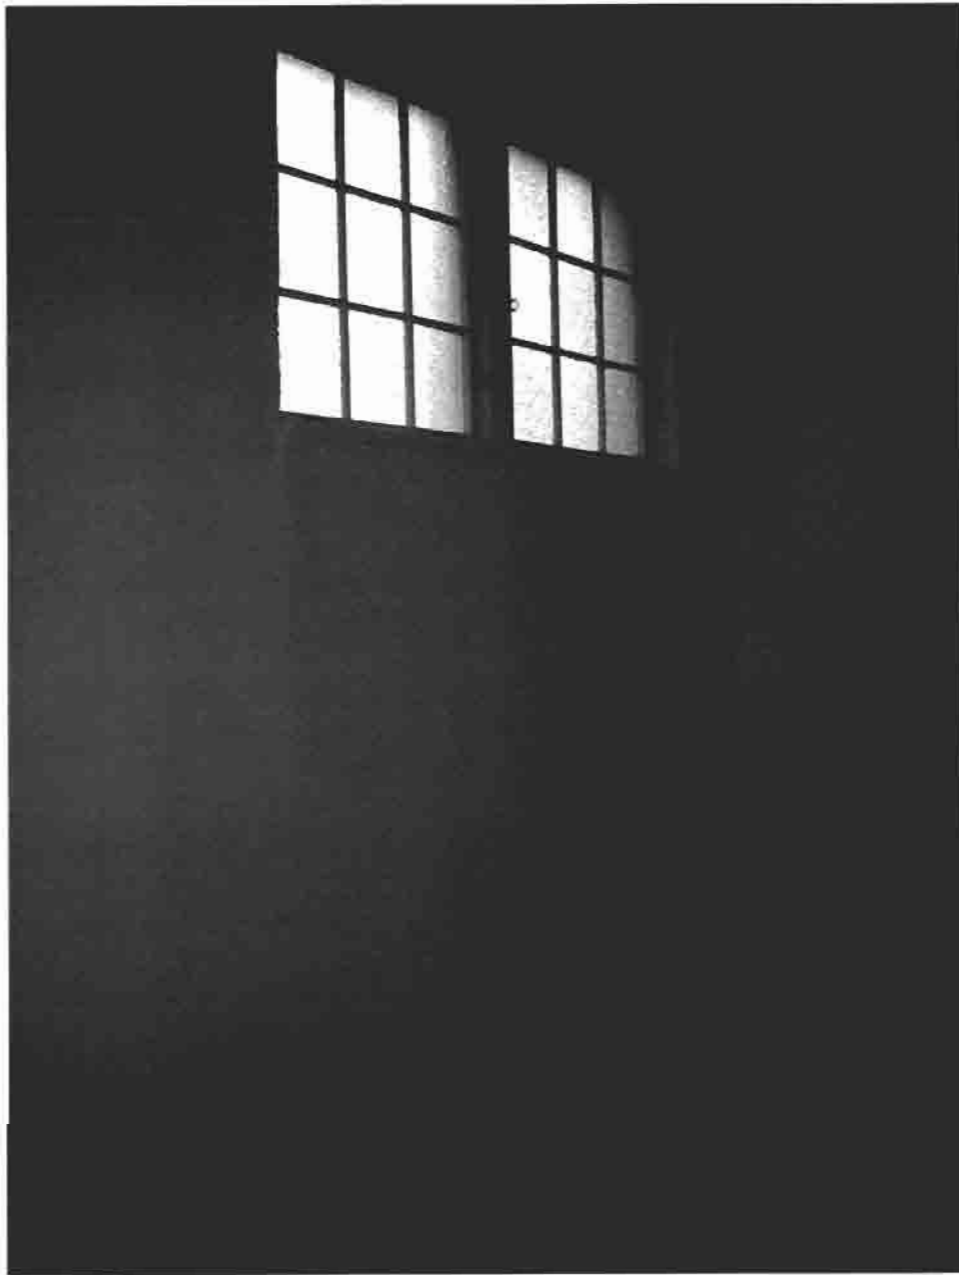
IC-119: Room 202, Toilet: East wall to southeast corner: Windows with complete hardware. Window: 215. 11/2003

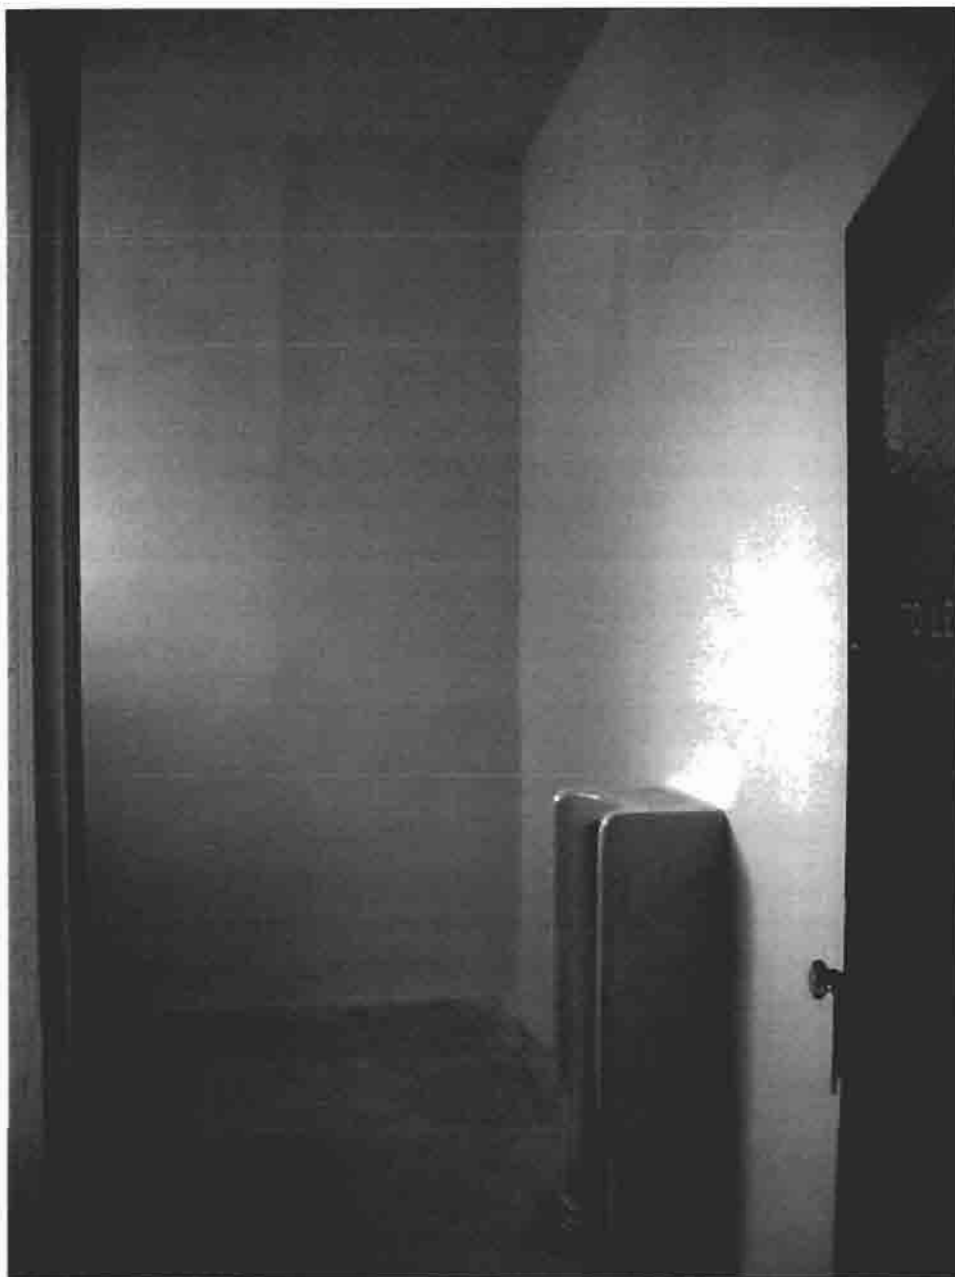
1C-120: Room 202, Toilet: South wall to southwest corner. Note: Original door. 11/2003

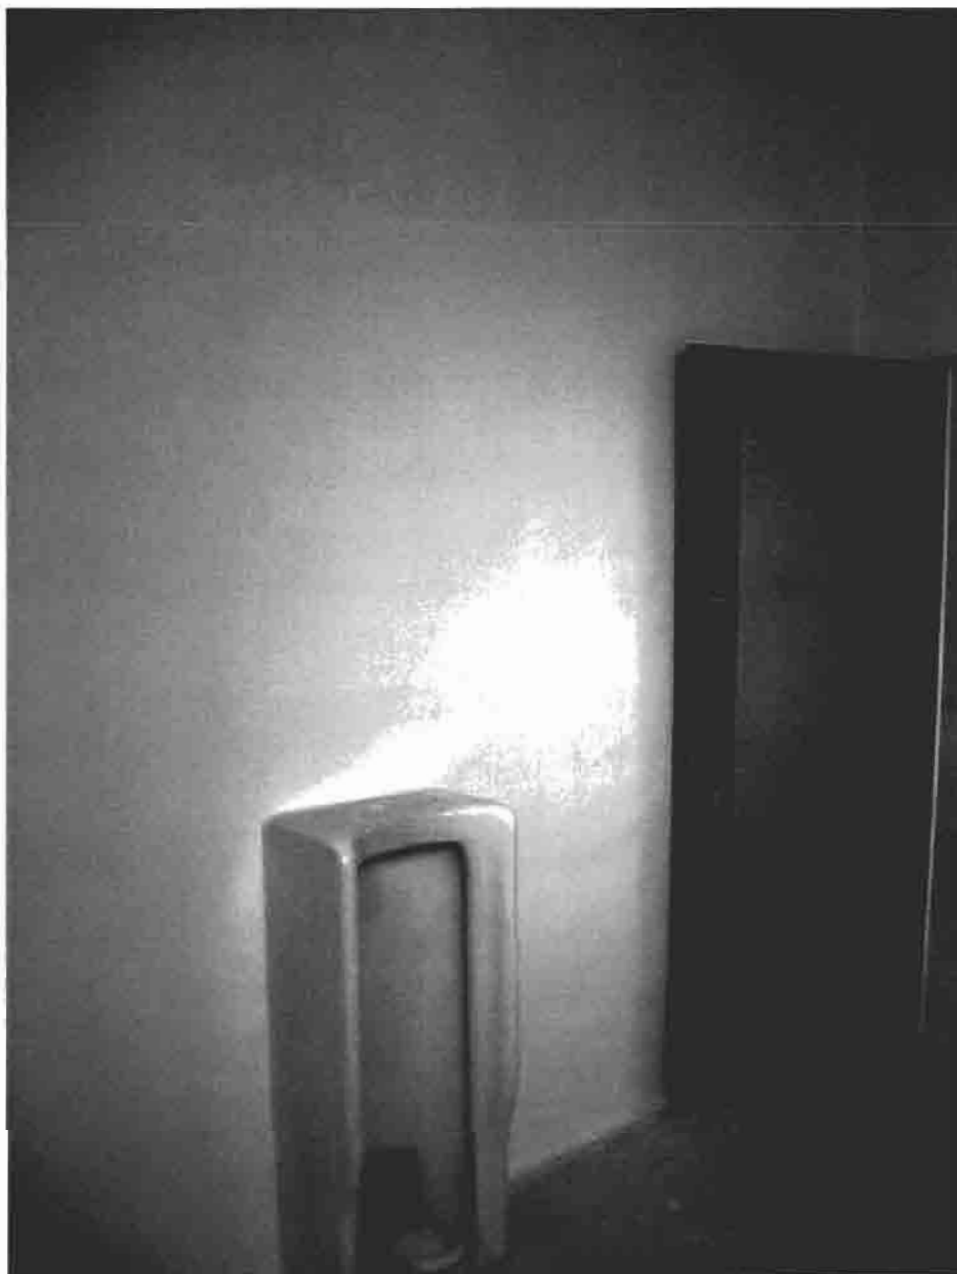
1C-121: Room 202, Toilet: West wall to northwest corner. Door: 202. 11/2003

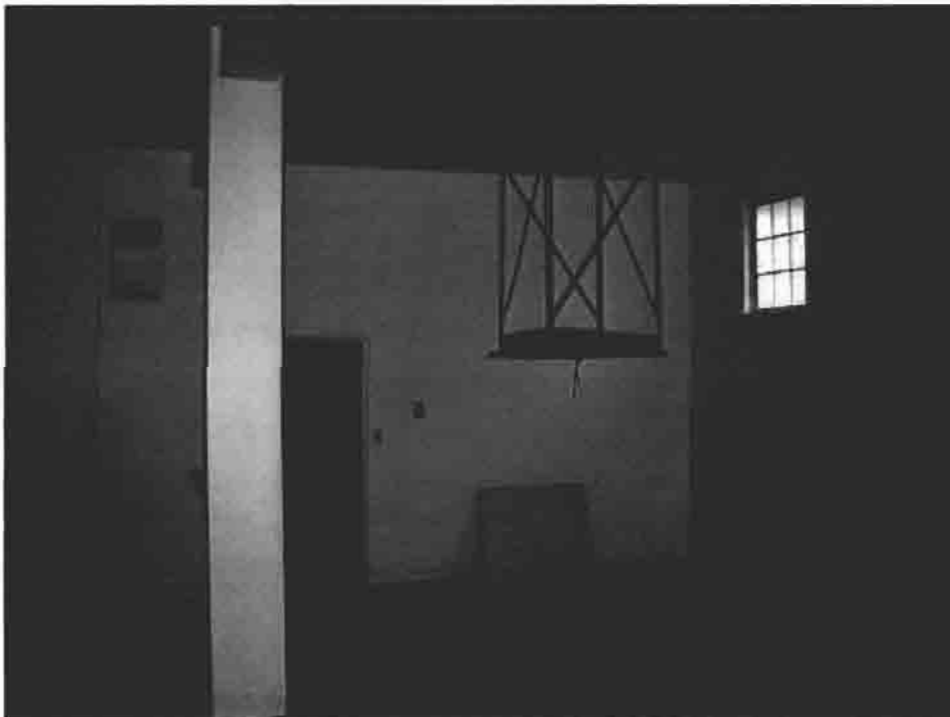
ROOM NUMBER:	204
ROOM NAME:	Gymnasium
FLOOR FINISH:	Wood floor, tongue & groove, varnished long-leaf yellow pine is likely species
WALL BASE:	
WALLS:	
NORTH:	Plaster
EAST:	Plaster
SOUTH:	Plaster
WEST:	Plaster
OTHERS:	Partition walls are plaster over fired clay hollow tiles
CEILING:	Plaster
WINDOWS:	4 - See "Window Conditions Schedule"
DOORS:	2 - See "Door Conditions Schedule"
SPECIAL FEATURE:	The door to the gymnasium is varnished and has wire reinforced translucent glass in a rib pattern. The hardware includes glass entry doorknobs, and a nickel finish push plate. Suspension plates on beam. Platform suspended from ceiling from which "speed bag" was hung. Also remnant signage text, east wall.
KEY CONDITIONS CONCERNS:	
<p>The gymnasium has a varnished wood floor, with damaged wood in the northeast corner of the room.</p>

1C-123: Room 204, Gymnasium: North wall to northeast corner. Door: 204. Window:
216. 11/2003

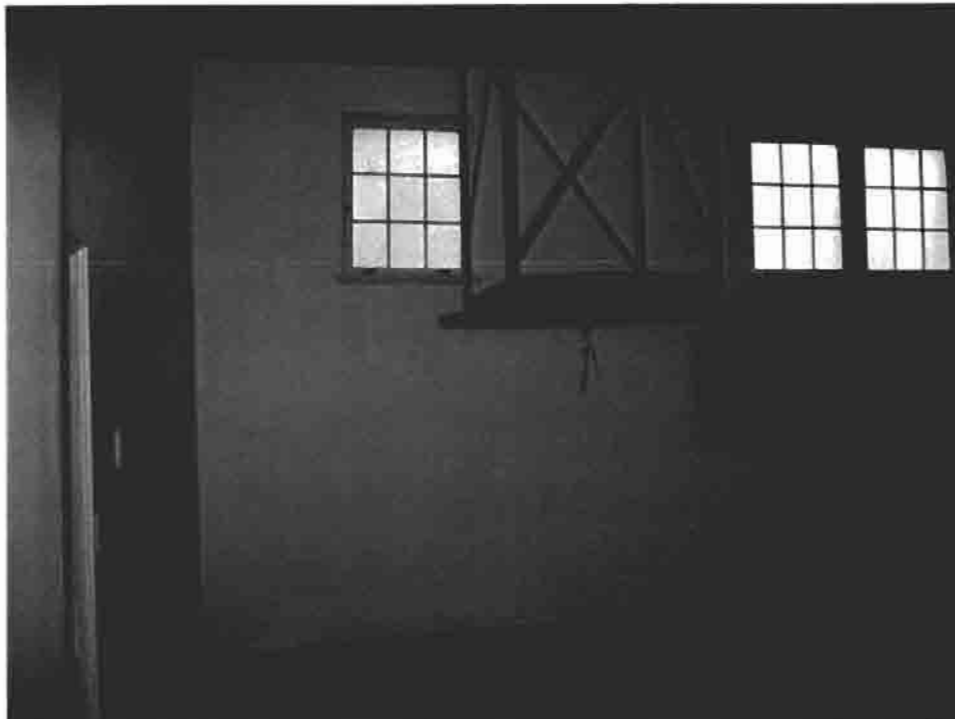
1C-124: Room 204, Gymnasium: Northeast corner to east wall. Note: Remnant signage.
Door: 204. Windows: 216 & 217. 11/2003

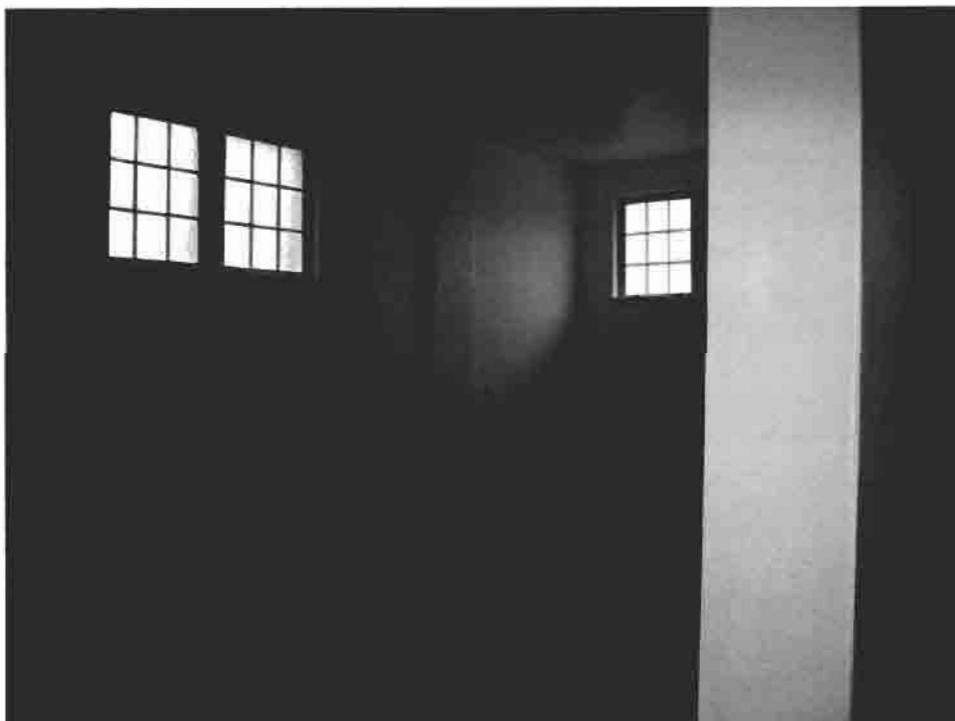
1C-125: Room 204, Gymnasium: East wall to southeast corner. Windows: 217 & 218.
11/2003

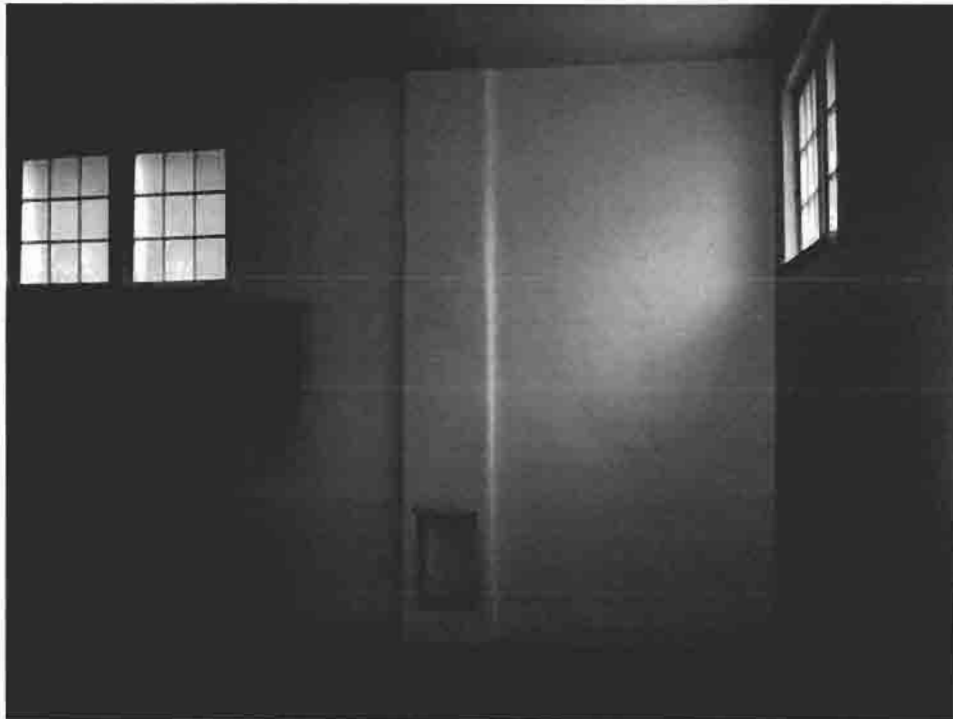
IC-126: Room 204, Gymnasium: East wall to southeast corner. Windows: 217 & 218. 11/2003

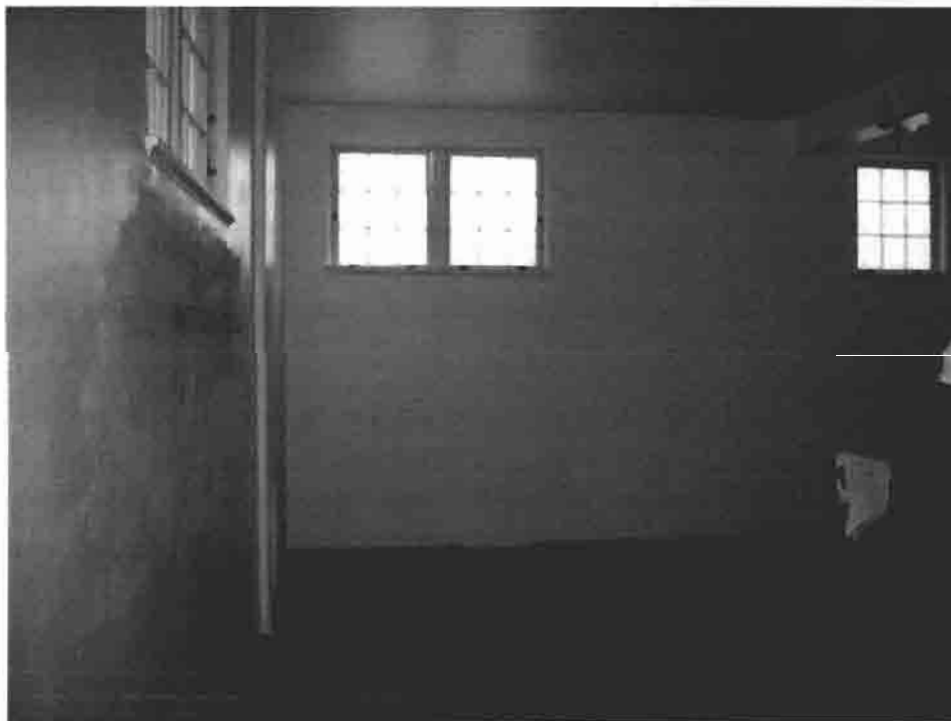
IC-127: Room 204, Gymnasium: South Wall. Windows: 217, 218 & 219. 11/2003

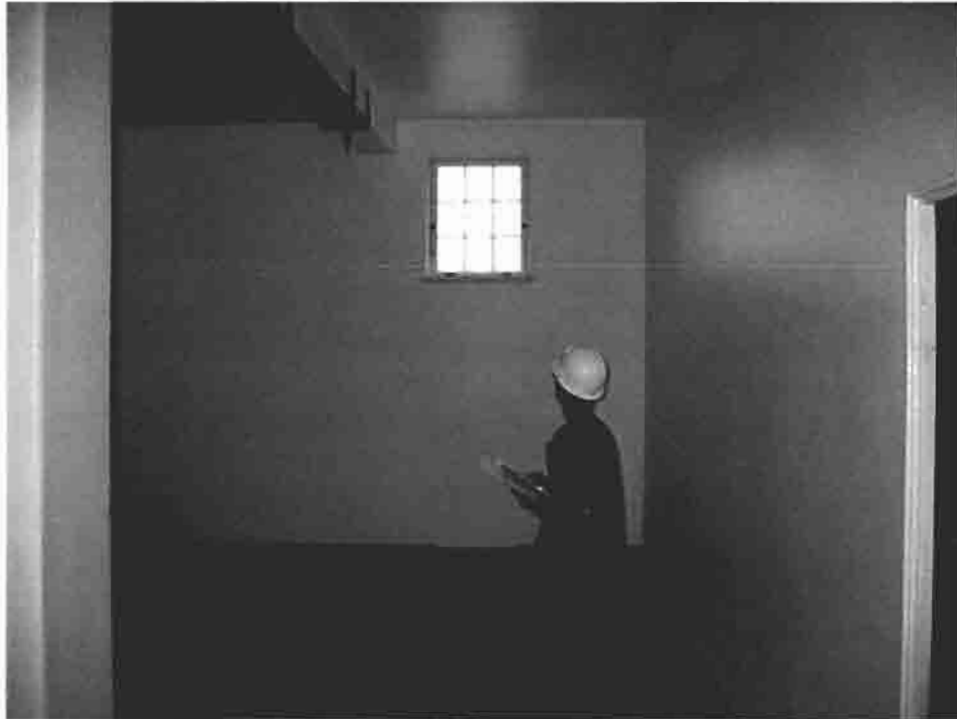
IC-128: Room 204, Gymnasium: South Wall to southwest corner: Note: Suspension plates on beam. Window: 219. Door: 207. 11/2003

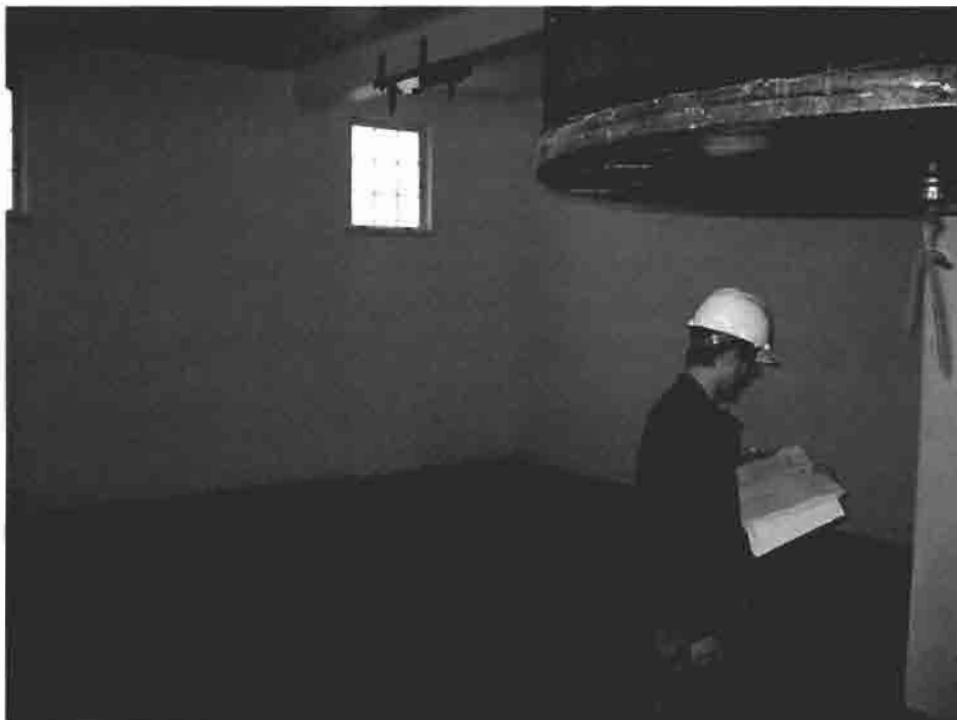
IC-129: Room 204, Gymnasium: Southwest Corner. Windows: 218 & 219. 11/2003

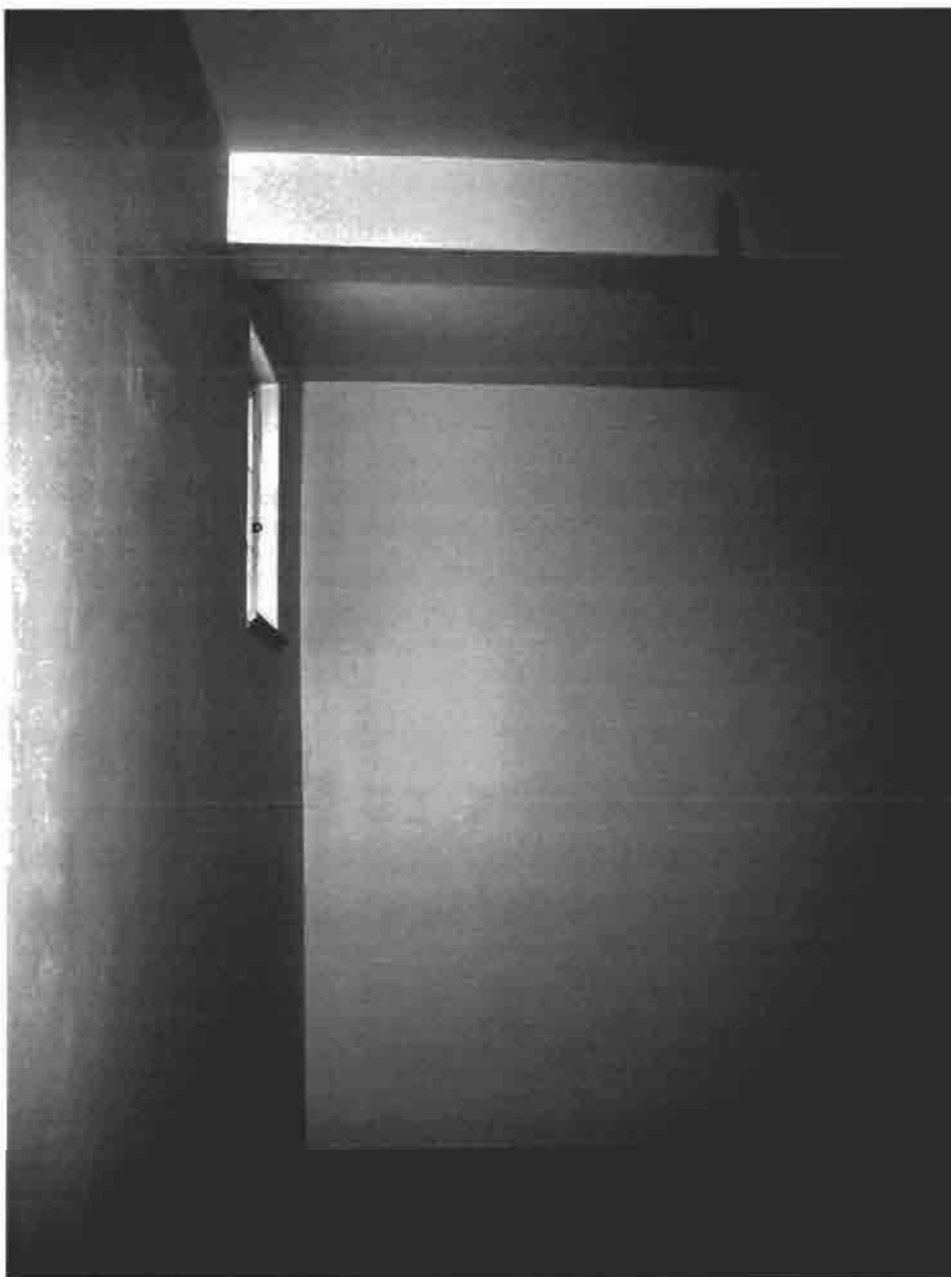
1C-130: Room 204, Gymnasium: Southeast corner. Note: Suspension Plate. Window:
219. 11/2003

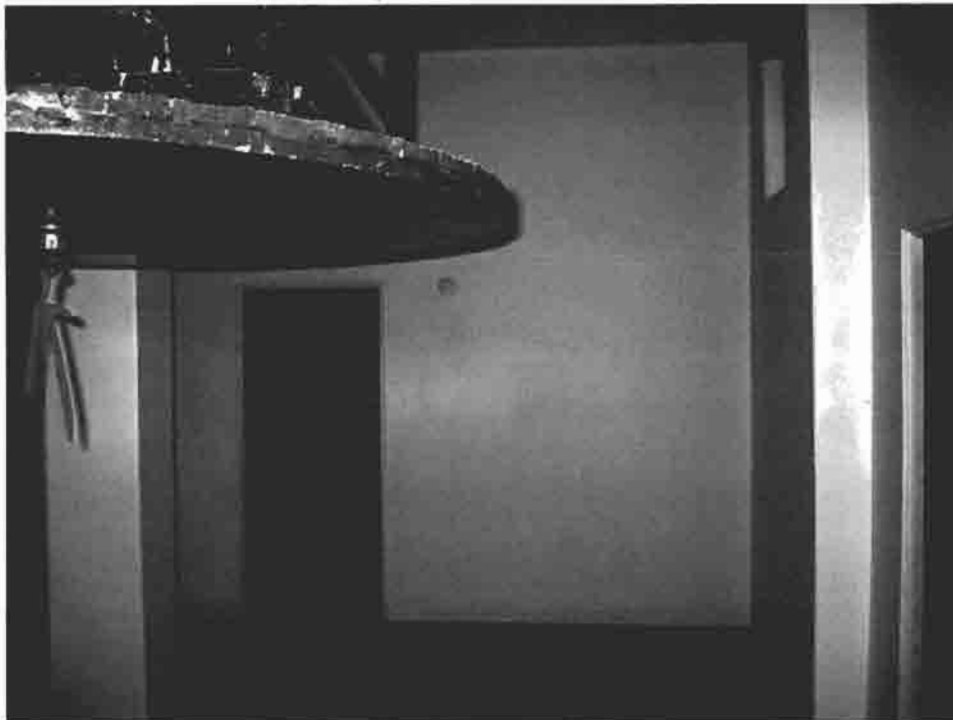
1C-131: Room 204, Gymnasium: West Wall to northwest corner. Doors: 207 & 204. 11/2003

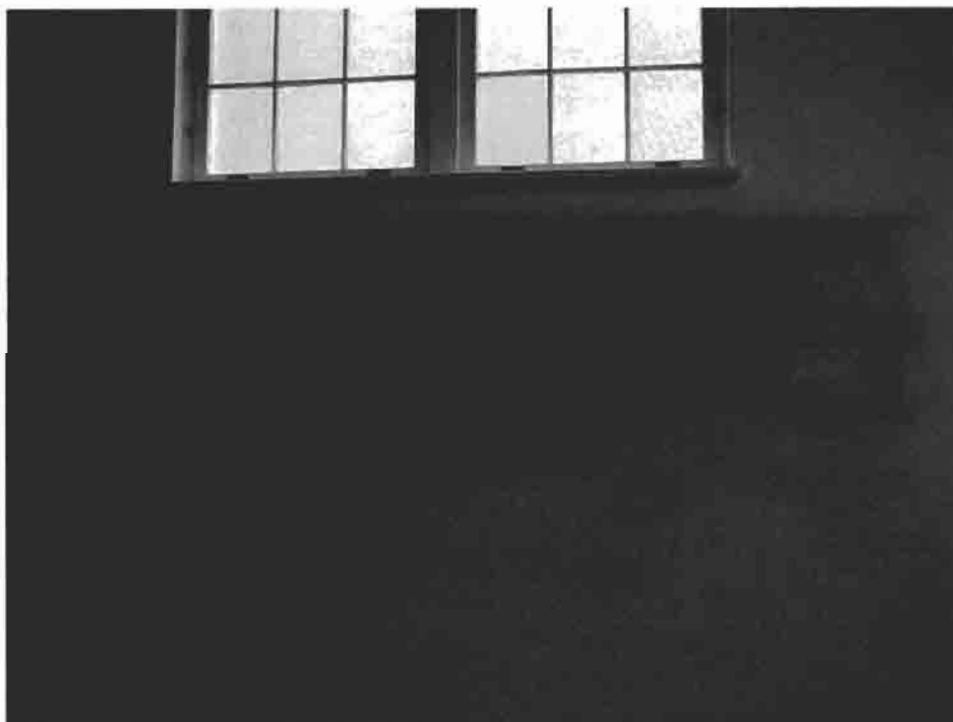
1C-132: Room 204, Gymnasium: East Wall. Note: Remnant text. Window: 217. 11/2003

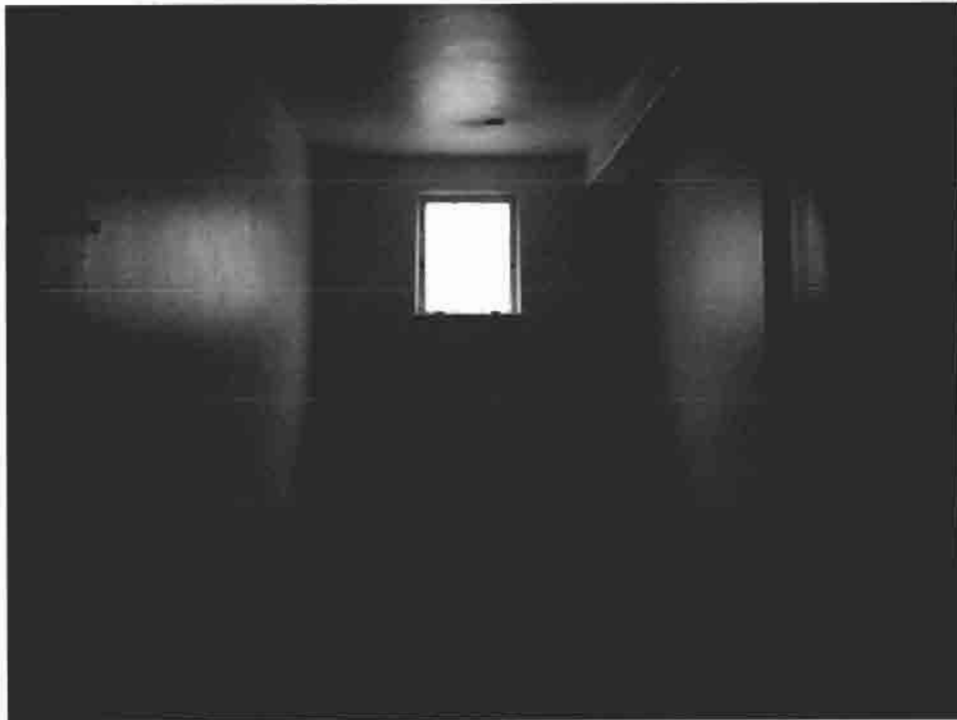
1C-133: Room 205, Women's Massage: South Wall. Window: 220. 11/2003
