Lamar Bathhouse

Historic Structure Report

HOT SPRINGS

National Park • Arkansas

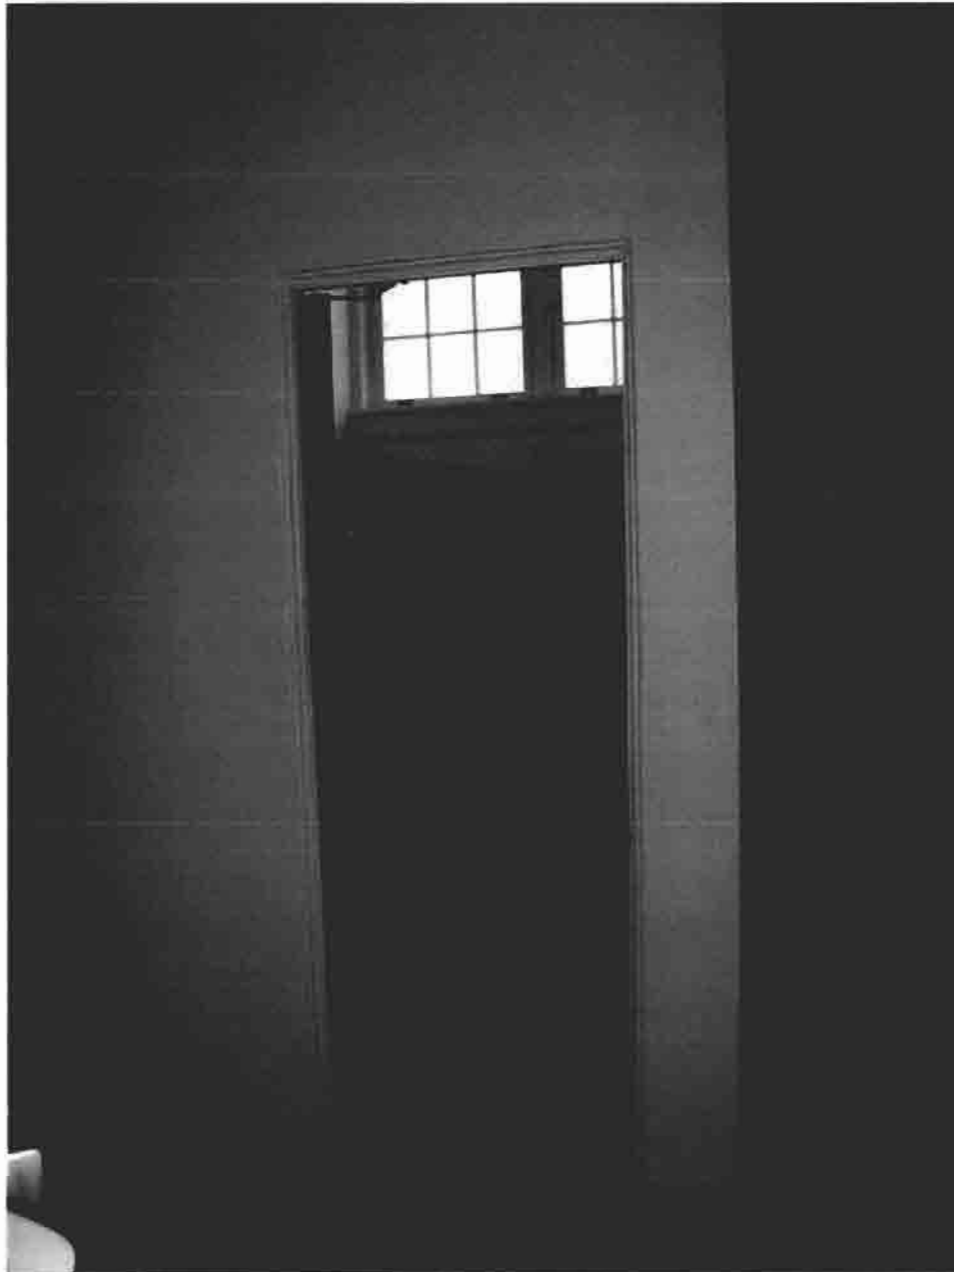
IC-134: Room 206, Toilet: South Wall through door. Door: 206. Window: 221.
11/2003

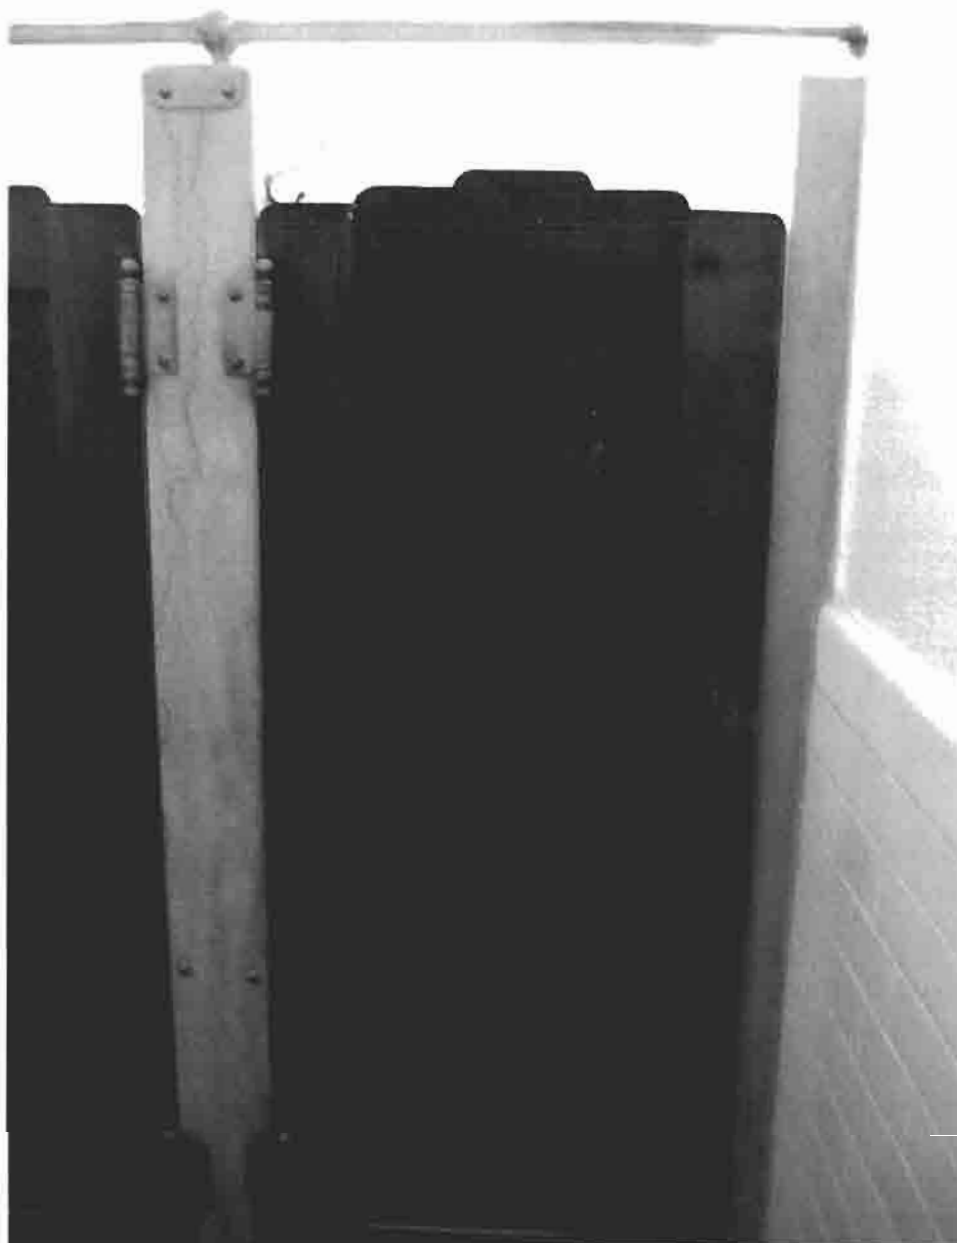
1C-135: Room 206, Toilet: Detail of Stall. 11/2003

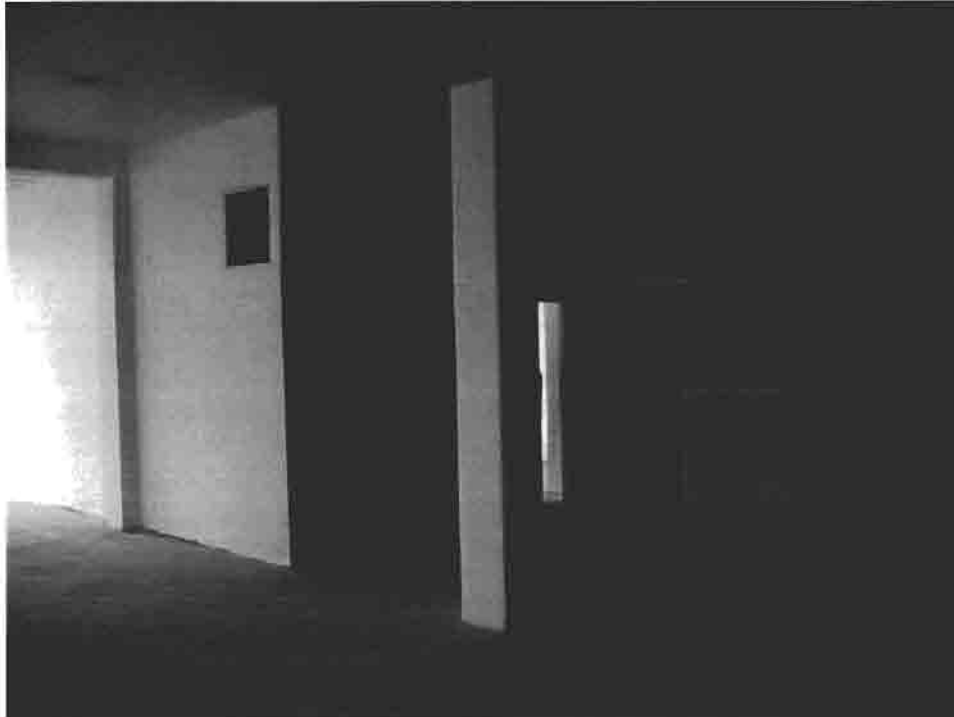
1C-136: Room 207, Women's Dressing Room: Northwest Corner. Doors: 208 & 209.
(See historic photo 1B-11.) 11//2003

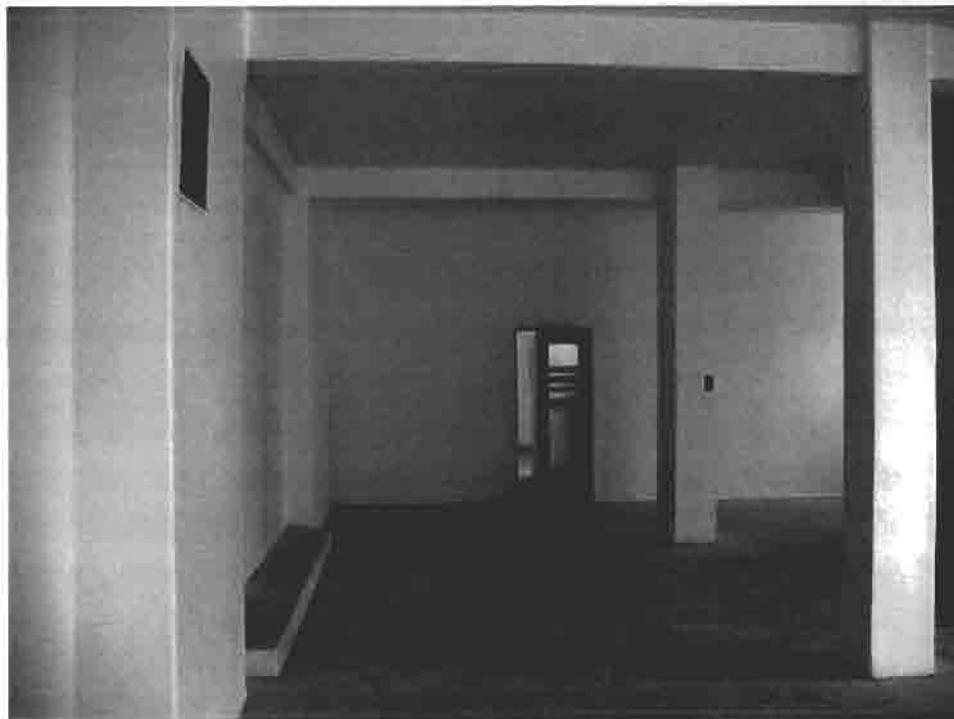
1C-137: Room 207, Women's Dressing Room: East Wall. Door: 207. 11/2003

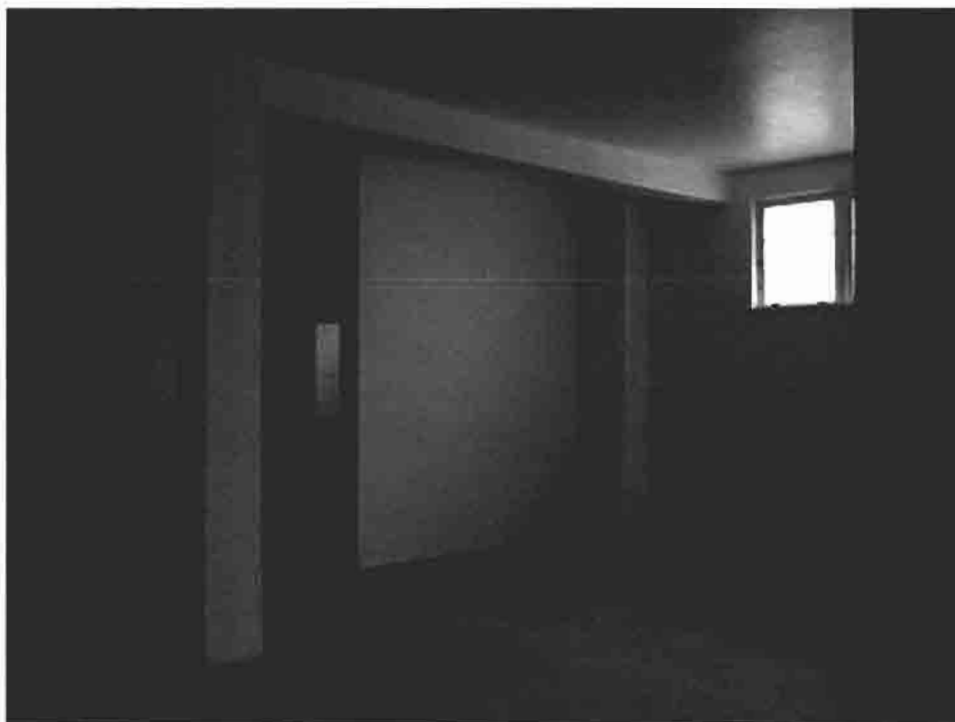
1C-138: Room 207, Women's Dressing Room: Southeast Corner. Looking at Room 206, Toilet. Door: 206. Window: 222. 11/2003

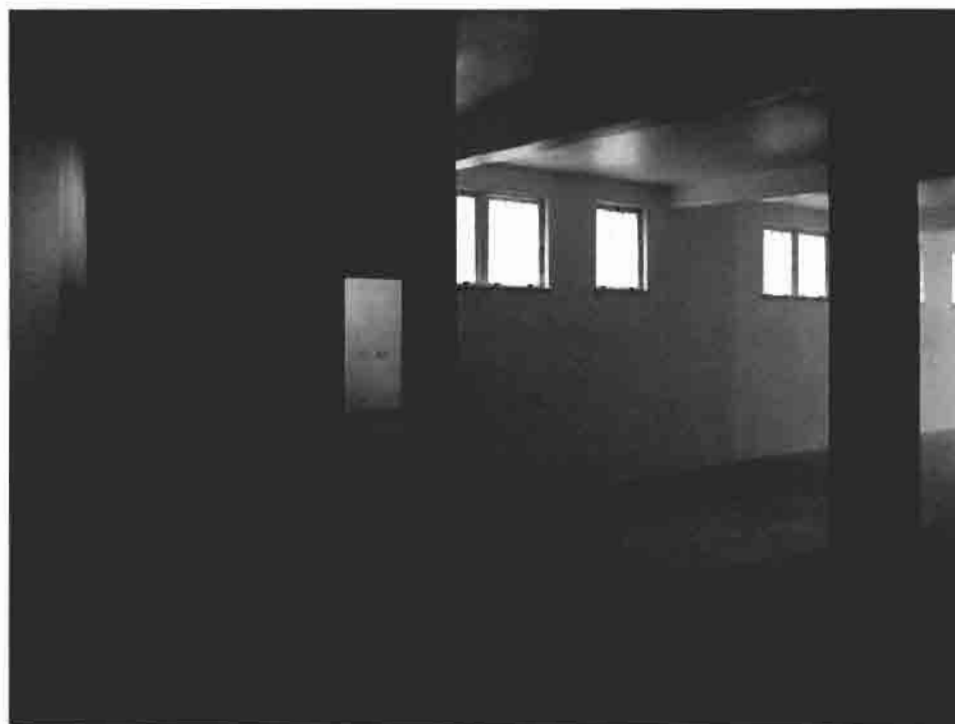
1C-139: Room 207, Women's Dressing Room: South Wall. Room 206 at photo left. Door: 206. Windows: 222, 223 & 224. 11/2003

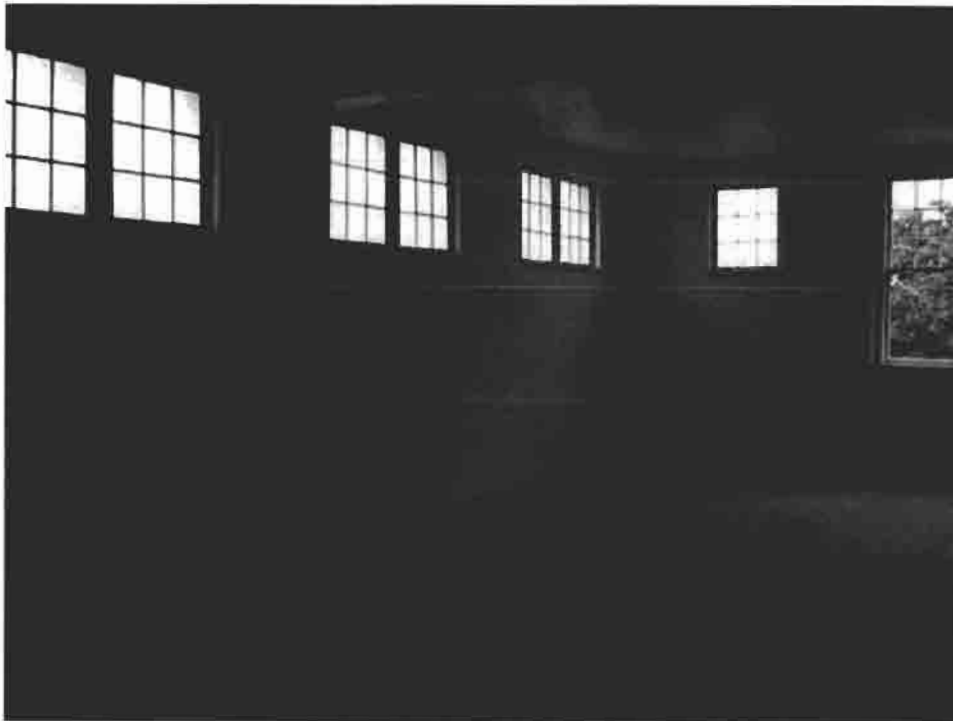
1C-140: Room 207, Women's Dressing Room: Southwest Corner. Windows: 224, 225, 226, 227 & 228. 11/2003

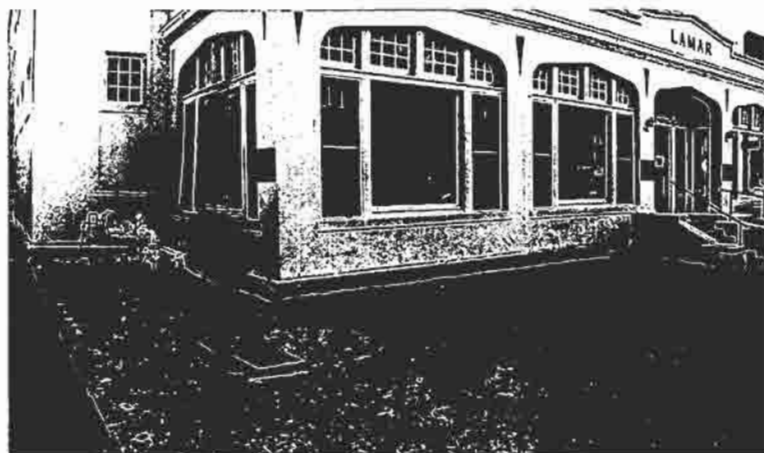
Figure CLA-4: Location of proposed universal access ramp would alter the building's strict symmetry. Note the flat lawn would be regraded to slope upward toward the entrance. (Shapins Associates, 2003)

Vegetation restoration can mitigate the ramp's distraction from the building's dominant lines. The building's planting scheme in the 1930s – as shown in the 1987 Wright/O'Gwynn vegetation study – indicates foundation plantings of deciduous shrubs and flower beds. There was also a line of Winged elm (*Ulmus alata*) trees on the east side of the Magnolia Promenade. These plantings can focus visitor's attention away from the ramp and toward historic building features.

As part of the universally accessible ramp modification, plans call for regrading the northern quadrant of the front lawn to accommodate the new ramp. Because the most-often described feature of the landscape is the broad, flat lawns in front of the bathhouses, this change will result in a loss of integrity to the cultural landscape and should not be implemented. Instead, the lawn should be left relatively flat in order to remain in character with its historic configuration.

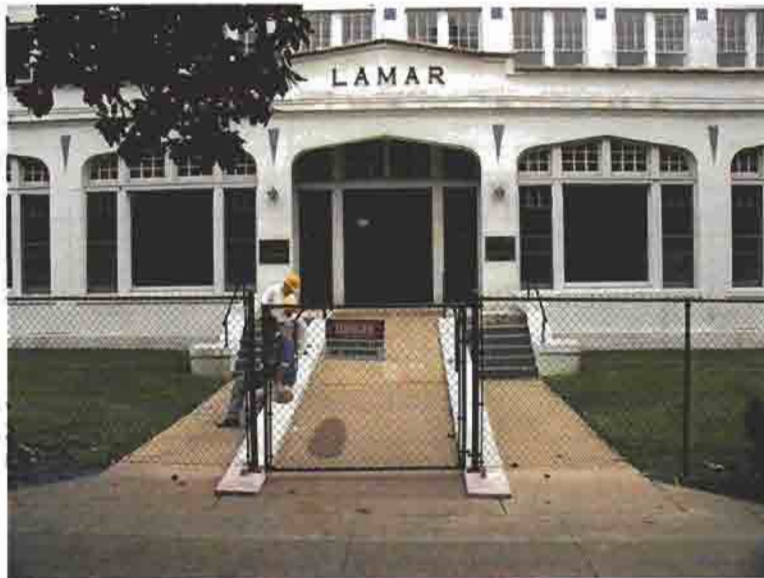
Figure CLA-5:
Original entry's
rigidly symmetrical
ramps emphasize
the building's
symmetry. The lawn
on the left is
planned to be
sloped toward the
new accessible
ramp. (Shapins
Associates, 2003)

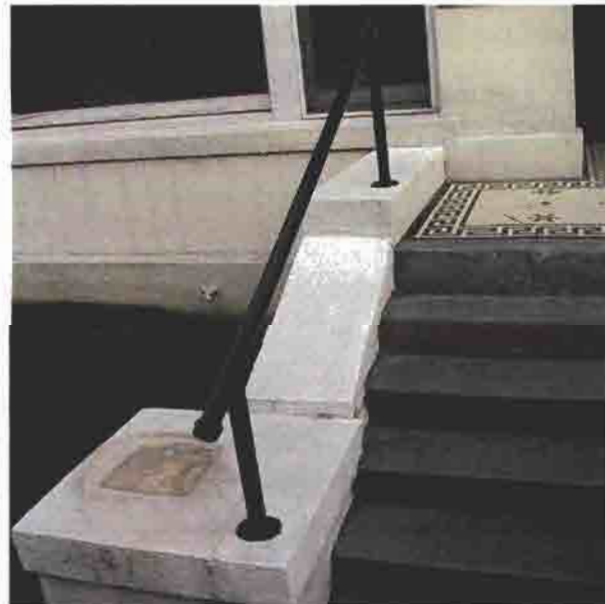
Concrete that forms the main entrance ramps, stairs and landings has deteriorated and will be removed/replaced. Plans call for replicating existing stair profiles including stair tread lips. Finish of stairs and top of walls is specified to be light broom finish to match existing. Insofar as these repairs match the original construction profiles, they will have no impact on the cultural landscape.

Figure CLA-6: Repair of degraded stairs and walls should replicate the existing profiles and finish. (Shapins Associates, 2003)

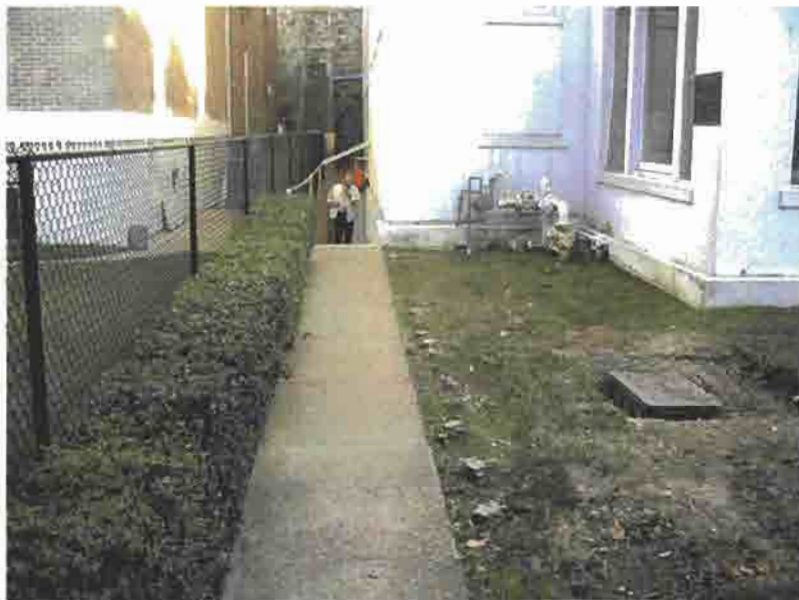
The Chinese holly (*Ilex cornuta*) clipped hedge that outlines the bathhouse lawn has been removed in places, or has become damaged due to construction activities. Once the building rehabilitation project is complete, these areas should be replaced so that the hedge once again forms a seamless border to the lawn. The areas most damaged by construction are those along the sidewalk to the basement stairs and the sidewalk to the comfort stations.

Figure CLA-7: Damaged hedges should be rehabilitated or replaced. This entire row of hedges was removed in order to widen the sidewalk and install a new entrance ramp. (Shapins Associates, 2003)

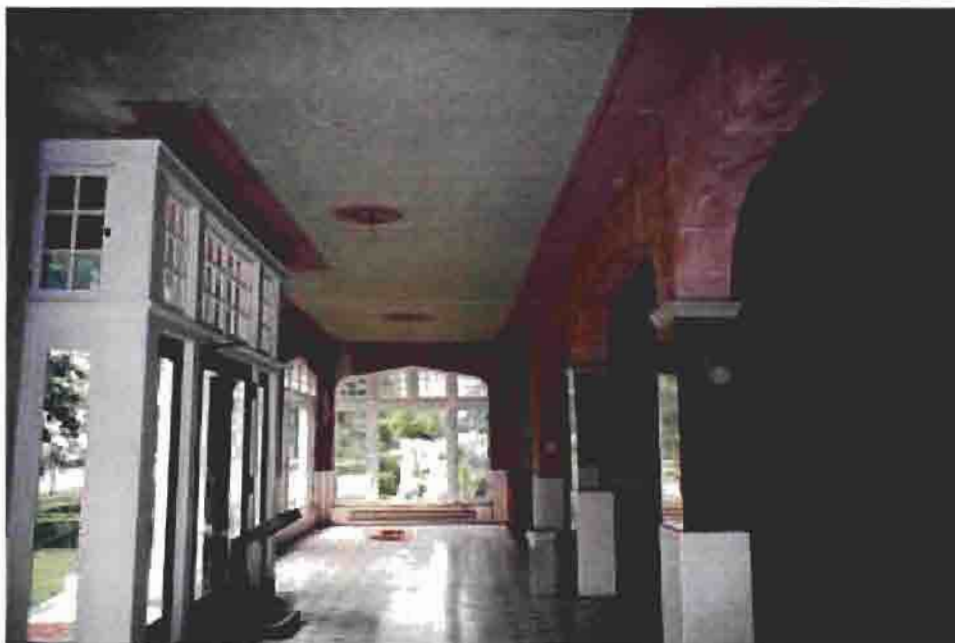
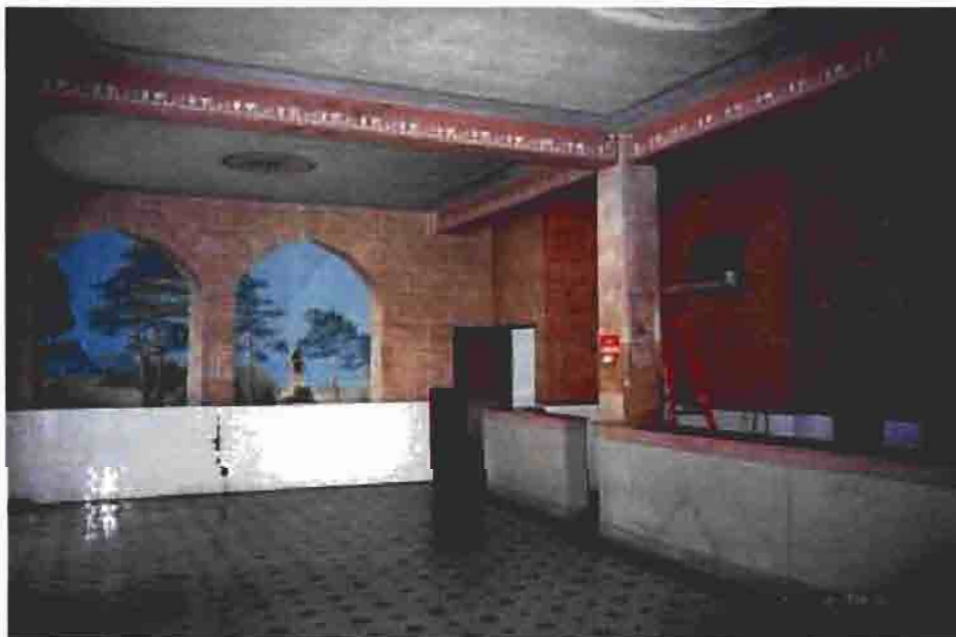
LAMAR SUN PORCH & LOBBY

OVERVIEW OF SUN PORCH:
NOTE THE PLASTER
DAMAGE AT PHOTO LEFT
(WEST WALL & CEILING),
DECORATIVELY PAINTED
CEILING, & FAUX STONE
TREATMENT ON WALLS &
ARCHES.

OVERVIEW OF LOBBY:
NOTE CRACK THROUGH
MURAL, DIFFERING
COLORS ON BACK WALL
(RIGHT) WHICH ARE
LIGHTER, & DECORATIVE
PAINTING IN GENERAL.

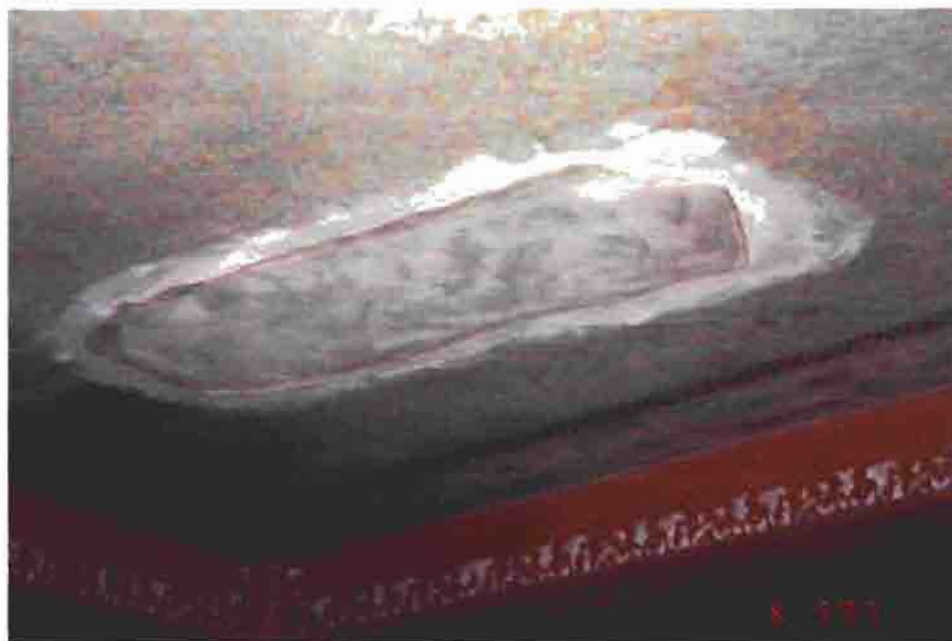
PLASTER: PATCH IN CEILING SECTION C, CENTER OF LOBBY. ALSO, NOTE MOISTURE DISCOLORATION SPOTS.

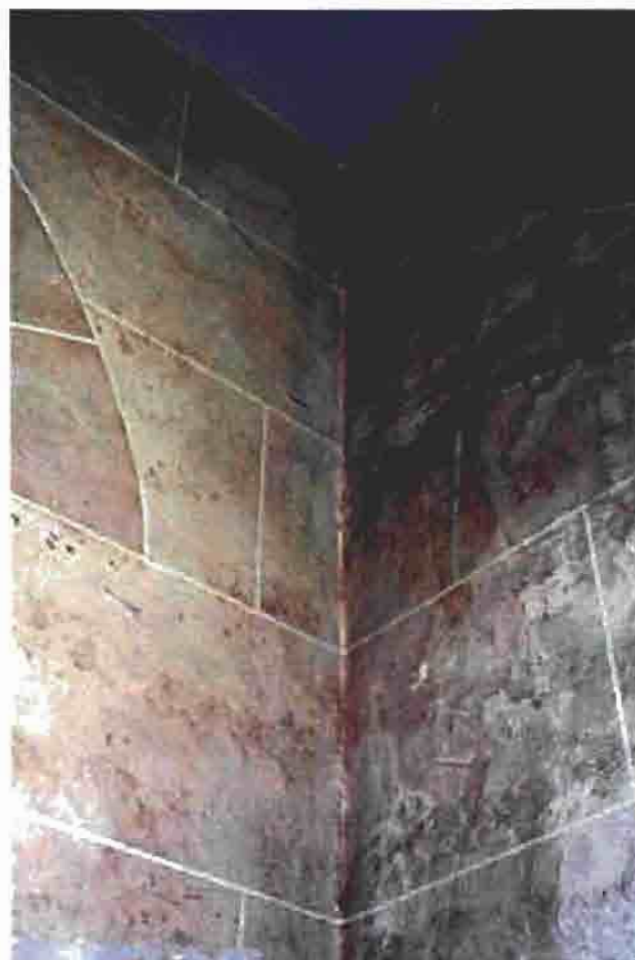
PLASTER: DISCOLORATION OF RIGHT
HAND WALL, WITH POWDERED PLASTER,
EVIDENTLY MOISTURE RELATED.

PLASTER: LOOSE &
FLAKING PAINT, LIKELY
DUE TO LOCATION
ABOVE HVAC SUPPLY
GRILLE.

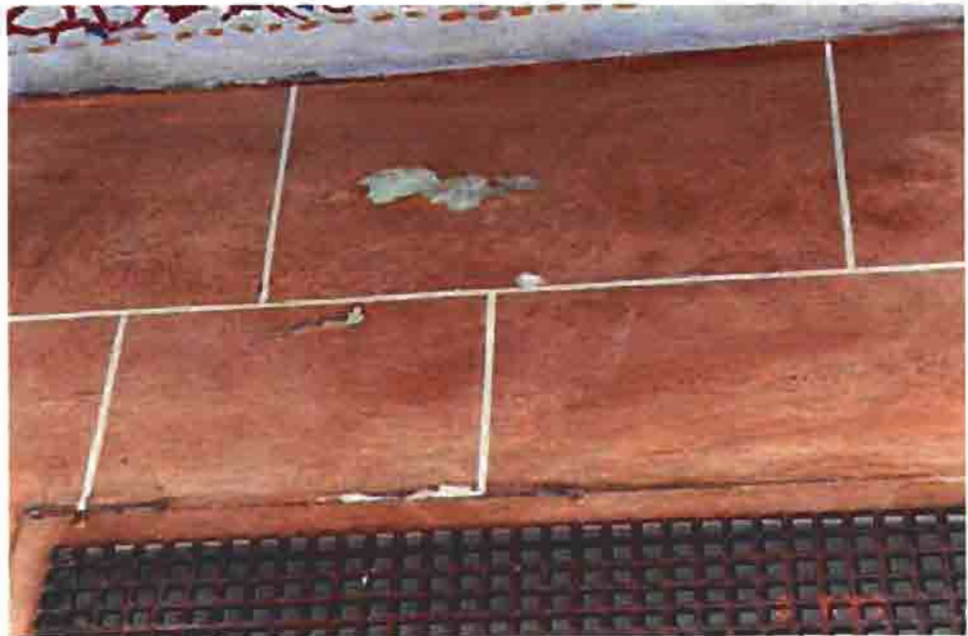
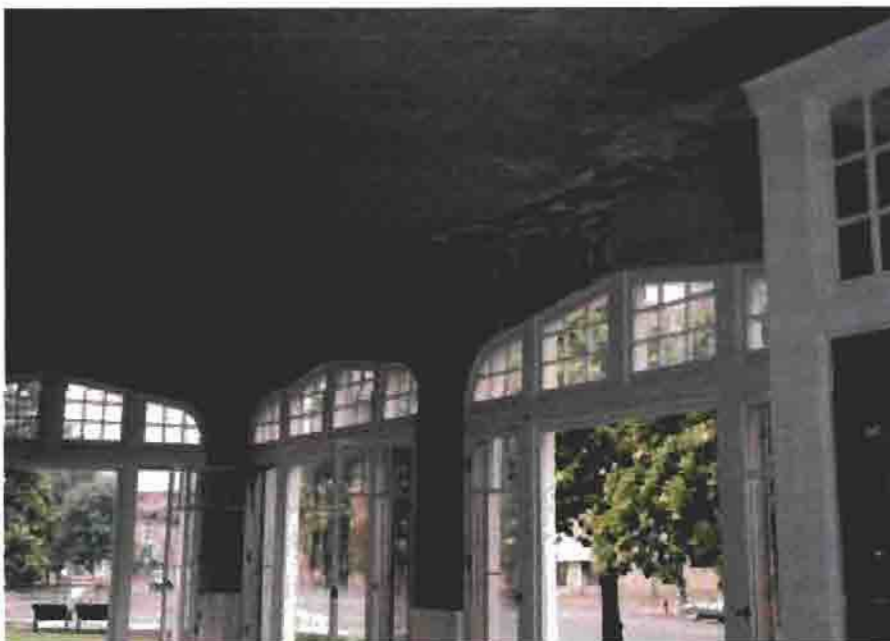
PLASTER: DAMAGE IS
EVIDENT IN SUN PORCH
WEST WALL (SOUTH END)
& CEILING. SOME
PRELIMINARY PATCHING
HAS OCCURRED.

PLASTER: SUN PORCH
WEST WALL, NORTH OF
ENTRY.

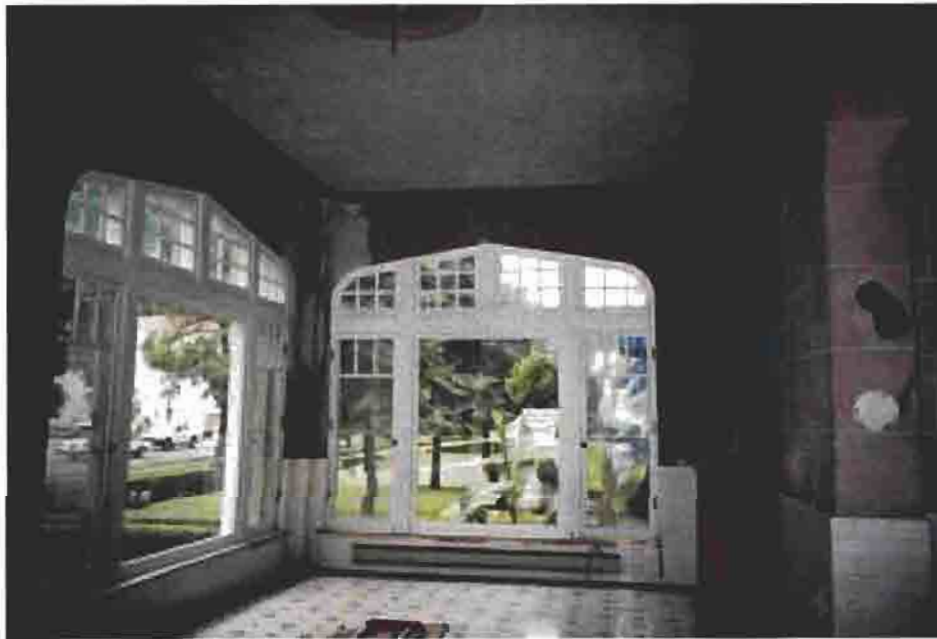
PLASTER: SUN PORCH,
WEST WALL (NORTH END),
HAS SLIGHTLY LESS
DAMAGE THAN SOUTH
END.

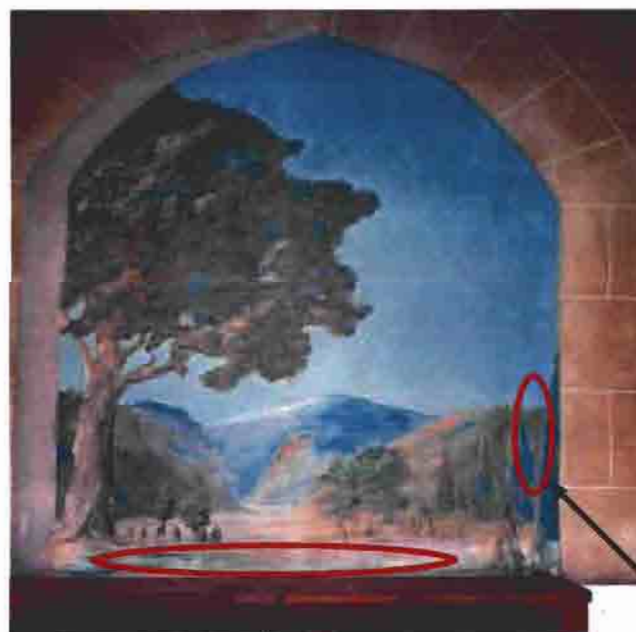
Mural #1: Landscape scene with low blue mountain
Size: 75" W x 87" H
Substrate: Plaster
Medium: Distemper

The overall condition of the mural is relatively stable. Small fissures can be seen in the plaster but upon sound testing they seem stable. Large areas of crazing are beginning to appear on the paint surface, mostly in the sky and low landscape area. In the lowest section of the mural, there is severe flaking paint and delamination mostly contained within a 12" horizontal band above the radiator. The paint that is flaking of the surface layer, the ground layer is still adhered well to the plaster. Also immediately above the radiator is some surface abrasion of the paint layer, probably from routine cleaning. The colors on the surface are slightly muted from surface dirt and dust. The faux painted arch soffit within the mural is a purple color instead of the tan found in the others of the lobby (#'s 2 - 5).

FLAKING PAINT

PAINT ABRASION & FLAKING PAINT

1. Stabilize flaking paint with a synthetic adhesive.
2. Dry clean surface with soft haired brush and vacuum.
3. Remove surface dirt with vulcanized rubber sponges.
4. Infill areas of paint loss with a synthetic filling emulsion.
5. Inpaint areas of loss with a matt paint such as high load acrylics.

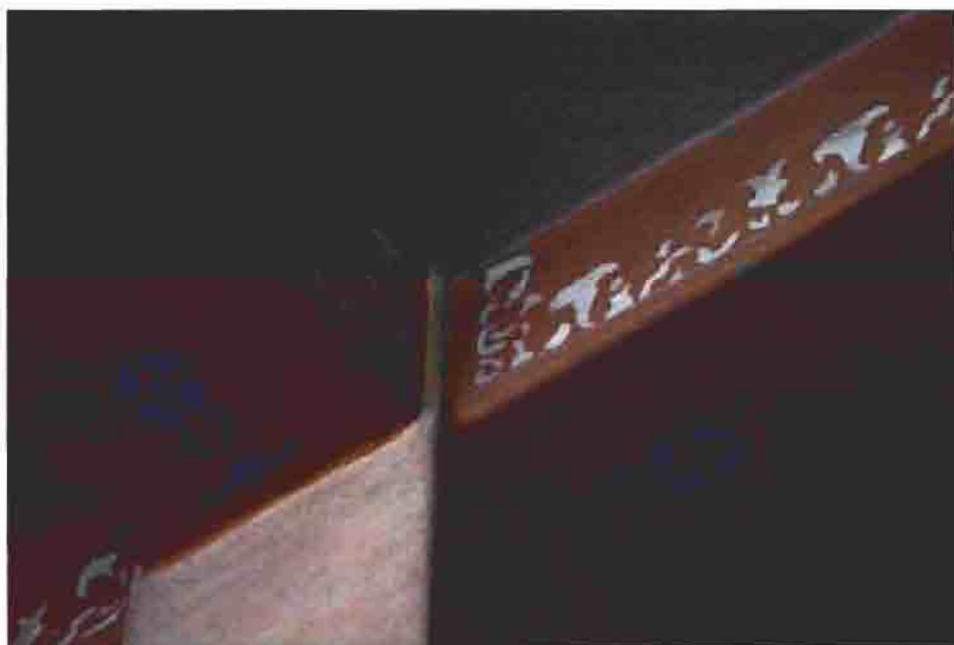
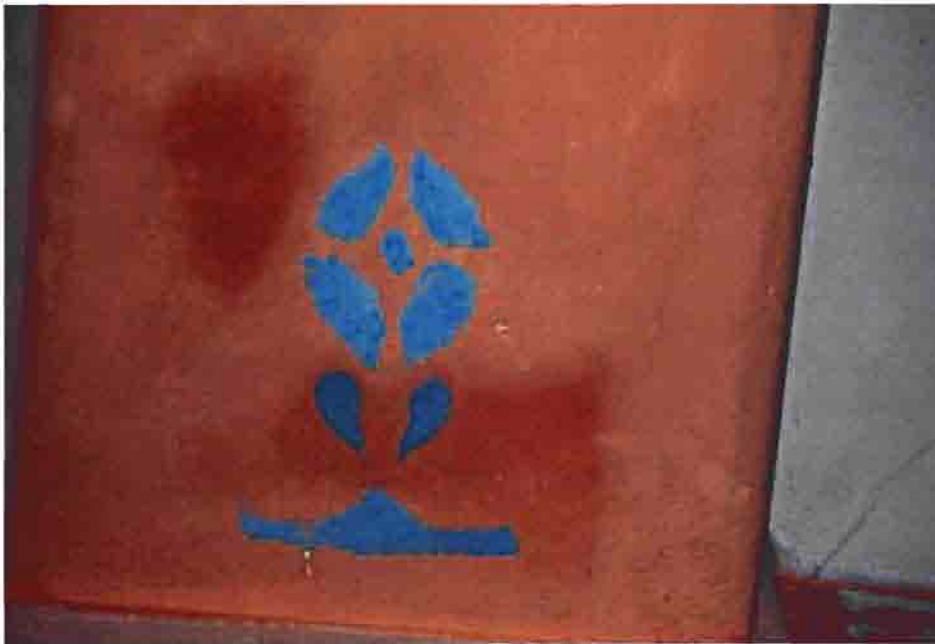
DECORATIVE PAINTING:
WHITE STENCIL ON
SIDE OF BEAMS,
MAUVE BORDER OF
PANEL, FLORA STENCIL,
SPONGED CENTER
SECTION.

DECORATIVE STENCIL
APPEARS ON BOTTOM
OF BEAM AT EACH END
OF BEAM. NOTE:
DARKENED AREAS ARE
DUE TO WATER
DAMAGE.

DECORATIVE PAINT:
MOISTURE STAINING OF
DECORATIVE PAINT AT
PANEL EDGE &
UNDERSIDE OF BEAM.

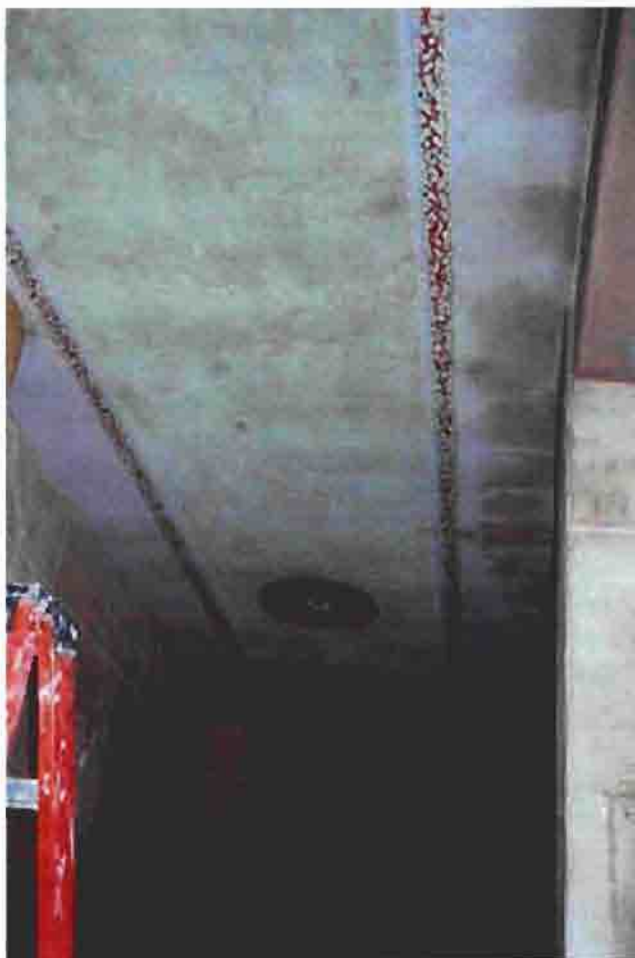
DECORATIVE PAINT: EXTENSIVE
STAINING AT EDGE OF EAST CEILING
PANEL.

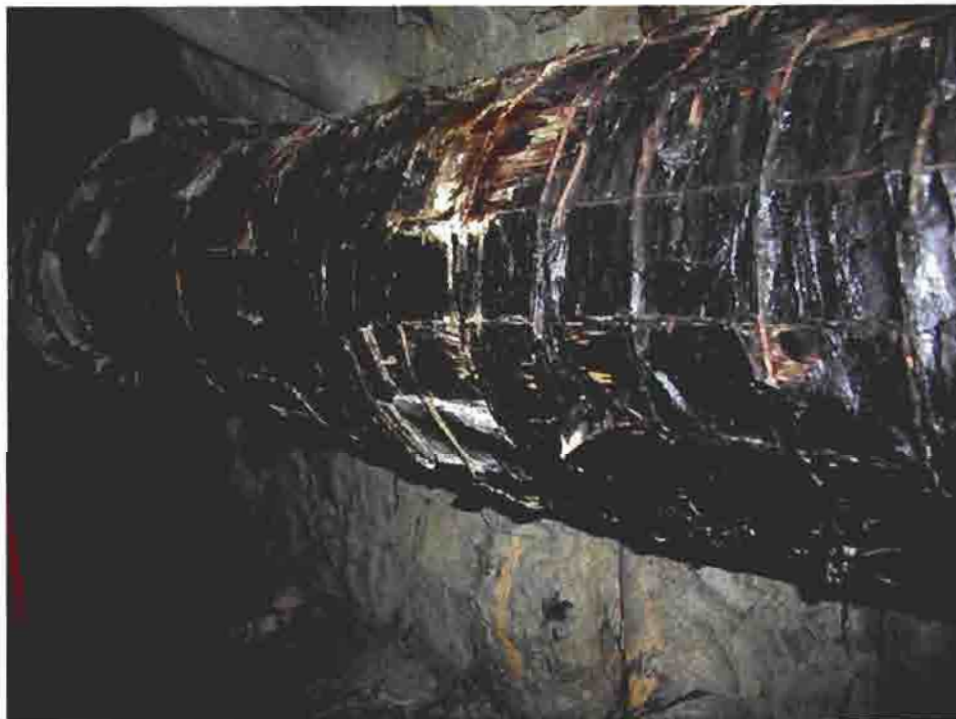
tunnel floor and east sidewall. The iron pipe is mostly covered by an outer wood stave pipe in poor condition and wrapping of roofing tar impregnated cloth material. The latter is discontinuous. The extent of the pipes' problems were not the primary subject of the investigation.

CA-5: The Creek Arch. The hot springs collection pipe.

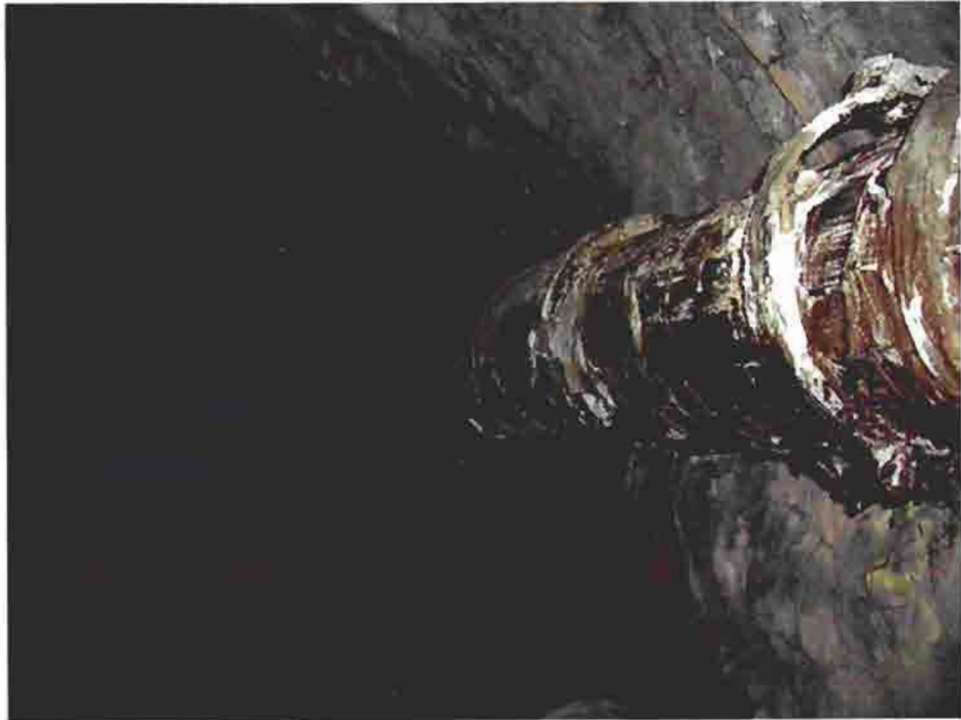
CA-7: The Creek Arch. The droplets glisten on the surface, indicating the passage of water through the masonry.

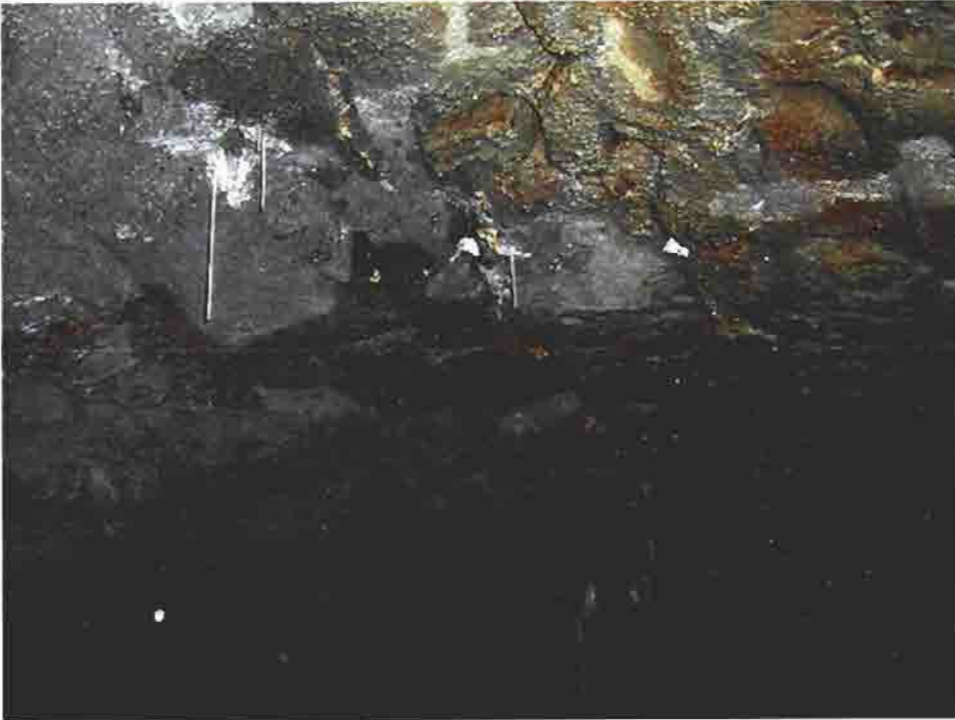
CA-8: The Creek Arch. A building up of stalactites from the arch surface. This is evidence of a steady drip.

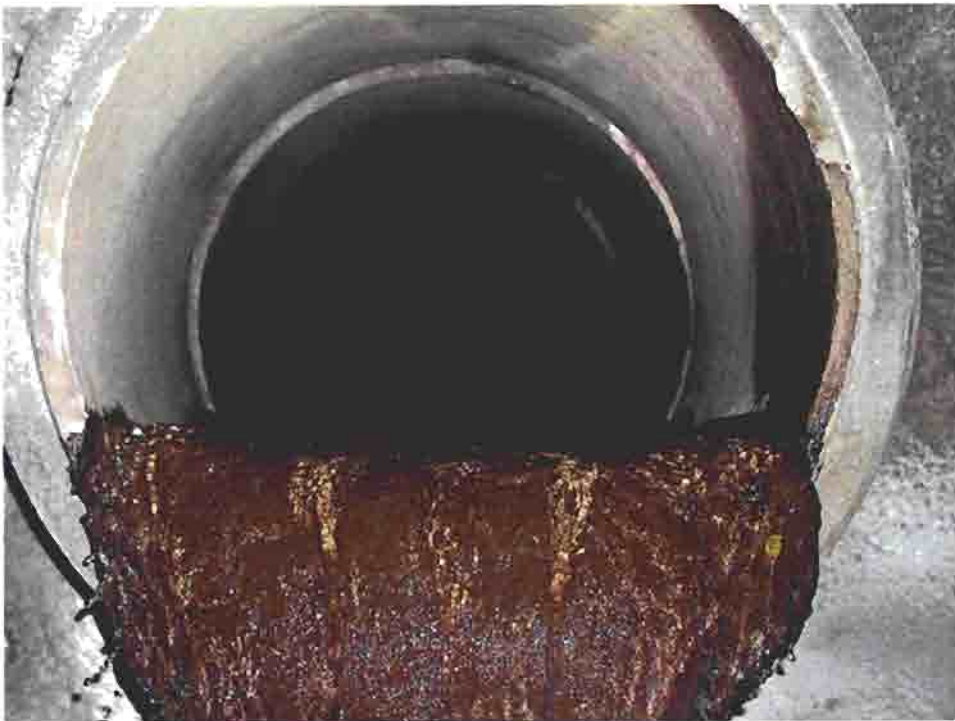
CA-13: The
Creek Arch. The
lower one-third to
two-thirds of the
pipe's diameter
has been blocked
by hot springs
mineral deposits
which can build
up quite rapidly.
