STRUCTURE REPORT

ARCHITECTURAL DATA SECTION - VOLUME I

LINCOLN HOME

Lot 8 - Block 10 Lincoln Home National Historic Site Springfield, Illinois

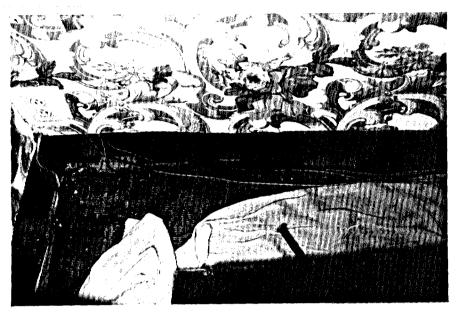
202 - P5

1) wiring for alarm system

5) joists added later are located next to each larger joist and in between the larger joist

6) newer joists are nailed to older joists or bear on beam or blocking.

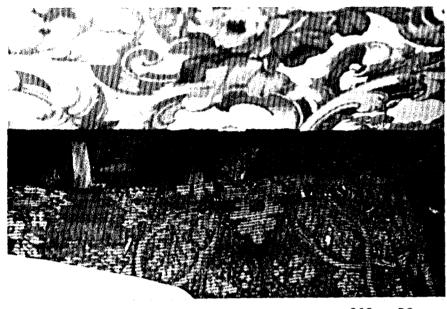
202 - P8

- stud notched for joist typical balloon frame detail
 new joist in center between studs
 stud turned sideways
 corner stud larger than typical ones and is not continuous

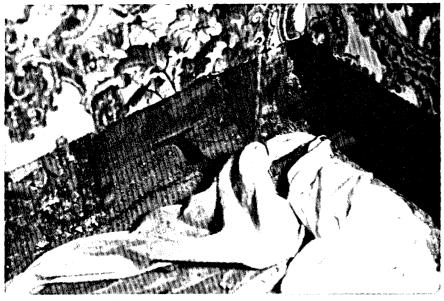
201 - P3

NOTE:
1) Closeup of corner

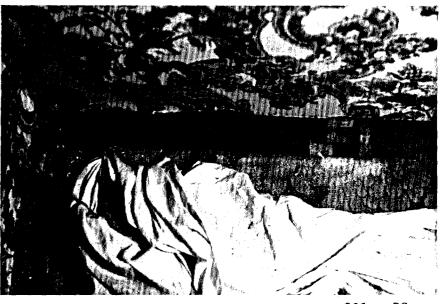
201 - P8

1) closeup of studs and joists

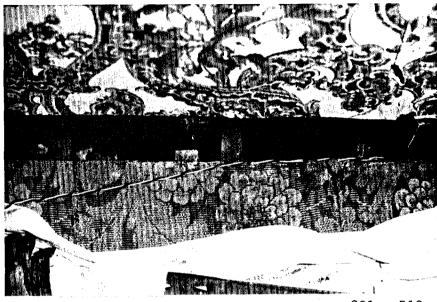
201 - P10

NOTE: 1) Closeup of studs and joists

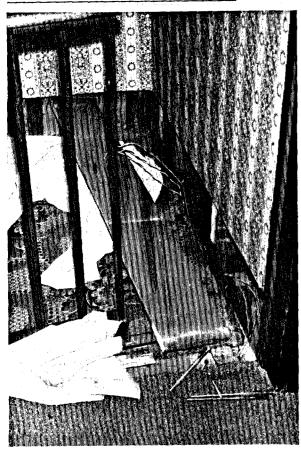
207 - P9

- 1) revision of studs (three) when door opening between Robert's Bedroom and Guest/Boys Bedroom was moved north
- 2) all studs are not continuous
- 3) one stud turned sideways (lines of plaster lath and plaster visible)

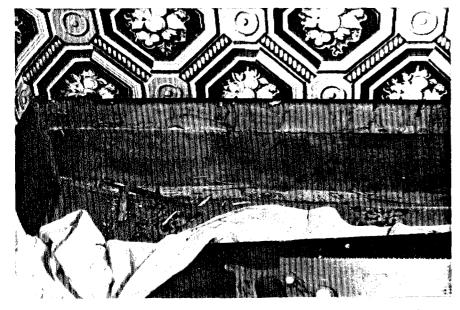
NOTE:
1) Sub-baseboard visible - only location this detail found (both sides of Stair Hall)

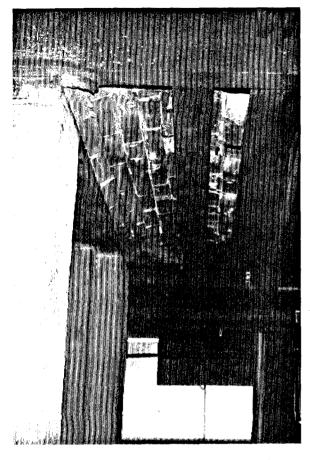
Base - 1

1) arch form of the "original" brick hearth support

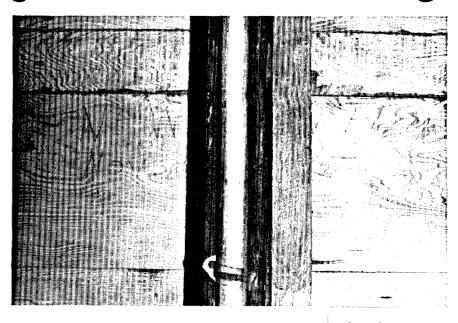
Craw1 - 2

- old and new joists
 new flooring <u>+</u> 1975

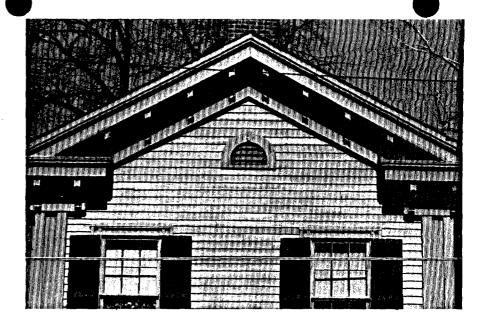
Close-up of Vent in south gable wall 420
