Henry House
Historic Structure Report
Final Revised Edition

Manassas National Battlefield Park
National Capital Region
Manassas, Virginia

Historic Preservation Training Center
U. S. National Park Service

August 2003

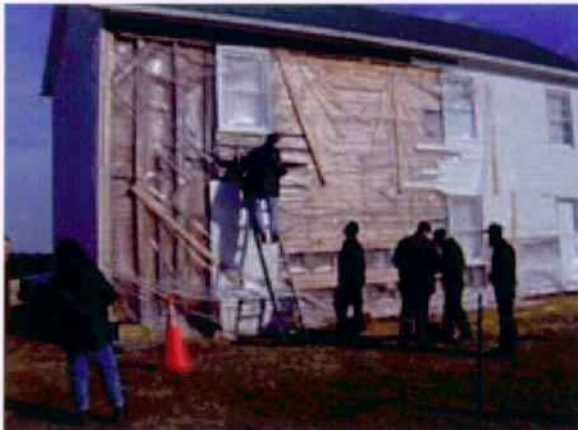
Fabric Investigation and Structural Evaluation of Exterior Wall Frame System at North Block.

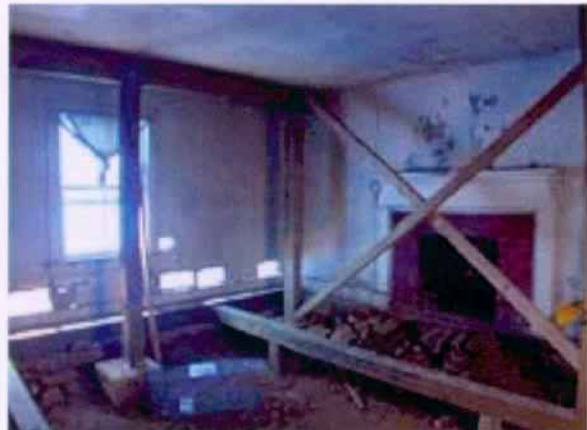
Temporary Emergency Structural Stabilization brace in place on 1st floor. Note lack of exterior wall structure.

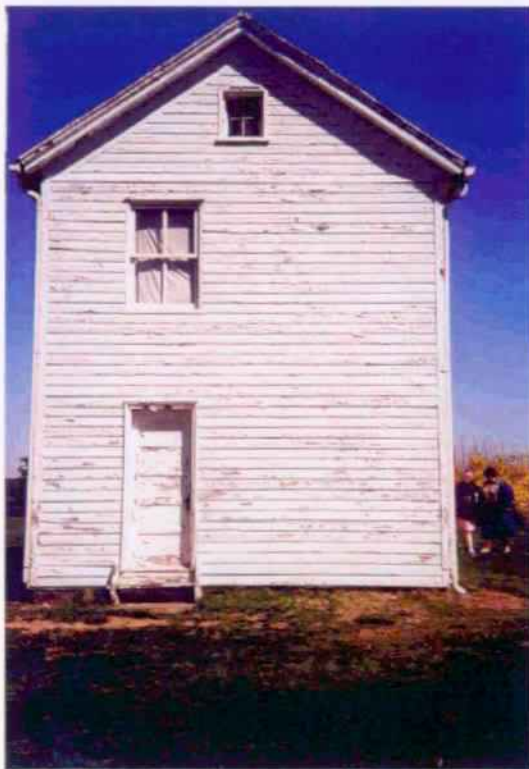
South Elevation Prior to Emergency Stabilization, 1998

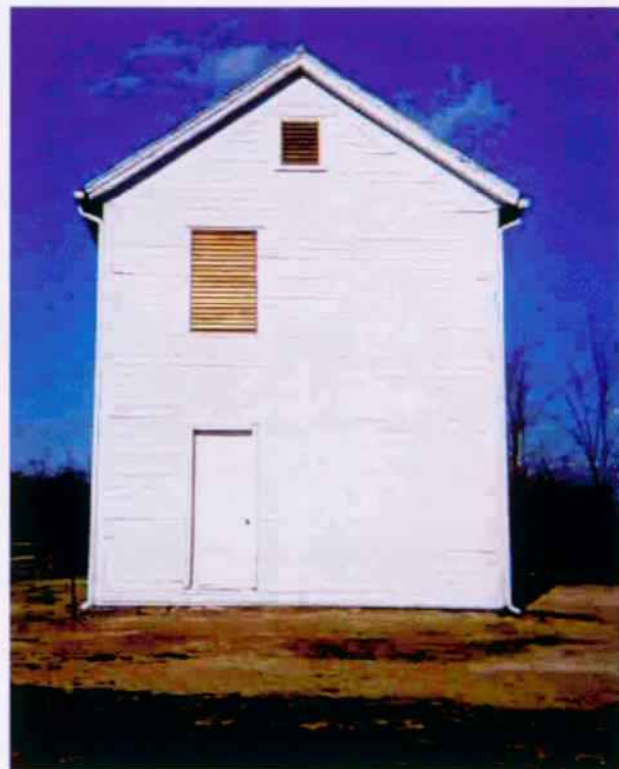
South Elevation After Emergency Stabilization, 2002

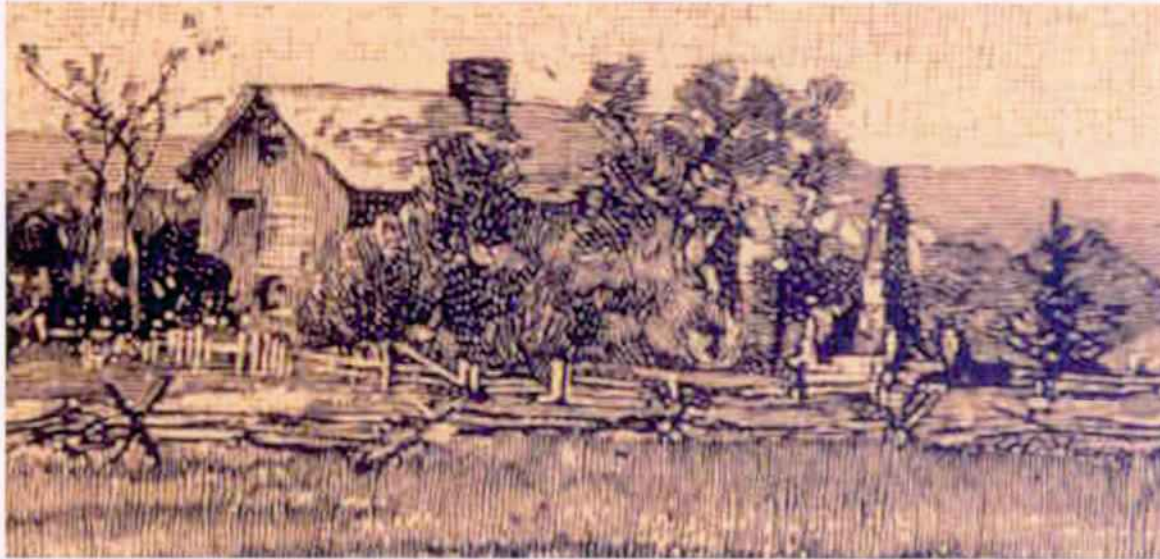
Figure 8. "The Main Battle-Ground. – No. 1." View of the Henry House, looking west from the spot where General Bee fell. The Bull Run Mountains and Thoroughfare Gap appear in the distance. The Sudley Road, a few rods beyond the house, under the hill, runs parallel with the fence rail (in the middle ground on the left). Just within the rail fence is where Griffin's and Rickett's batteries were planted. Near the house stands the Union Monument, commemorating the battle".

Note: Image depicts the south east corner of the Henry House. Chimney is not accurately positioned. Opening shown in south gable end are good representation of actual openings. Building seems to have been shortened to one and half stories from its actual two story height.

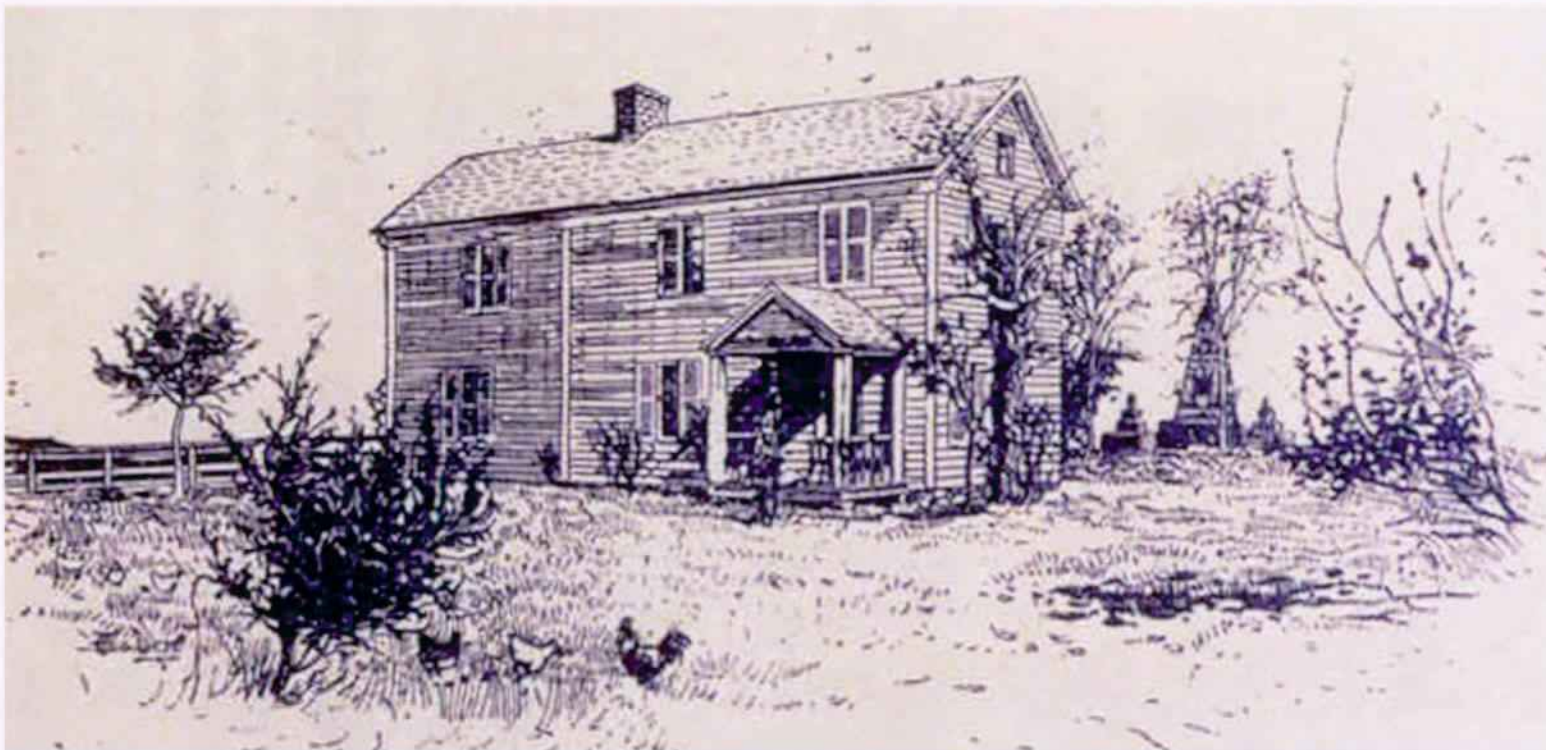
Figure 9. "The New Henry House and the Monument of the First Battle. From a Photograph Taken In 1884".

This is a very accurate depiction of the Henry House in the mid 1880's. Compare to Figure 10, or 12; photograph taken in 1896 by Albert Kern.

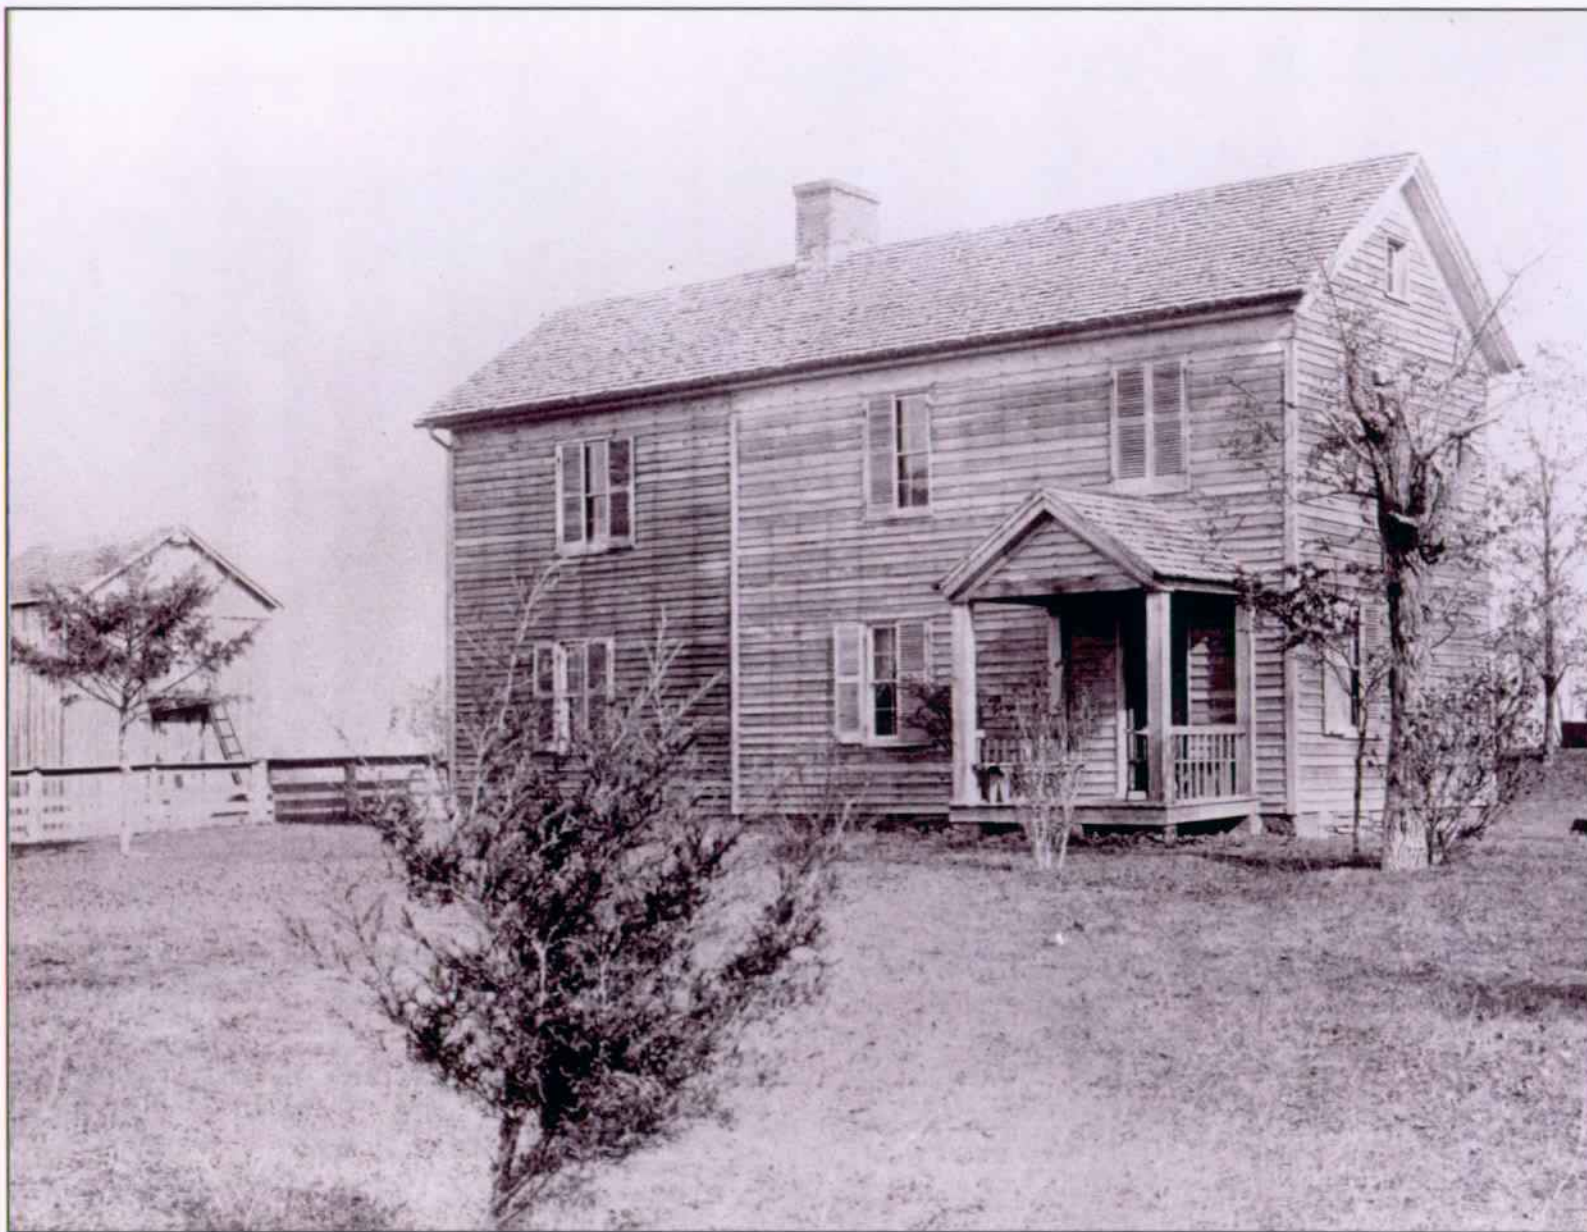
Figure 10. This is the earliest photograph in the sequence of Henry House photographs; most of the window shutters are in-situ. It illustrates the structure as a three (3) bay¹ wide by one (1) bay deep structure with 6/6 shuttered windows on the west and south elevations. The eastern side of the south gable elevation features a 6/6 shuttered window on both the first and second levels. A small 4/4 window is evident in the gable. All shutters are accounted for except for the south shutter on the central second floor window of the west elevation (W206). It cannot be determined if the east elevation was similarly shuttered, many times it was not for environmental reasons. Eastern light was desired to penetrate the interiors of buildings, whereas shutters would be necessary to block out southern, western and northern light. It would be somewhat unusual to have windows in the north wall.

Figure 10. *New Henry House, Bull Run, VA*. Unattributed, date unknown, c. 1884. "Henry House II", historic Photo collection, Manassas National Battlefield Park library.
Note the Bull Run Monument off to the south of the house and the shed to the north.

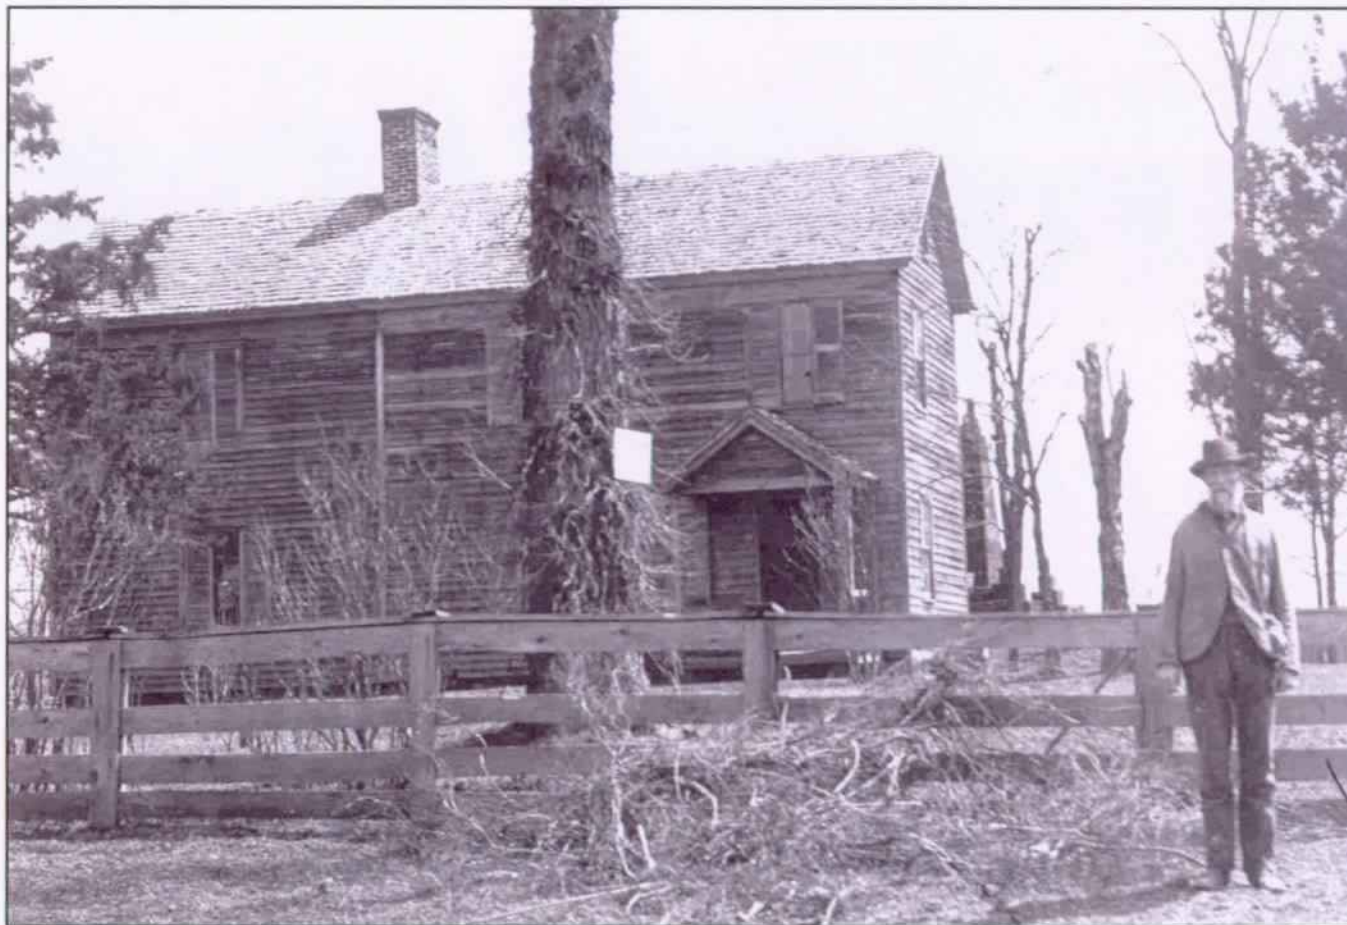
Figure 15a. Electronic (non-photographic) enlargement of Shannon photograph showing additional detail.
Note: shutters are no longer hanging at windows on south elevation.

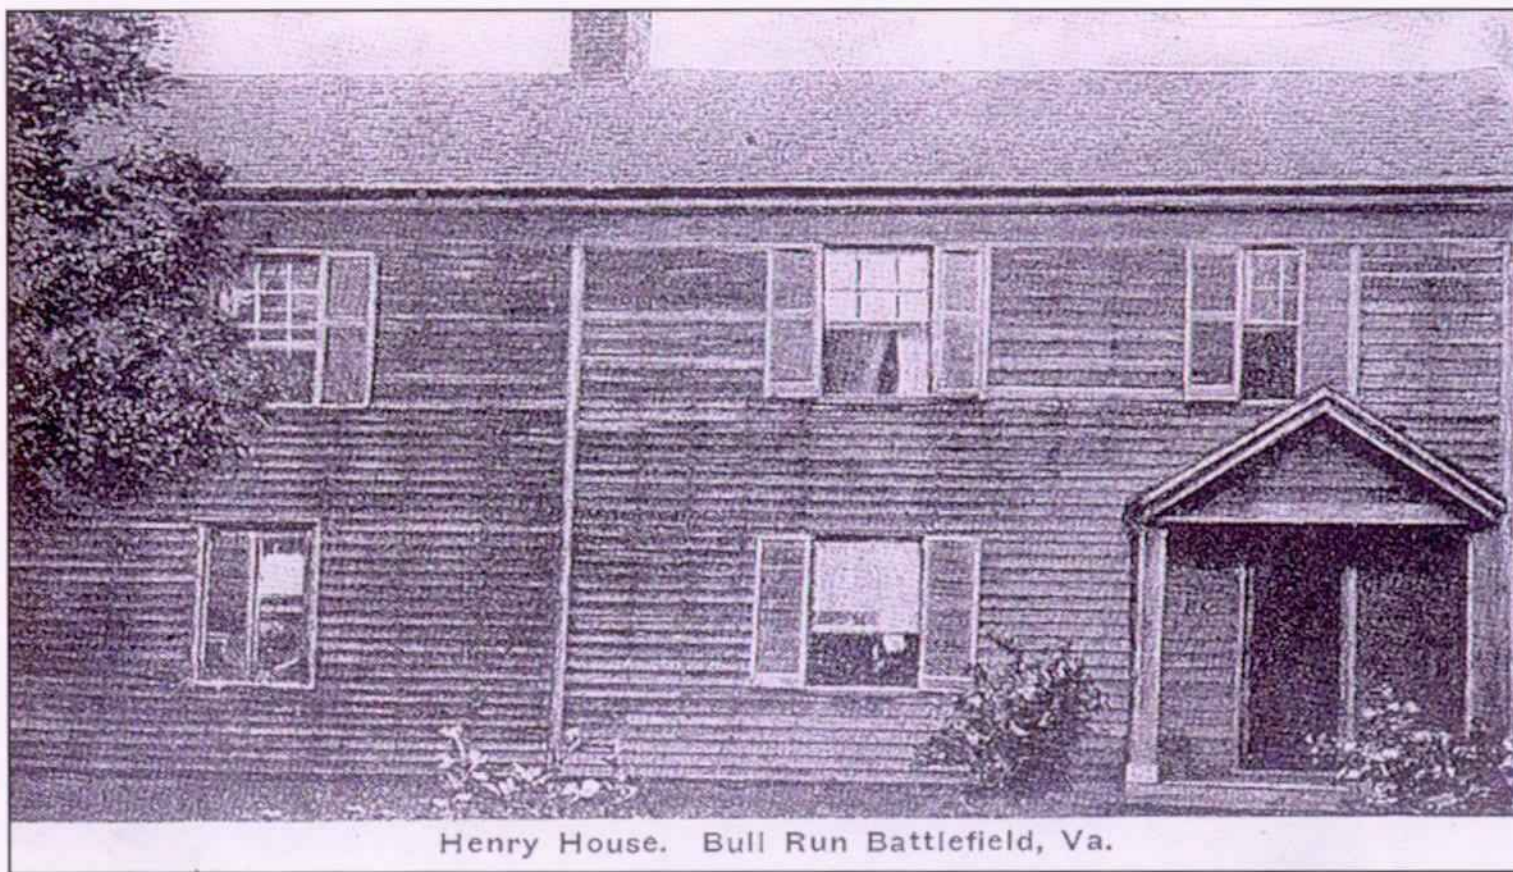
Figure 17. Henry House. Unattributed, date unknown, c. late 1880's, partial enlargement of house photo.
"Henry House II", historic photo collection, Manassas National Battlefield Park library.

Note backlit figure in doorway – indication of door at opposite end of hallway, no internal walls to block light from passing through to front; suggests original architectural plan and doorway positions.

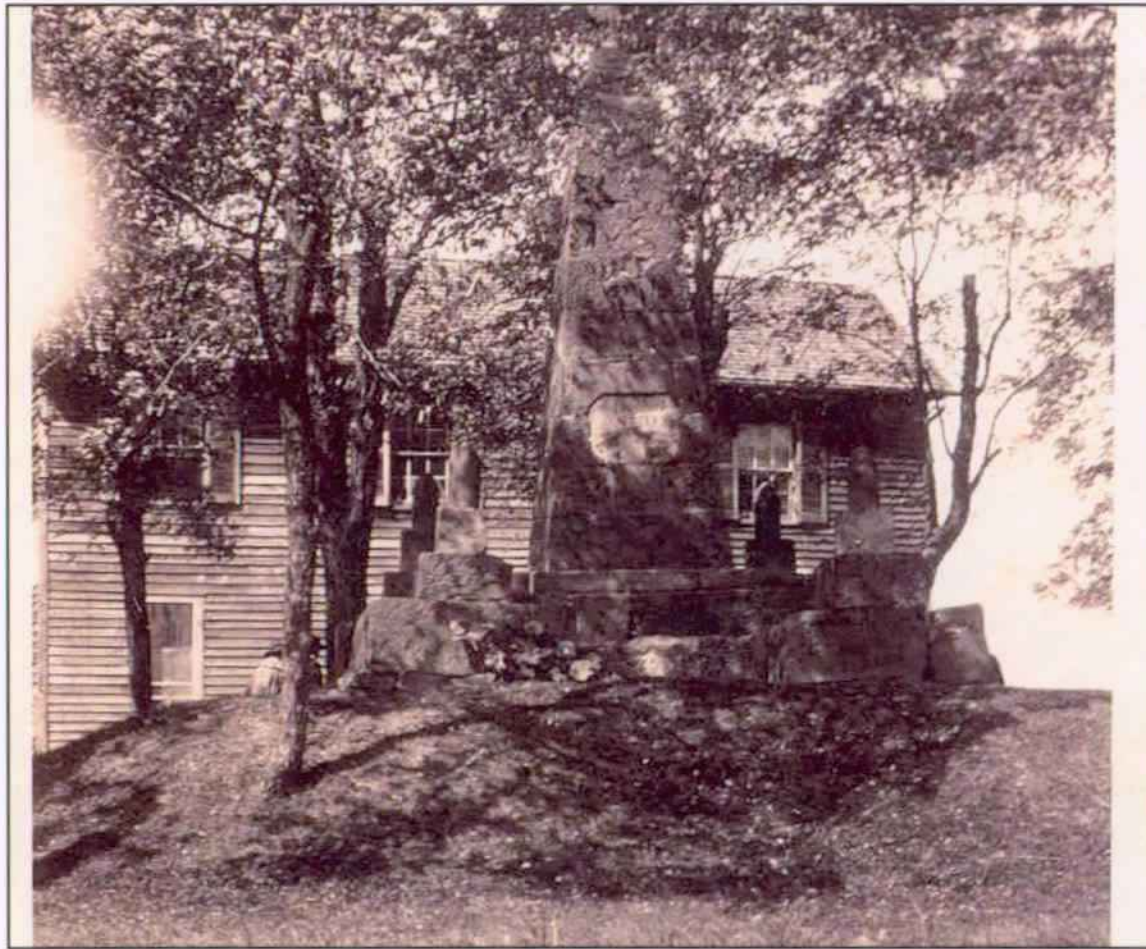
Figure 20 Rear. View of east elevation of Henry House with Bull Run Monument in foreground.
Courtesy Manassas Museum, Historic Photograph Collection.

This is an unusual photographic perspective. Of primary architectural interest is the view of the door at the lower left corner of the house. This original opening was later changed to a window, most likely by the NPS once occupied by a Caretaker as early as 1942 or as late as 1949. White edge of sign along left edge of building SE corner – may be edge of Museum of the Henry House sign, directly associated with the Sons of Confederate Veterans ownership and use of the building between 1922 and 1940.

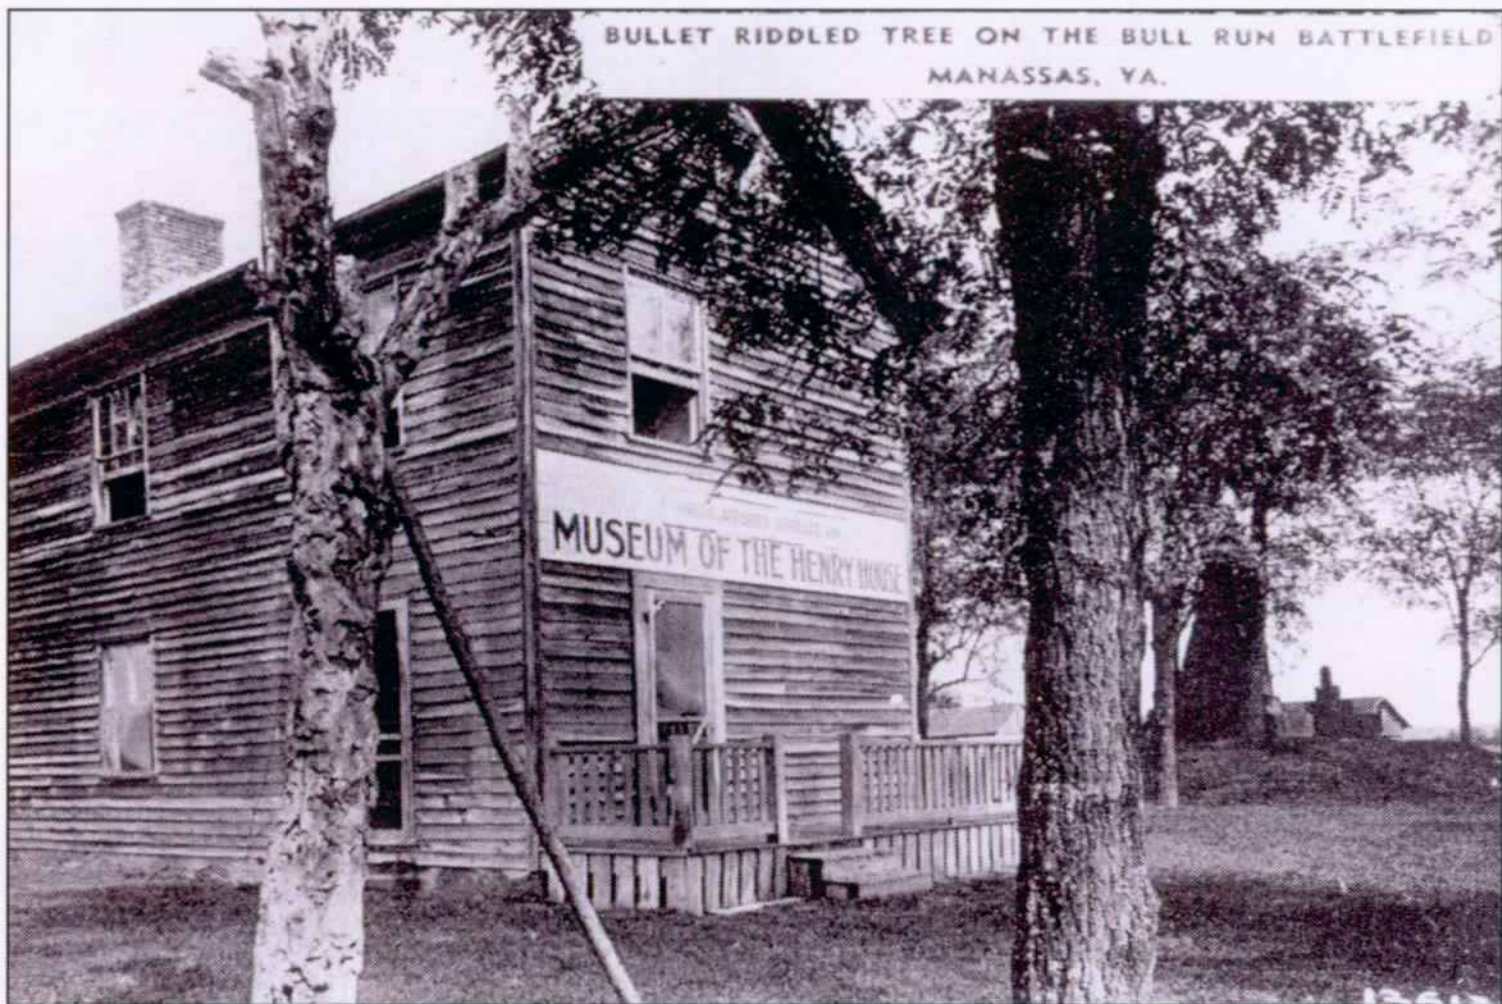
Figure 20. Postcard. Bullet Riddled Tree on the Bull Run Battlefield, Manassas, Virginia. No. 13513. Reverse side information includes, "Silver Craft – Made by Dexter Press, Pearl River, New York". Postcard loaned from Historic Postcard Collection, Manassas Museum System, McBryde Library and Archives, Manassas, VA. Also found in Henry House Historic Photo Collection, Manassas National Battlefield Park library.

Photo taken between 1922 and mid 1930's; note original siding in-situ (vertical nail pattern), siding was replaced in 1930's according to former occupant (Fred Ebhardt, personal communication, 2001).

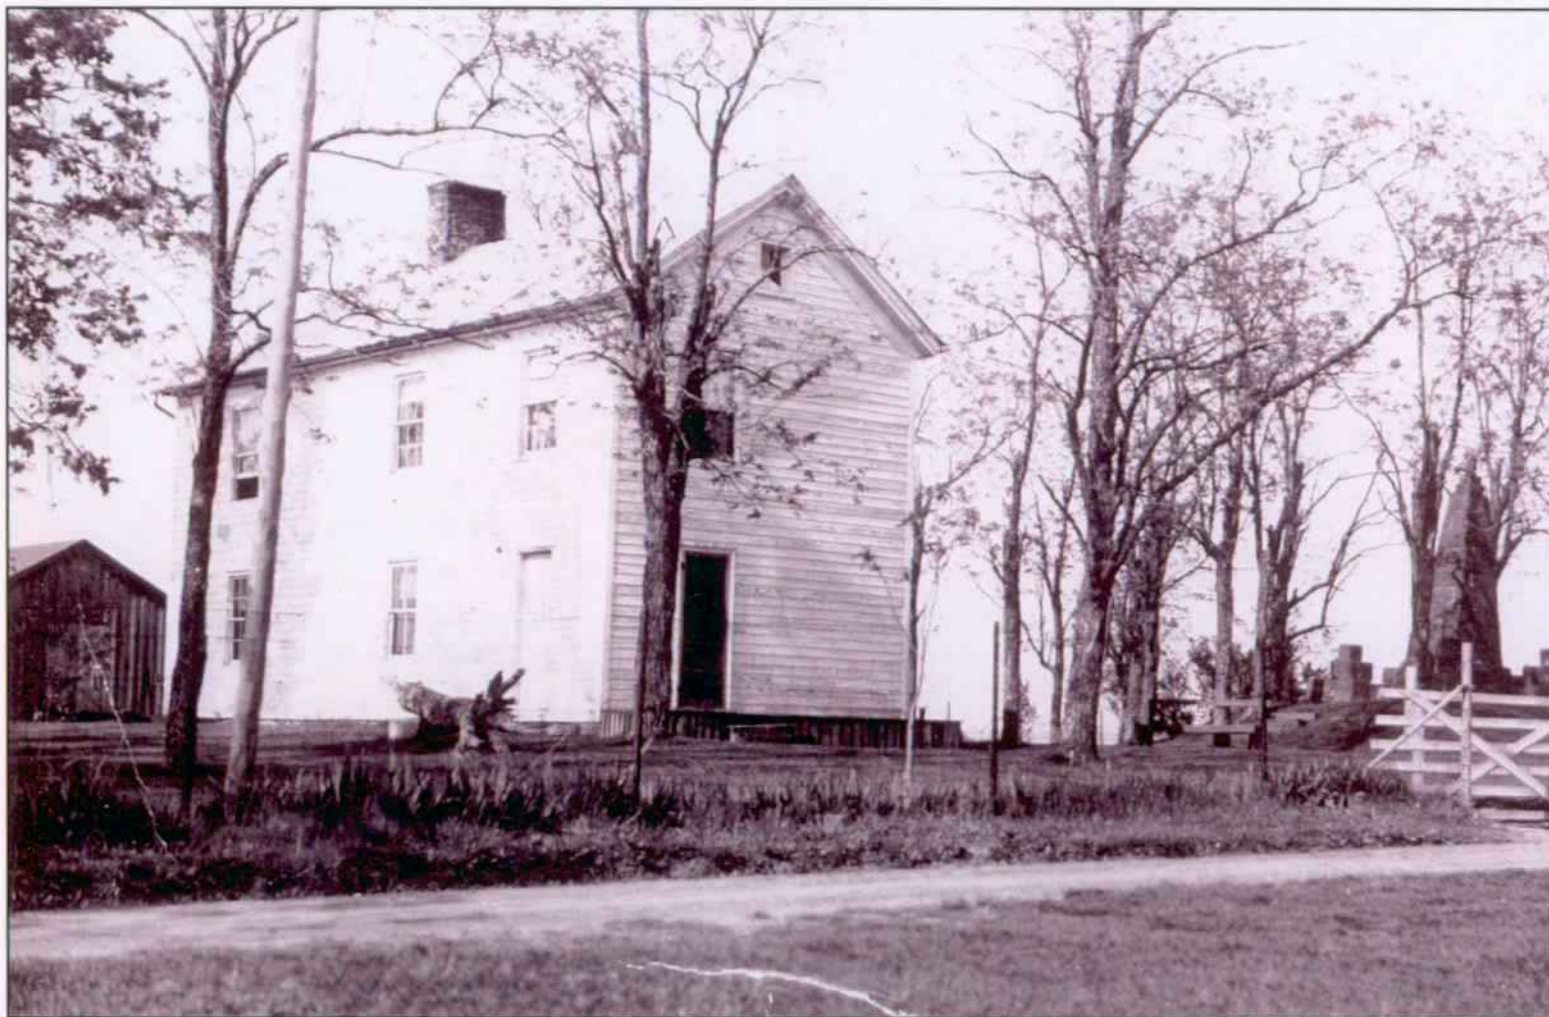
Figure 25. Overview of Henry House SW corner, new shed and monument in background. Bullet ridden tree seen in horizontal position propped up on cement pier previously used as support. South gable "veranda" entry platform in place without railing, "Museum of the Henry House" sign has been removed. Courtesy of the Fred Ebhardt Family, Manassas, Va., circa 1935 – 1942 (prior to NPS ownership).

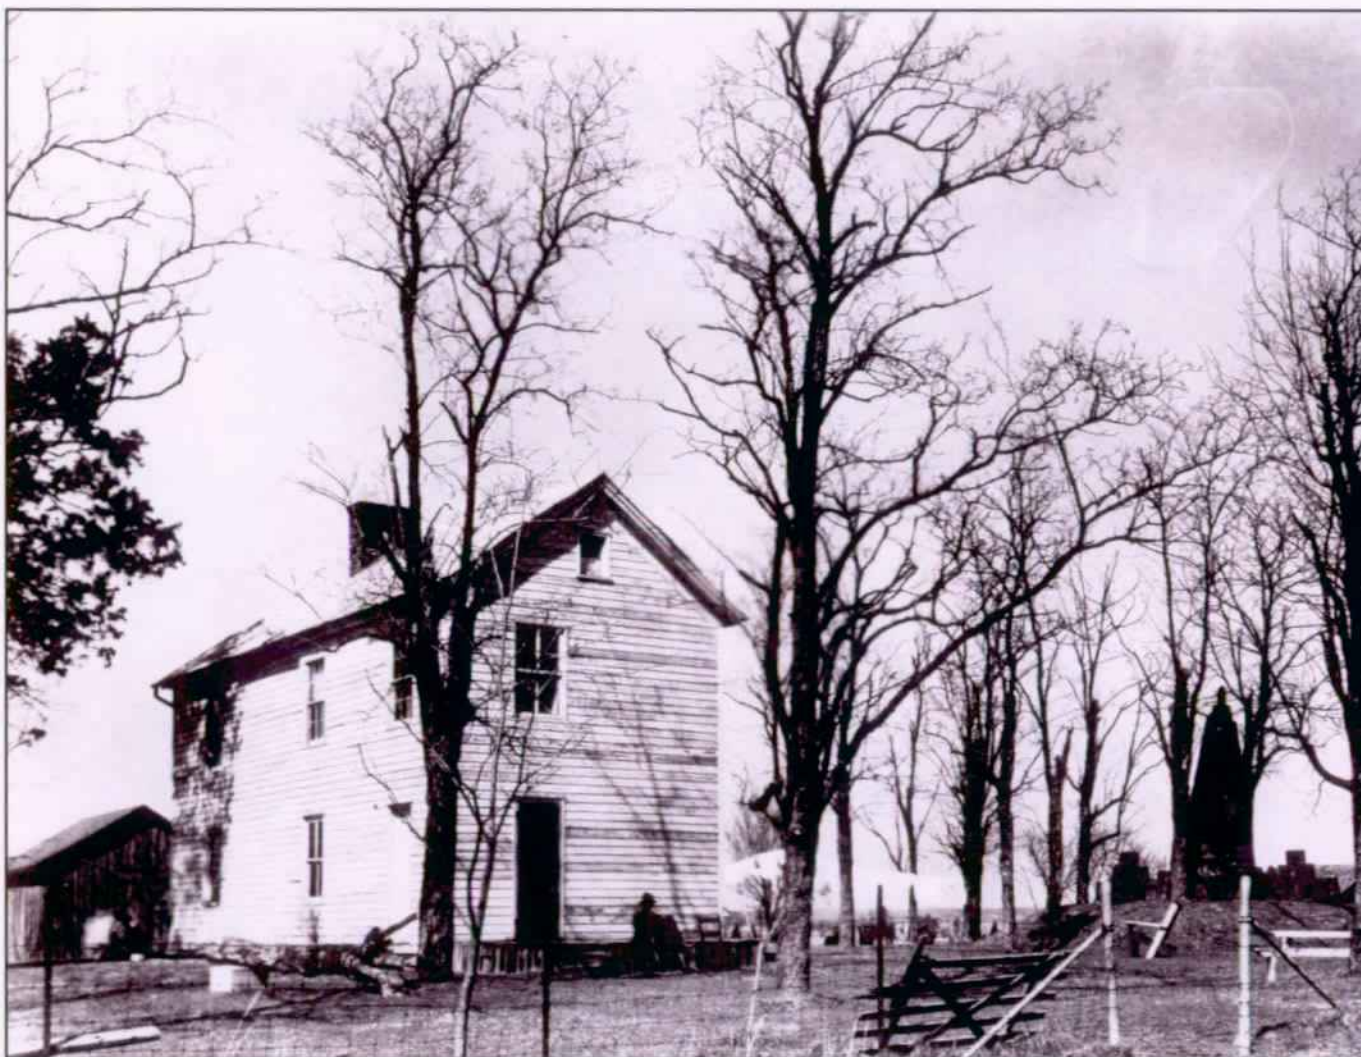
Figure 26. Overview of Henry House SW corner with person sitting on south gable veranda platform. Very similar to Figure 25, fence gate is in disrepair compared to Fig. 25 and platform skirting boards are in not as good condition. Photo attributed to Walter H. Sheffield, dated 04/10/1940. Located in NPS, Harpers Ferry Center Historic Photograph Collection, MANA park file, Harpers Ferry, West Virginia. "Henry House 1940 – Present", historic photo collection, Manassas National Battlefield Park library.

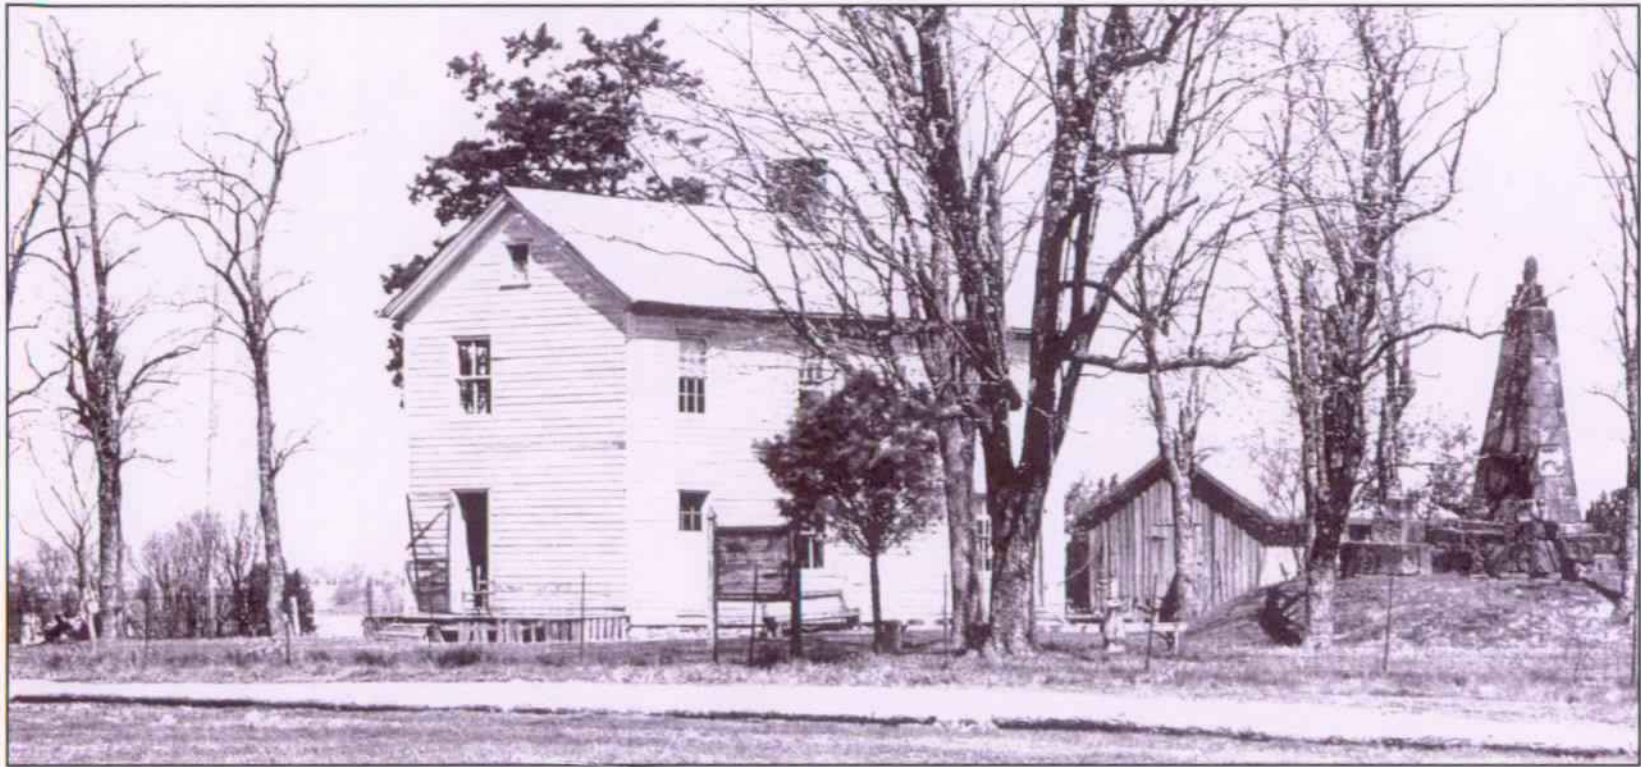
HSR Figure 27. The east elevation is now partially in view. W102 is 2/2, though W203 is still 6/6. W103 is 6-paned with a partial door filling in the space below the window. Some of the slats are missing from the porch apron. The shed now appears to be in its current configuration. Manassas National Battlefield Park interpretive signs are in place. *Photo dated April 25, 1942, by NPS Chief Photographer George Alexander Grant.*

Figure 27. *"The Henry House and Yard. The Monument to the right of the House was Erected by Union Soldiers in 1865 after the Surrender at Appomattox".* Original caption and photo attributed to George Alexander Grant, NPS Chief Photographer (1929-1954). Photo dated April 25, 1942. Located in NPS, Harpers Ferry Center Historic Photograph Collection, MANA park file #6, Harpers Ferry, West Virginia. MANA park file, "Henry House 1940 – Present", historic photo collection, park library.

Overview of Henry House and Yard. SE corner, full view of shed and Bull Run Monument. South gable screen door is hanging open, south gable veranda platform intact. Clearly visible on east elevation is east cross hallway door with large 6 light transom. Also, large interpretive sign appears along roadside. Other features in the yard include the kitchen water pump head and a few chairs and benches. Bull Run Monument is in disrepair. A tall wood flagpole is visible near the family cemetery that is enclosed with an iron fence.

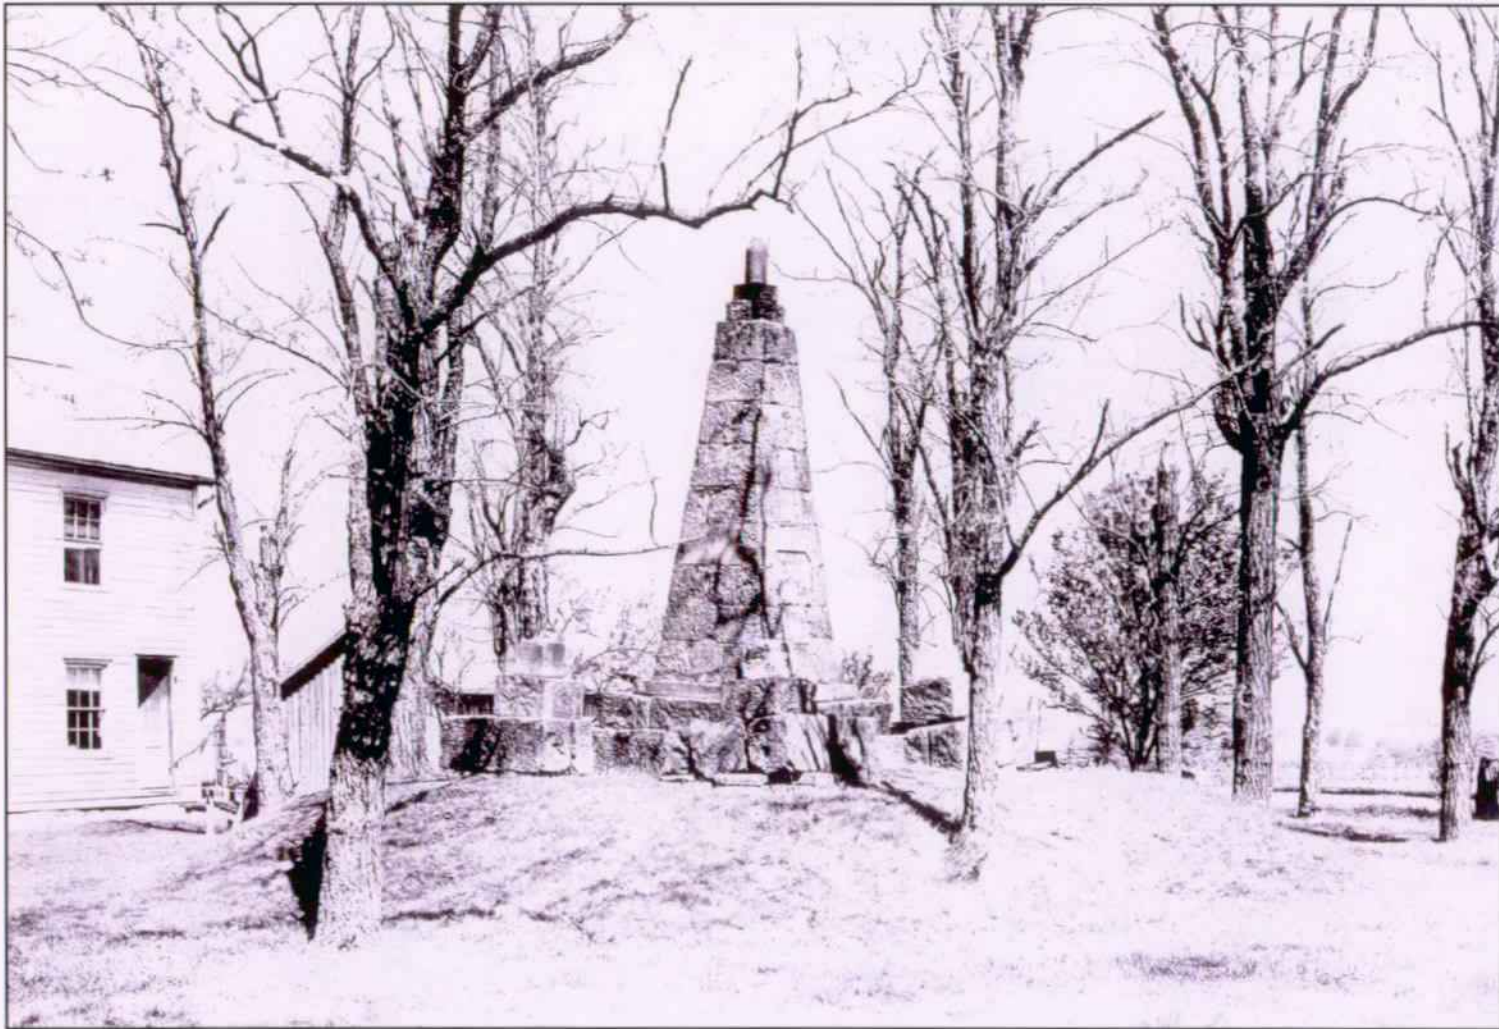
HSR Figure 28. "Monument in the Henry House Yard", NPS Photo. The highlight of this photo is the view of the original kitchen door (D101) in situ. It is clearly visible at the NE corner of the east elevation and is a typical 4 panel door used elsewhere at the Henry House; it appears very similar to the original west elevation door, D106. This door is no longer extant. A gutter and a downspout elbow are also visible at the roofline along the east elevation. Windows W101 and W210 are also clearly visible. *Photo dated April 25, 1942 by NPS Chief Photographer George Alexander Grant.*

Figure 28. *"Monument in the Henry House Yard, Built by Union Soldiers in 1865, After the Surrender at Appomattox".* Original caption and photo attributed to George Alexander Grant, NPS Chief Photographer (1929-1954). Photo dated April 25, 1942. Located in NPS, Harpers Ferry Center, Historic Photograph Collection, MANA park file #7, Harpers Ferry, West Virginia.

The highlight of this photo is the view of the original kitchen door (D101) in situ. It is clearly visible at the NE corner of the east elevation and is a typical 4 panel door used elsewhere at the Henry House; it appears very similar to the original west elevation door, D106. This door is no longer extant. A gutter and a downspout elbow are also visible at the roofline along the east elevation. Windows W101 and 210 are also clearly visible.

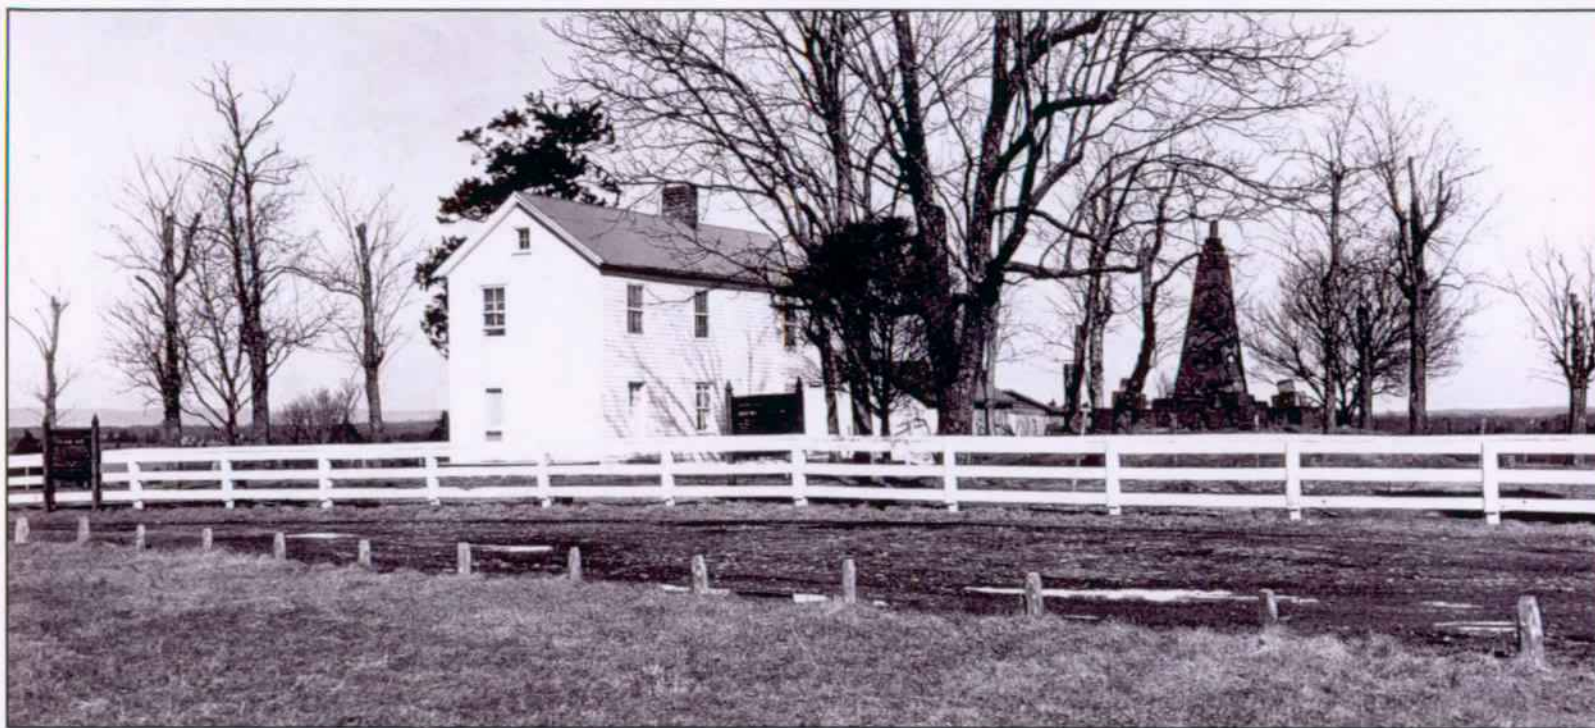
HSR Figure 29. This is a good overview of the east and south elevations; the house appears in very good condition and is freshly painted white. The south gable screen door is repaired and in place. W202 and W203 on the east elevation still remain as 6/6 type sash. W102 and W204 still remain as 2/2 type sash. W 201 is unclear. The roof is painted a dark color.

Figure 29. Overview of Henry House, South and East Elevations. Attributed to NPS National Capital Region Chief Photographer (1932-1967) Mr. Abbie Rowe, dated February 1949. Located in NPS, Harpers Ferry Center Historic Photograph Collection, MANA file, negative # 429, Harpers Ferry, West Virginia. MANA park file, "Henry House, 1940 – Present" folder, Park Negative # (1043-V) historic photo collection, park library.

Good overview of east and south elevations, house appears in very good condition, freshly painted white. South gable screen door repaired and in place. Wood rail fence lines north side of unpaved road to the south of the house. A row of low fence pole bollards lines the south side of the road. Two wooden interpretive signs are seen, one along the roadside south of the fence and the other in the background beyond the fence line.

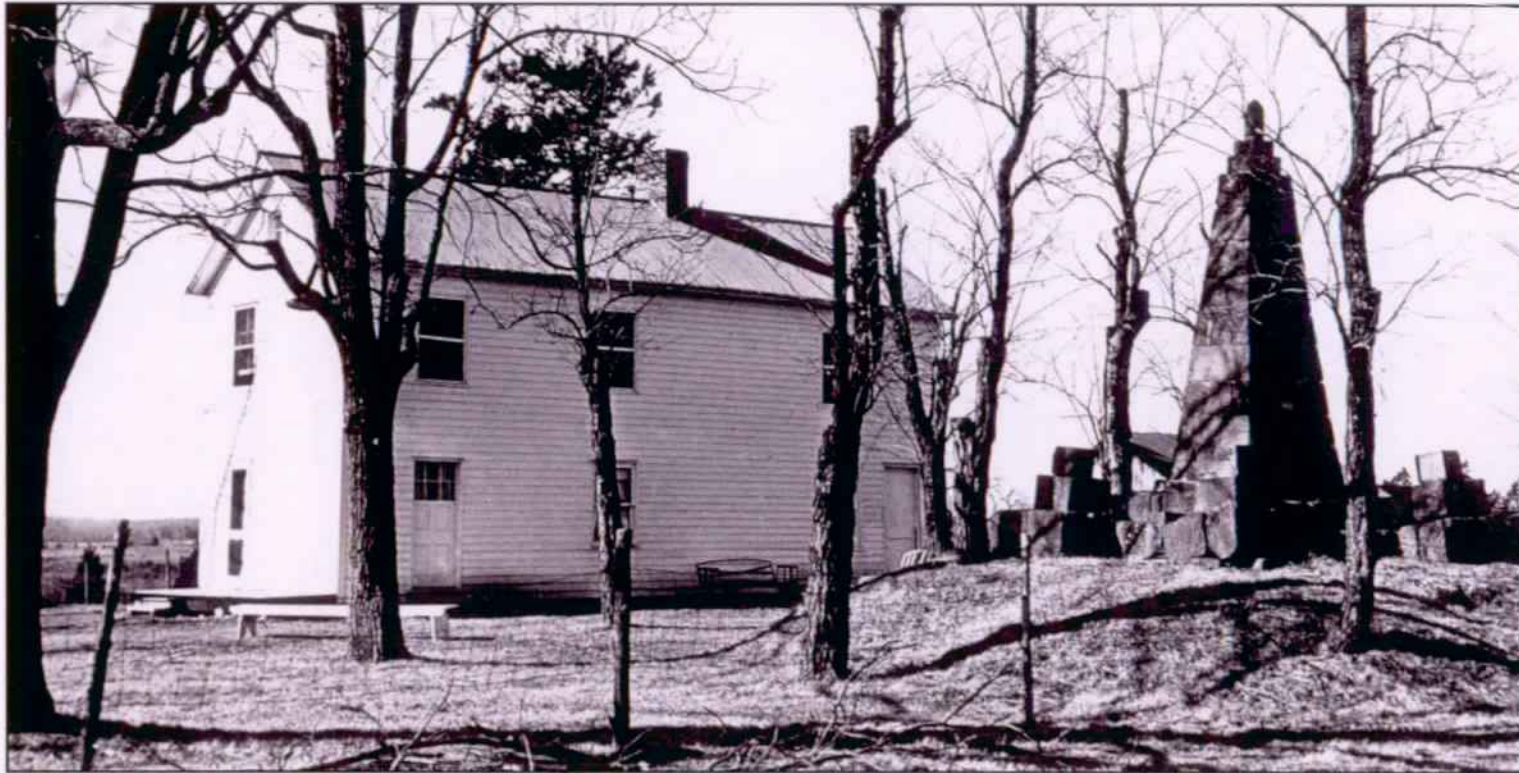
HSR Figure 30. Very clear view on east elevation of east cross hallway 4 panel wood door with large 6 light transom (103). It is not clear if the transom is part of the door (which is normal height) or fixed as part of the wall. If the transom is fixed the door would be a $\frac{3}{4}$ scale door as the door opening matches other full height doors. The door appears to have been a 6-paneled door with the top panels cut off.

Figure 30. Overview of Henry House, East Elevation and Yard with Bull Run Monument. Attributed to NPS National Capital Region Chief Photographer (1932-1967) Mr. Abbie Rowe, dated February 1949. Located in NPS, Harpers Ferry Center Historic Photograph Collection, MANA file, negative # 430, Harpers Ferry, West Virginia. MANA park file, "Henry House, 1940 – Present" folder, Park Negative # (1043-?) historic photo collection, park library.

Very clear view on east elevation of east cross hallway 4 panel wood door with large 6 light transom. It is not clear if the transom is part of the door (which is normal height) or fixed as part of the wall. If the transom is fixed the door would be a $\frac{3}{4}$ scale door as the door opening matches other full height doors. Also clearly seen in this view is the old kitchen door still in situ. House appears in very good condition with exterior storm windows on the second floor windows, both elevations. This view taken more from the southeast includes the Bull Run Monument that is observed in disrepair.

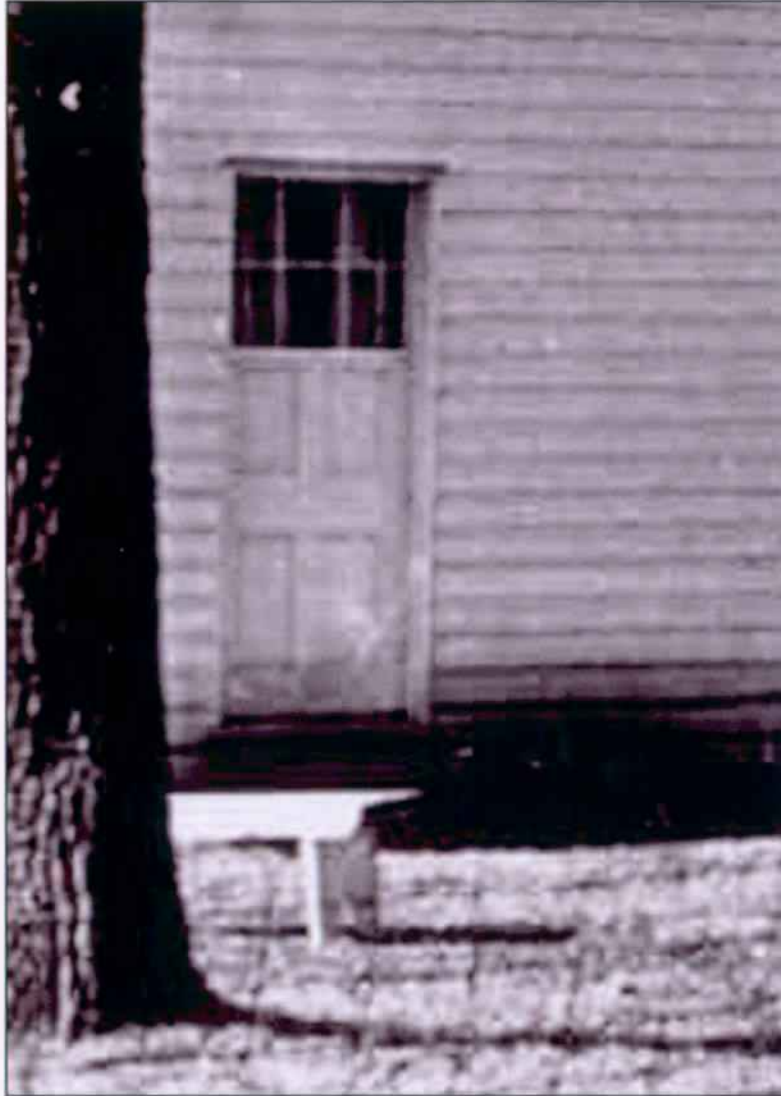
HSR Figure 30a. The east cross hallway door with a large 6 light transom window (possibly actually a window sash given its proportion) is seen in this rare rear view of the house. This door was later removed and converted to a window (W103) as labeled on the architectural field drawings associated with the HSR.

This alteration of the building may be directly related to the installation of the bathroom (R104) precisely at this location on the interior. The bathroom was most likely installed by the NPS during the habitation of the NPS Caretaker Mr. Leonard and his wife. The same door is seen in Figure 27, which is dated 1942. *Electronic (non-photographic) enlargement of HFC HPC MANA 430 (Figure 30) by HPTC.*

Figure 30a. Electronic (non-photographic) enlargement of HFC HPC MANA 430 (Figure 30). The east cross hallway door with a large 6 light transom window (possibly actually a window sash given its proportion) is seen in this rare rear view of the house. This door was later removed and converted to a window (W103) as labeled on the drawings associated with the HSR.

This alteration of the building may be directly related to the installation of the bathroom (R104) precisely at this location on the interior. The bathroom was most likely installed by the NPS during the inhabitation of the NPS Caretaker Mr. Leonard and his wife. The same door is seen in Figure 27 which is dated 1942.

That seems within the timeline as it is known today although it could be as late as 1949 based on other NPS records.
