Henry House
Historic Structure Report
Final Revised Edition

Manassas National Battlefield Park
National Capital Region
Manassas, Virginia

Historic Preservation Training Center
U. S. National Park Service

August 2003

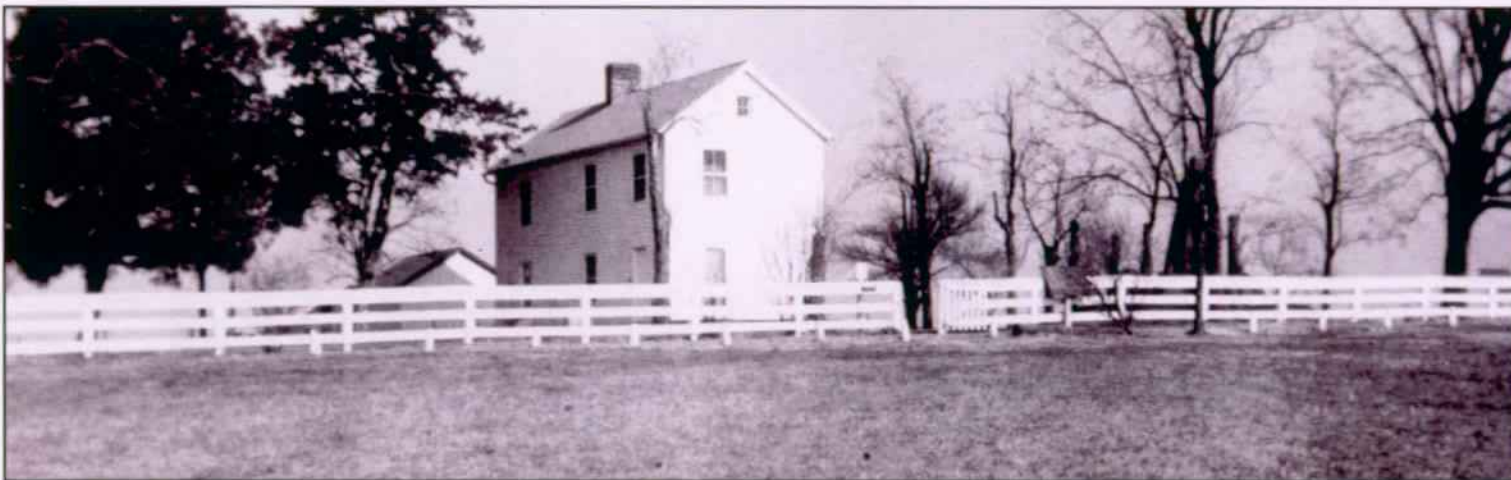
HSR Figure 31. Overview of the Henry House and Yard, photo dated January 1956, photographer unknown. Appearance of house is very similar to its look today (2003).

Figure 31. Overview of Henry House and Yard. Taken from Polaroid photograph dated January 1956. MANA park file, "Henry House, 1940 – Present" folder, historic photo collection, park library, unknown photographer.

House seen in good repair with white rail fence running along north side of road. Cast iron interpretive tablet seen located to south of fence line. Tablet is titled "Battle of First Manassas, The Henry House – July 21, 1861". Tablet is detailed in an addition Polaroid photo also dated Jan. 1956 in the same file.

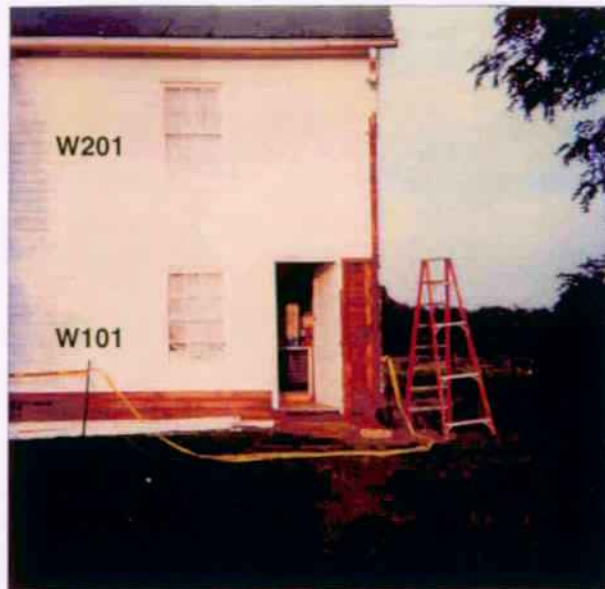
HENRY HOUSE
9/92

East Elevation @ NE Corner Post and D101
Removal of Extant Exterior Siding.

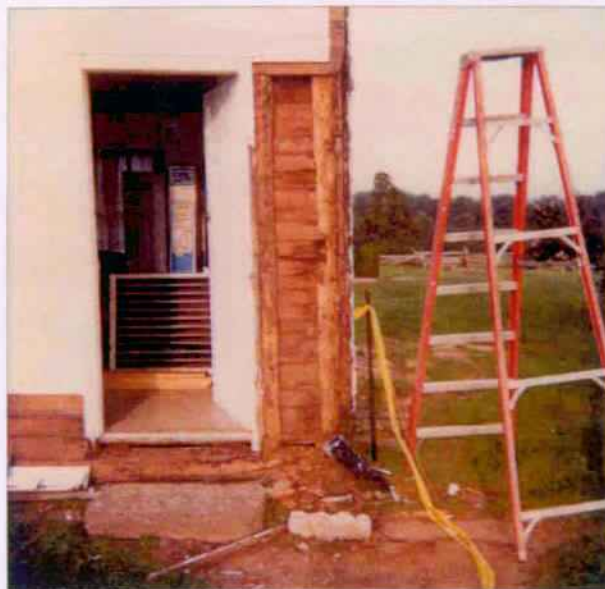
HENRY HOUSE
9/92

D101 @ East Elevation, Siding Removed to Reveal Severely Deteriorated
NE Corner Post.

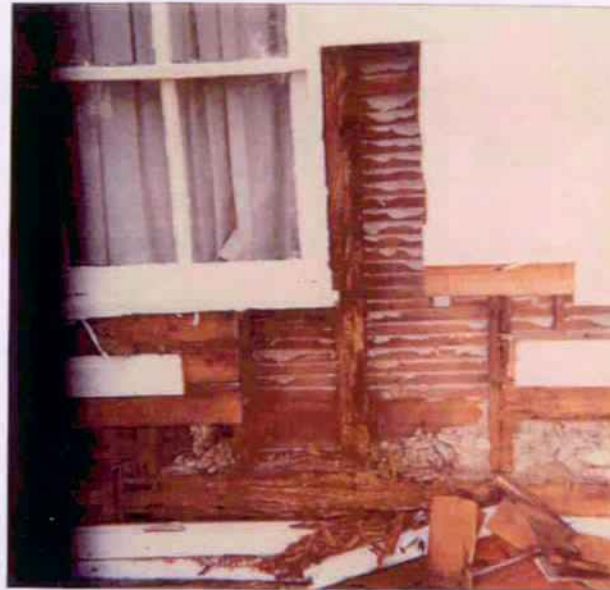
HENRY HOUSE
9/92

W102, SE portion of south wall, deteriorated sill plate and structural wall frame components exposed.

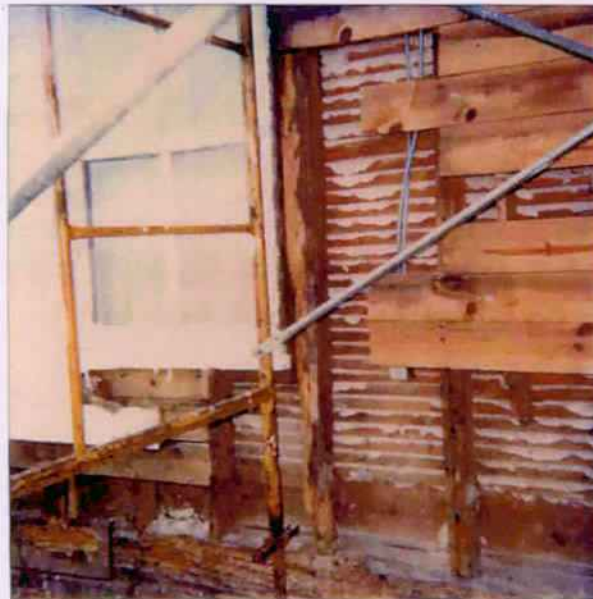
Henry House
9/22/92

W102 at South Block, note lath and plaster revealed at interior surface of wall and deteriorated vertical structural element at window frame.

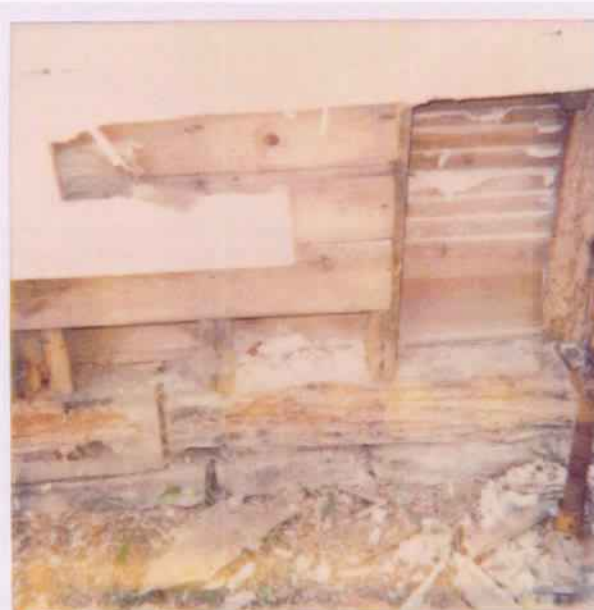
Sill Plate with Termite Damage prior to Replacement. Note Sill Plate Sections Butted Together and exterior siding installed over sub sheathing boards. Lath & plaster interior denotes south block construction.

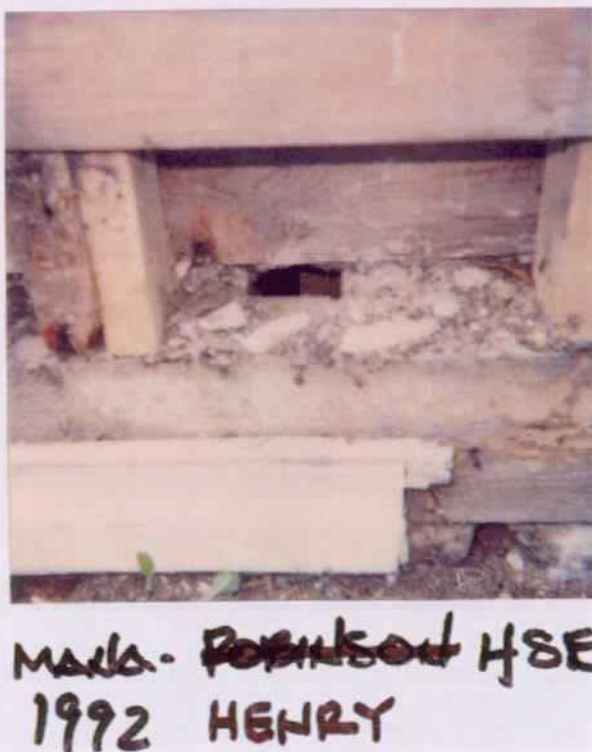
MAKLA - ROBINSON HSE
1992 HENRY

East Elevation Sill Plate with Termite Damage Prior to Repair

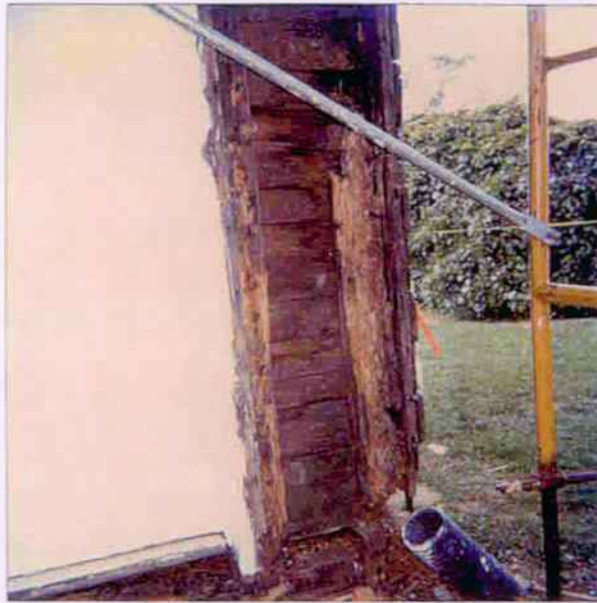
HENRY HOUSE
9/22/92

NE Corner Post Damage.

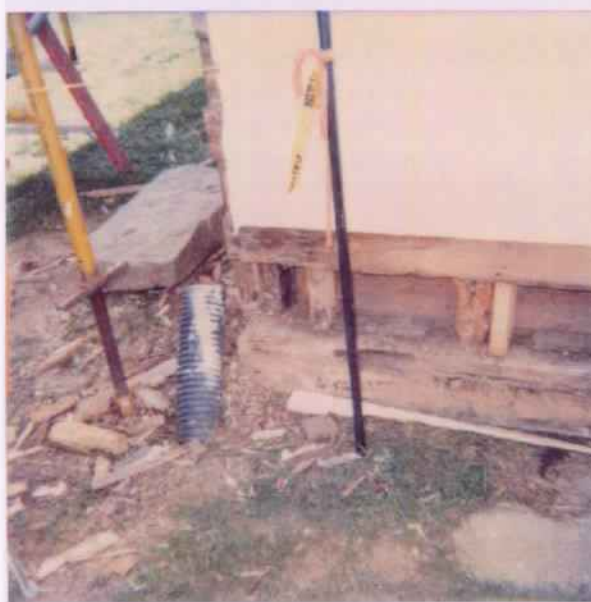
MANASSAS-ROBINSON HOUSE
1992 HENRY

Deterioration of sill plate at corner post visible.

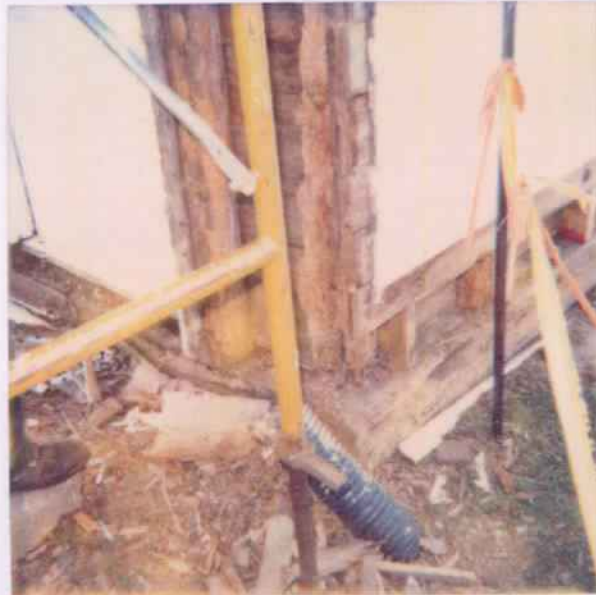
MONA - ROBINSON 48E
1992 HENRY

NE Corner Post Termite Damage Revealed.

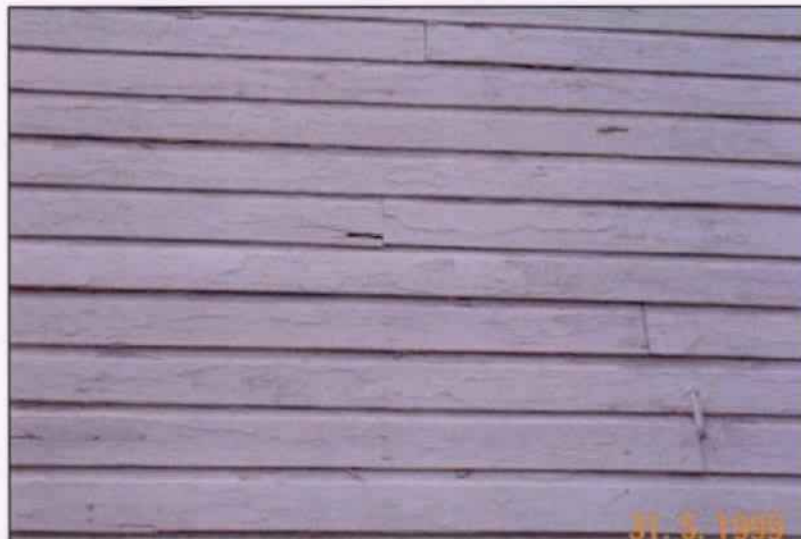
Figure 2. Detail exterior "German Style" ship-lap weatherboard siding, prior to 1999/ 2000 north elevation repair project. 05/31/99

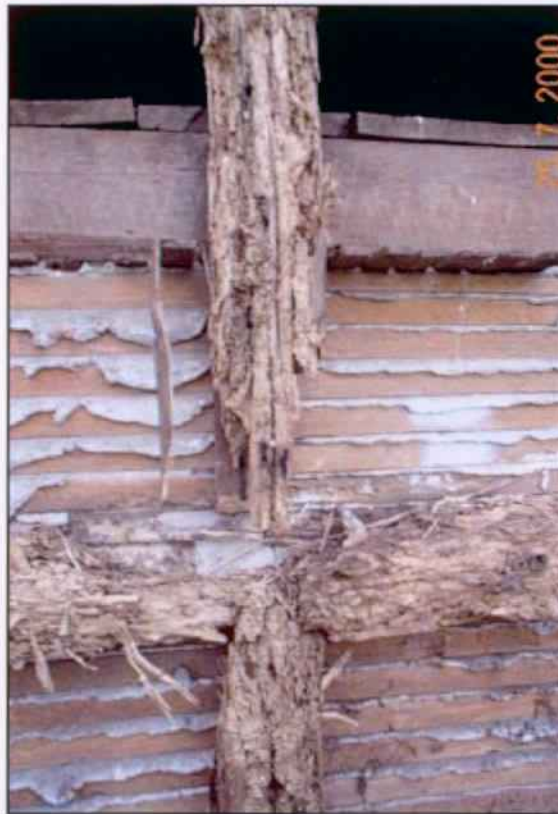
Figure 9. North Elevation Gable End, vertical stud and horizontal wall plate exposed. Attic floor planking and top wall plate seen above wall lath with plaster keys exposed.

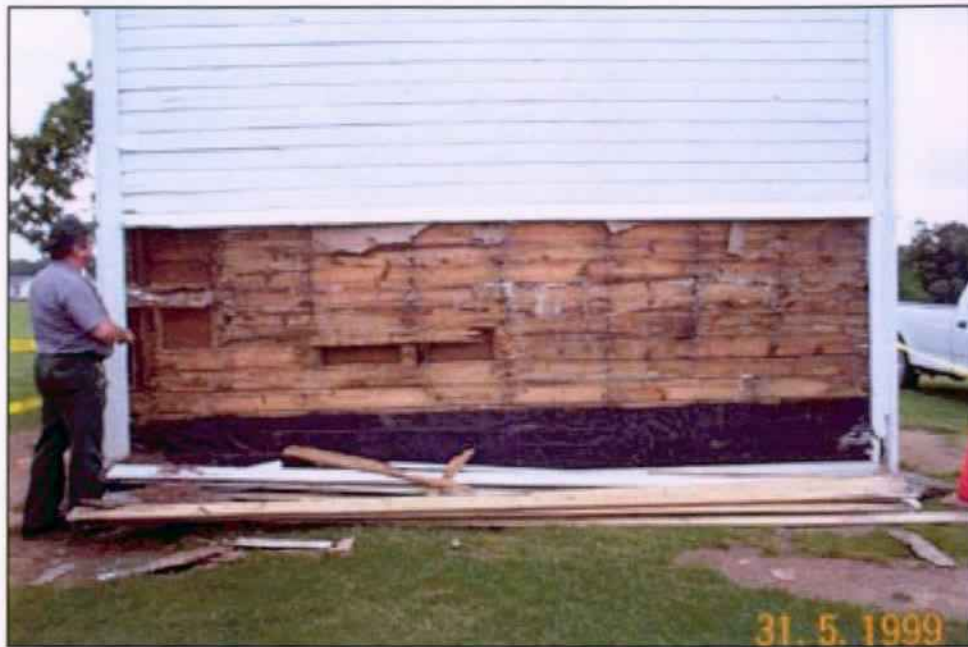
Figure 1. North Elevation Gable End – Exterior Siding Being Removed. 05/31/1999

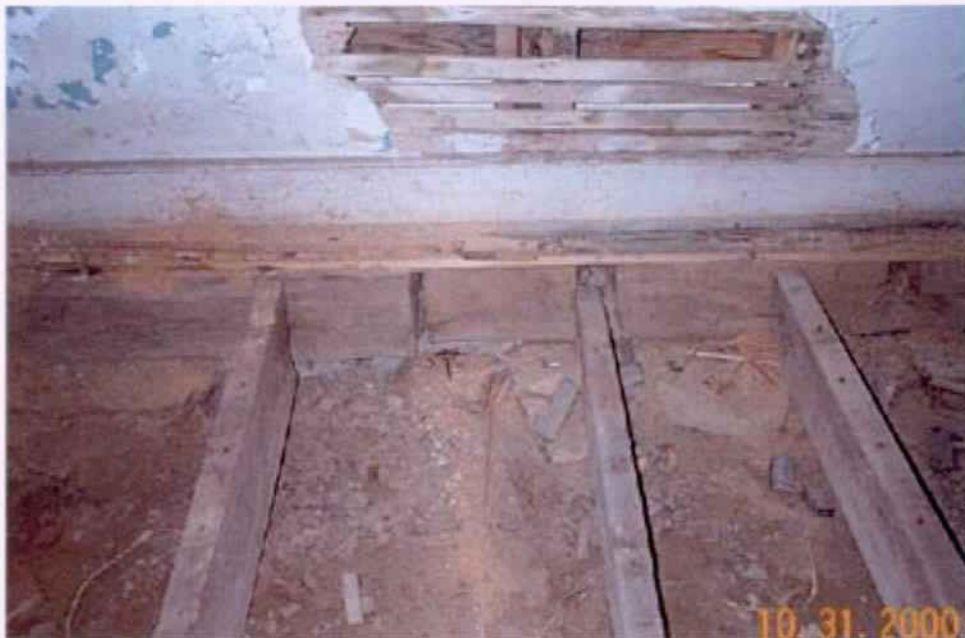
Figure 5. East Wall Near Center, note split in sill plate between joists.

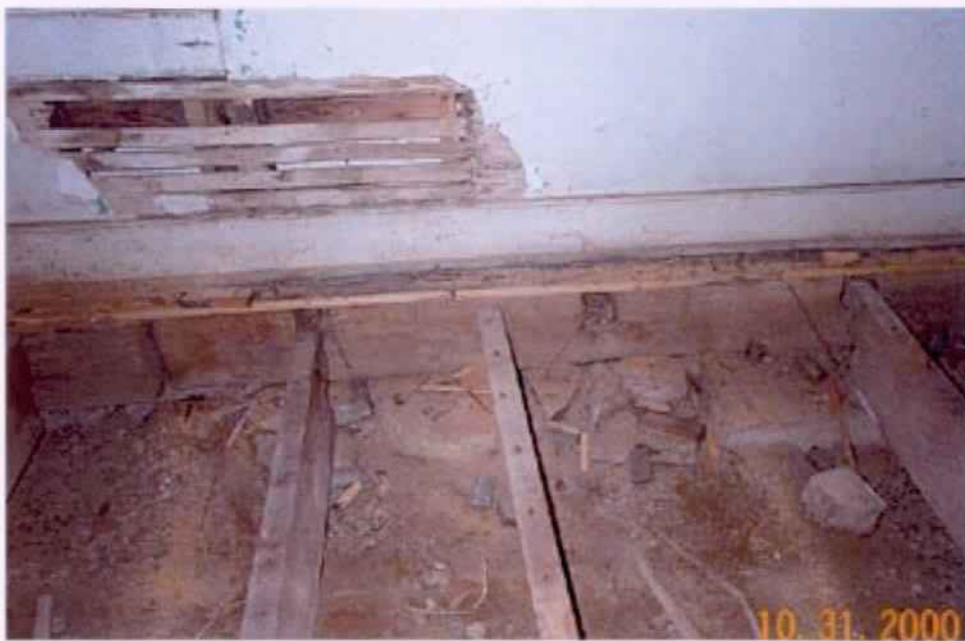
Figure 6. East Wall Near Center, further north, showing empty joist pocket.

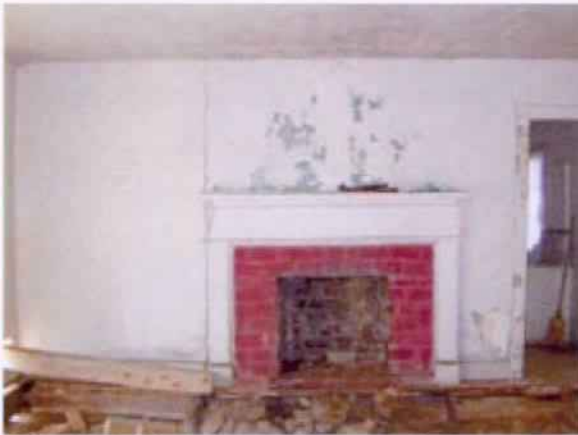
RM 102. Floor to ceiling crack is seen to west of mantle on north wall of room. Note missing floor joists. Monitored as Crack 1.

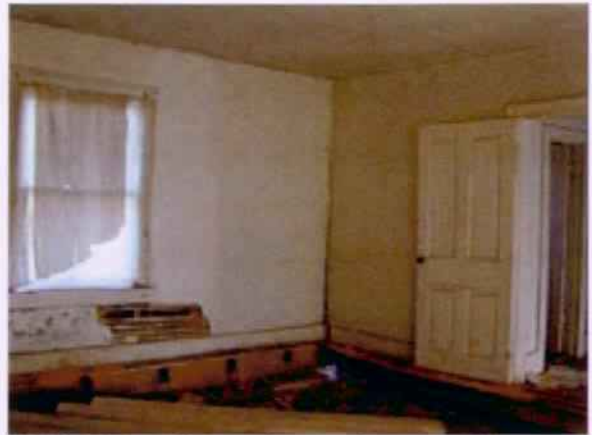
RM 102. SE quadrant of room. Floor to ceiling crack is at corner. Monitored as Crack 2.

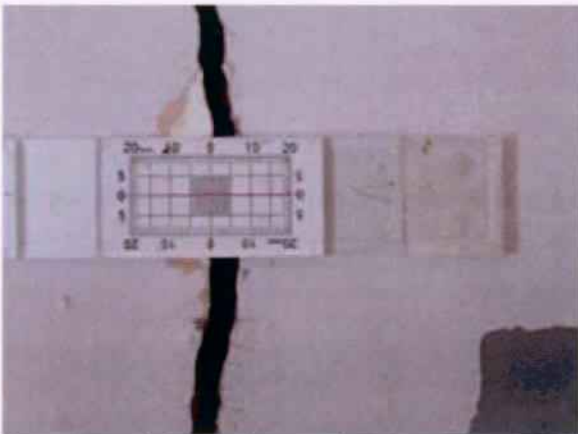
Crack 1 with crack monitor in place. This is initial placement of monitor in the "zeroed out" position. Note red cross marks centered on black tracking graph.

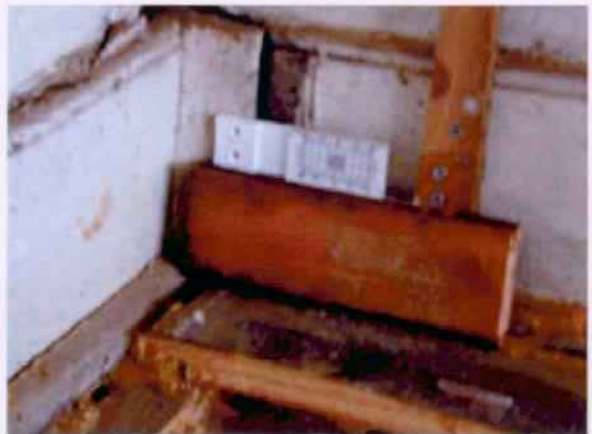
Crack 2 at SE corner of room supported by wood blocking to measure at bottom of wall to track floor width movement.

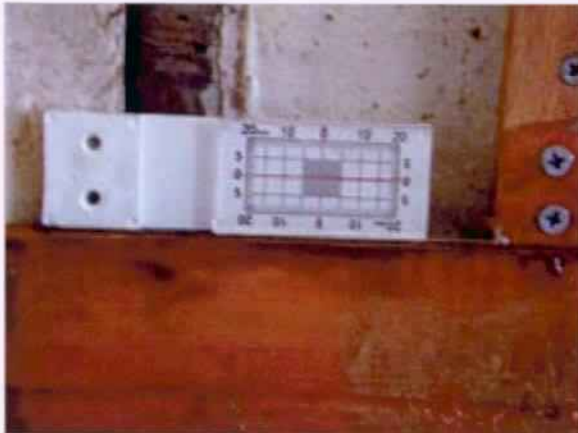
Crack 2 detail. Crack monitor with its first graph setting in the center "zeroed-out" position.

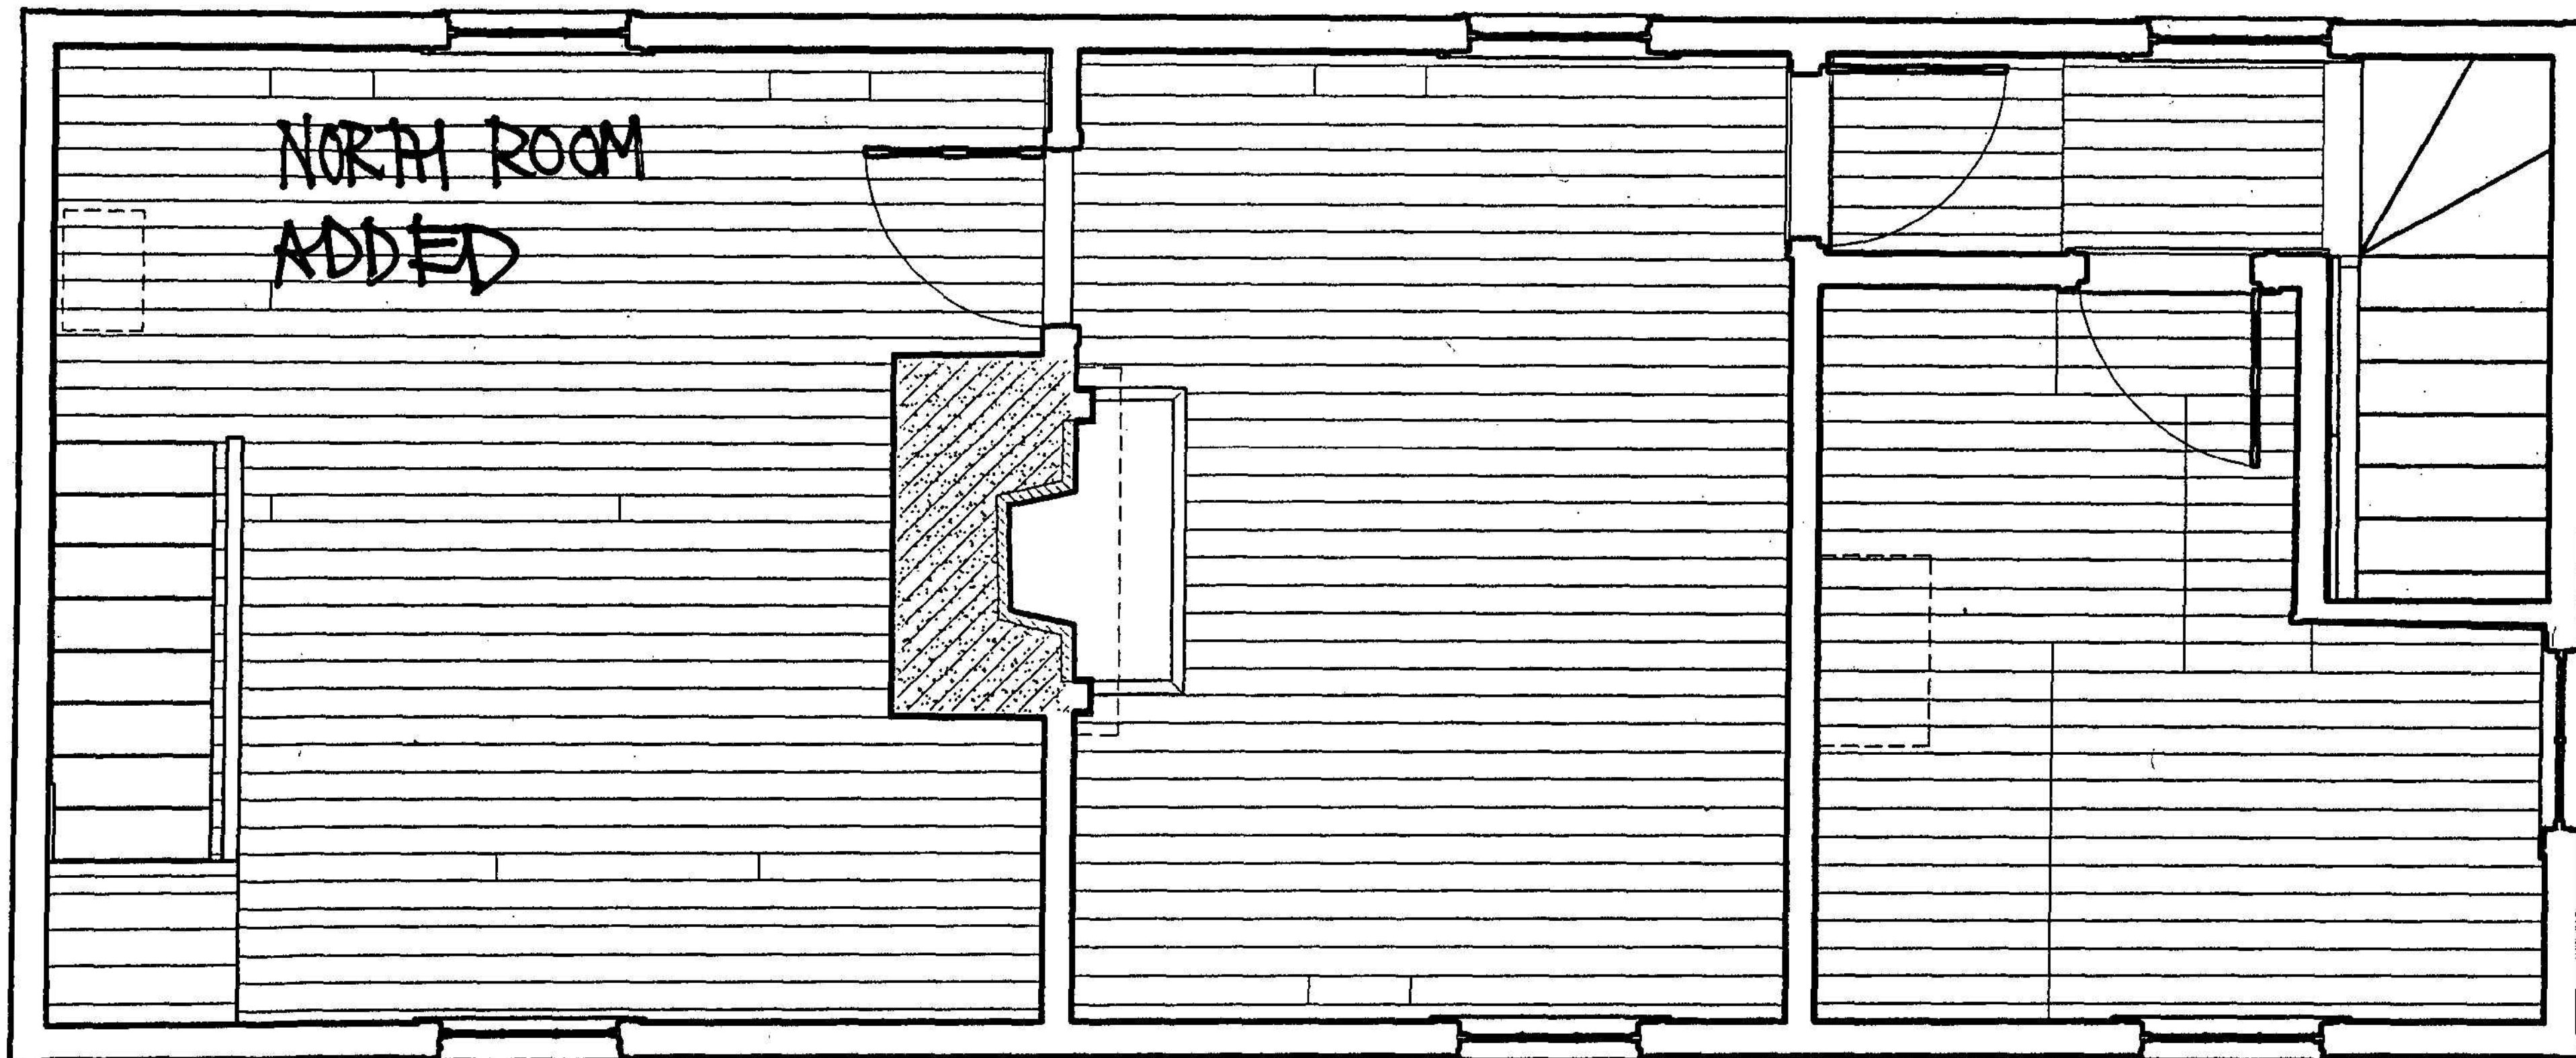
SECOND PERIOD (POST 1883) HENRY HOUSE - SECOND FLOOR PLAN
2/3 I. HOUSE PLAN W/ NORTH SADDLE BAG ADDITION.

- ① WINDOW CHANGED TO DOOR.
- ② STAIR SHORTENED TO ACCOMMODATE NEW DOOR.
- ③ SOUTH ENTRANCE DECK ADDED.

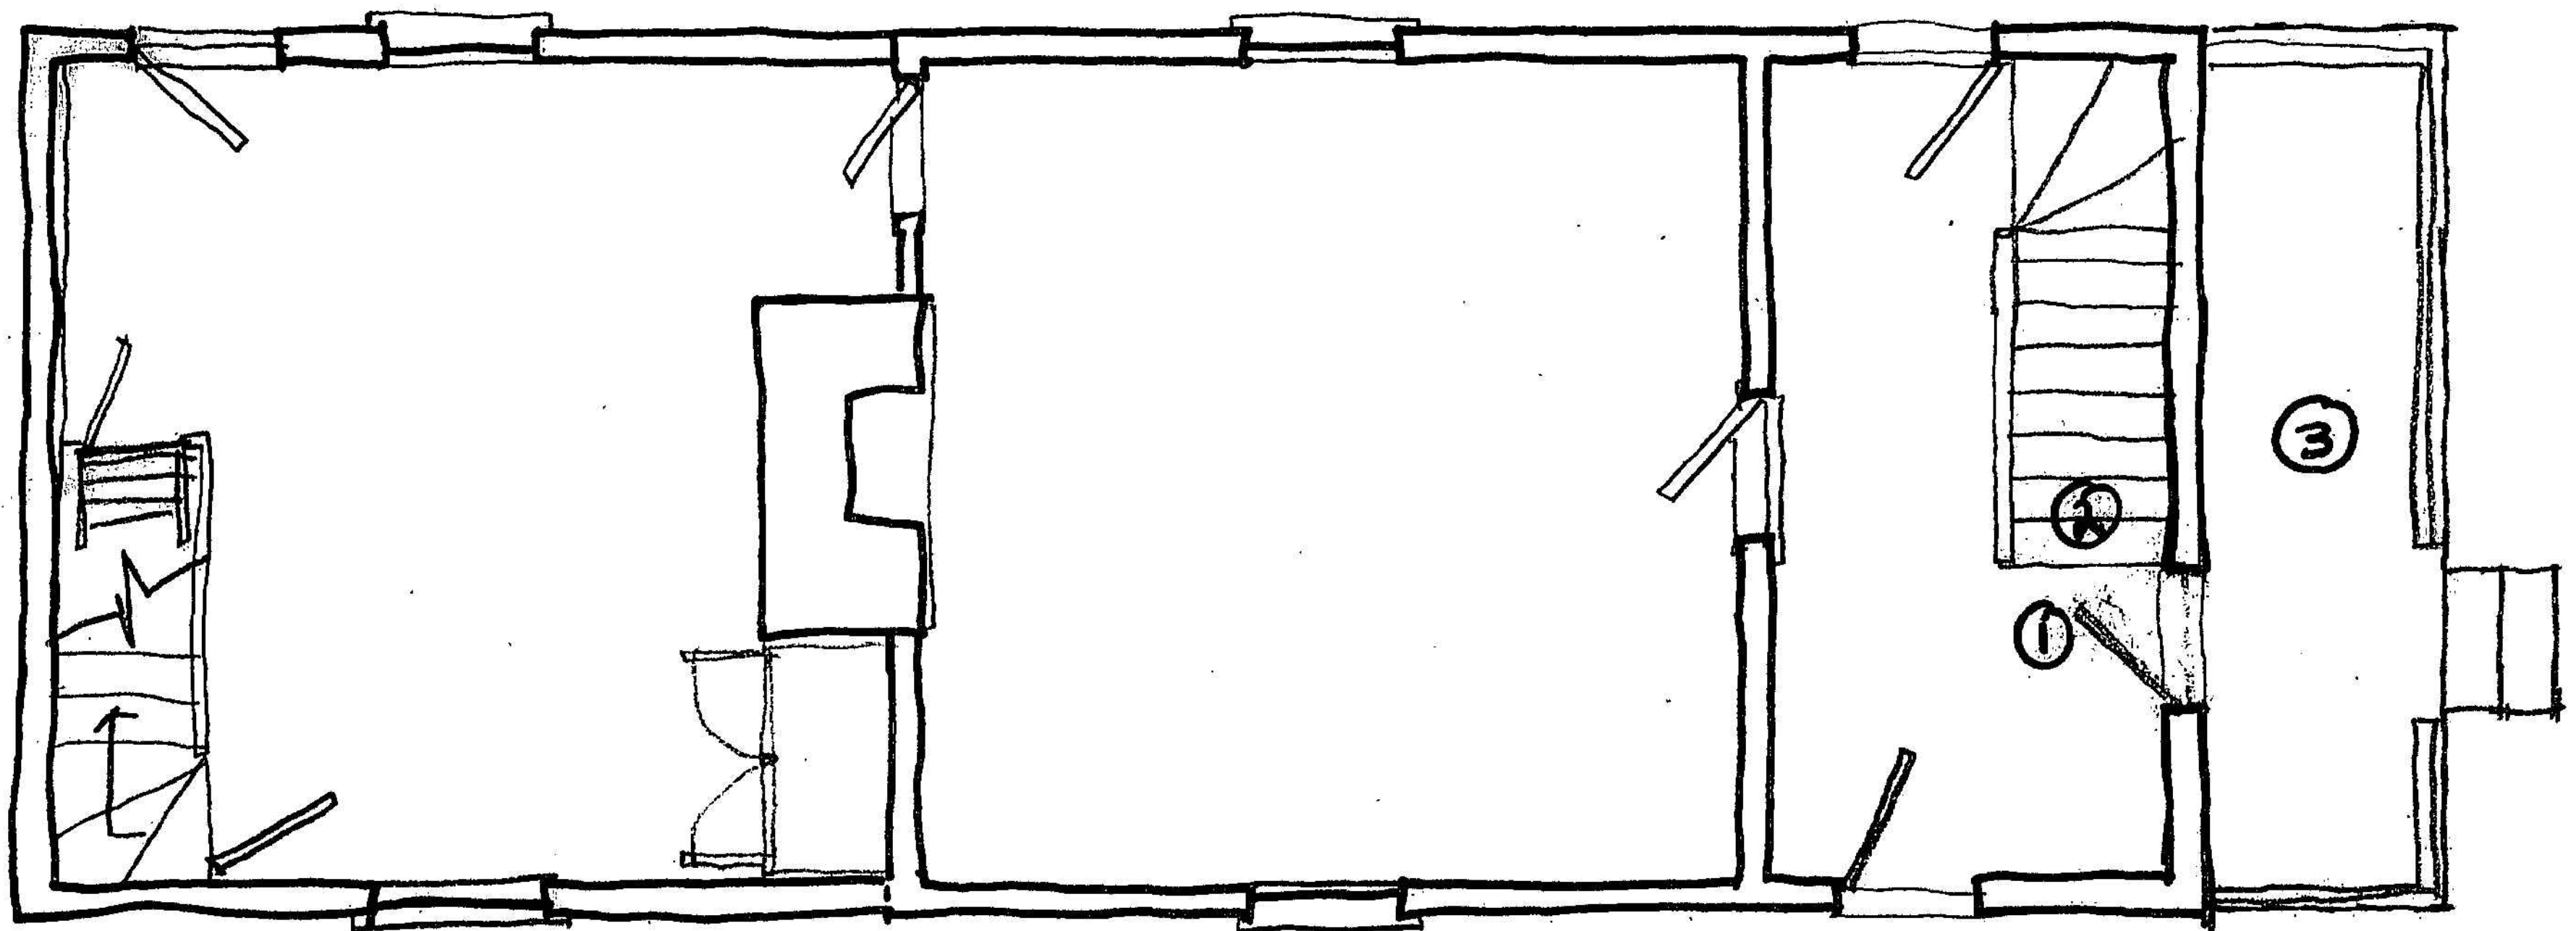
PG 3A

THIRD PERIOD - SONS of the CONFEDERATE VETERANS (1920-1946 \pm).
 HENRY HOUSE - FIRST FLOOR PLAN W/ ALTERATIONS

- ①. WINDOW CHANGED TO DOOR.
- ②. STAIR SHORTENED BY 2 TREADS.
- ③. SOUTH "VERANDA" REMOVED.
- ④. BATHROOM ADDED APPROX. 1945 +/-.
- ⑤. DOOR CHANGED TO WINDOW.

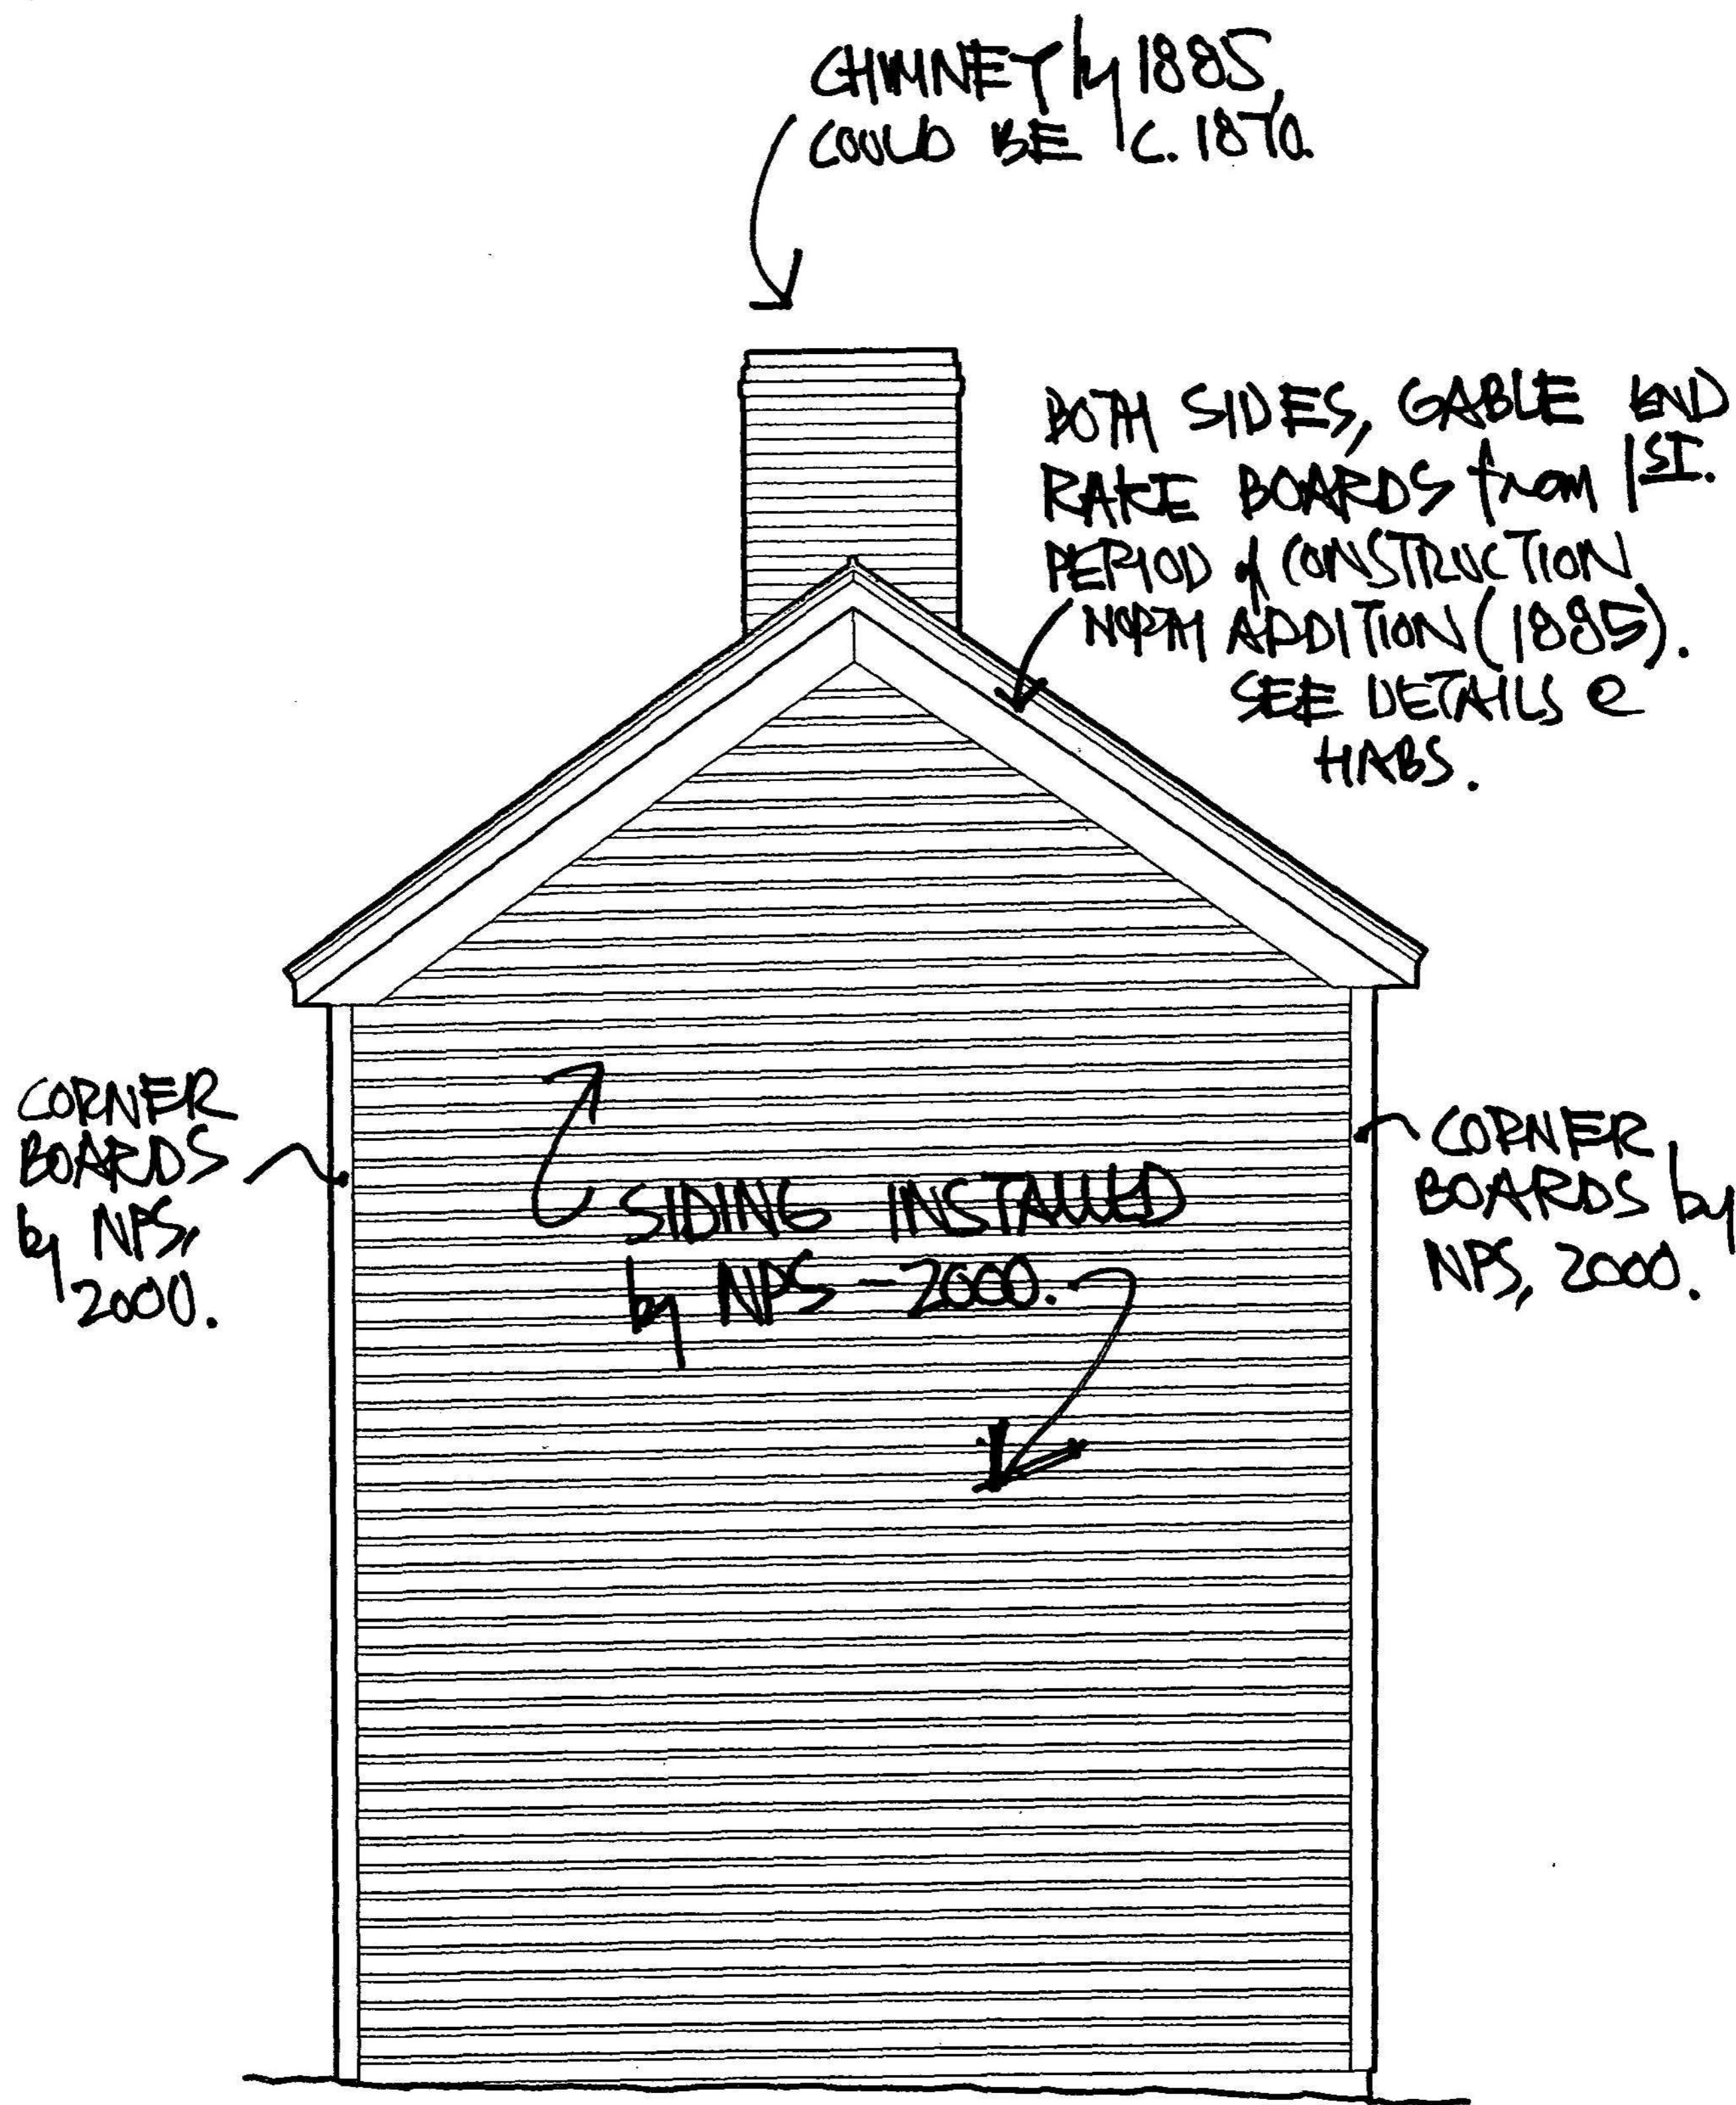
PG 4D
09/2001.

ANNOTATED NORTH ELEVATION (HABS)
(1/4" = 1'-0" +/-) • HENRY HOUSE, MANA. •

CORRUGATED METAL ROOF INSTALLED in 1930's - SAME TIME AS SIDING WAS REPAIRED (1932-1940)

CORRUGATED METAL ROOF INSTALLED in 1930's - SAME TIME AS
SIDING WAS REPLACED by S.C.V. C. 1932-1940.

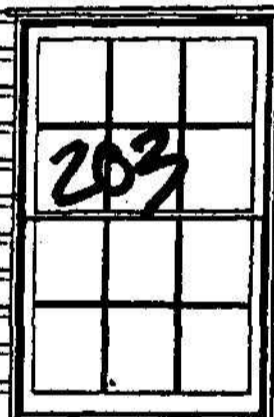
SIDING THIS
AREA DATES
from 1935±
RESIDING by

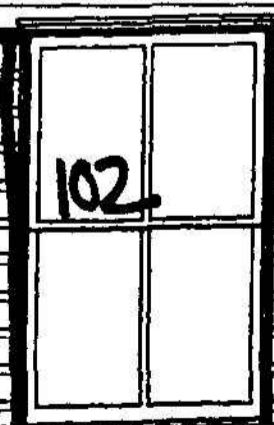
SIDING THIS AREA
REPLACED by NPS
in 1992

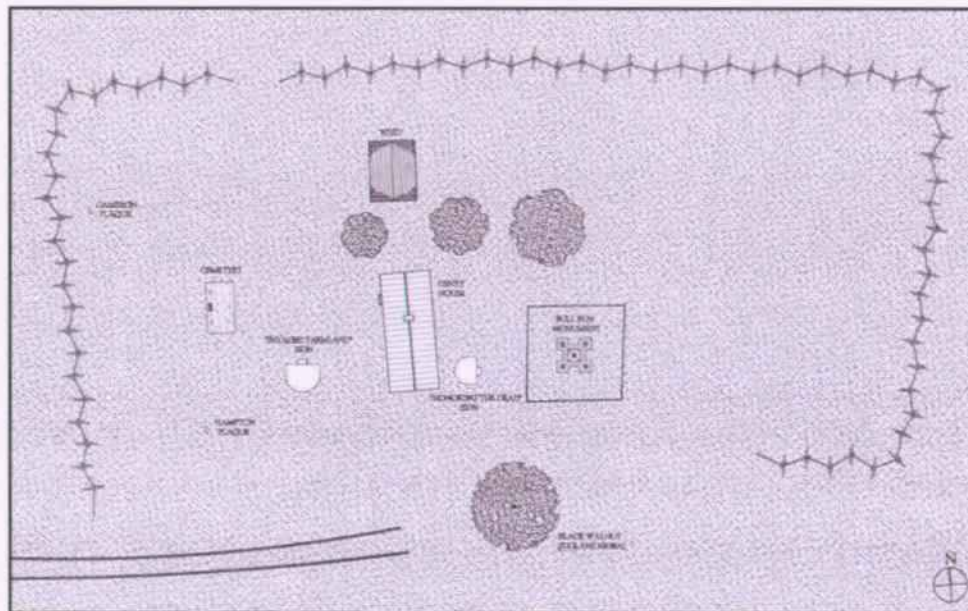
A narrow concrete apron slab abuts the north cellar walls and house foundation near the cellar ventilation well at the northwest corner. This slab may allow water to drain back toward the house foundation walls.

Site Plan taken from HABS Drawing Set No. VA-1363, Henry House, Sudley Road, Manassas Vicinity, Manassas National Battlefield Park, Prince William County, Virginia, Cover Sheet, 2001.

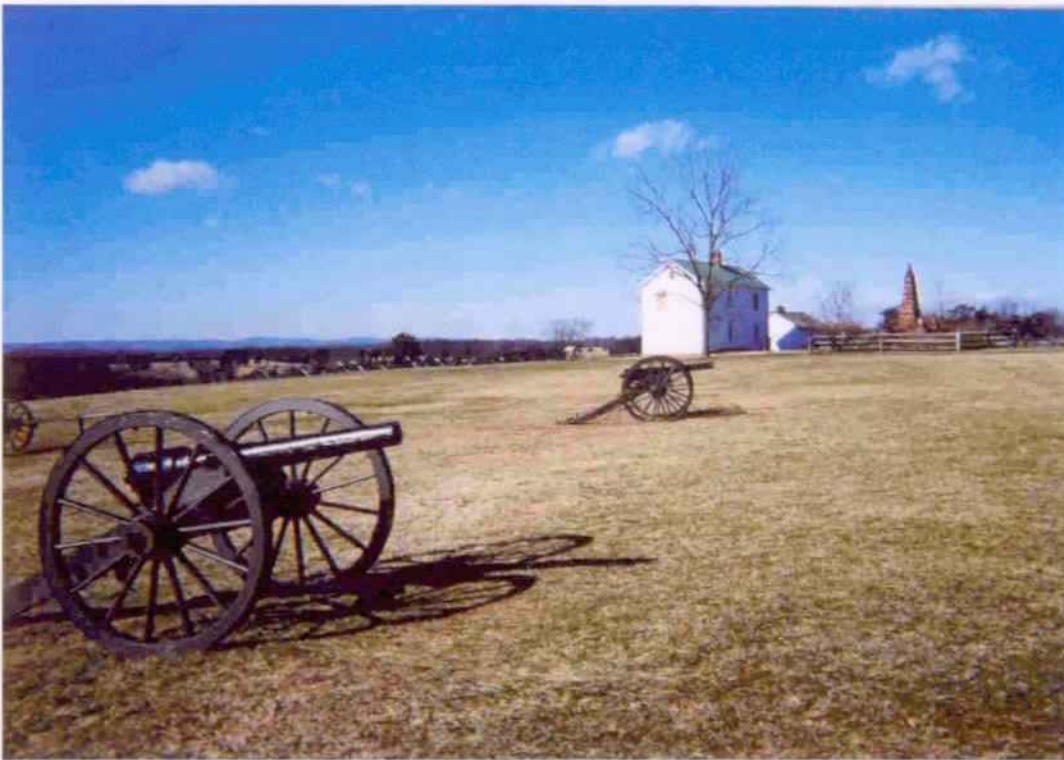
Photo by author, 11/ 2002.

The location of previous porch structures near the southwest corner and along the south elevation has also created minor depressions that tend to collect and retain moisture and water. The archeological units that have been excavated along the perimeter of the house also create shallow pits of disturbed soil that collect moisture and water. Other localized depressions occur at the northeast kitchen door area where repeated foot traffic has eroded and compacted the soil level.

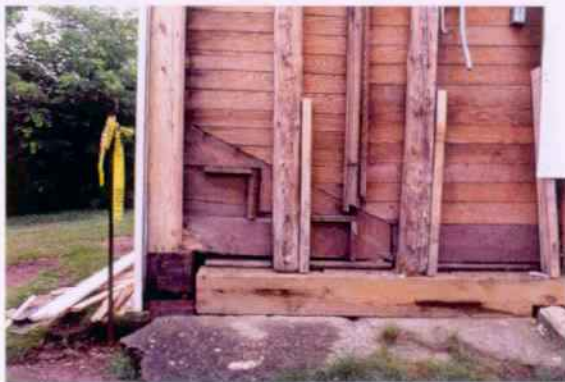
NORTH ADDITION: Lower West Elevation; sill plates, corner post, wall studs and interior sheathing exposed.

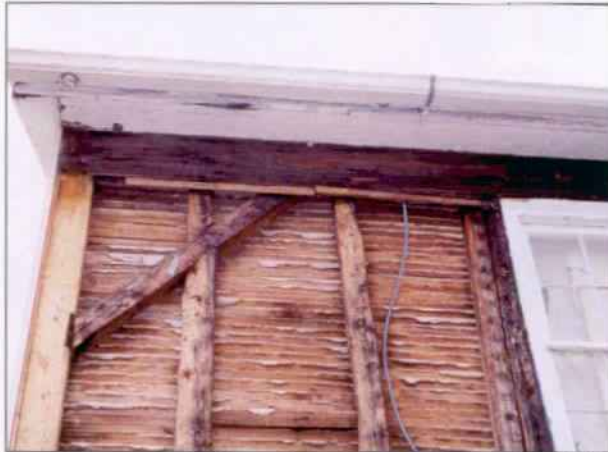
Corner Brace at northwest corner post in north addition.

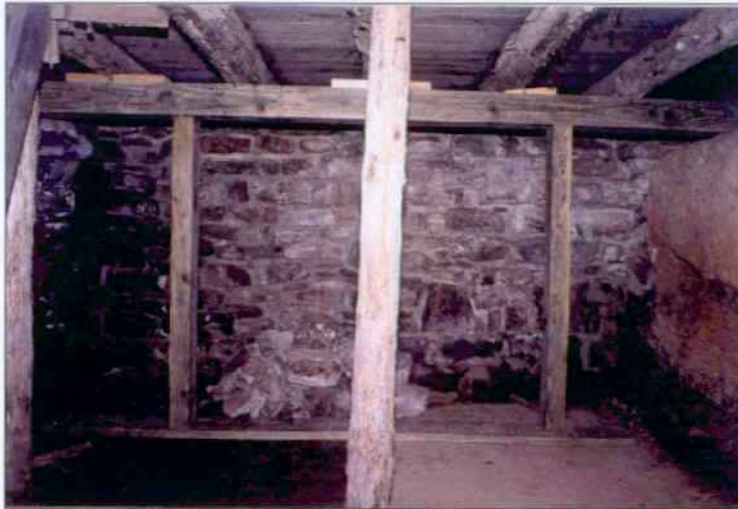
East stone foundation wall in north cellar represents typical mortared construction for this part of the house.

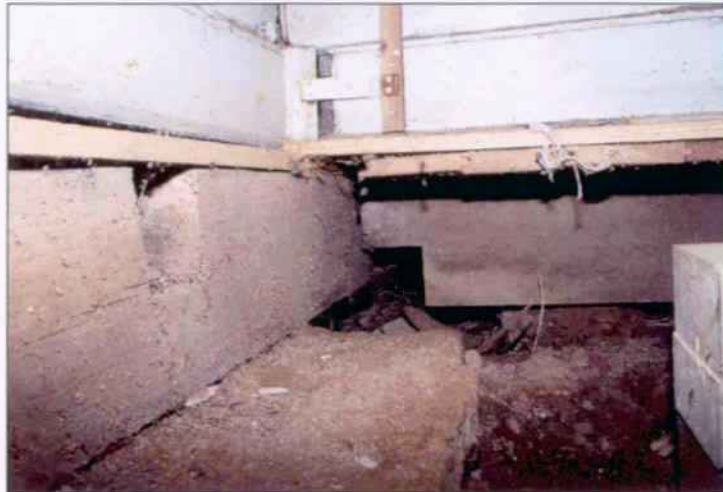
East wall sawn sill plate is notched for floor joists.
Sill plate sits on shallow stone foundation.
Floor joist is not connected to sill plate at this location.

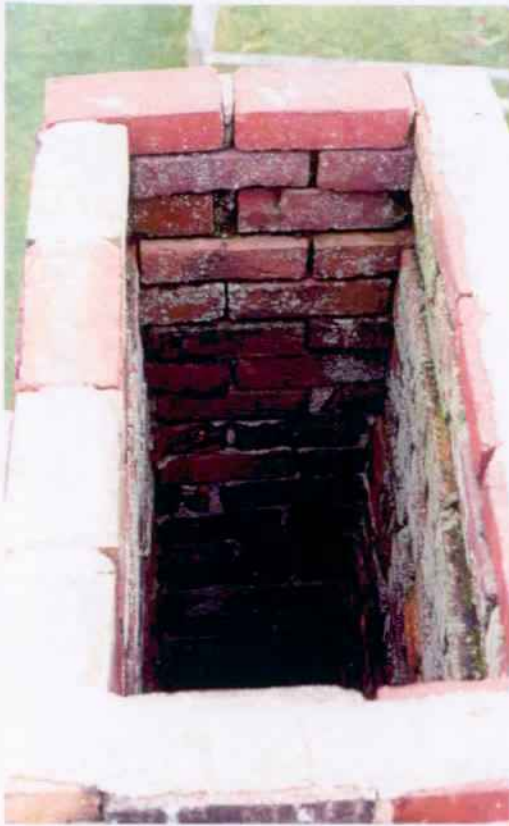
Birdseye view of top of chimney stack with thin mortar wash.

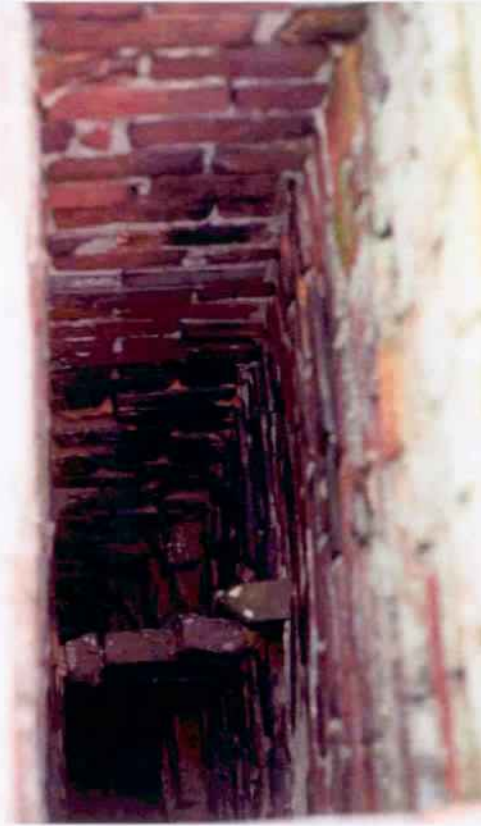
View down throat of chimney showing one wythe brick flue divider.

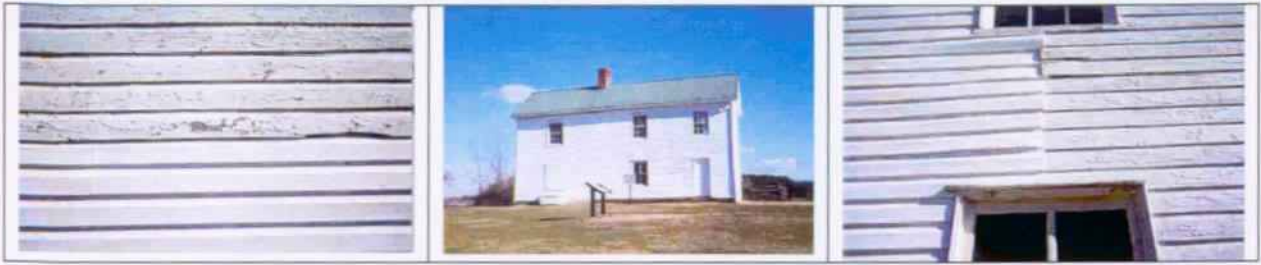
As part of the temporary mothballing of the building in 2002, the purpose of which is to protect the structure from the weather and rodents until permanent repairs are made, a synthetic siding was used to replace the wood siding boards that had been previously removed. This temporary siding is laced into the exterior wall surface to replicate, but not duplicate, the removed historic german siding weatherboards.

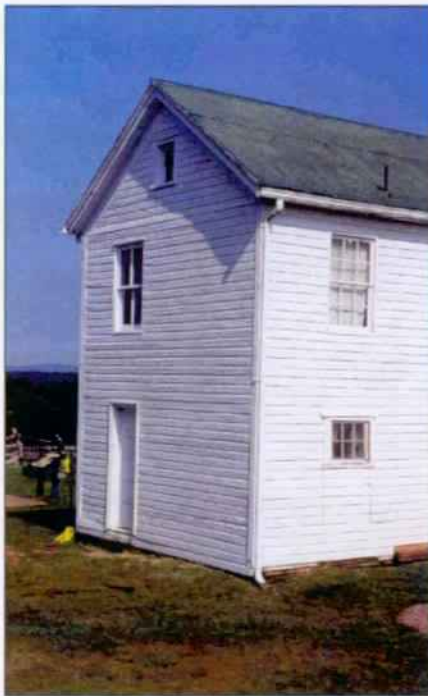
This view of the southeast corner of the house illustrates the gutter and downspout system, the corrugated sheet metal panel roof system, the architectural trim at the windows and door openings and the type of exterior siding. It also illustrates the extent of the exterior foundation on the south block and the perimeter and building drainage conditions. 08/01.

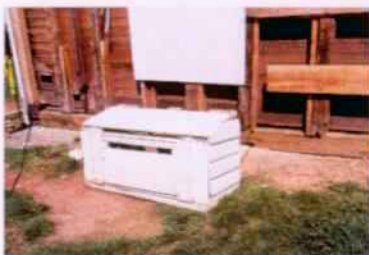
Wood frame cellar vent hood, exterior vent slats are covered with plywood.

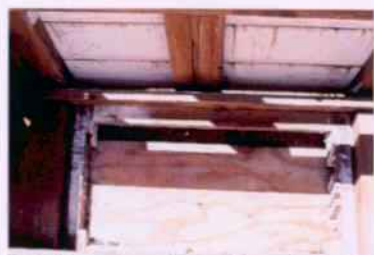
Interior of well vent hood, note mortised grooves for missing vent slats at inner frame.
