Henry House
Historic Structure Report
Final Revised Edition

Manassas National Battlefield Park
National Capital Region
Manassas, Virginia

Historic Preservation Training Center
U. S. National Park Service

August 2003

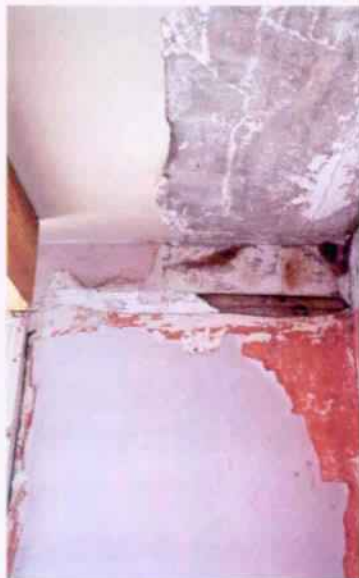
Wallpaper, border paper and ceiling papers are obscured by multiple layers of paint. Papers are applied over interesting peach-color paint used as a wall treatment.
R204, SW corner.

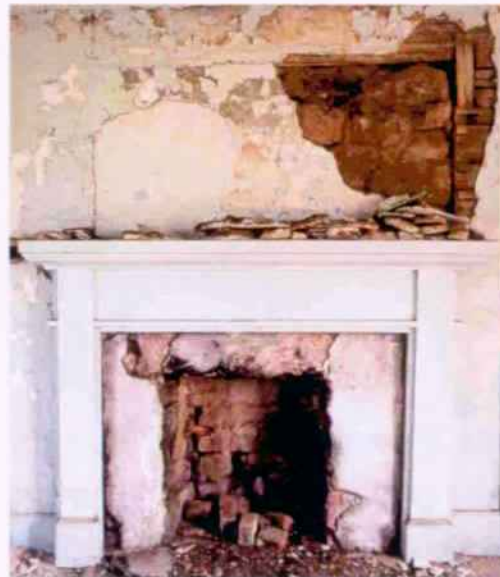
The over mantle area in Room 202 shows evidence of multiple layers of finishes as well as the original plaster over lath construction. No fewer than 5 layers of finishes have been discovered in this area.

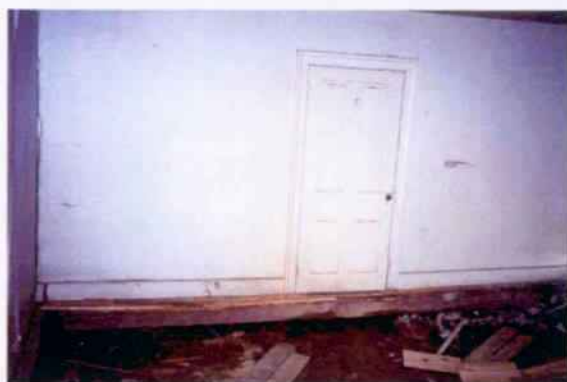
R102 south wall. Features baseboard, door casing for D103 and telephone shelf. Floor framing system has been removed. 03/01.

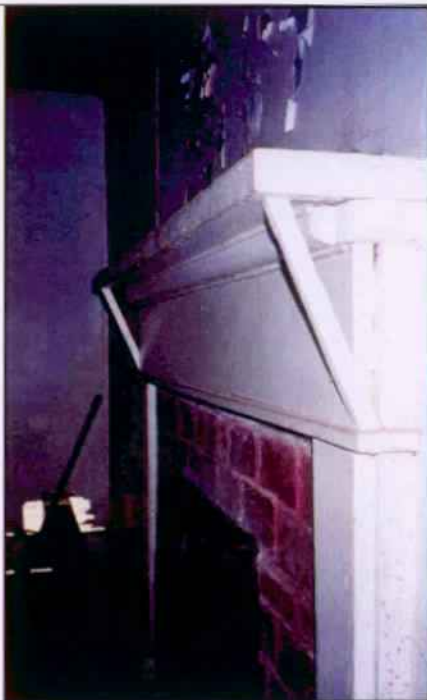
Paint analysis of this wood fire place mantle piece in R102 confirms that it is probably an early feature of the room, predating circa 1922 and likely as early as circa 1870. Fifteen (15) layers of finish were counted during the analysis.

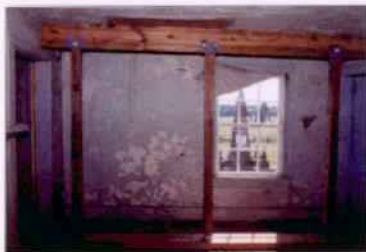
R202, East wall, W202.
Temporary emergency structural system bracing seen along wall.

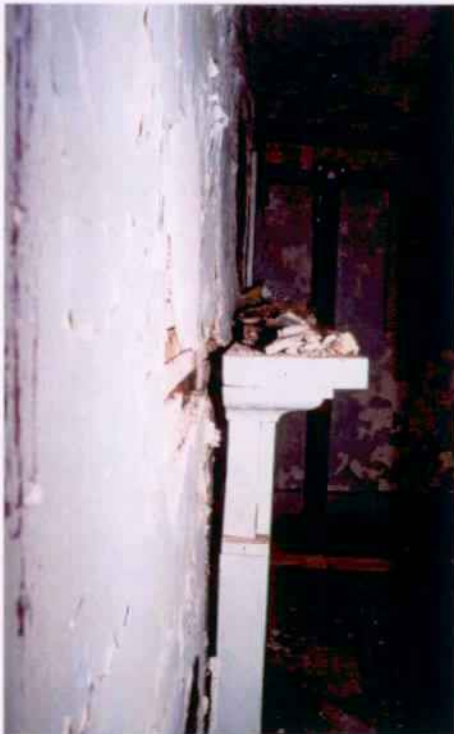
Profile view of west side of fireplace mantle in R202. Mantle is mounted against plaster wall (installed after wall was plastered).

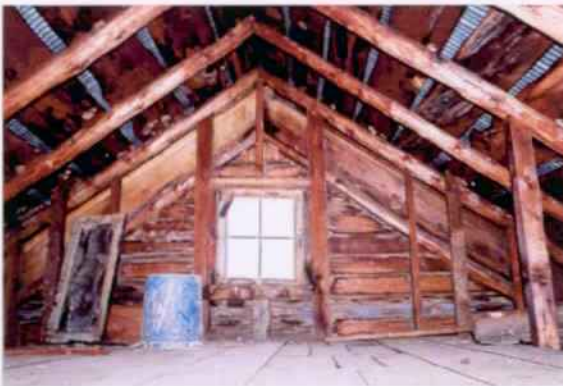
South attic, view of south gable interior, W310 at center. Note 10 inch wide frieze boards at top of gable and post and pole framing.

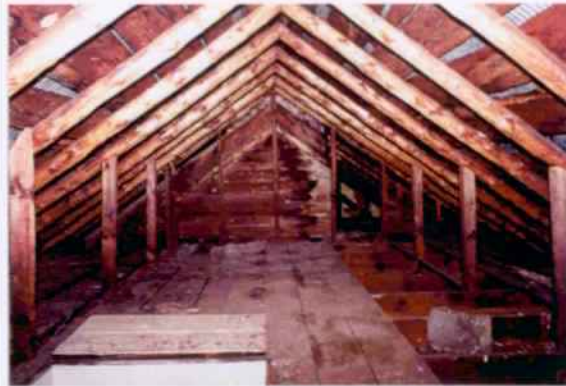
South attic, view of north gable wall, attic hatch and attic floorboards. North gable is first period construction exterior wall.

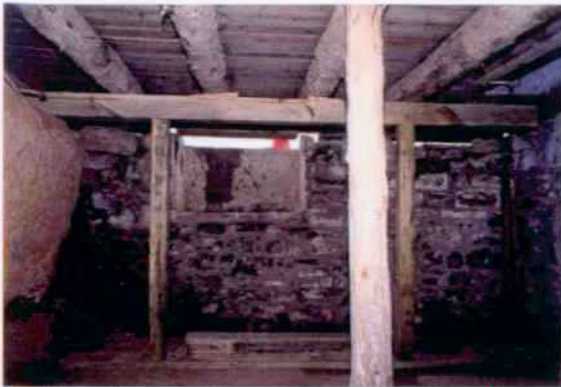
North Cellar, west foundation wall with cellar vent well cut into stone wall. Well is concrete.

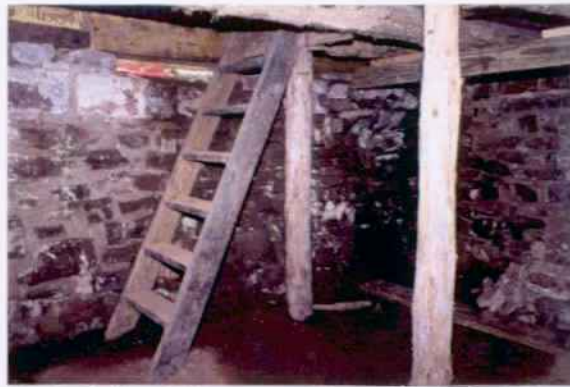
North Cellar, NE corner of two stone foundation walls at stair (S102).

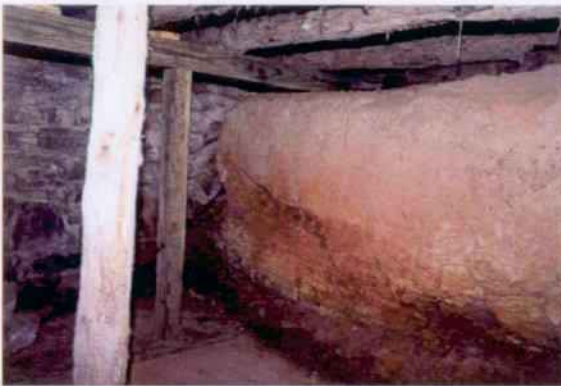
North Cellar, southeast interior view of earth embankment that supports chimney at juncture with east foundation wall.

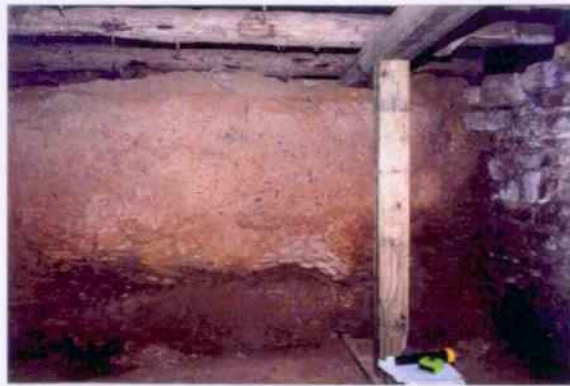
North Cellar, southwest interior view of earth embankment that supports chimney at juncture with west foundation wall.

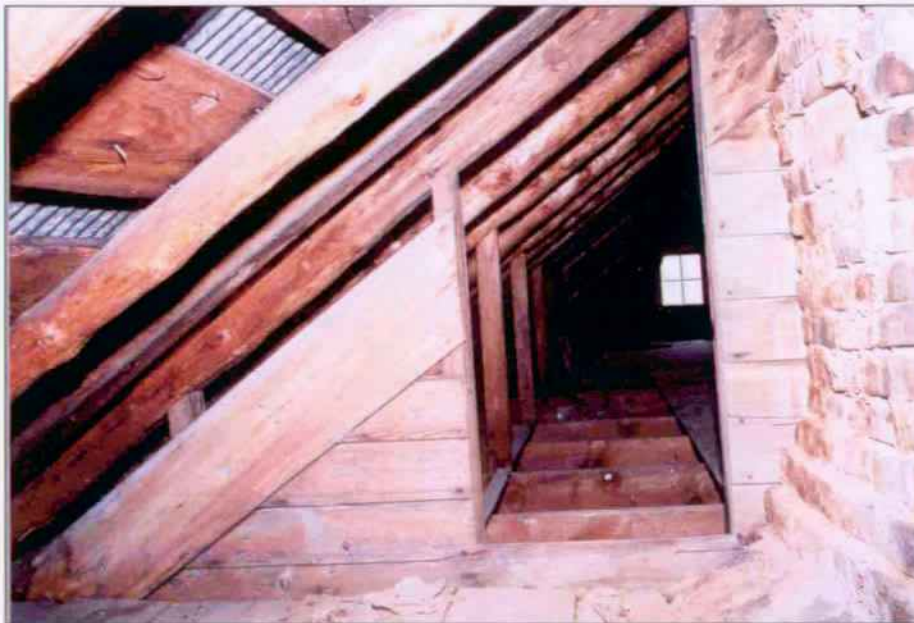
View from north attic through wall opening in north gable wall into south attic. Note 10 inch wide first period frieze board and exterior siding boards – all unpainted. Note also transition of chimney construction from stone to brick just above the finished floor.

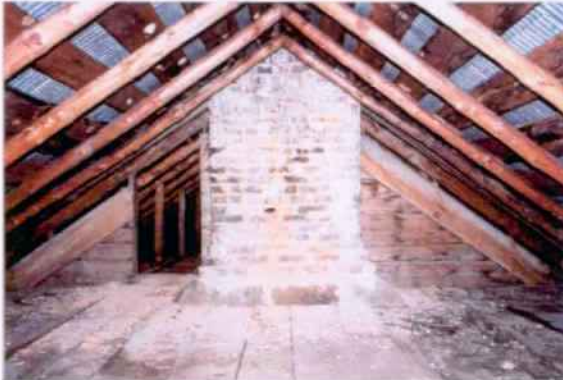
North attic, view of interior south attic wall and chimney stack.

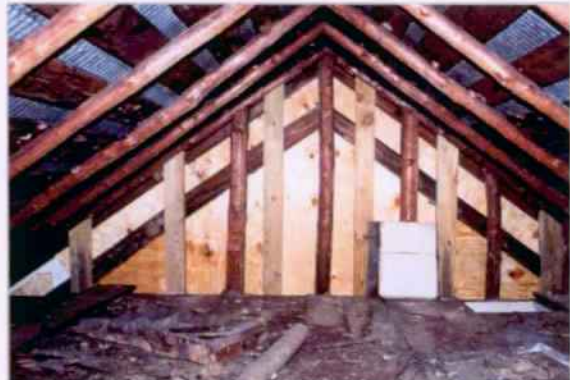
The north gable wall has been extensively repaired and is sheathed in plywood with coved siding applied on the exterior. The rafters of the roof framing system form a gable truss and are sheathed with roughly sawn planking. The corrugated sheet metal roof is visible through the gaps in the roof sheathing. Further description of the roof framing system is found elsewhere. Architectural detailing visible from the reverse side in the south attic is the first period frieze board that has been maintained at both gables.

North attic, view to largely reconstructed north gable wall.

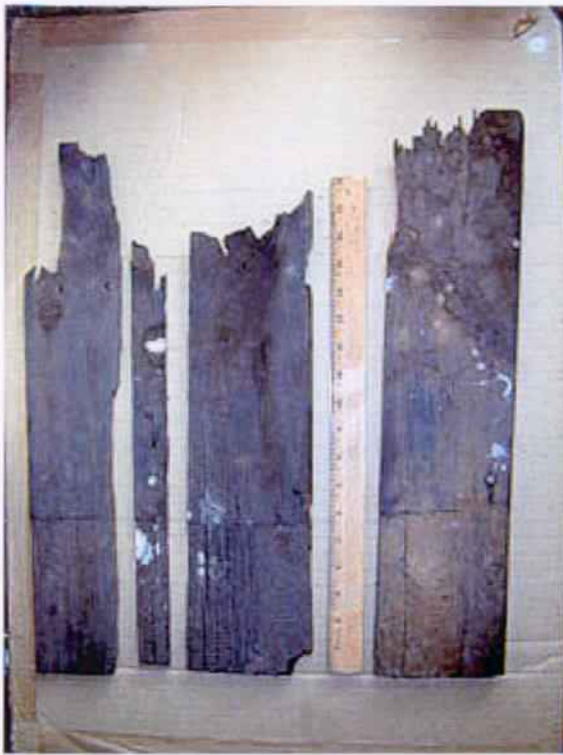
Erosion of the shingle surface due to weather exposure and water runoff has left a 2 inch side strip along one edge clearly deteriorated. This could be the result of improper coverage (wide gaps between the roof shingles), due to a lack of properly sized shingles. Shingles appear to have been attached to the spaced roof sheathing with 1 or 2 nails per each. Shingle nails have not been discovered to date, but nail holes in the shingles indicate both square cut and round shank nails were used for installation. One or two nails were used at the top of the shingle positioned approximately 6 inches from the top edge of the shingle. If one nail was used it was placed in the center of the shingle. If two nails were used they were evenly placed across the neck of the shingle.

Examples of wood shingles recovered from Henry House attic; shown with 18 inch ruler.

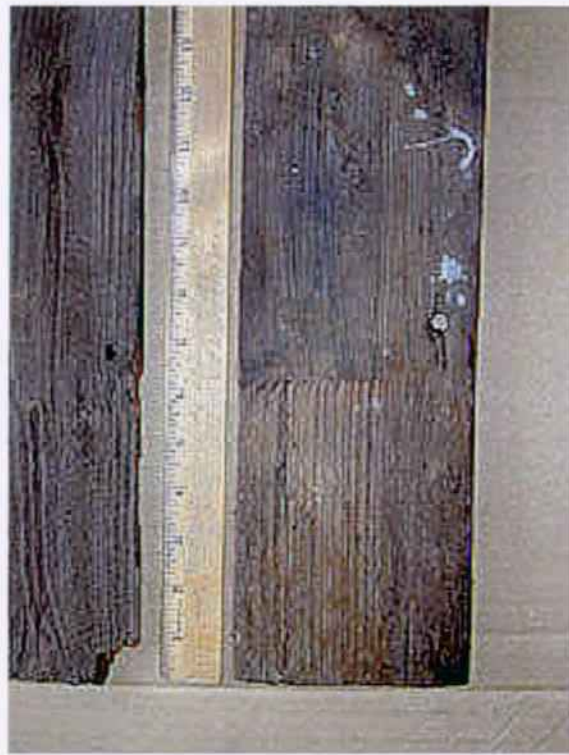
The shingles samples recovered from the south side of the attic have a weathering pattern on them indicating that 6 inches of the shingle was exposed to the weather. The weathering and nailing pattern indicates this shingle may also have been installed in a pattern where it overlapped side to side as well as course to course. This may have occurred at the ridge (photographic evidence dated 1896 indicates only a course to course overlap in the field of the roof, and perhaps an overlap pattern at the ridge courses). Assuming a construction date of circa 1870, the weathering of the shingles in the 1896 photo is consistent with that of a 26-year-old wood shingle roof.

Detail showing exposure pattern, shown with 18 inch ruler. Note exposure area at lower edges of the shingles, this is the 5 inches to the weather described in the text.

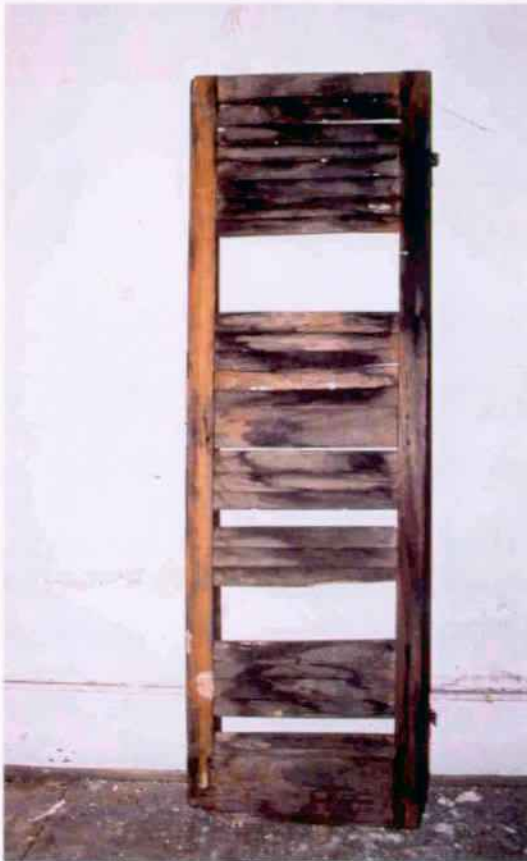
Two panel slatted shutter, obverse elevation.

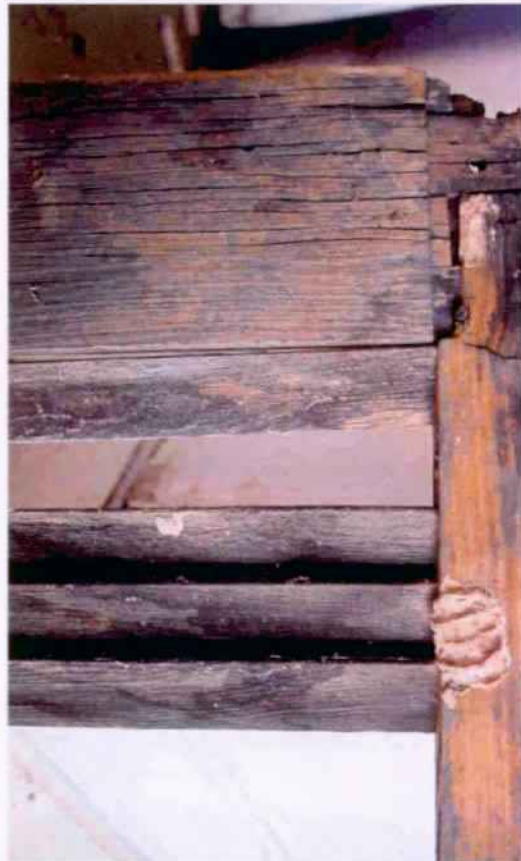
Shutter in inverted position to view mortise and tenon construction of frame, note pegged connection and thru tenoned detail.

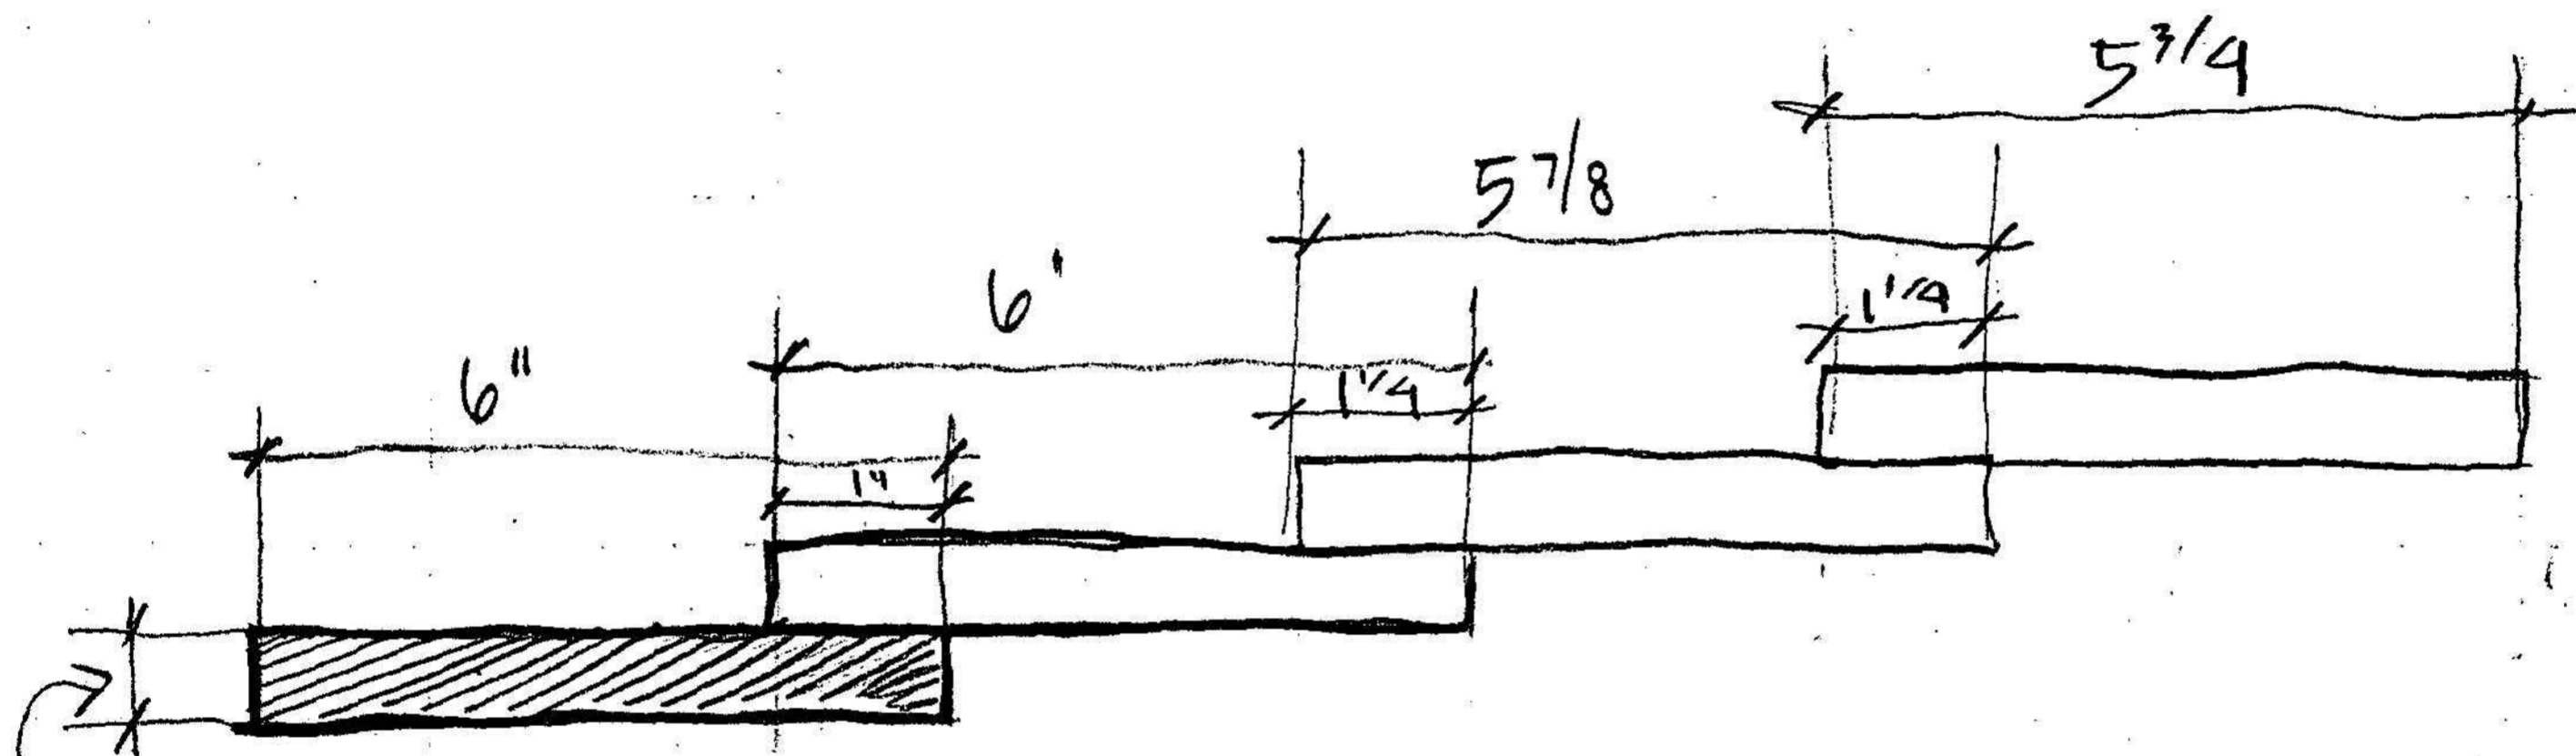
1/2" to 5/8" UNPAINTED EXTR. SIDING in SECTION.

NOTE: SIDING IS THICKER
@ BOTTOM 2 COURSES.
ALMOST 3/4"

SIDING
2'4 x 1/2
EXTANT
NAILED
BLOCK
(PPE NO. WINO). MISSING CORNER
BOARD & SIDING?

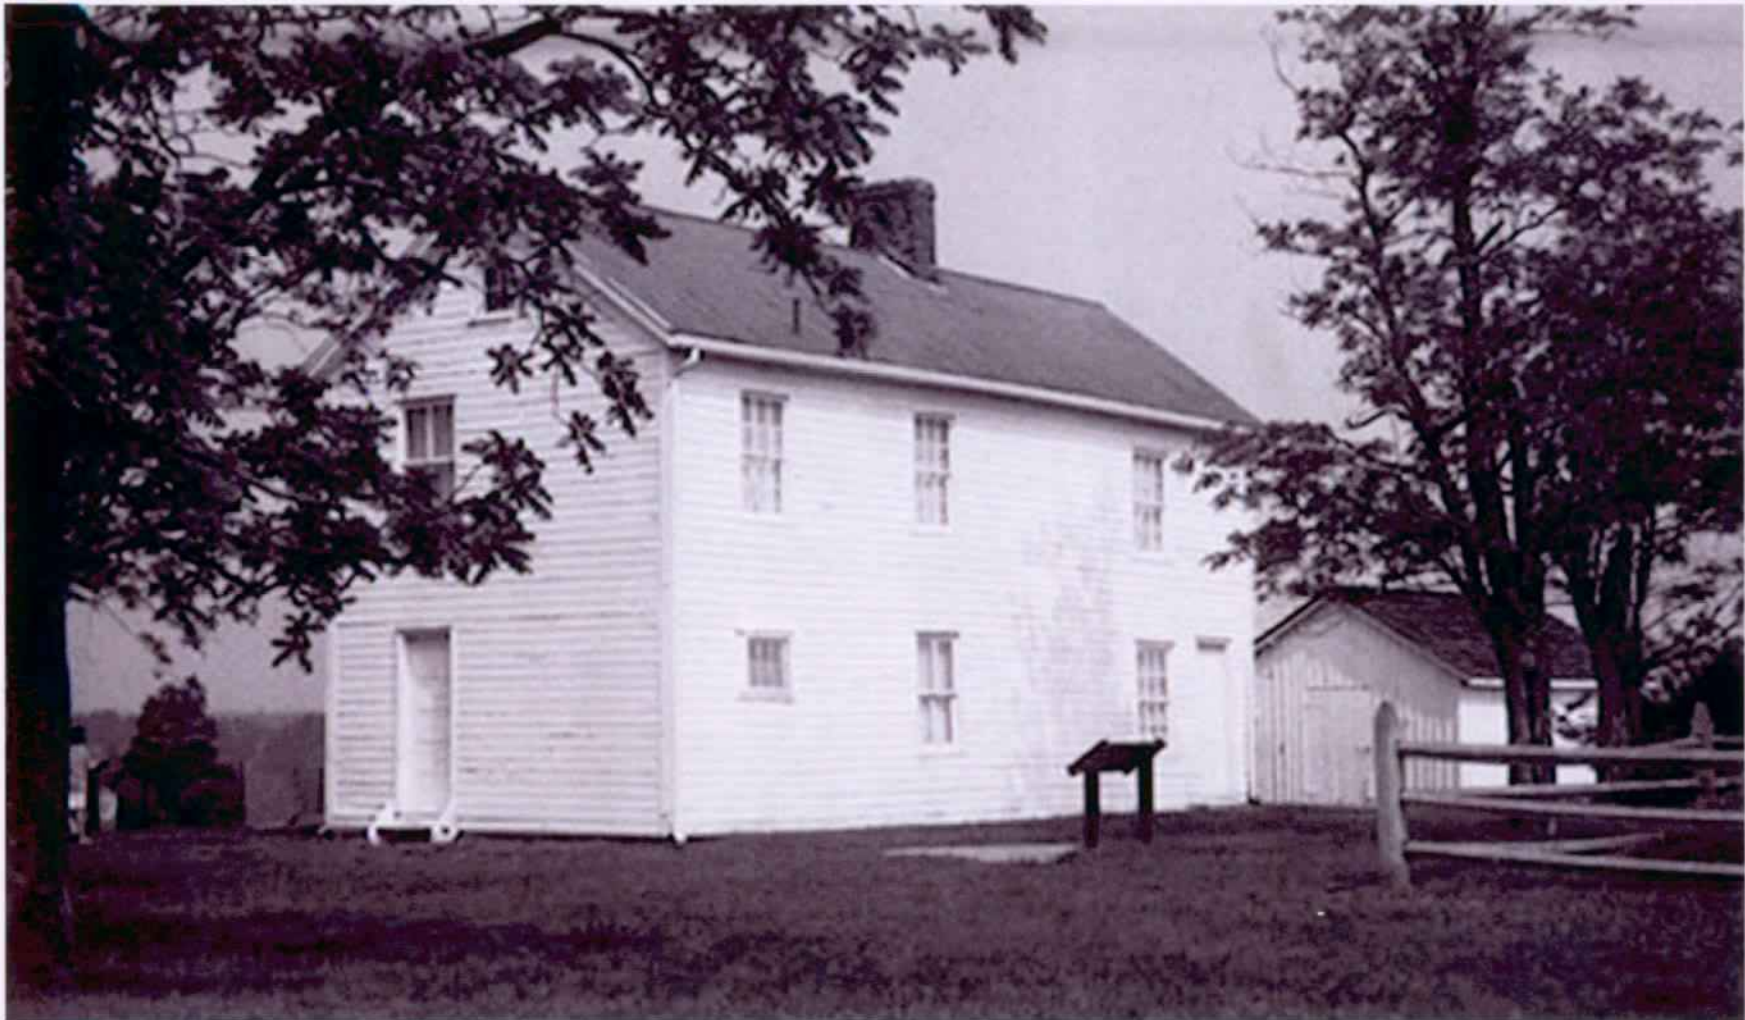
Figure 32. National Capital Region List of Classified Structures, 1991. View of Henry House, IDLCS 10782, South and East elevations showing corrugated metal roof. Shed visible in background. Rail fence to photo right encloses historic Bull Run Monument. Photo documents structure in 1991 prior to recent NPS preservation maintenance projects, 1992 - 2001. Courtesy of National Capital Region, Office of Chief Historical Architect.

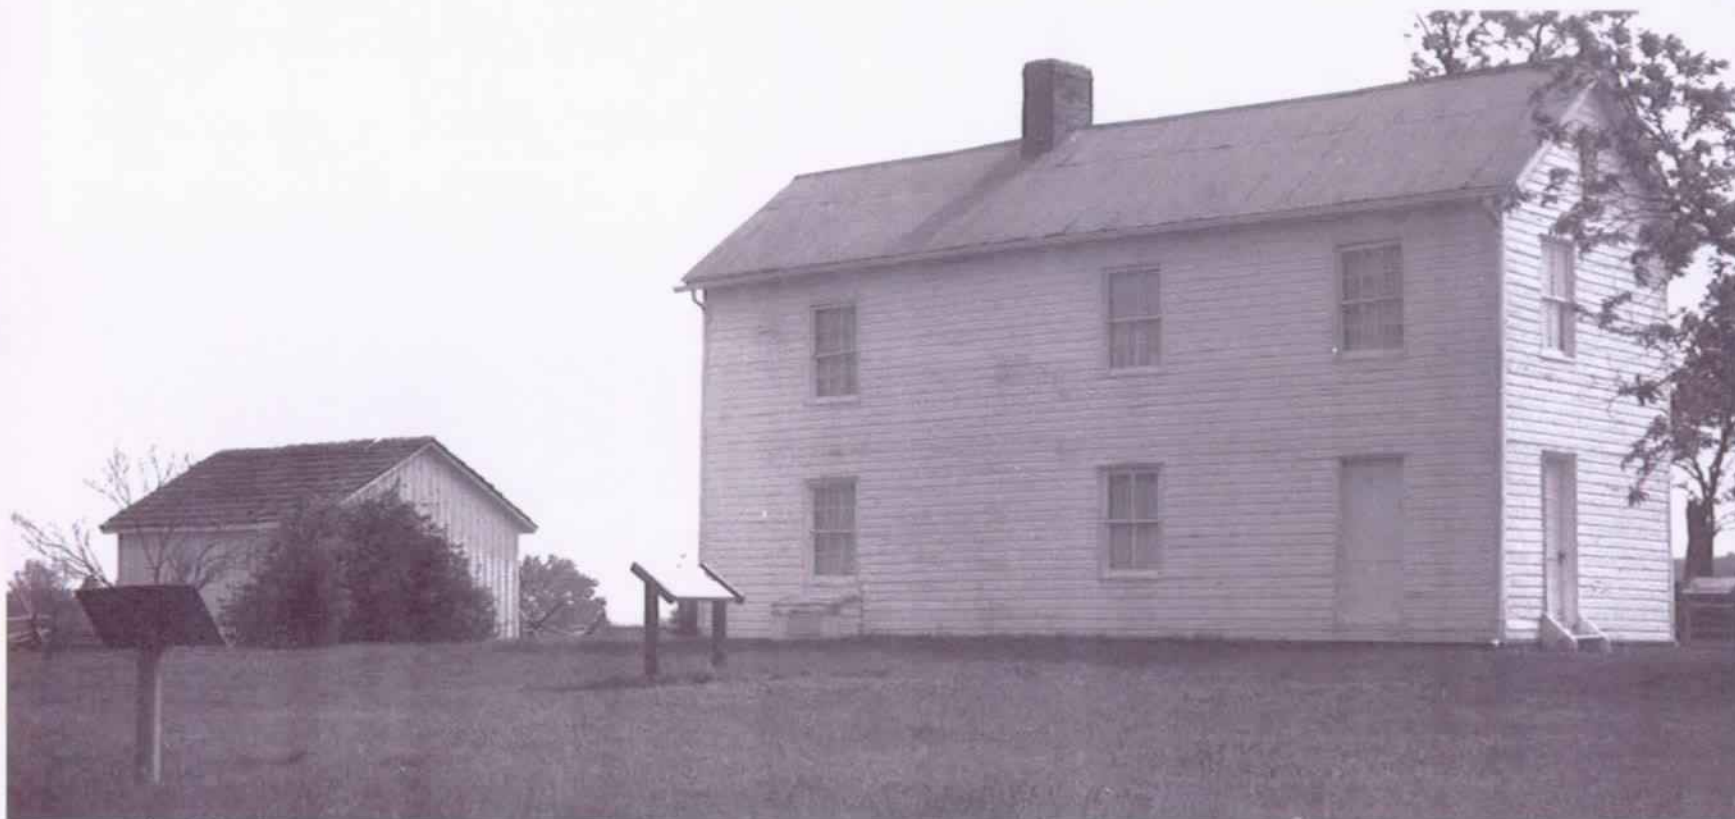
Figure 33. National Capital Region List of Classified Structures, 1991. View of Henry House, IDLCS 10782, West and North elevations showing corrugated metal roof. Shed visible in left background. Photo documents structure in 1991 prior to recent NPS preservation maintenance projects, 1992 – 2001. Courtesy of National Capital Region, Office of the Chief Historical Architect.

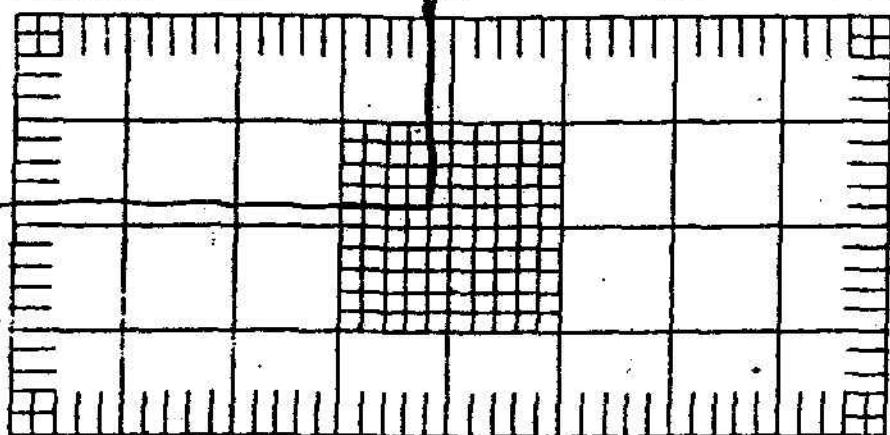
Date of Reading: 0309.01

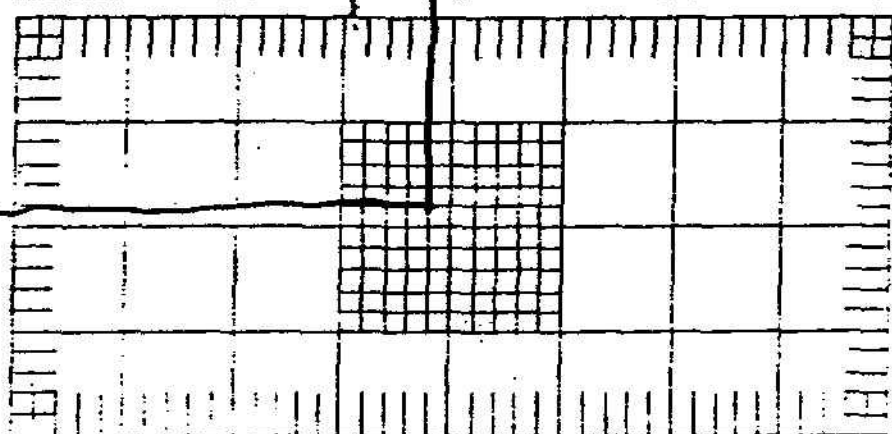
Date of Reading: 0523.01. SAME AS 0309.01.

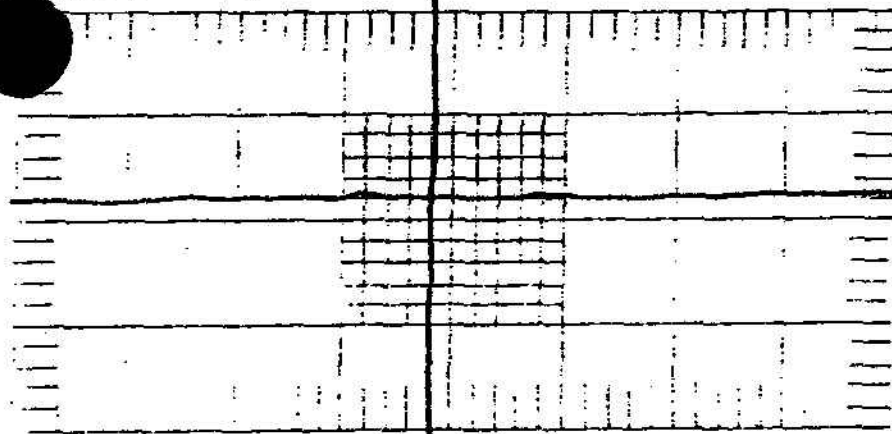
Date of Reading: 05.30.01

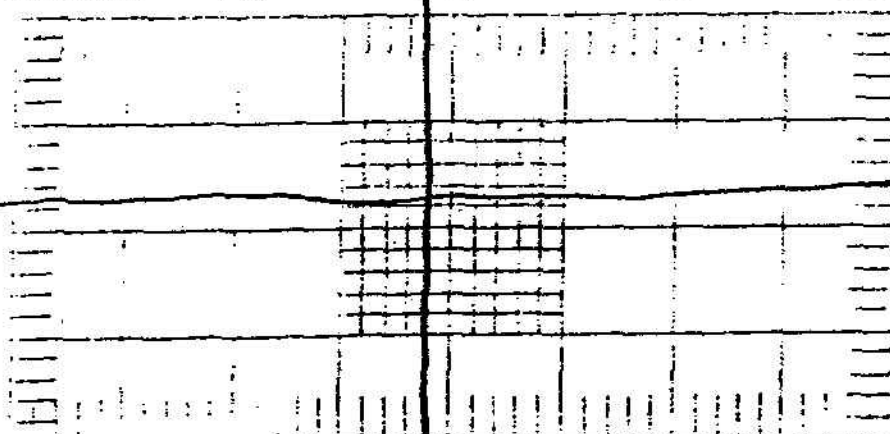
Date of Reading: 06.14.01

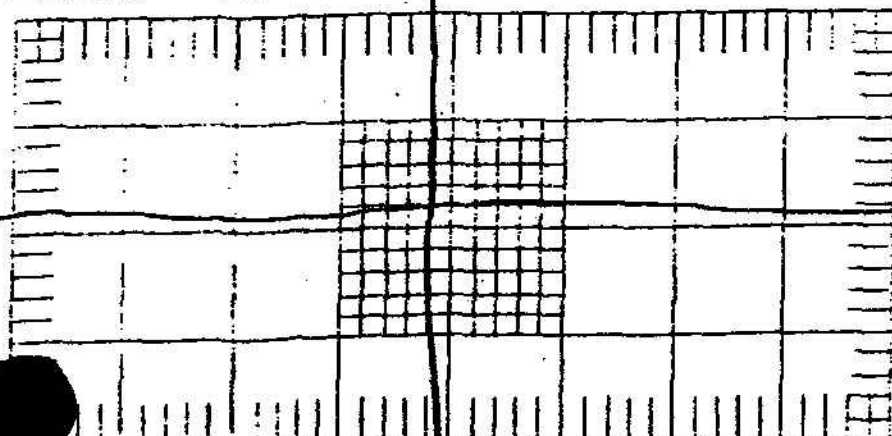
Date of Reading: 07.31.01

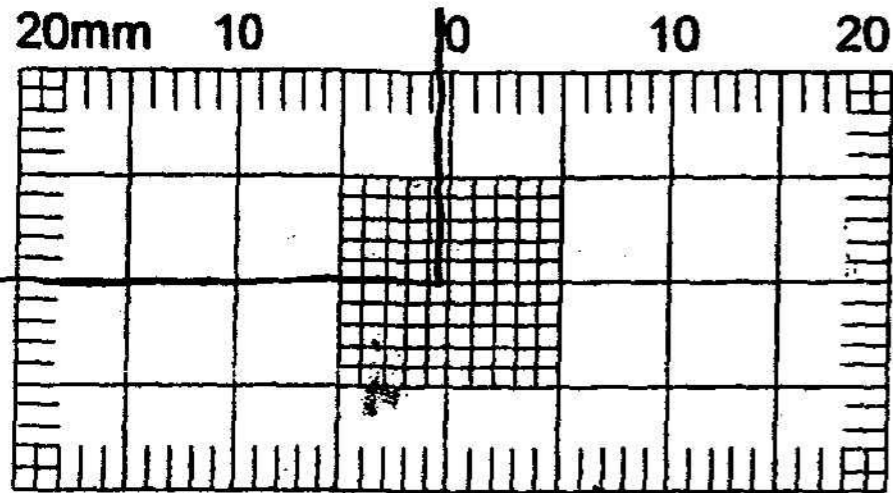
Date of Reading: 03/09/01

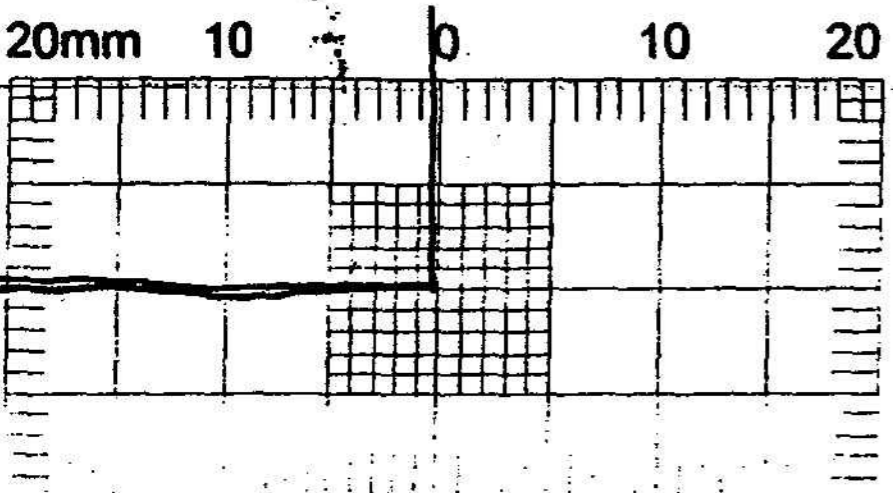
Date of Reading: 05/30/01 - SAME AS 03/09/01

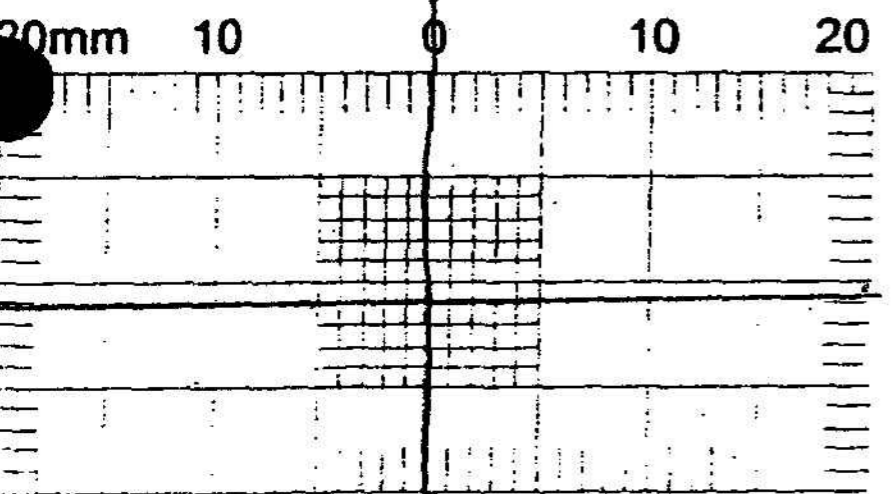
Date of Reading: 05/30/01

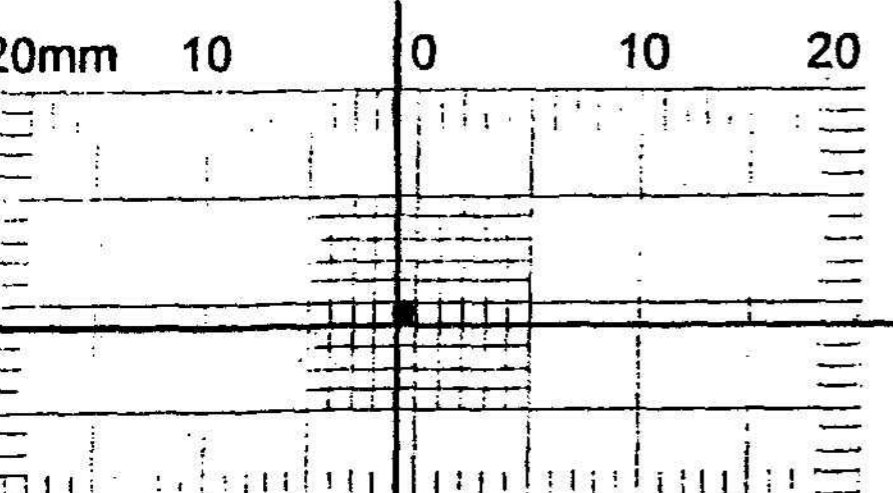
Date of Reading: 06/19/01

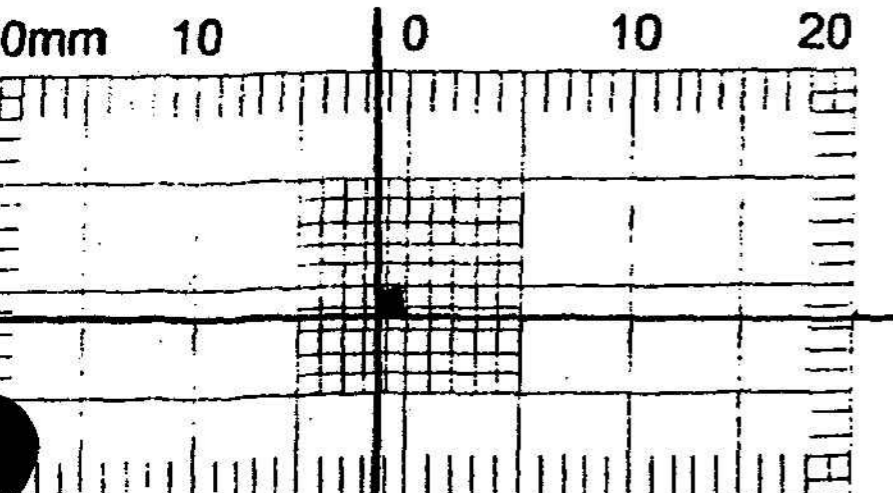
Date of Reading: 07/31/01

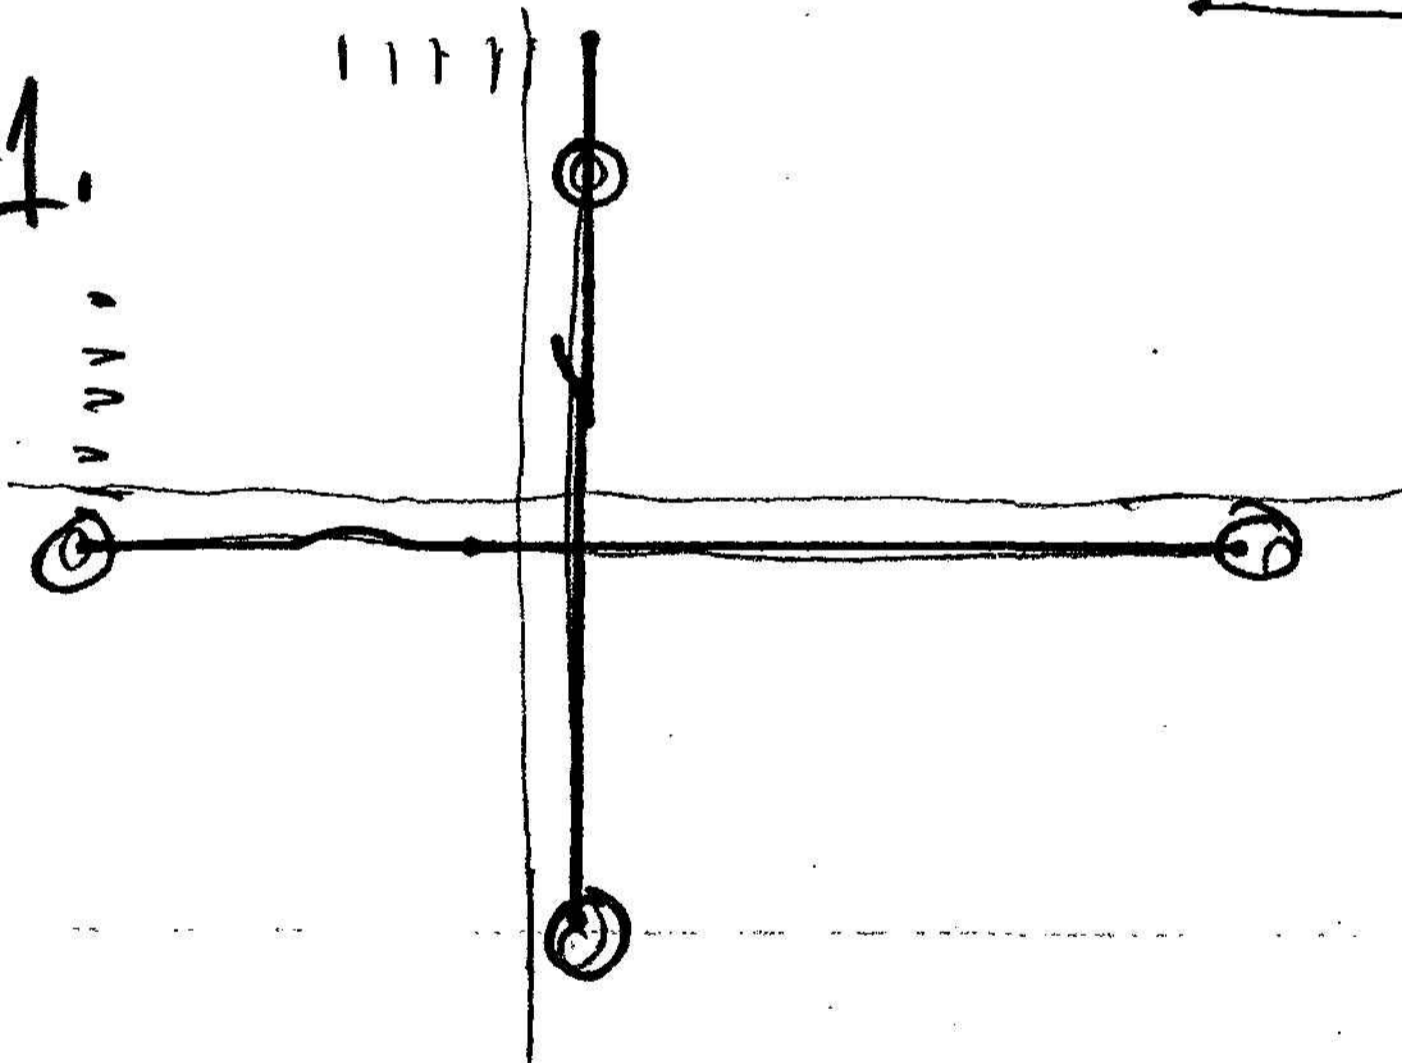
#1.

05-30-01 4PM.

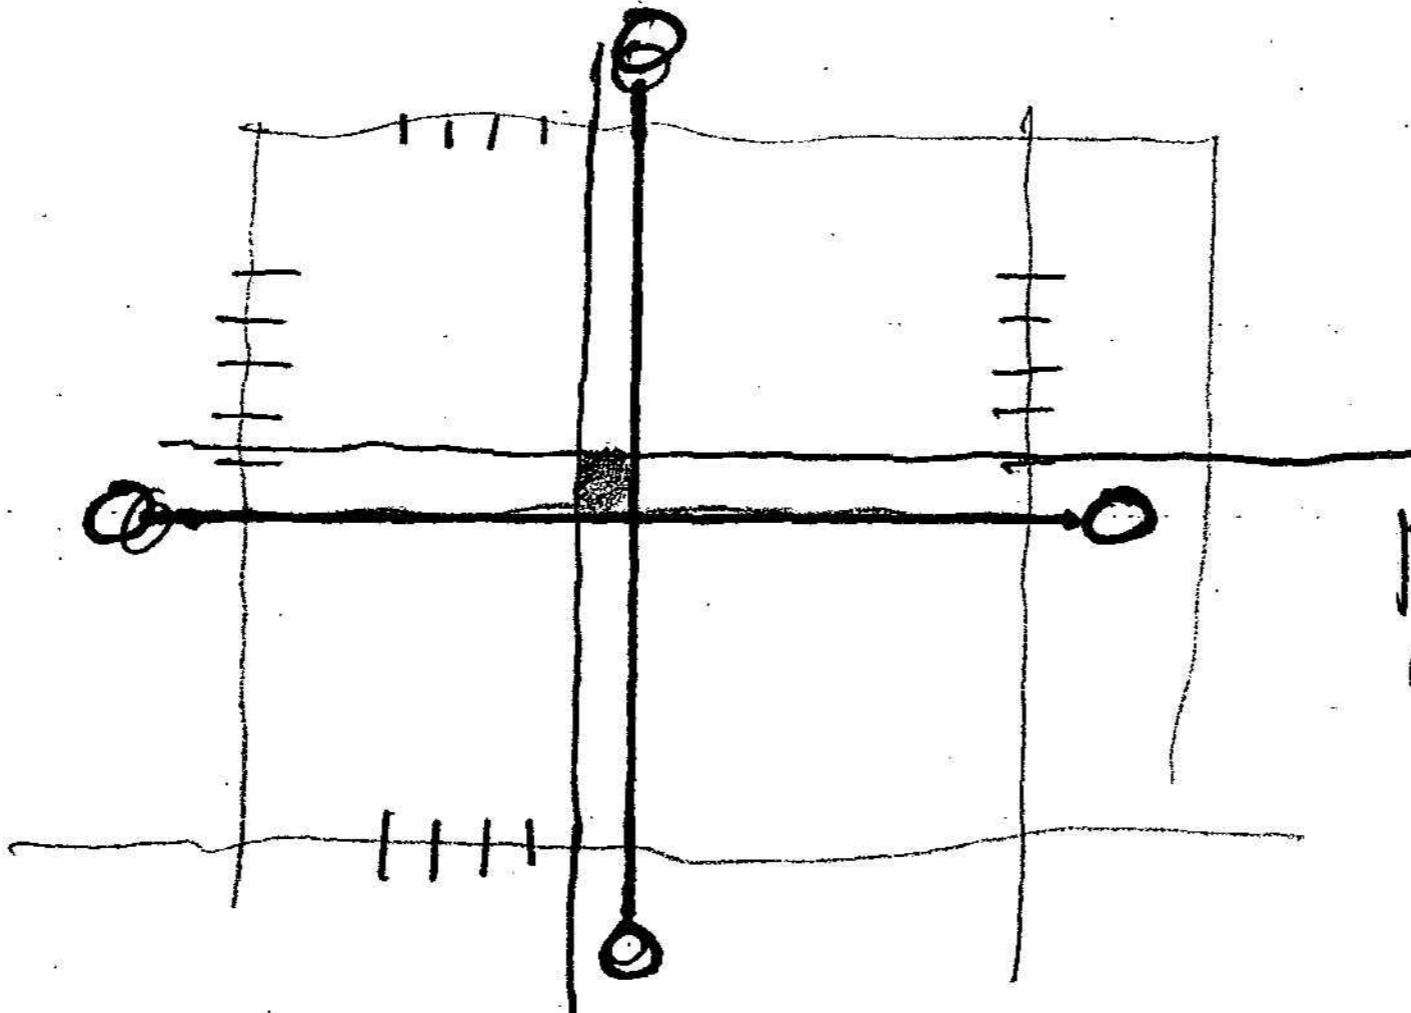
#1

NST ABOVE
GAUGE LINE

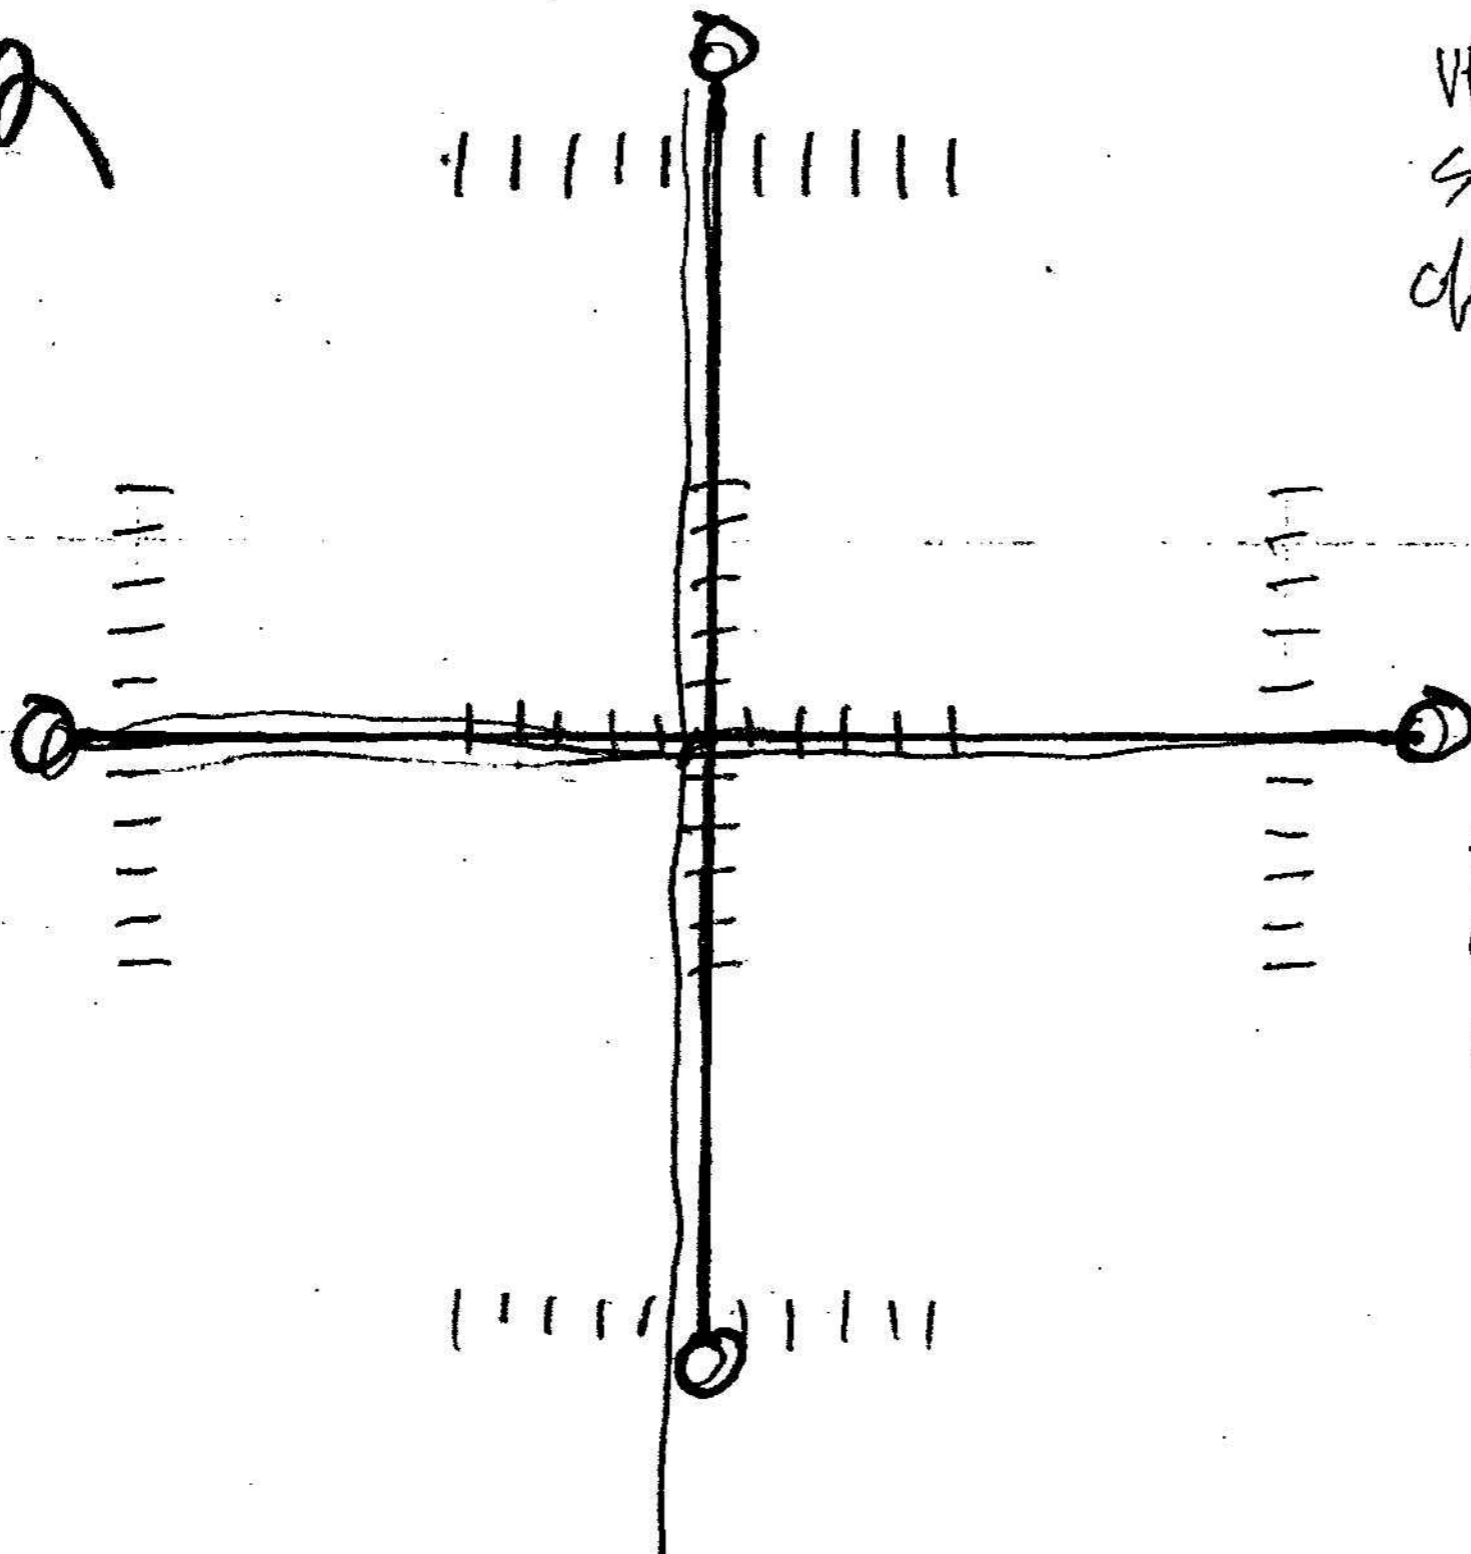
#2

VERT LINE
SHIFTED SLIGHTLY
OFF Φ TO EAST.

HORIZ LINE
SHIFTED BELOW LINE
@ EAST MARKER
