historic structure report
architectural data section
volume 2: appendixes
june 1985

HISTORIC STRUCTURE REPORT

Architectural Data Section

MARTIN VAN BUREN NATIONAL HISTORIC SITE

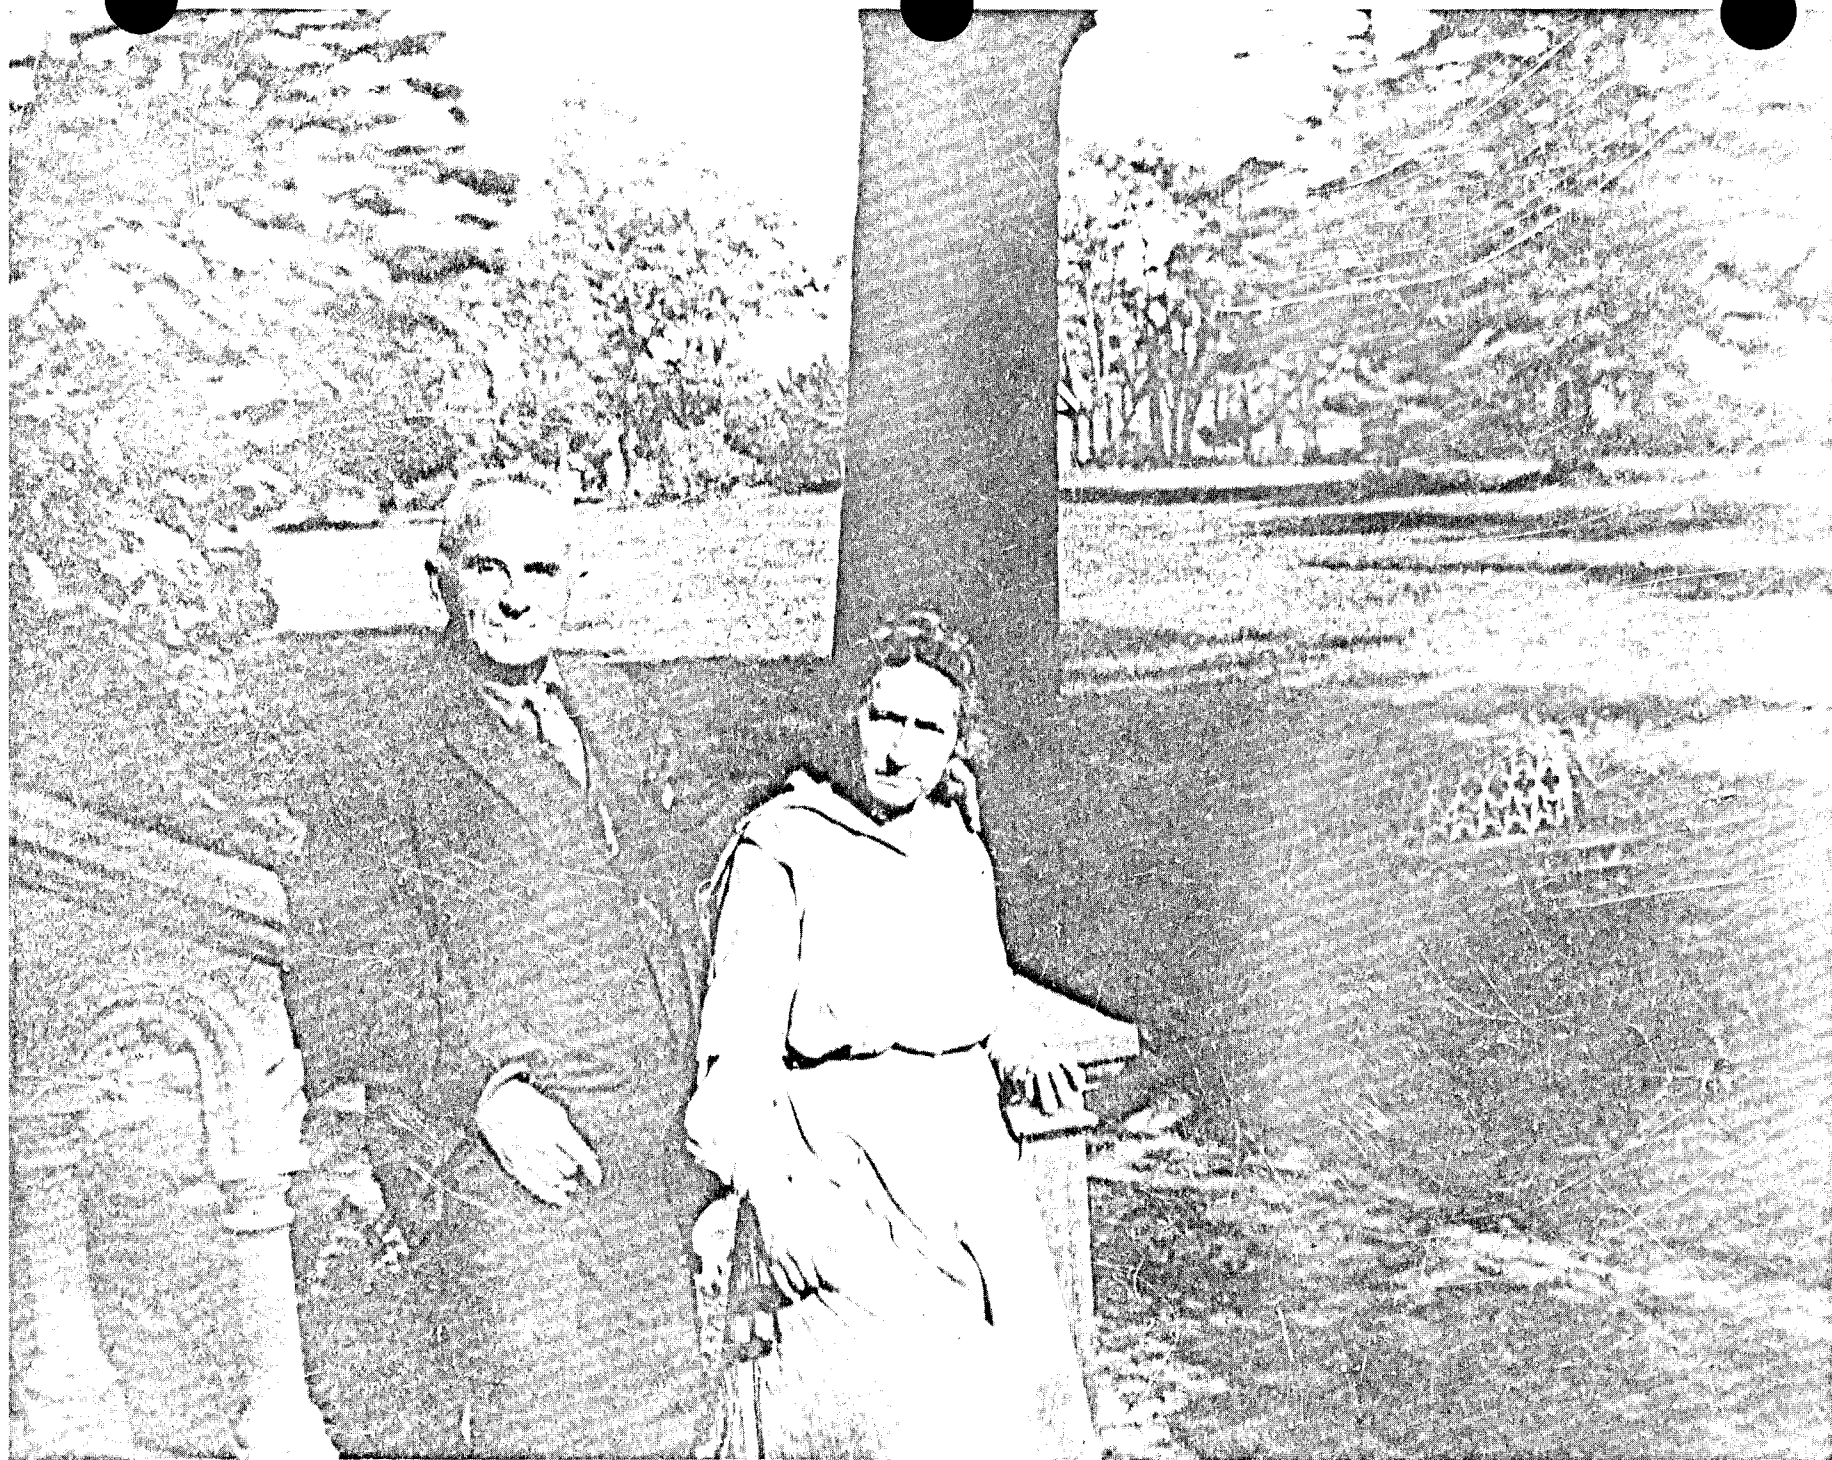
HP8. Lindenwald, ca. 1910-1917. This photograph is dated ca. 1910-1917 on the basis of the growth of the small foreground tree compared to HP6 and the presence of lightning rods compared to HPI8. Note also the following details:

The foundation has been painted so that repointing at the southeast corner is no longer visible. The shutters, window frames, porch, and foundation are a dark tone. The bricks and cornice are painted a lighter tone.

Some of the bricks are loose in the flat arch over window 127.

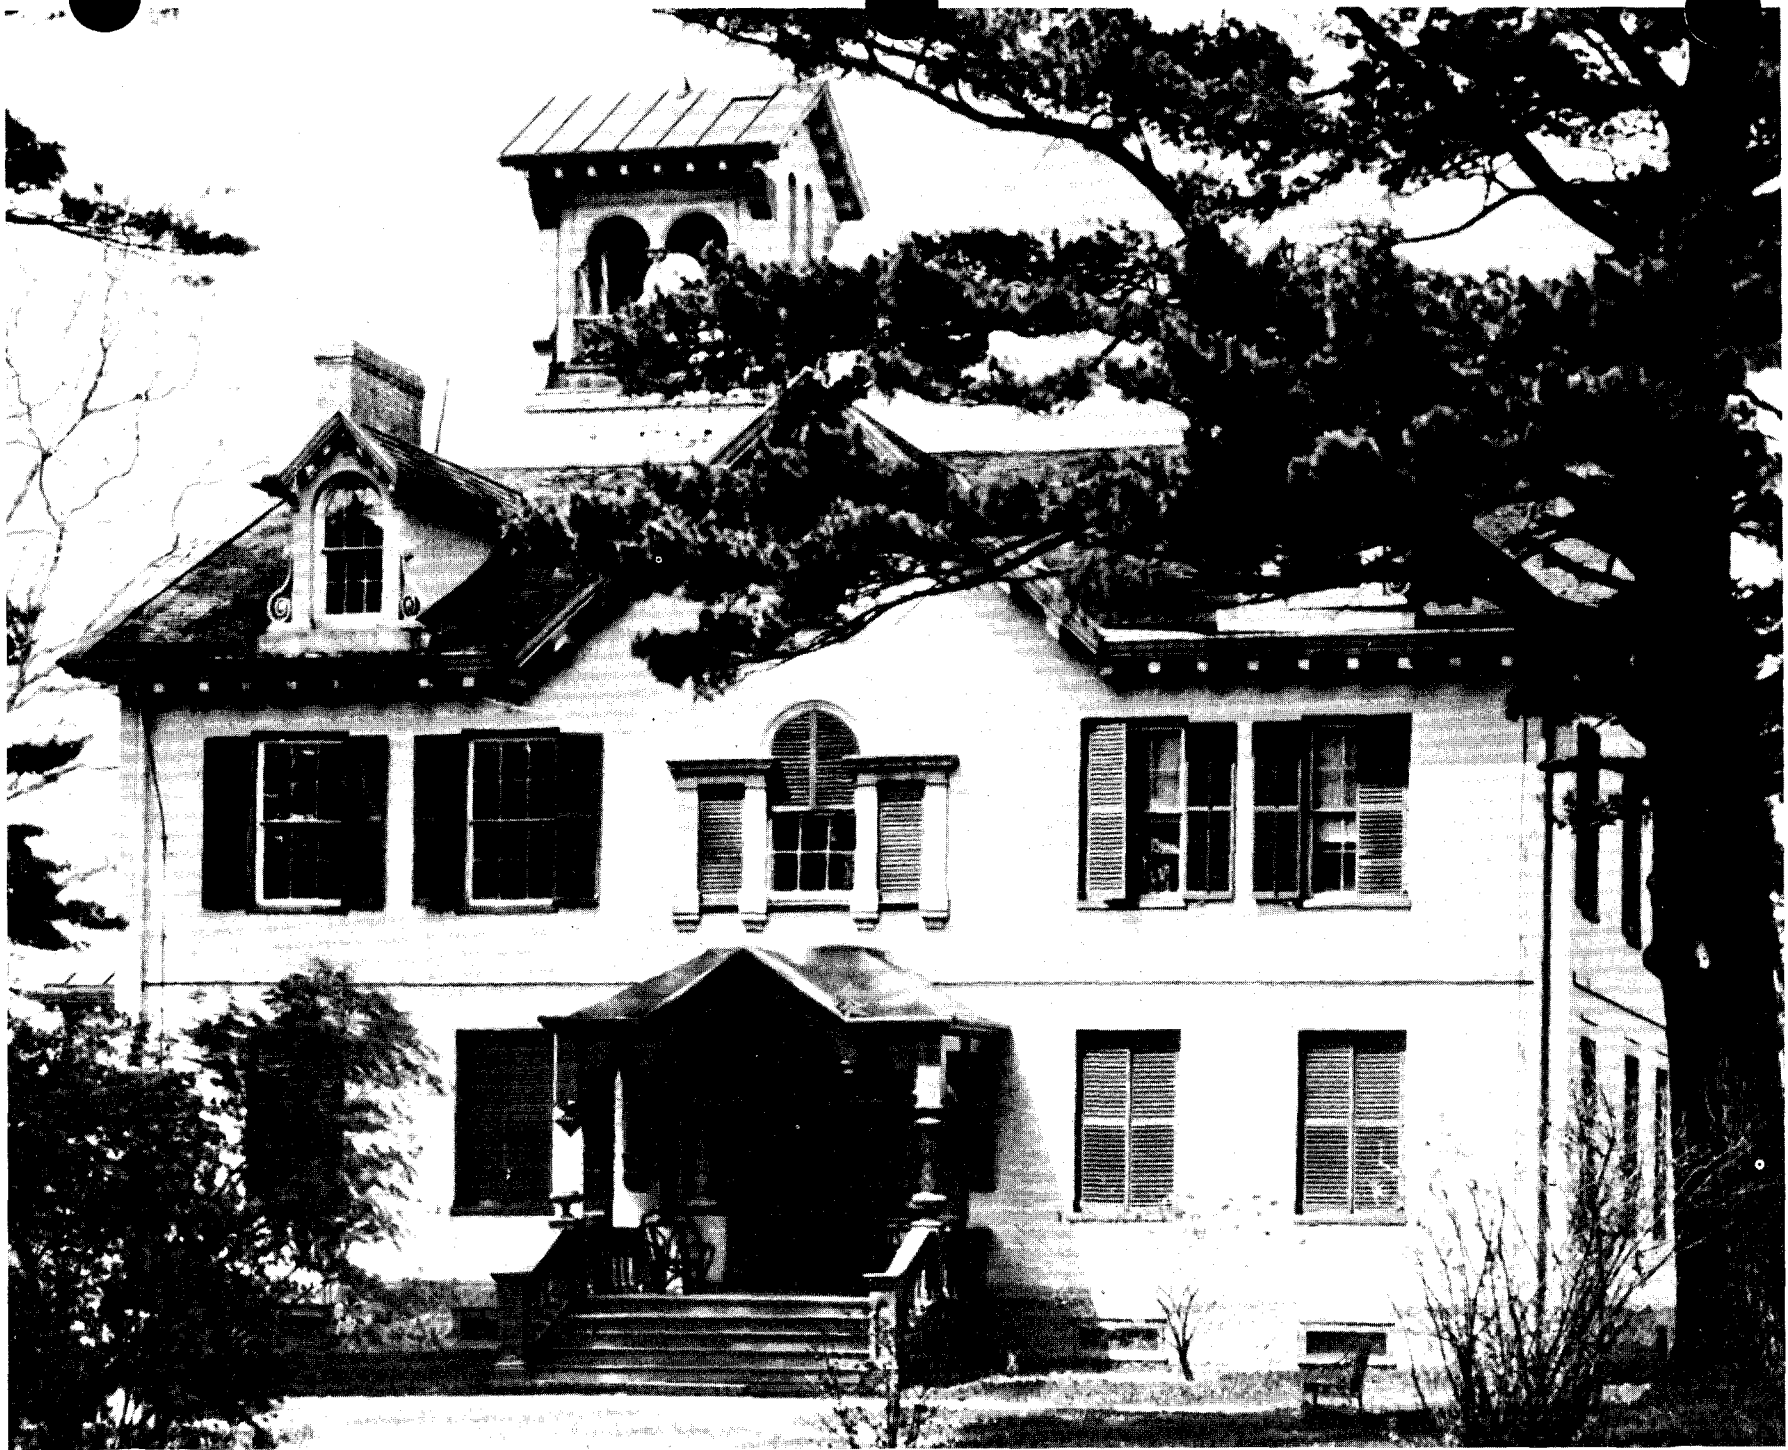
HP11. Lindenwald, East Elevation, ca. 1913-1917. This date is based on similarities with HP10, the fact that the hydrangeas are slightly larger, the state of deterioration of the dormer sill boxes, the continued presence of lightning rods, and the wood shingle roof. The following details should be noted:

The foundation window frames, shutters, and front porch appear to be painted a darker tone. Sash, bricks, and cornice appear to be painted a lighter tone.

The north hydrangea is 7' to 8' tall and the south one 4' to 5' tall. Two rustic chairs and a wicker rocker can be seen on the front porch. Two cast-iron benches are placed in the shade of the north and south pine trees. A row of potted plants lines a path or drive parallel to the front of the house. A cluster of similar potted plants is to the east of this line and on axis with the front door. What may be a cast-iron cauldron appears in the left foreground under the south pine tree.

There is a rainwater diverter at the east end of the north gable capping board.

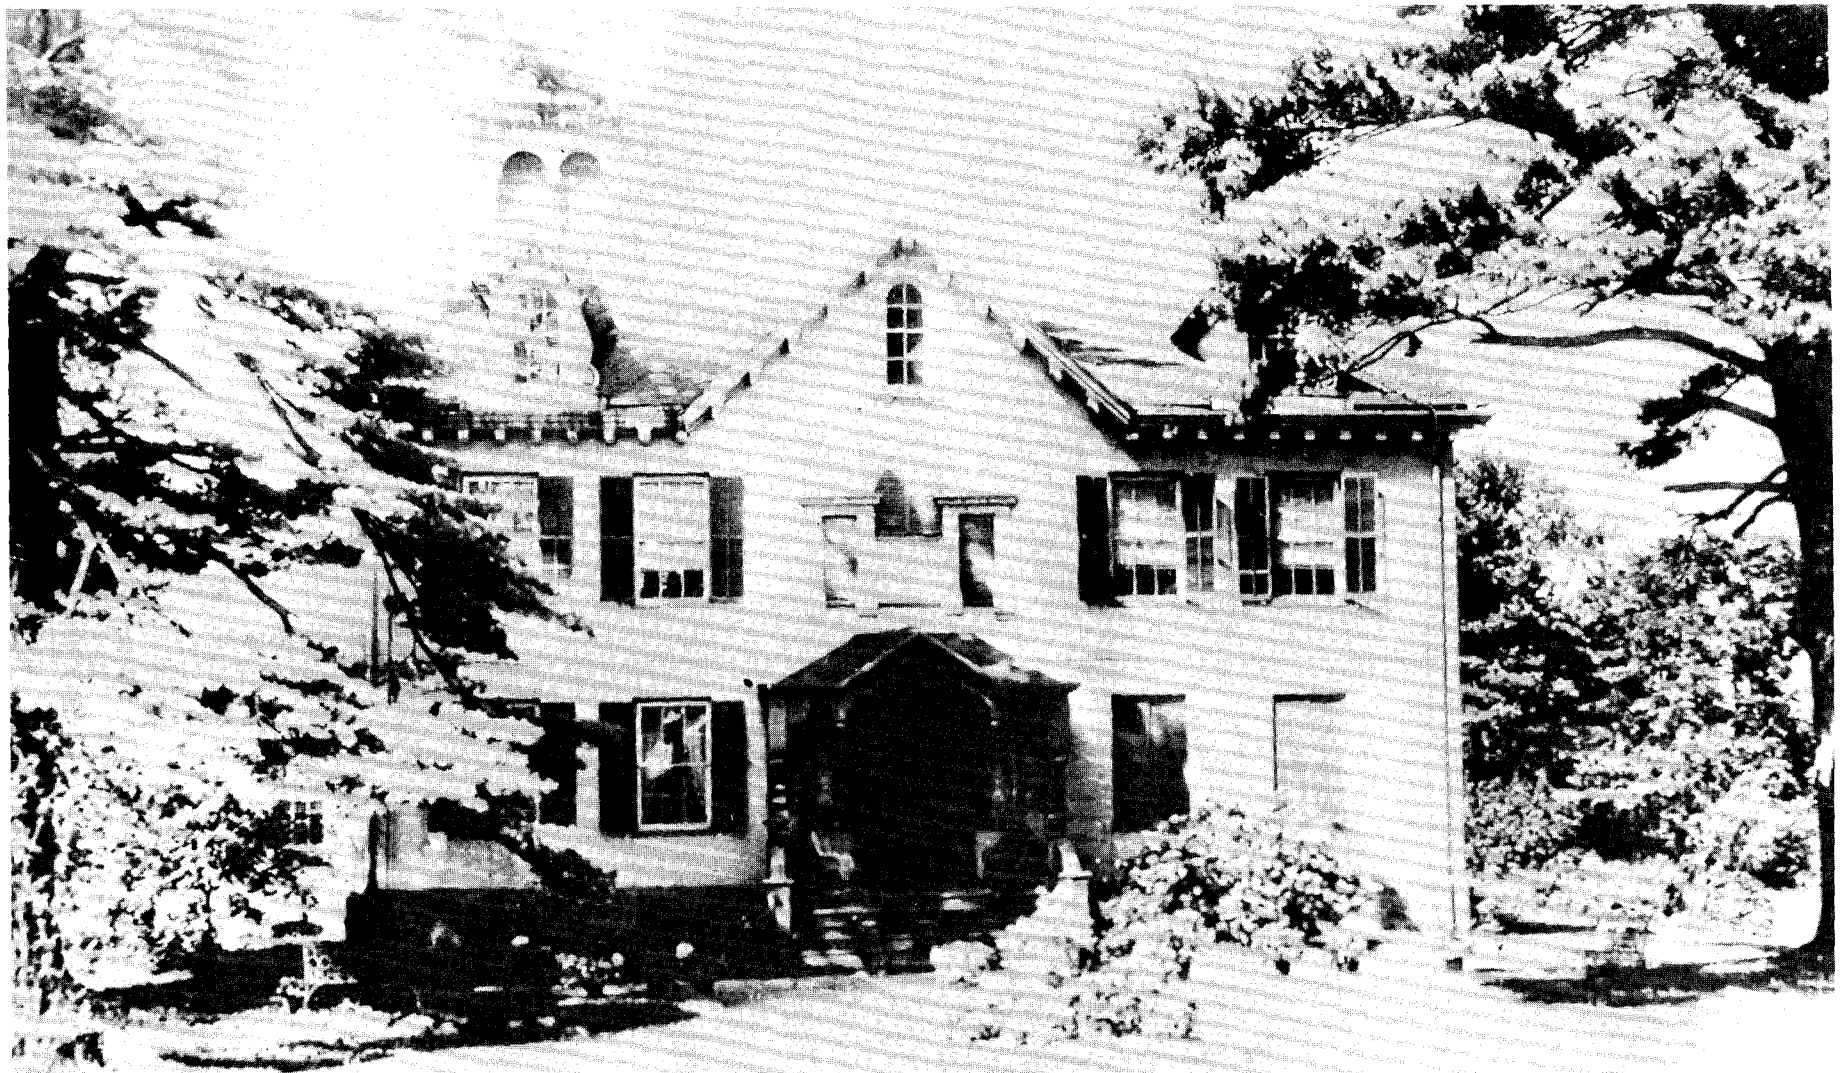
HP12. Mrs. Bascom Birney at Lindenwald, after 1917. This photograph was probably taken after the Birneys' acquisition of Lindenwald in 1917. The following details should be noted:

The foundation and trim appear to be painted a dark tone. Brickwork has been painted a light tone but is now quite weathered. Window frames are painted a lighter color.

The replacement cornice on the door pediment is in place.

The downspout appears to be a replacement consisting of lengths of stock corrugated pipe and a wooden board and trough to direct rainwater away from the foundation.

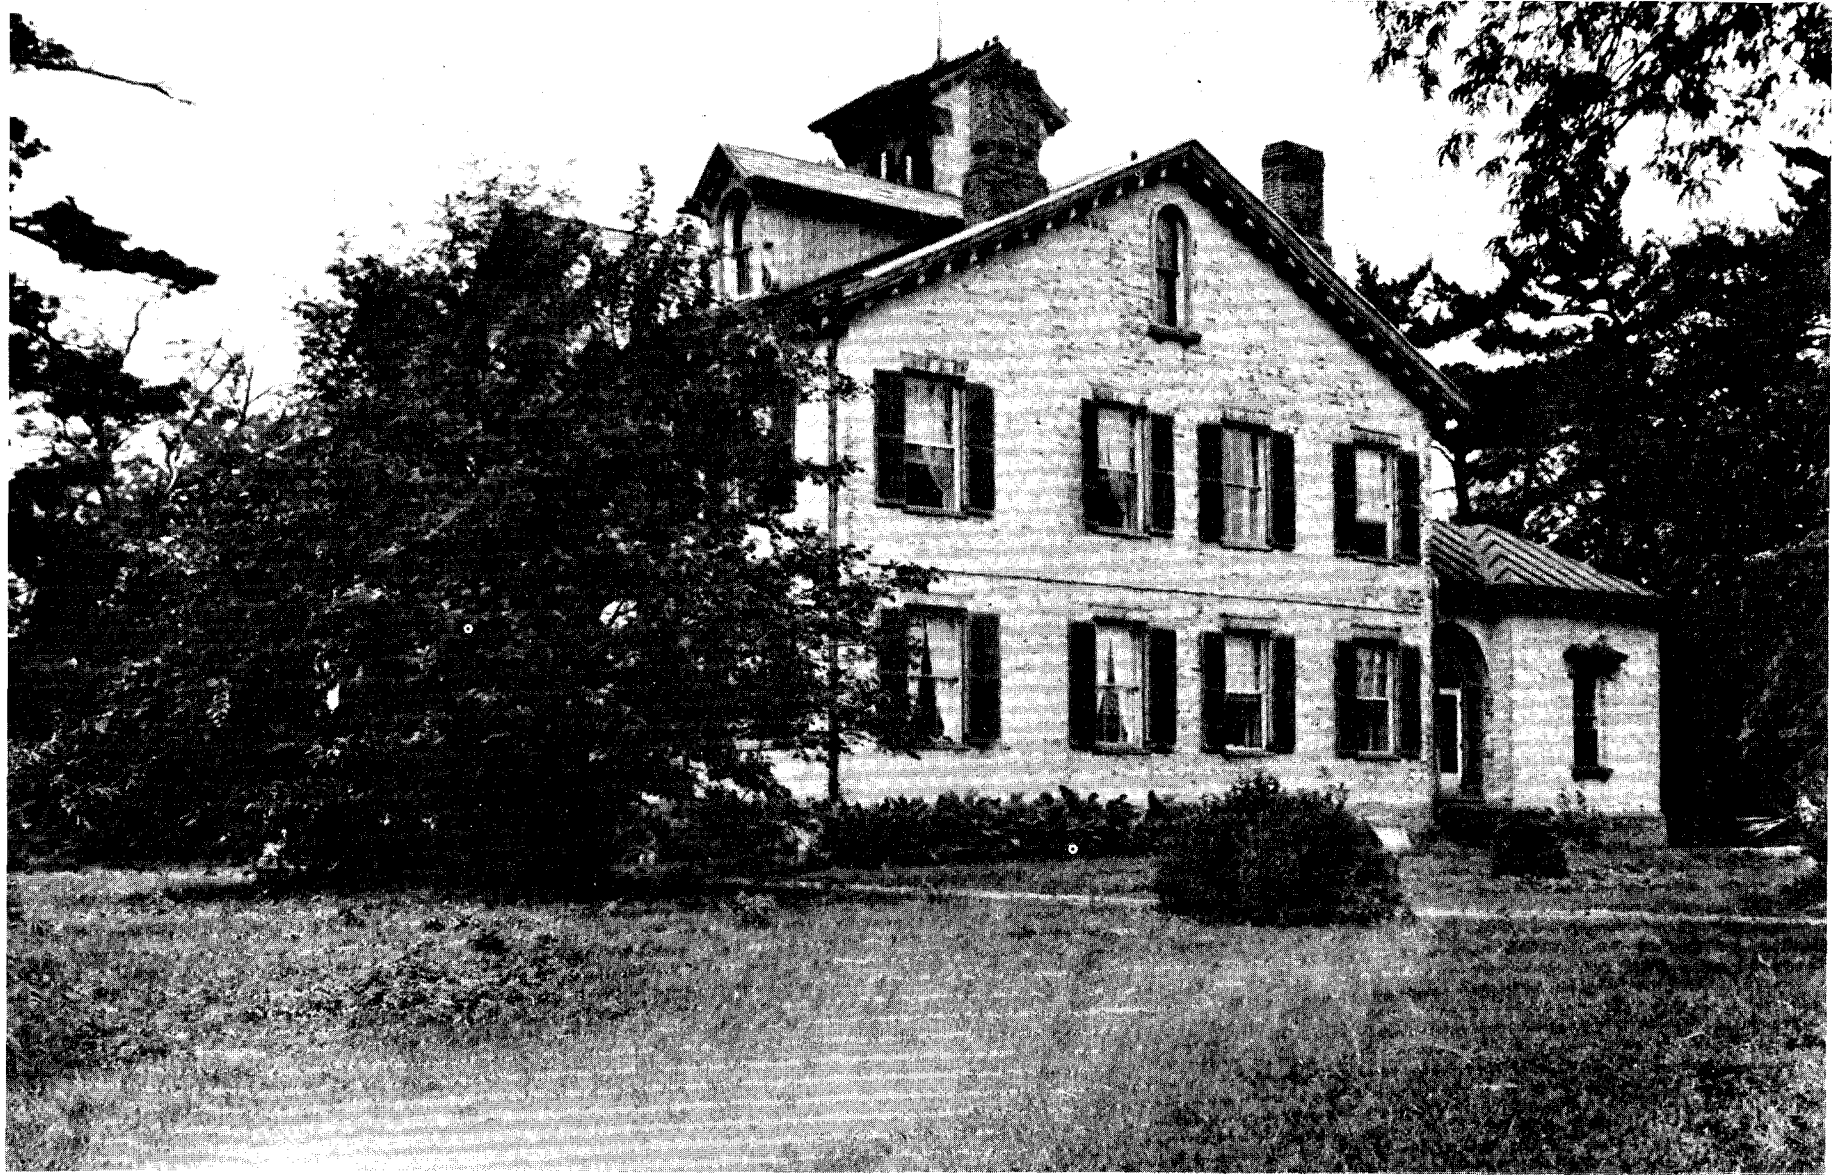
HP27. West End of the North Elevation of Lindenwald, 1936. This photograph was taken by Melvin Weig on August 3, 1936. The following details should be noted:

There is a white-painted screen door at door 109.

The belvedere windows are missing lights.

The lower section of the downspout is stock corrugated sheet metal (replacement).

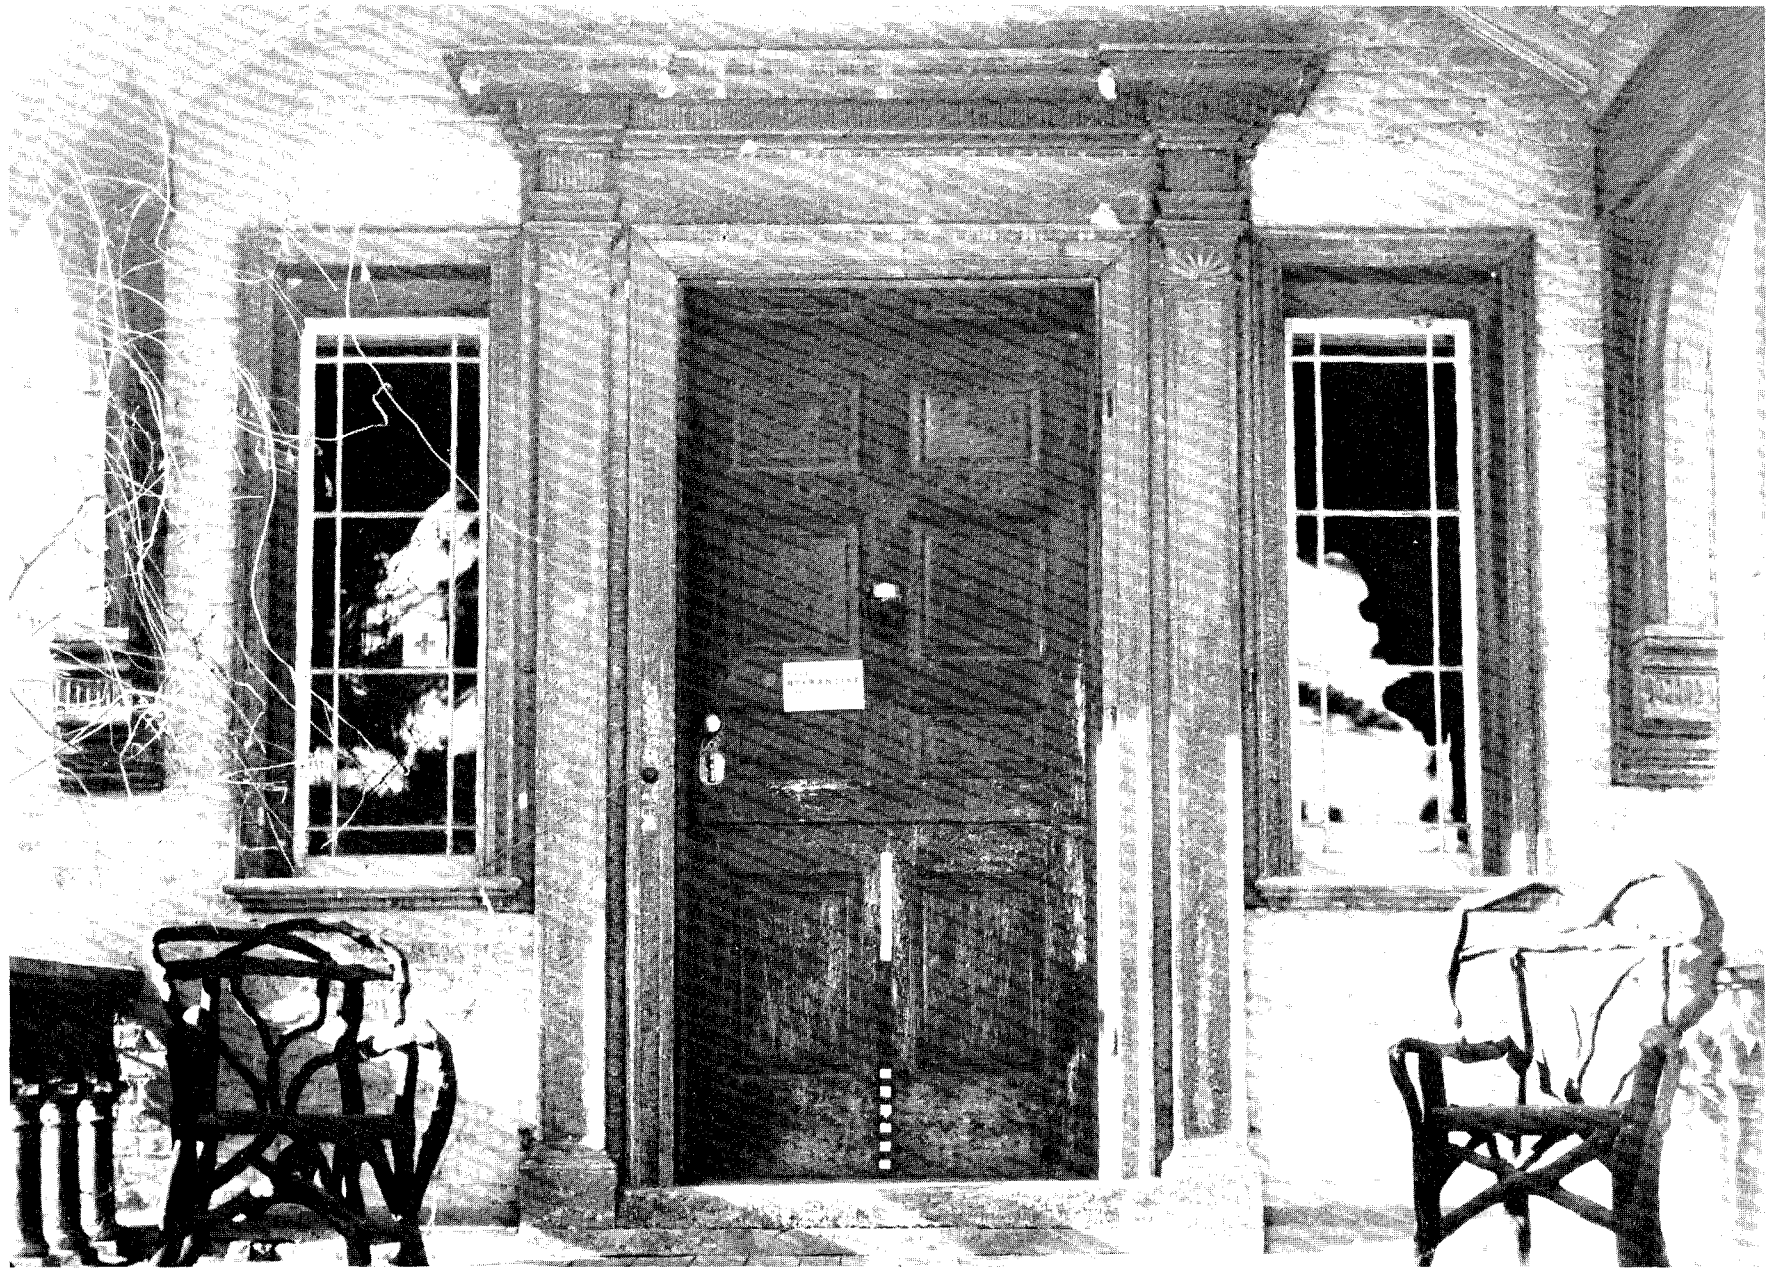
HP36. North Elevation of Lindenwald, 1937. This photograph was taken by Nelson Baldwin in January 1937. The following details should be noted:

The paint scheme is the same as in HP33.

Remnants of ferns are present at the east end of the north foundation wall.

There is a cover over window 007.

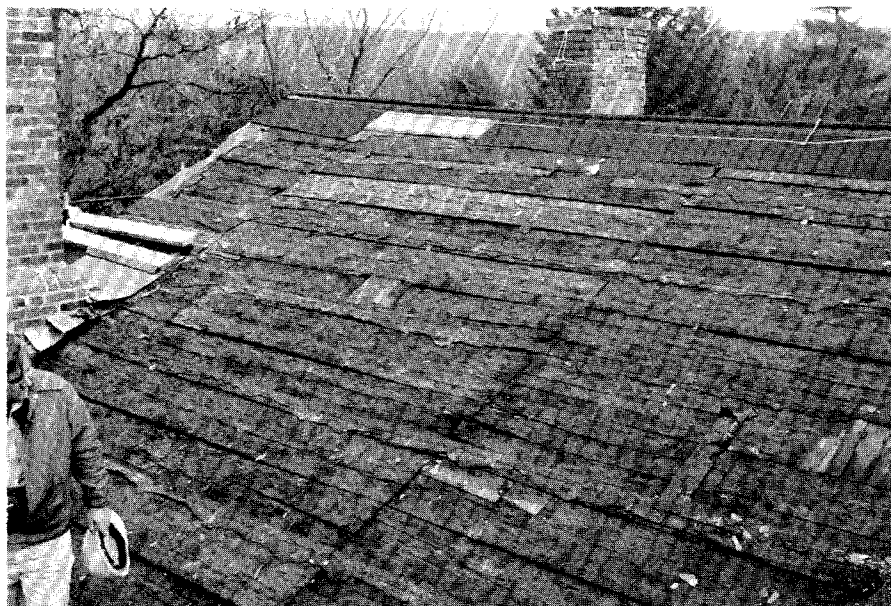
IP004, N039-07. Main roof, northwest corner looking northeast. Note shingle shims.

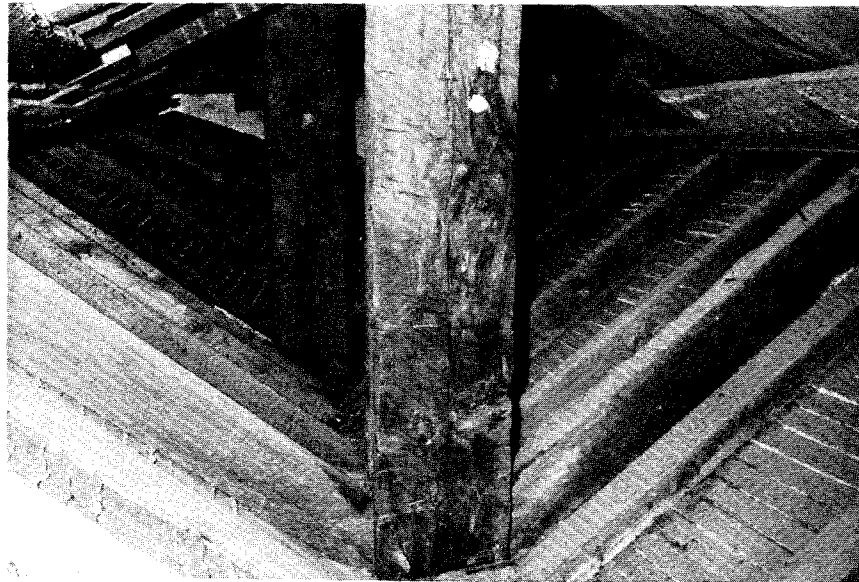
IP005, N002-11. Kingposts above ca. 1849 ceiling. Note plaster on end wall.

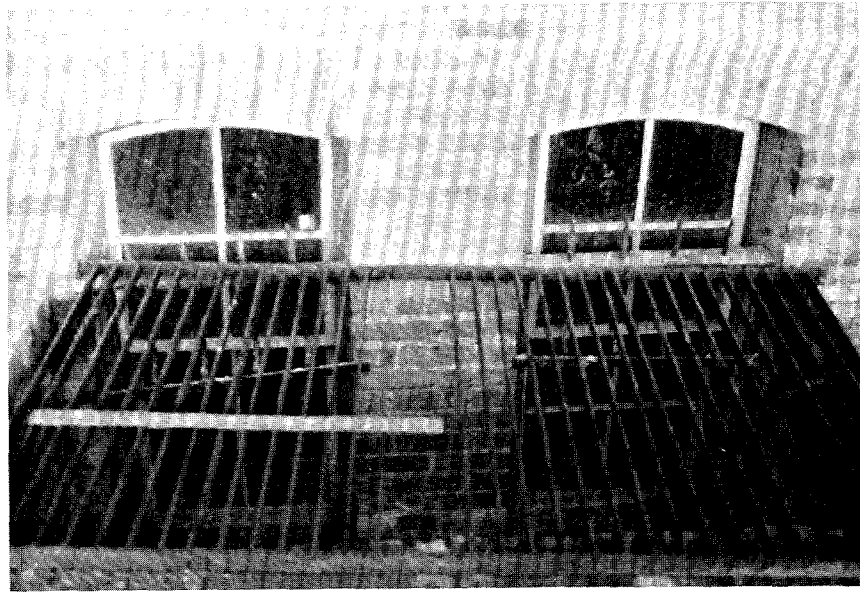
IP010, N019-14. Window well 012-13.

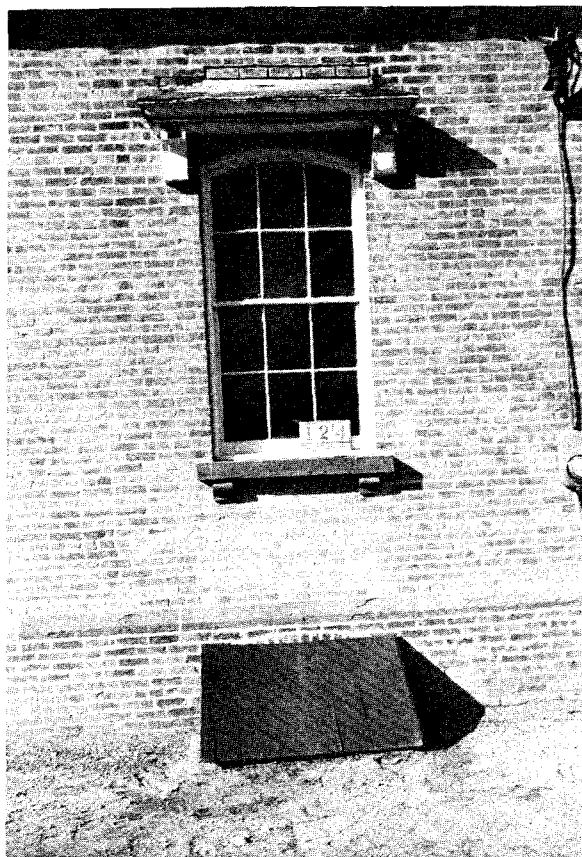
IP013, N013-05. Window 204, ca. 1797 "Gothick" sash above ca. 1840 six-light sash.

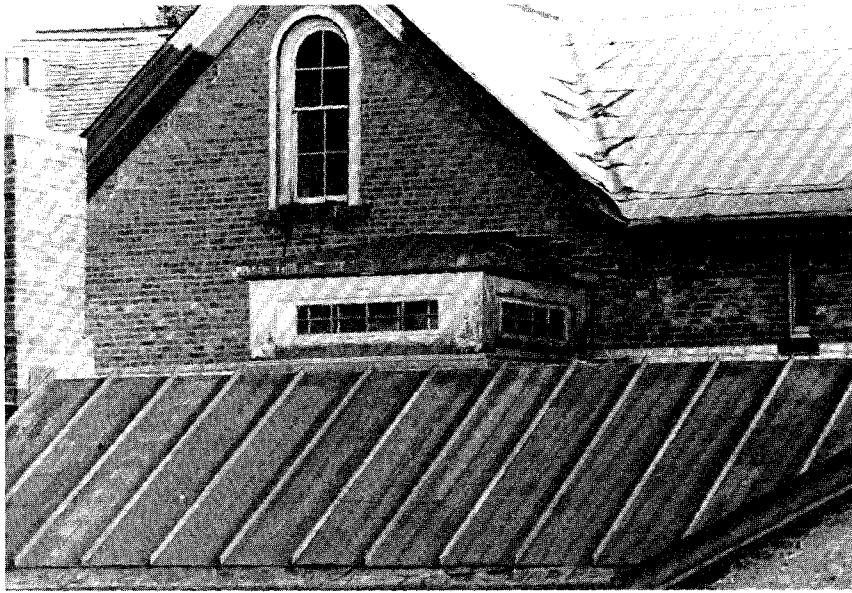
IP016. Gutter liner, rake capping board, and downspout at northwest corner, main roof.

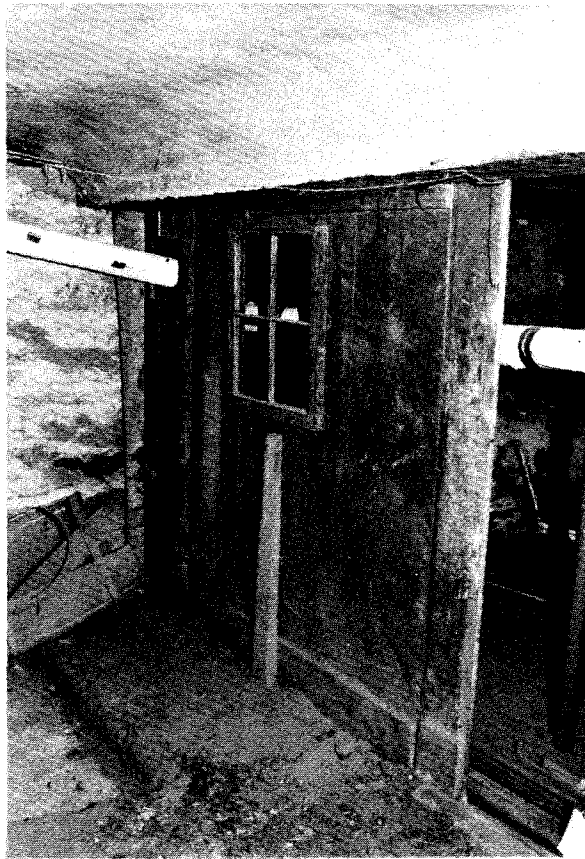
IP018, N008-37. Unidentified feature in floor of room 002.

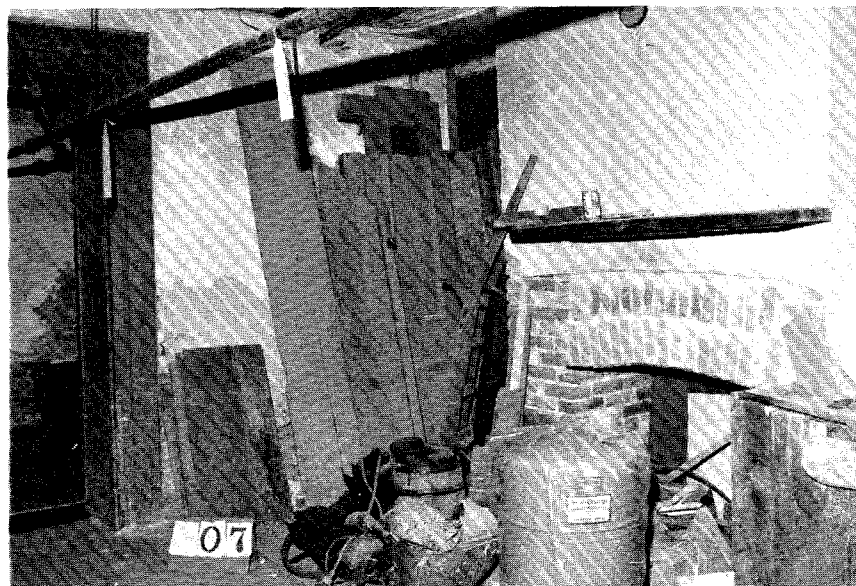
IP021, N007-30. Room 004, northeast corner. Note barrels on rack and porch pieces on floor.

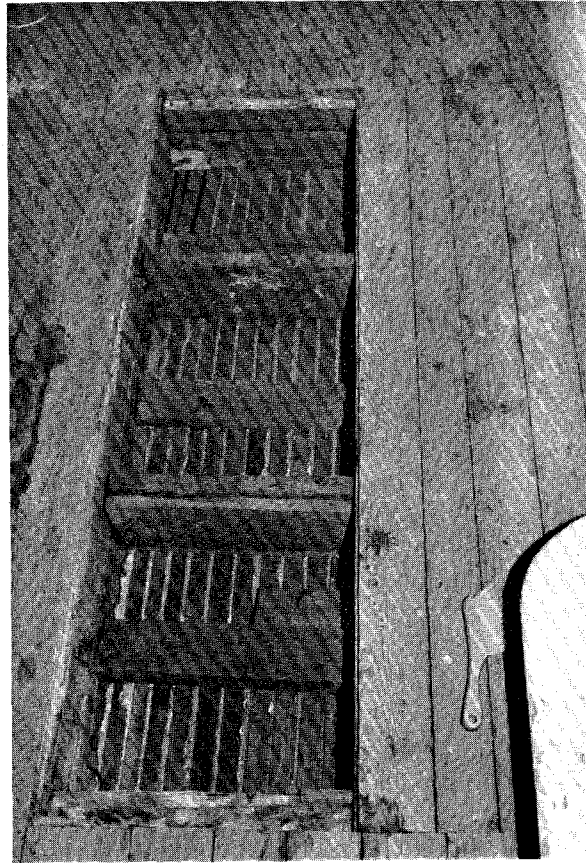
IP026, N022-29. Room 104, south wall and door 102. Note register opening in southwest corner.

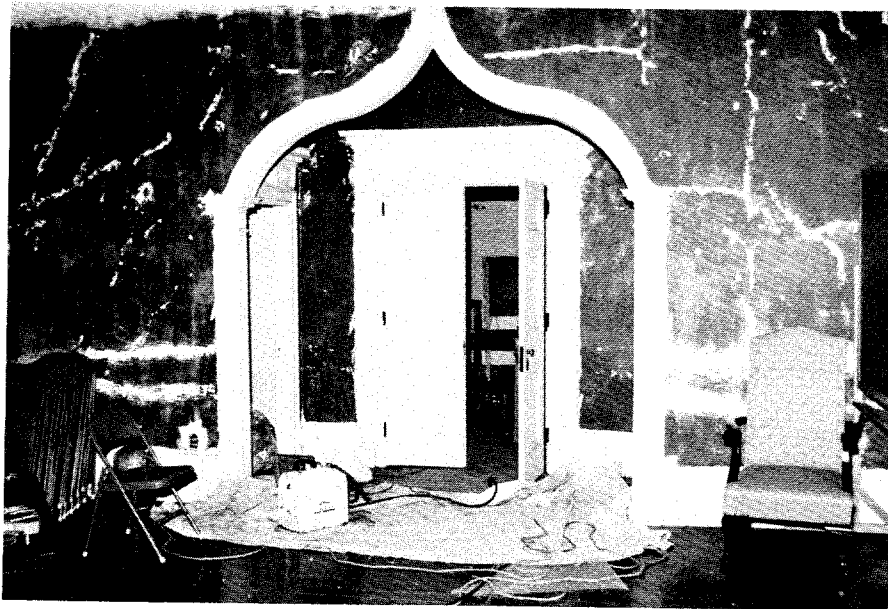
IP030, N023-24. Room 106, east wall. Note historic wallpaper revealed by removal of mirror between windows 101 and 102.

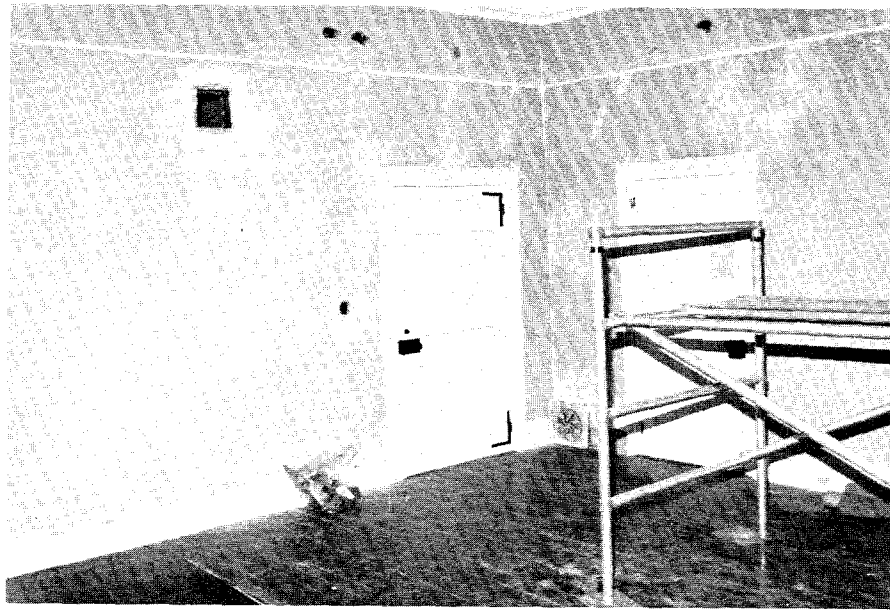
IP042, N030-37. Room 201 west wall. Note shelves in former window opening.

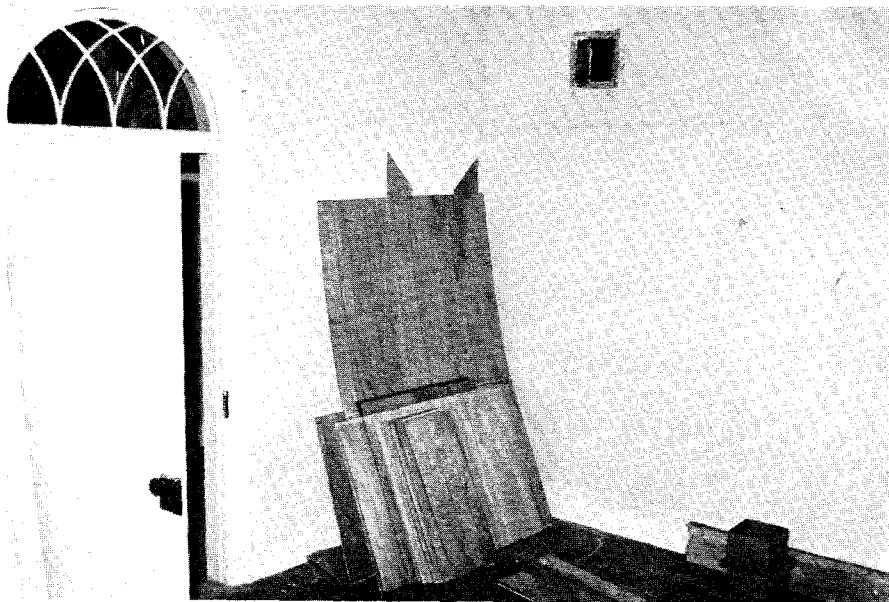
IP043, N030-31. Room 205, south and west walls. Note outline of former door opening (door 219) on south wall and ventilation opening above.

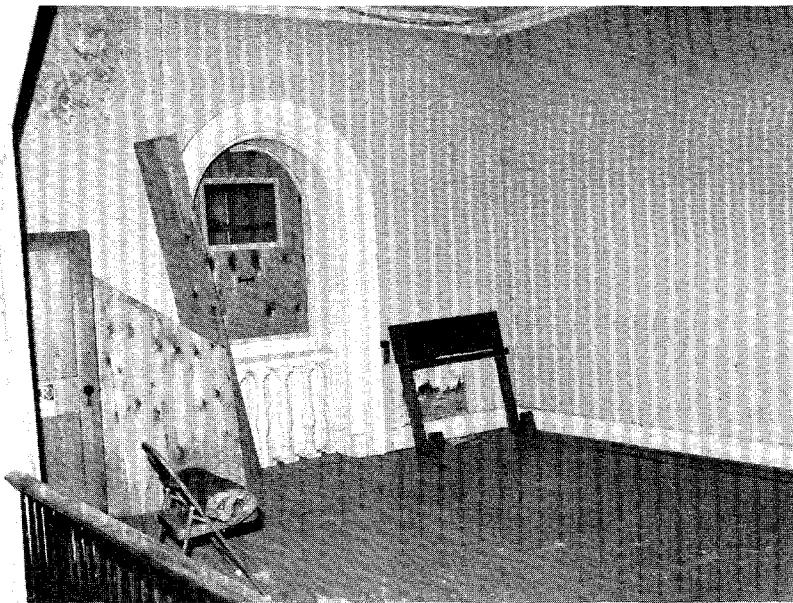
IP044, N030-23. Room 208, northwest corner. Note faint outline of former door opening (door 219) on north wall below ventilation opening and patch of chair rail across door opening.

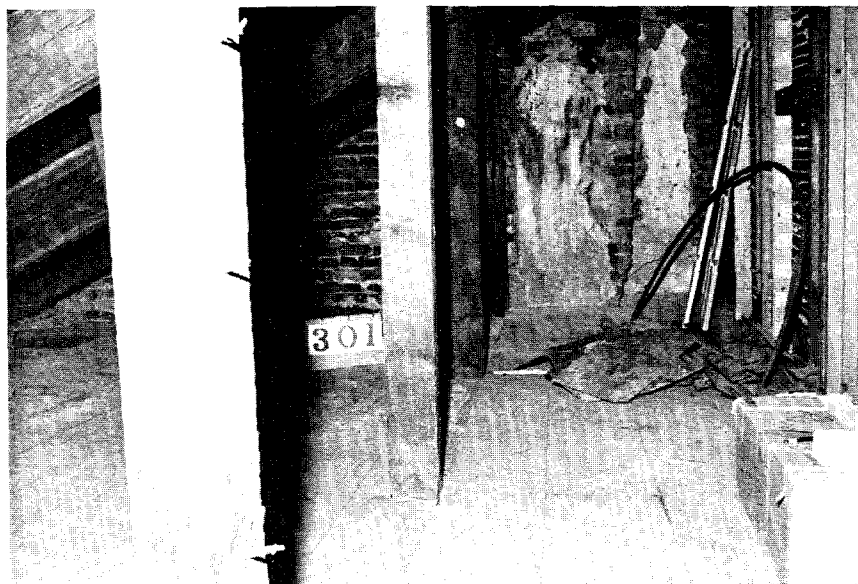
IP059, N006-32. Room 301, looking north to plastered gable end, with knee braces to the left. Note T-head wrought nails in nearest knee brace.

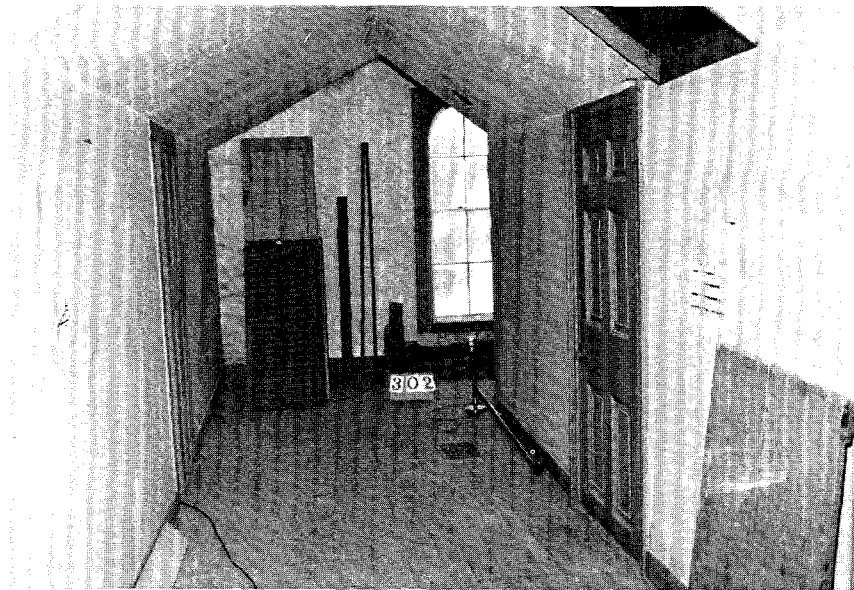
IP060, N008-08. Room 302, looking north past door 305 on the right and 306 on the left to window 305. The faint outline of the former stair opening can be seen near door 305. Note also the floor register and the hatch opening to the ridge space.

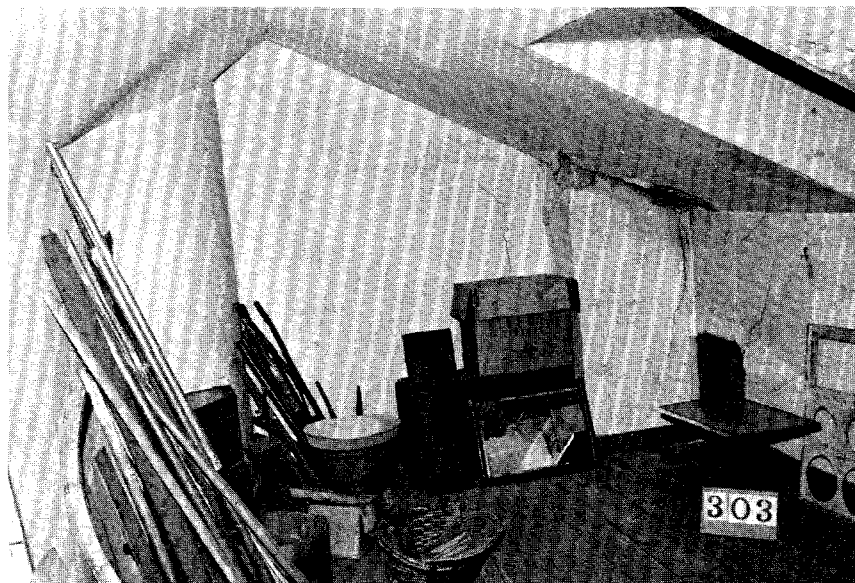
IP061, N008-11. Room 303, looking north. Curve at left was made to provide light from window 305 to room 302. Faint outline of former window 304 can be seen on north wall.

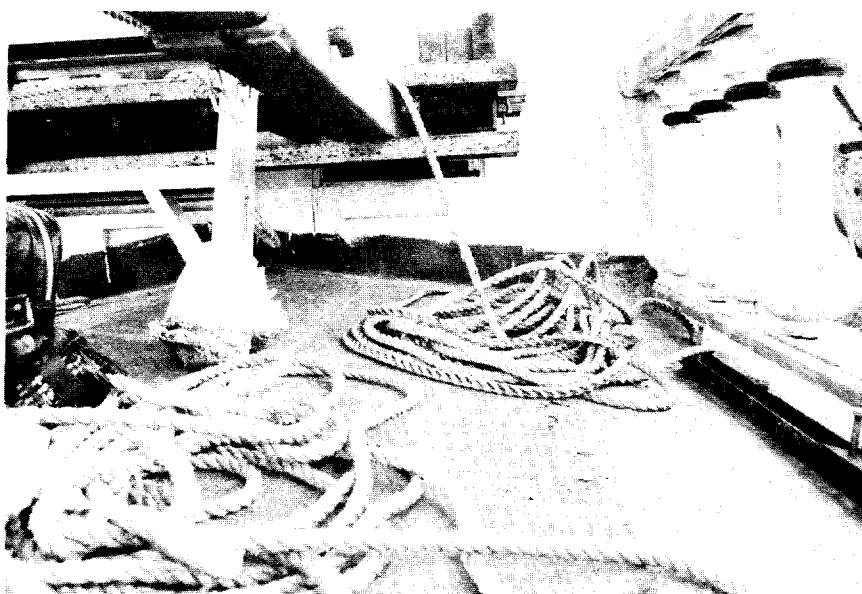
IP007, N032-02. Belvedere (room 501), deck.

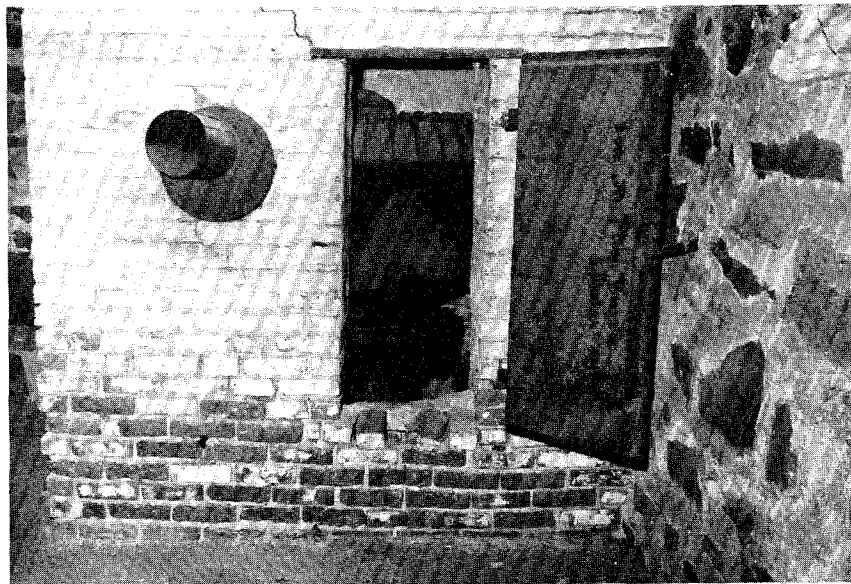
IP081, N010-05. North wall of furnace enclosure. Note inscription on door.

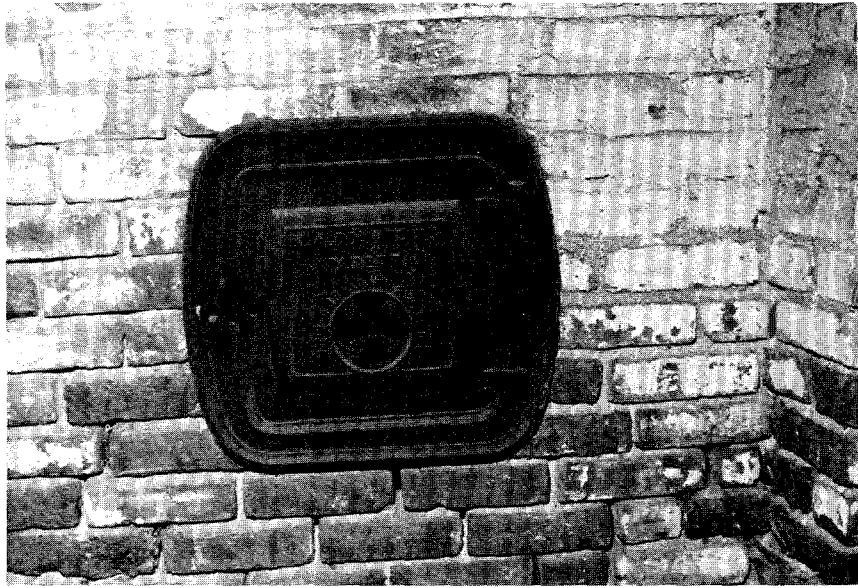
IP083, N010-04. Cast-iron fuel door with patent data.

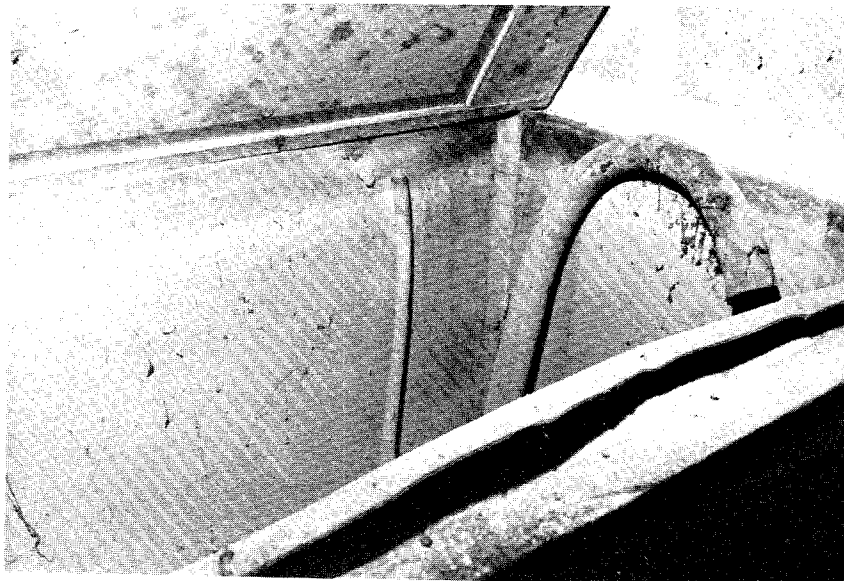
IP094, N018-17. Water tank, room 115, filler and overflow pipes.

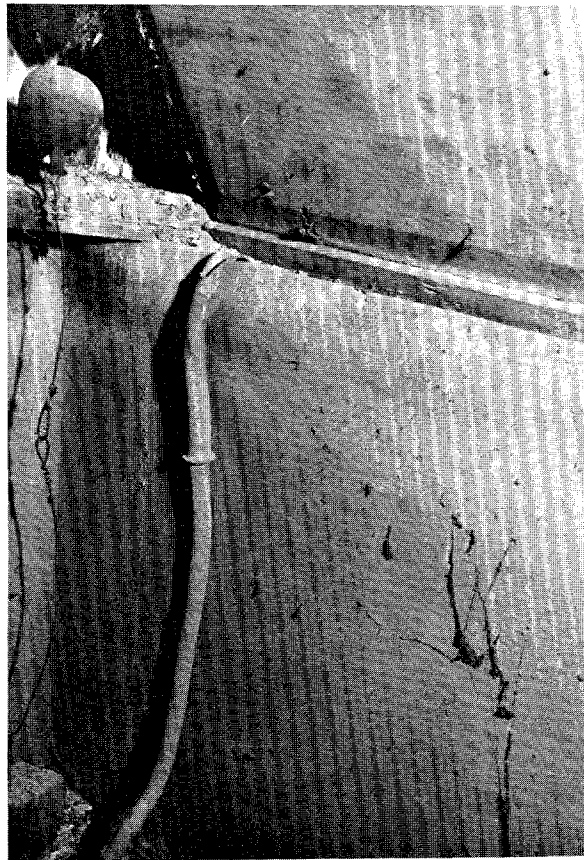
IP095, N018-18. Water tank, room 115, stopper lever and vacuum breaker pipe.
