historic structure report
architectural data section
volume 2: appendixes
june 1985

HISTORIC STRUCTURE REPORT

Architectural Data Section

MARTIN VAN BUREN NATIONAL HISTORIC SITE

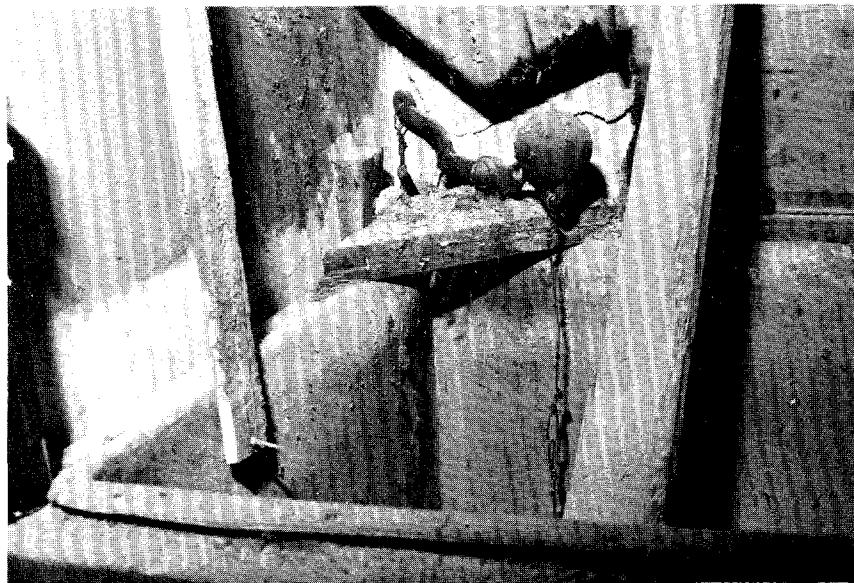
IP096, N018-16. Water tank, room 115, stopper lever.

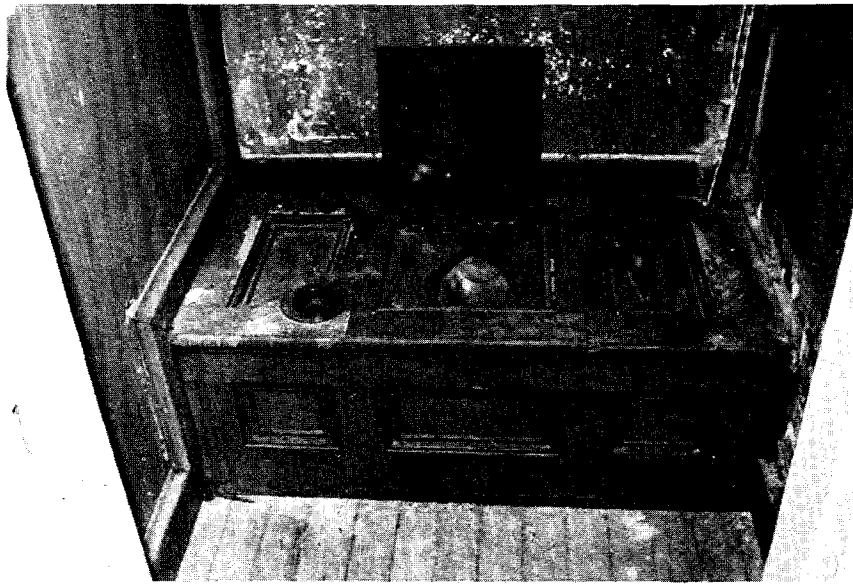
IP097, N018-20. Room 115 water closet and enclosure.

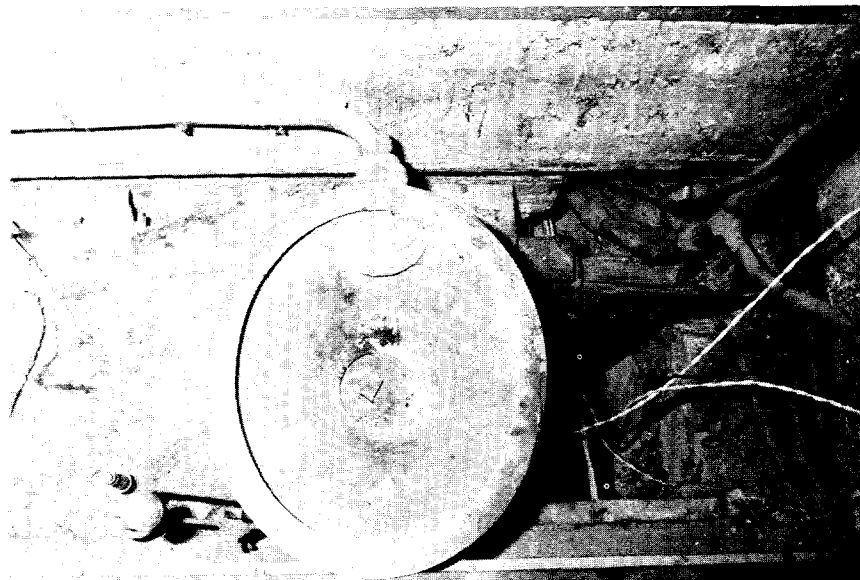
IP098, N036-03. Water closet with top removed.

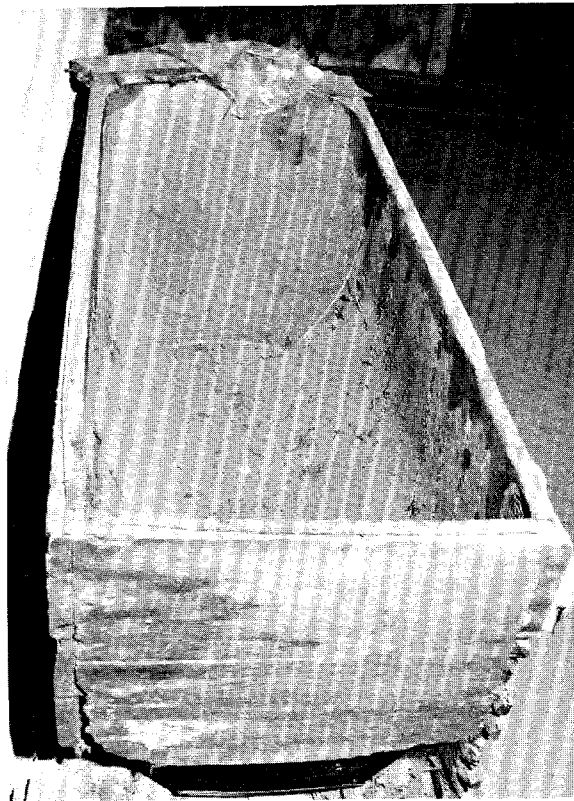
IP099, N007-26. Historic bathtub and case. Note dovetailed joints.

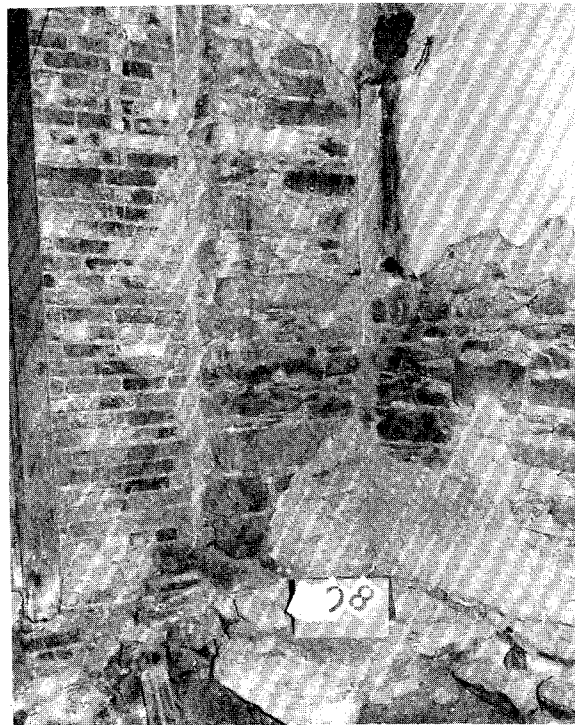
IP100, N009-18. Room 009, brick platform at southeast corner and stovepipe hole above.

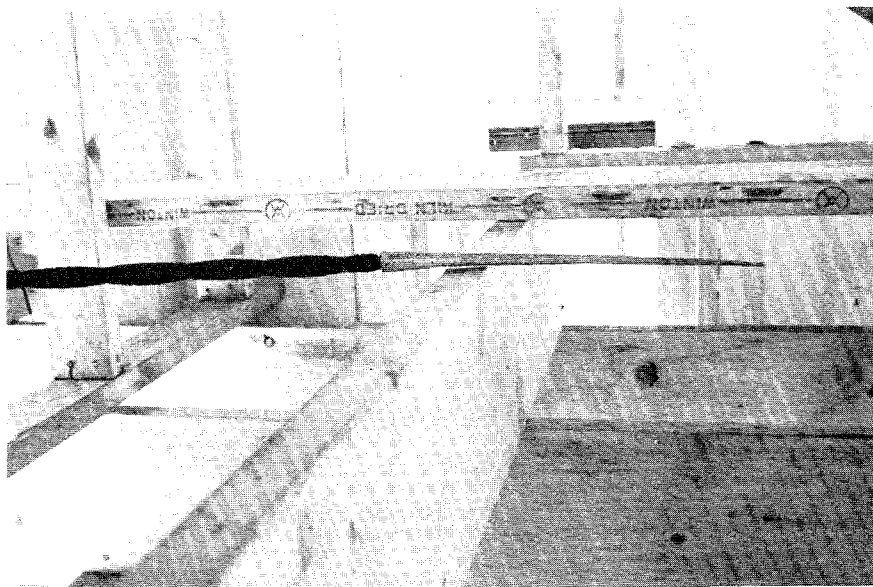
IP102, N031-36. Copper point attached to spiral fluted iron lightning rod.

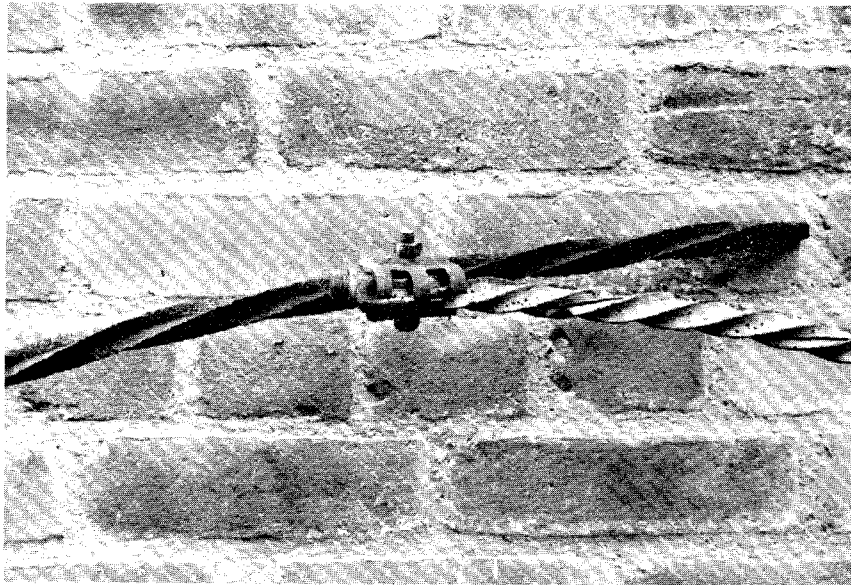
IP103, N050-12. Detail of iron lightning rod.

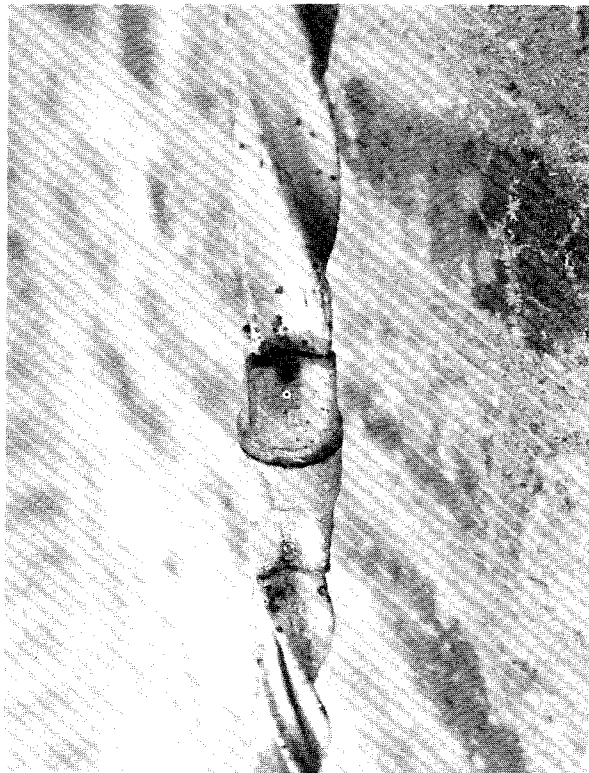
IP104, N034-9. Detail of more recent sheet copper spiral fluted rod with brass connectors marked "RHCO."

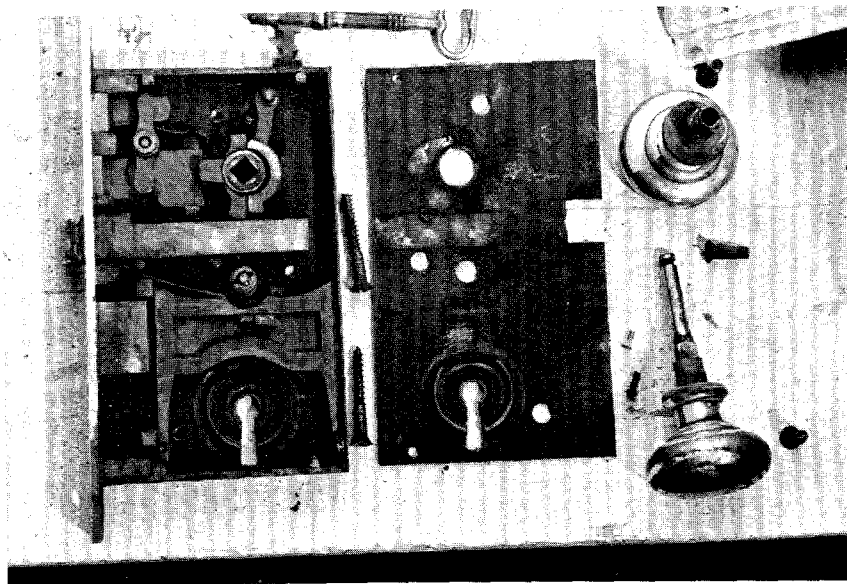
IP121, N017-19. Escutcheon for lock 101.

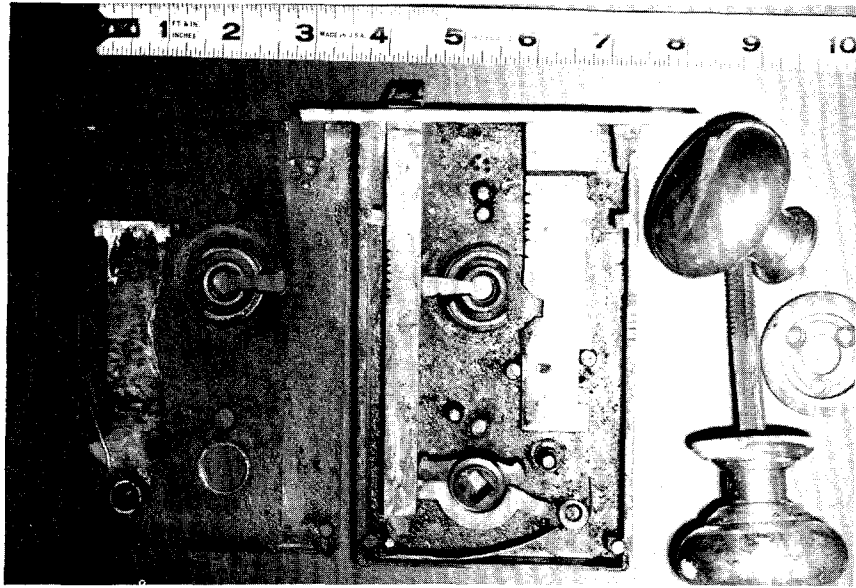
IP124, N016-18. Lock 133.

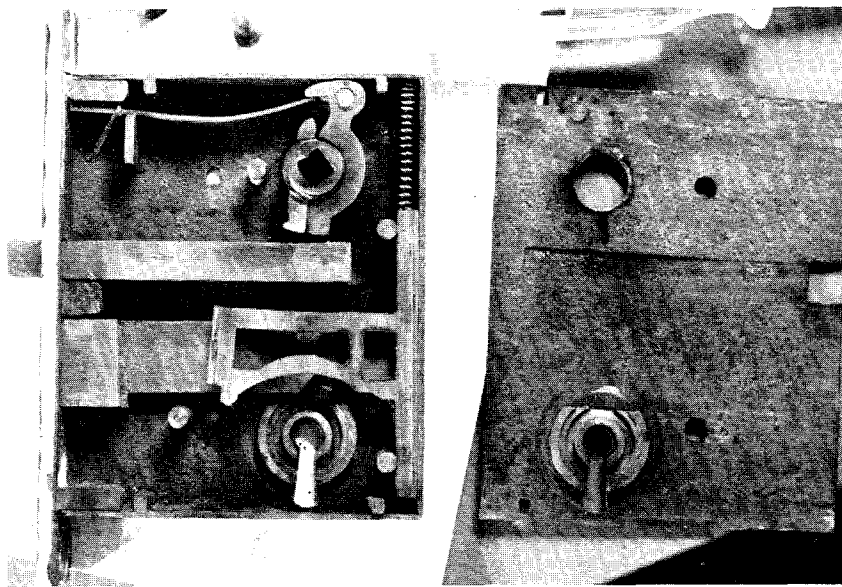
IP126, N026-34. Lock 113.

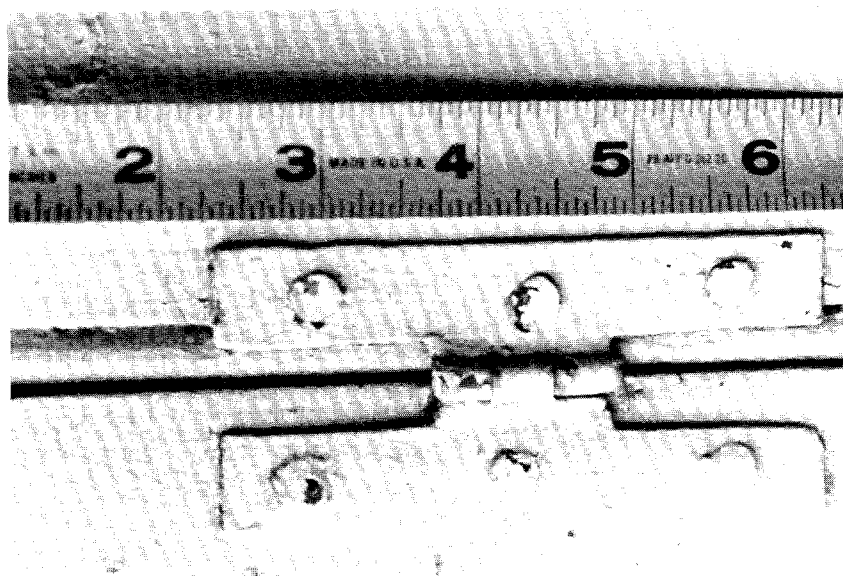
IP129, N030-06. Door 210, typical mounting of HL hinges on ca. 1797 door.

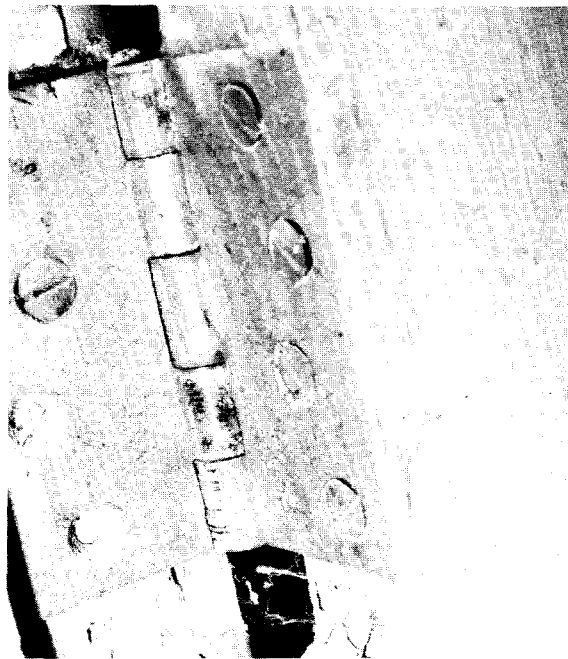
IP131, N037-27. 5" by 3" five-knuckle, ten-hole cast-iron butt hinge.

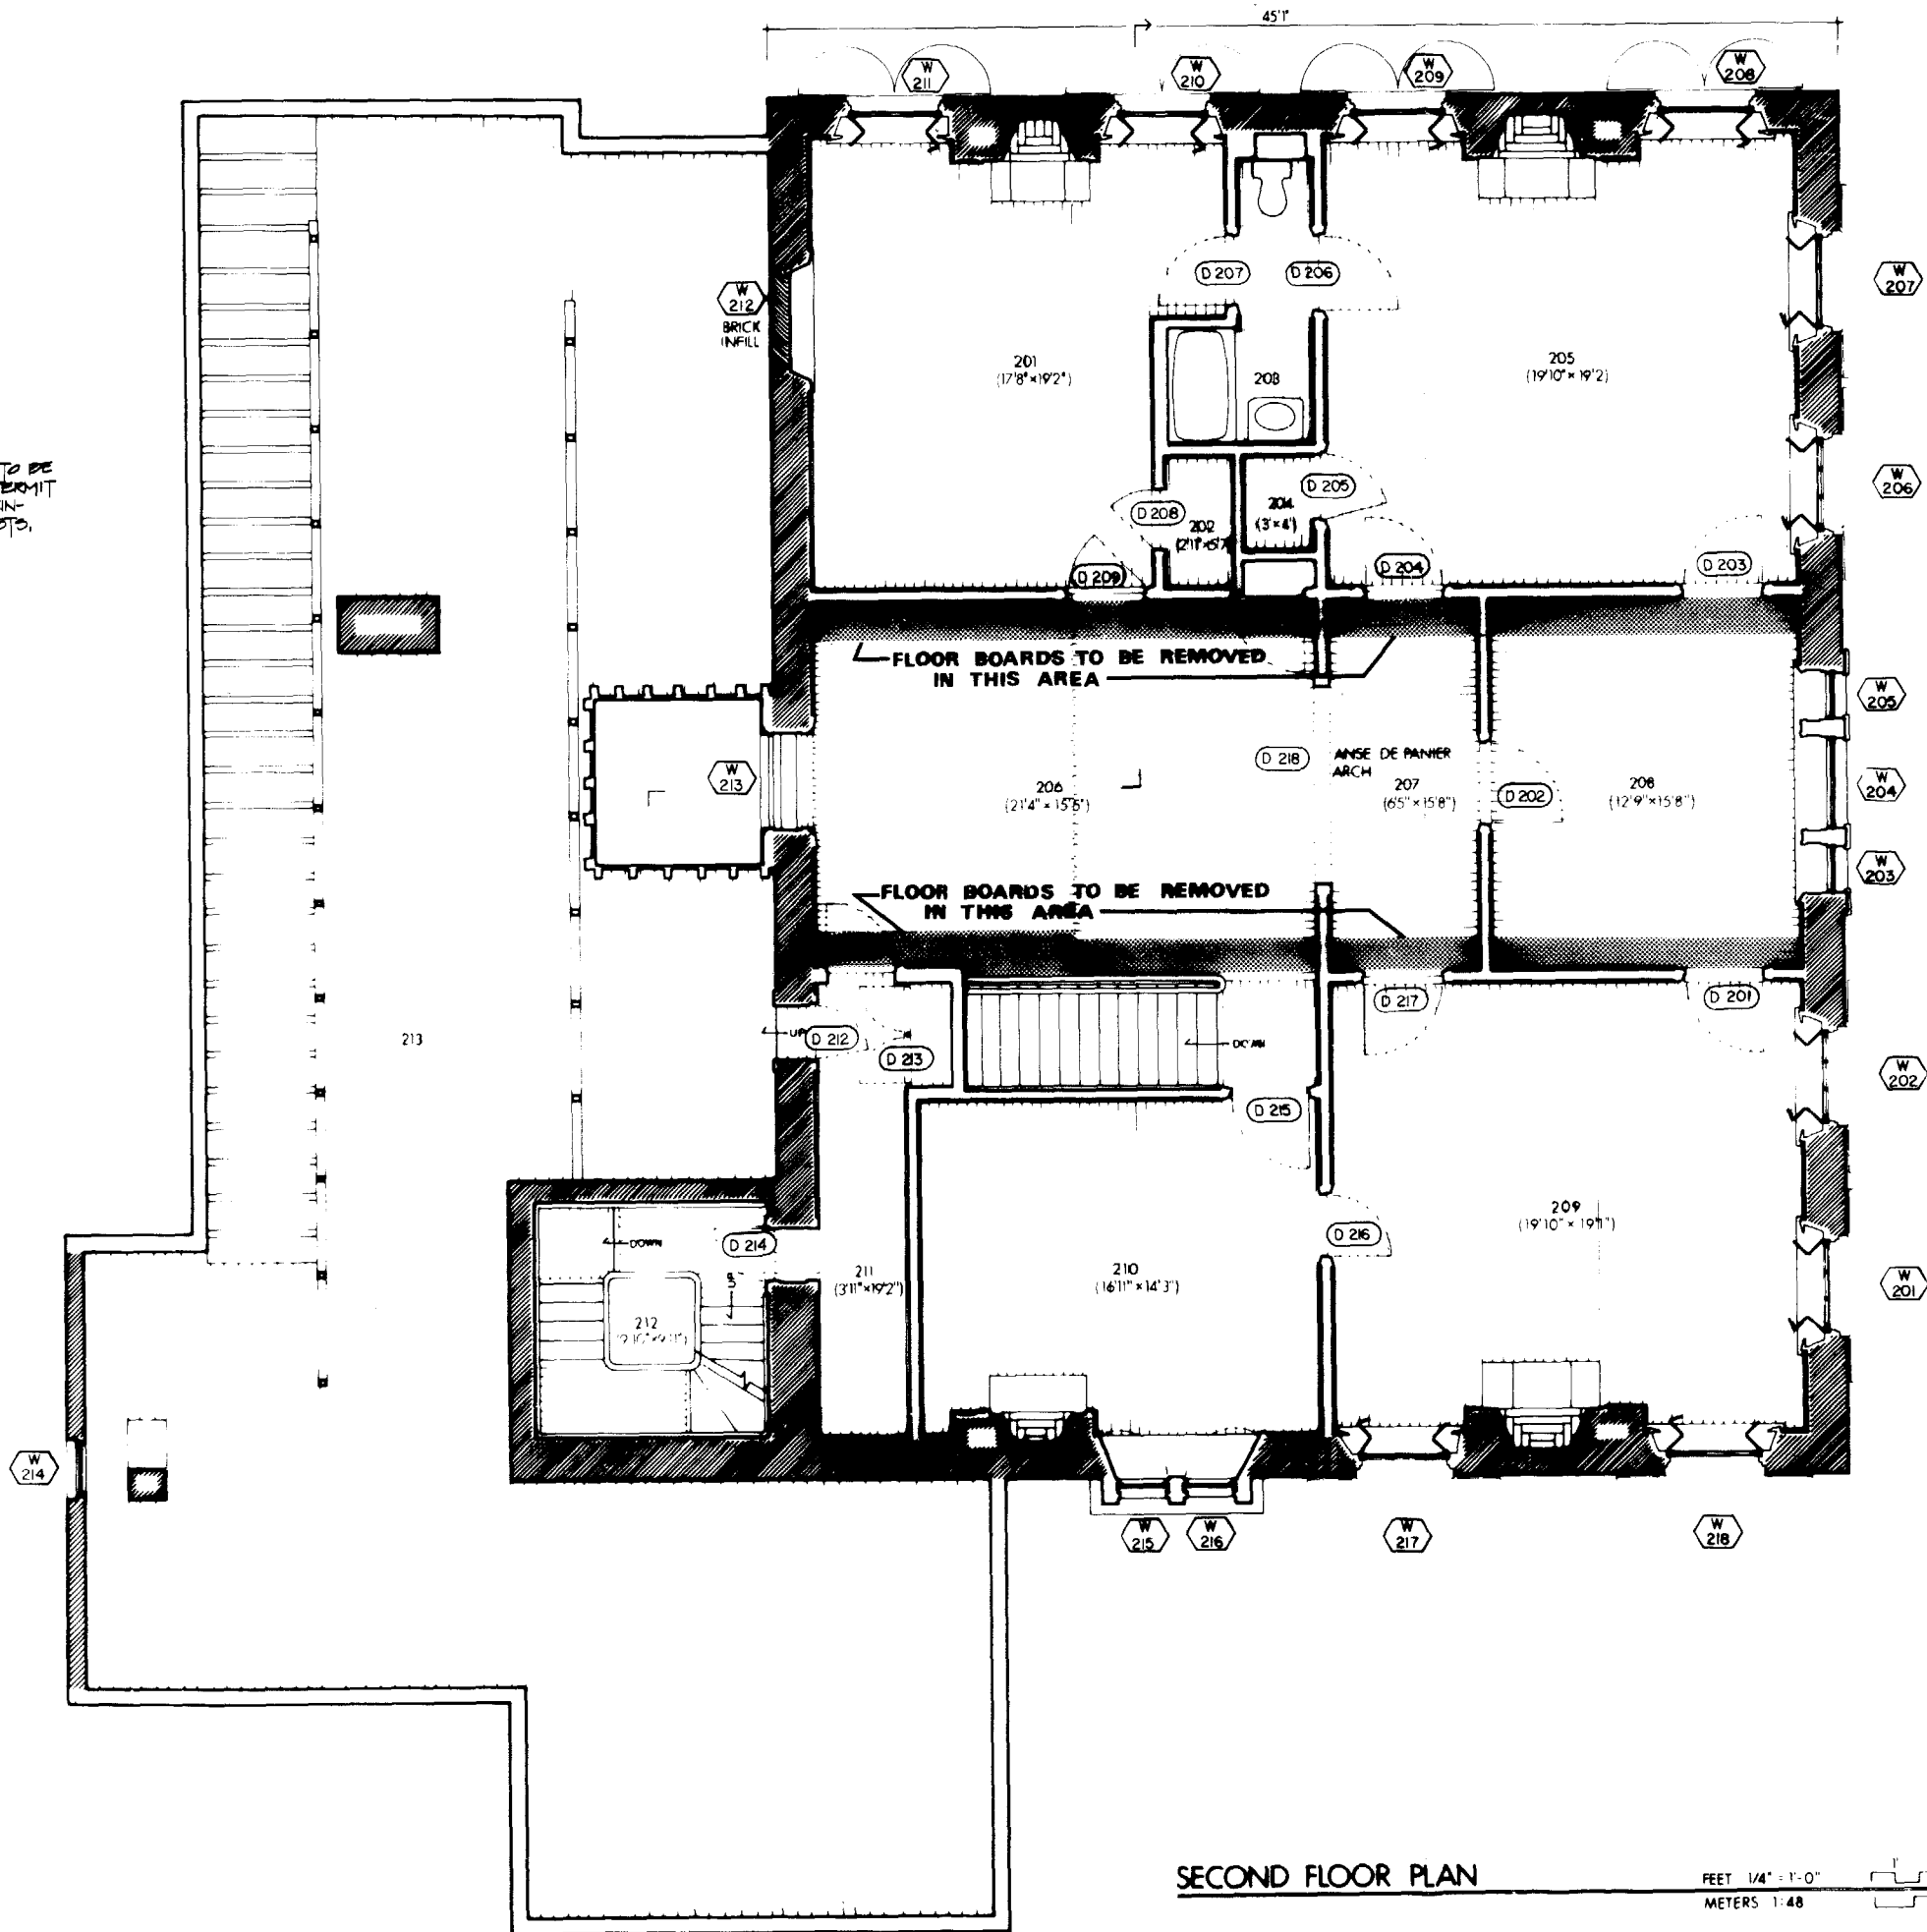
SECOND FLOOR PLAN

FLOOR BOARDS TO BE REMOVED TO PERMIT STRUCTURAL REINFORCING OF JOISTS.

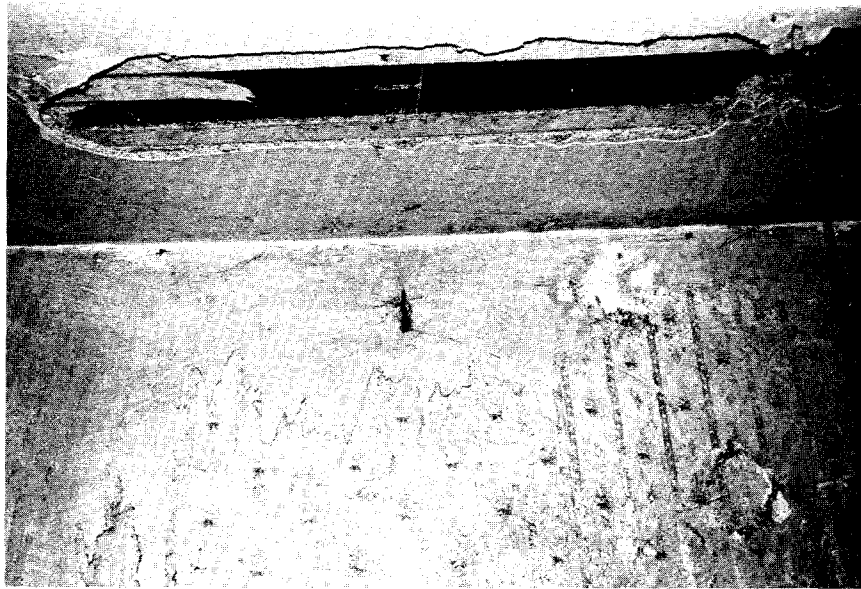
Sample No: MAVA 01 WP001
Location: Room 005 (west wall)
Substrate: Plaster

Comments: This wallpaper hangs in the servants' dining room. It was the only wallpaper found in the basement. The moisture of the basement has caused the paper to deteriorate significantly so that it crumbles when an attempt is made to remove it from the walls.

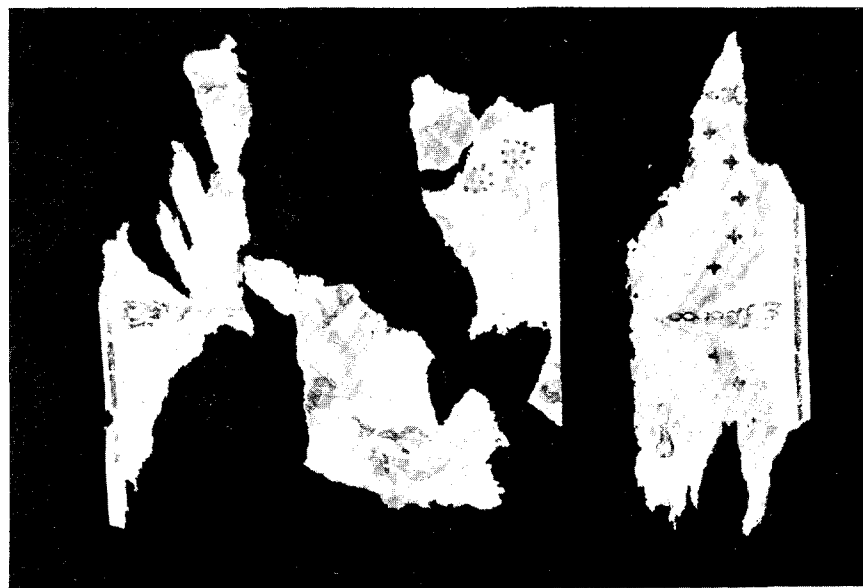
Comments: This paper was found on the east wall of room 106, behind the pier mirror that hung between the windows. It was covered by two later layers of wallpaper before the pier mirror was hung. The wallpaper does not extend across the chair rail area. The border ran down the sides of the windows as well as at the cornice. The paper has horizontal seams, indicating that it was handmade. A portion of this wallpaper is still on the walls and should be conserved.

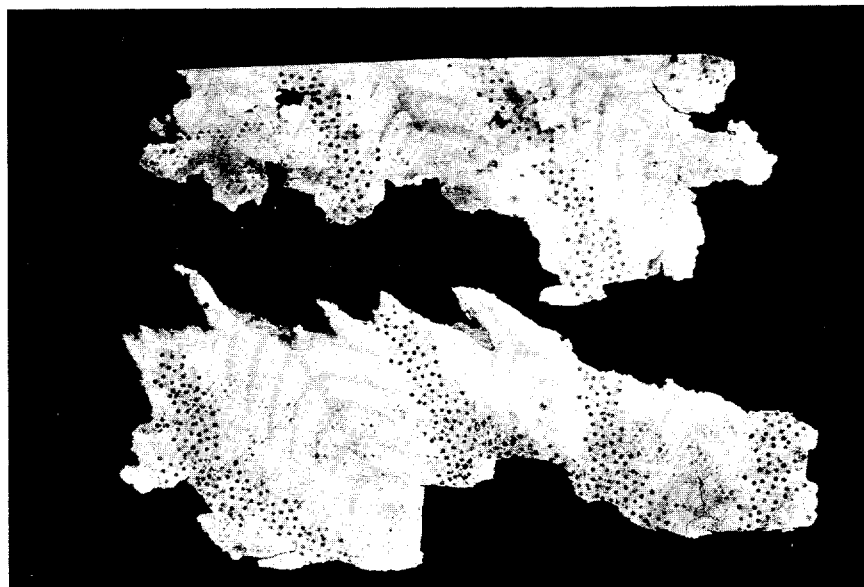
Sample No: MAVVA 01 WP 005
Location: Room 106 (east wall)
Substrate: Plaster

Comments: This is the second layer of wallpaper (counting up from the plaster) found under the pier mirror in room 106. It does not extend across the area from which the chair rail was removed, indicating that it predates Van Buren. Part of a strip of this wallpaper is still on the walls and should be conserved.

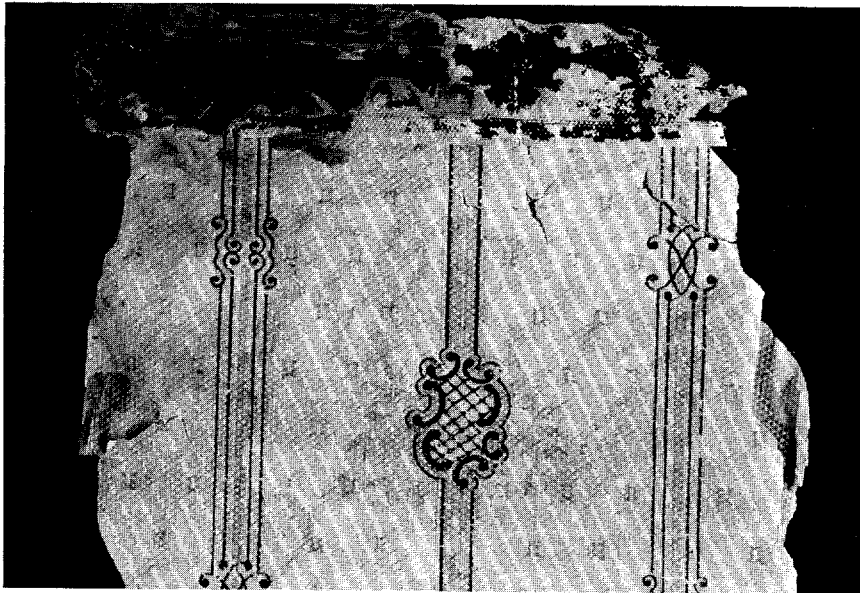
Comments: This is the third layer of wallpaper (counting up from the plaster) found under the pier mirror in room 106. It extends across the area from which the chair rail was removed. It is directly on top of the green lining paper that was placed over the chair rail area, indicating that it is very likely a Van Buren wallpaper. Nearly a full panel of this wallpaper still hangs in room 106. It should be removed from the walls and conserved. The border is the same border found on the fireboard of room 109.

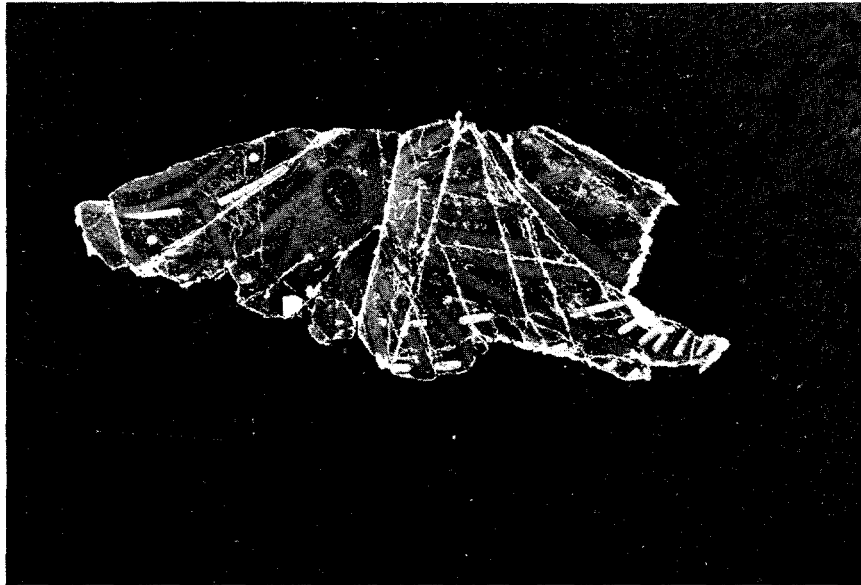
Sample No: MAVA 01 WP009
Location: Room 109 (north wall
under stair platform)
Substrate: Plaster

Comments: This sample was found under the stair platform of room 109. It was loose and therefore cannot be positively identified as having come from this room. The fragment is too small to be used as the basis for a reproduction wallpaper.
