VIRGIN ISLANDS NATIONAL PARK
Cruz Bay, St. John, U.S. Virgin Islands

CANEEL BAY
STRUCTURAL ASSESSMENT REPORT

NATIONAL PARK SERVICE (NPS)
SOUTH EAST REGION (SER)

July 2025

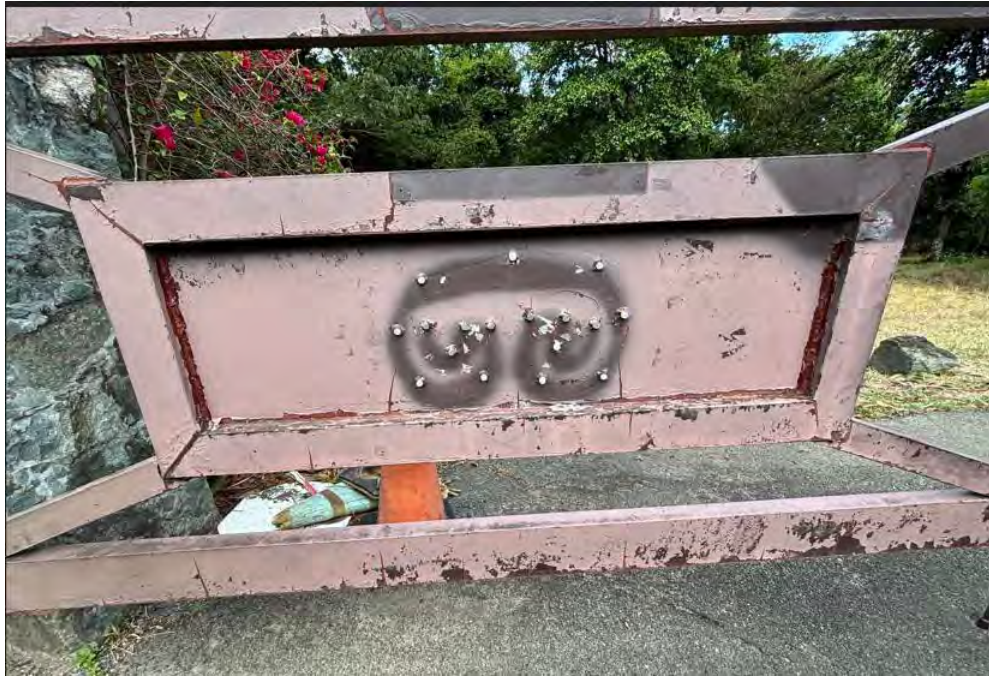
Building: 88 Welcome Center

Structural Assessment: Potentially

Repair or Rebuild

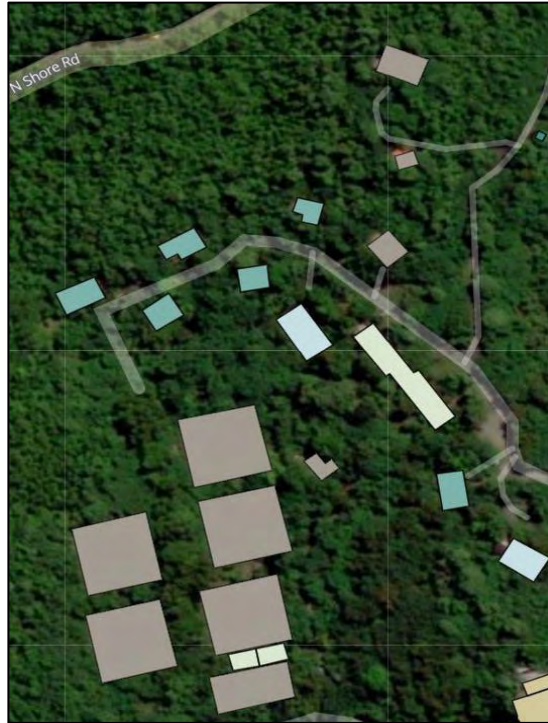
Building: 57 Garden View Units 132-133

Structural Assessment: Structurally Sound

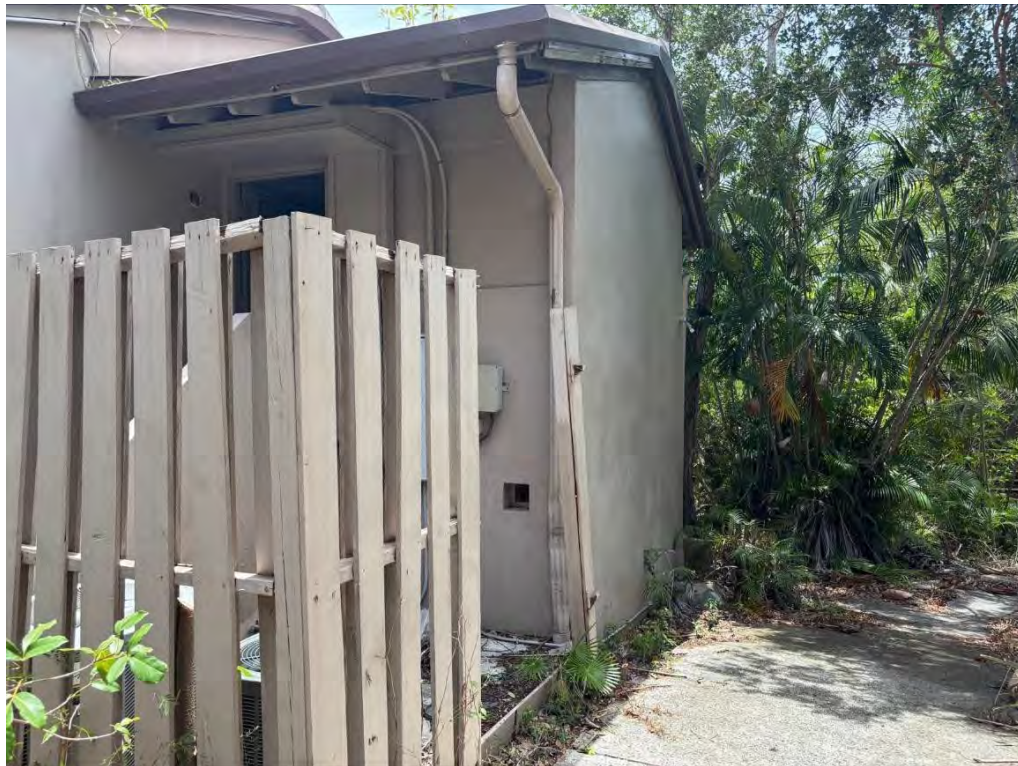
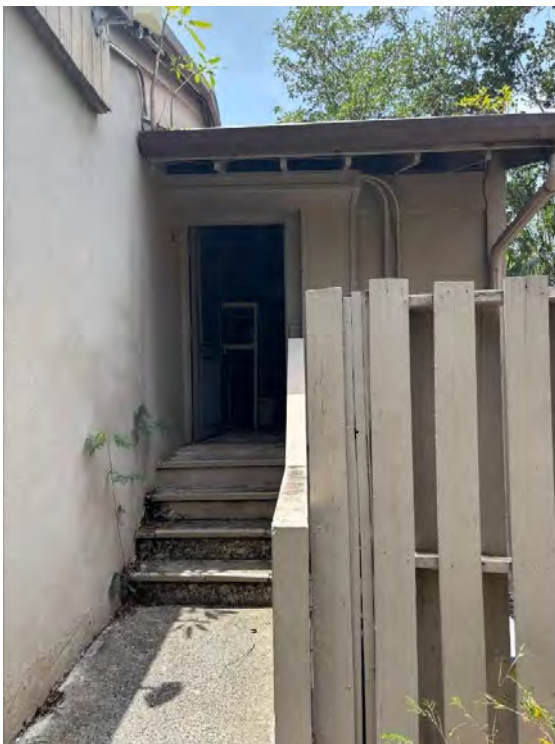
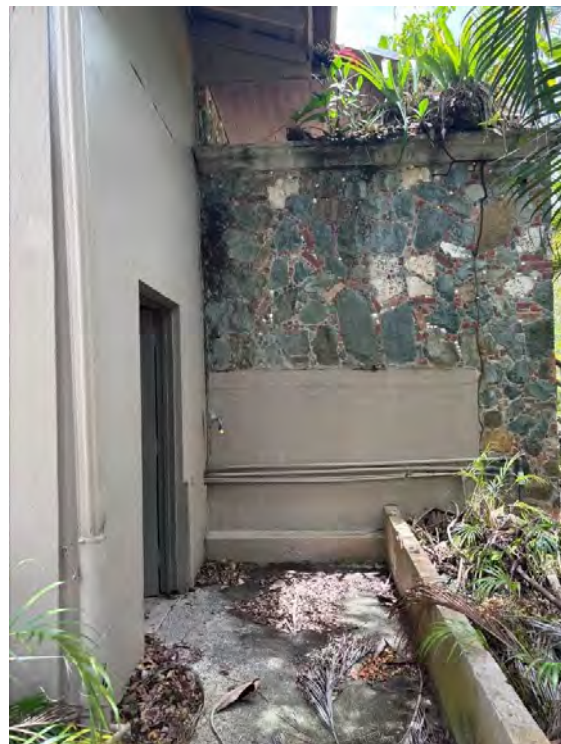
Building: 54 Garden View Unit 154

Structural Assessment: Structurally Sound
